ASBESTOS REFURBISHMENT SURVEY REPORT

1 - 3 Boltro Road, Haywards Heath, RH16 1BP

14 Mar 2023

Report By	Summit Environmental
Client	Changing Work Place
Project	SE02911
Site Address	1 - 3 Boltro Road, Haywards Heath, RH16 1BP
Site Location

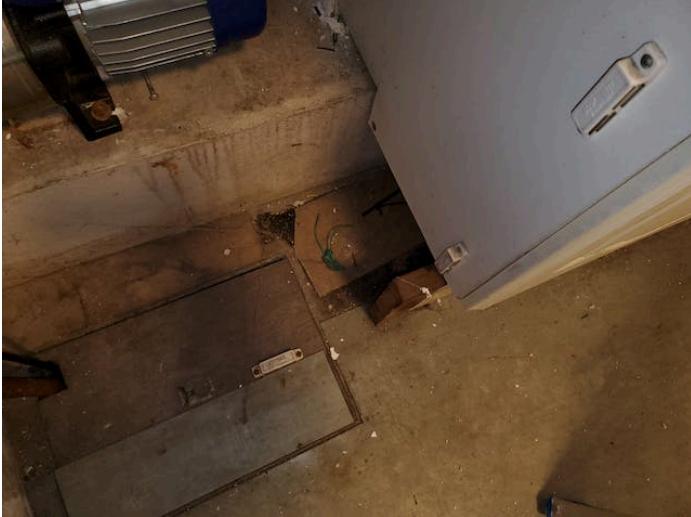
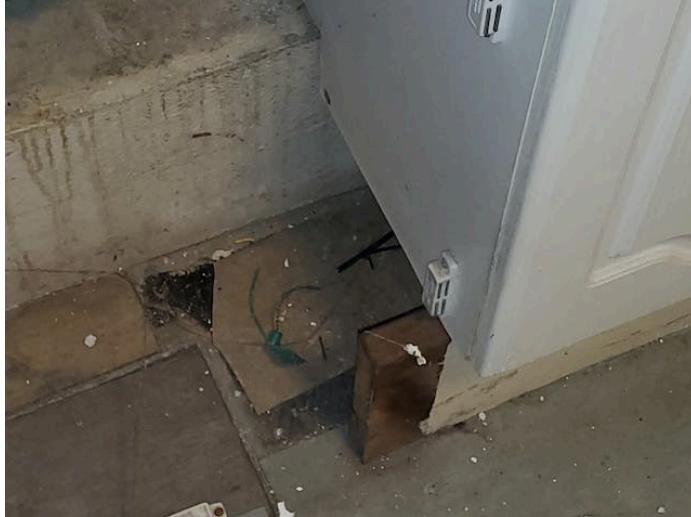
1 - 3 Boltro Road > -1 > 002 - Hallway > Floor tiles

Building	1 - 3 Boltro Road	Level	-1
Location	002 - Hallway	Item	Floor tiles
Material	Vinyl Products	Extent	10m. sq.

Strategy / Sample Id	Sample / 001	Fibre Type	Chrysotile
Recommendation	Remove

Product Type (or Debris from Product)	1	Extent of Damage / Deterioration	1
Surface Type / Treatment	0	Asbestos Type	1
Material Score	3 / Very Low

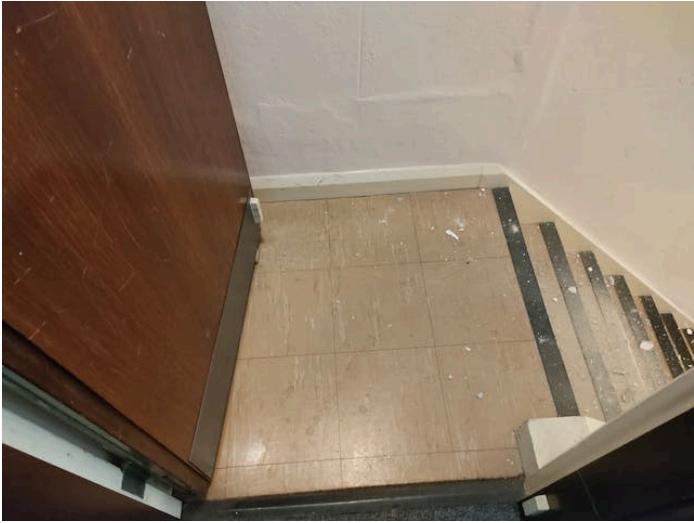
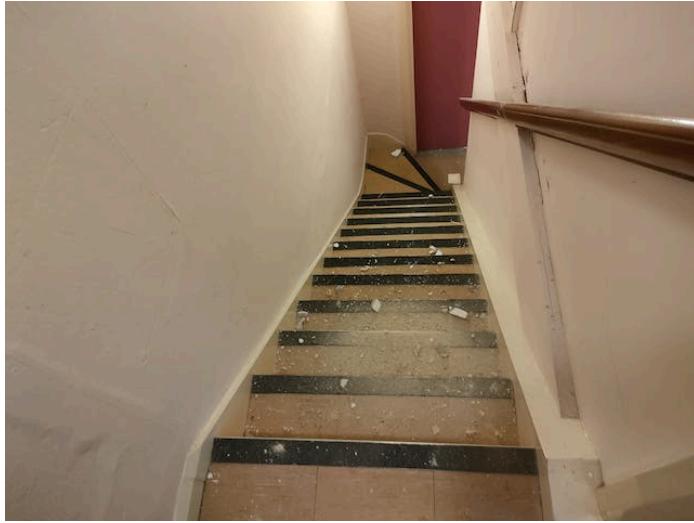
1 - 3 Boltro Road > 0 > 001 - Stairwell to Basement > Floor covering and stair treads - Floor tiles

Building	1 - 3 Boltro Road	Level	0
Location	001 - Stairwell to Basement	Item	Floor covering and stair treads - Floor tiles
Material	Vinyl Products	Extent	10m. sq.

Strategy / Sample Id	Strongly Presume / 001	Presumed Fibre Type	Chrysotile
Recommendation	Remove

Product Type (or Debris from Product)	1	Extent of Damage / Deterioration	1
Surface Type / Treatment	0	Asbestos Type	1
Material Score	3 / Very Low

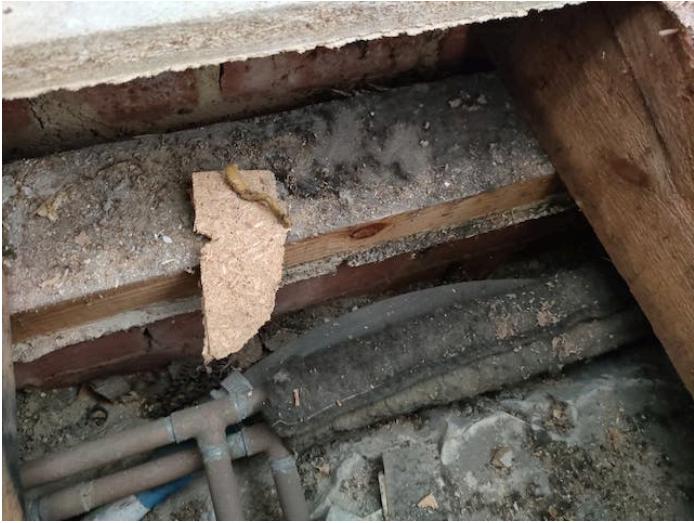
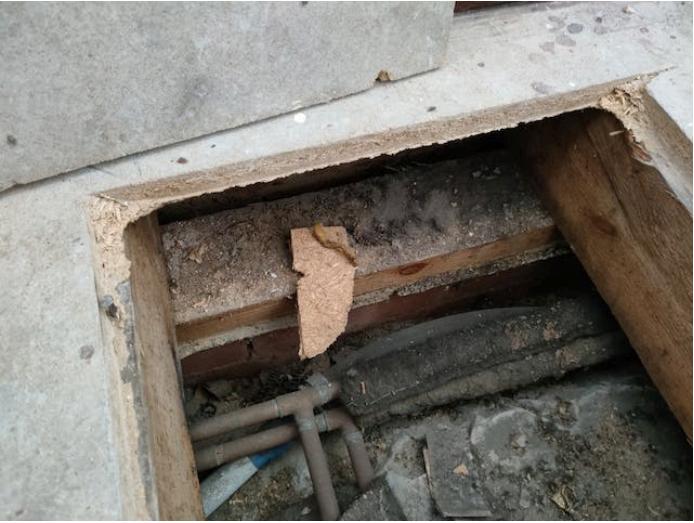
1 - 3 Boltro Road > 0 > 002 - Open Plan Office and Meeting Room > Wall plate lining in floor void

Building	1 - 3 Boltro Road	Level	0
Location	002 - Open Plan Office and Meeting Room	Item	Wall plate lining in floor void
Material	Bitumen	Extent	50 m.

Strategy / Sample Id	Sample / 002	Fibre Type	NADIS

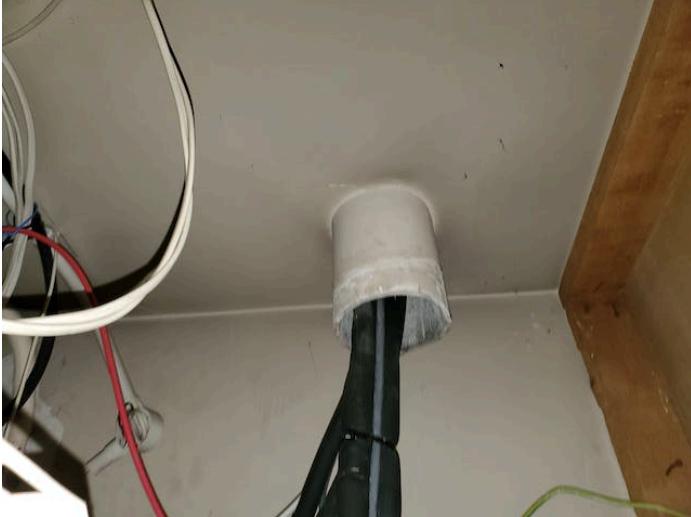
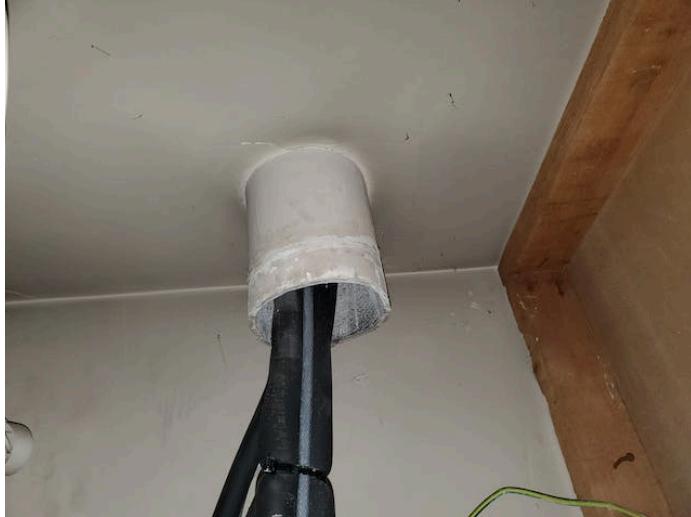
1 - 3 Boltro Road > 0 > 003 - Open Plan Office > Flue

Building	1 - 3 Boltro Road	Level	0		
Location	003 - Open Plan Office	Item	Flue		
Material	Cement	Extent	1 No.

Strategy / Sample Id	Sample / 003				
Recommendation	Remove

Product Type (or Debris from Product)	1	Extent of Damage / Deterioration	1
Surface Type / Treatment	1	Asbestos Type	1
Material Score	4 / Very Low

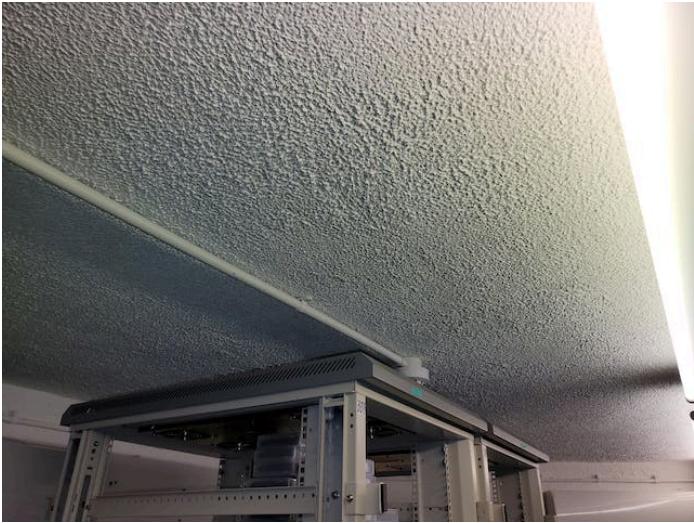
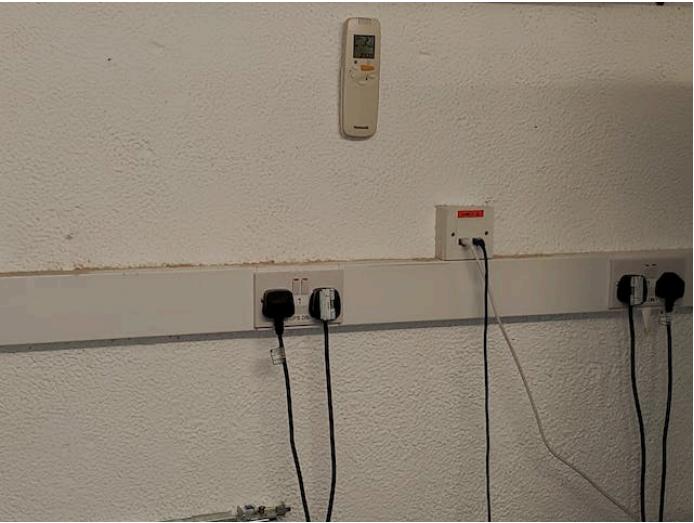
1 - 3 Boltro Road > 0 > 005 - Server Room > Ceiling and Walls

Building	1 - 3 Boltro Road	Level	0
Location	005 - Server Room	Item	Ceiling and Walls
Material	Textured Coating	Extent	20m. sq.

Strategy / Sample Id	Sample / 004	Fibre Type	NADIS

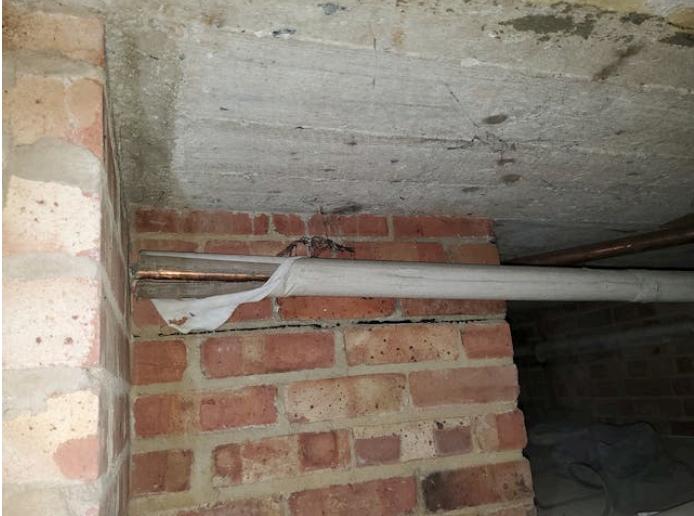
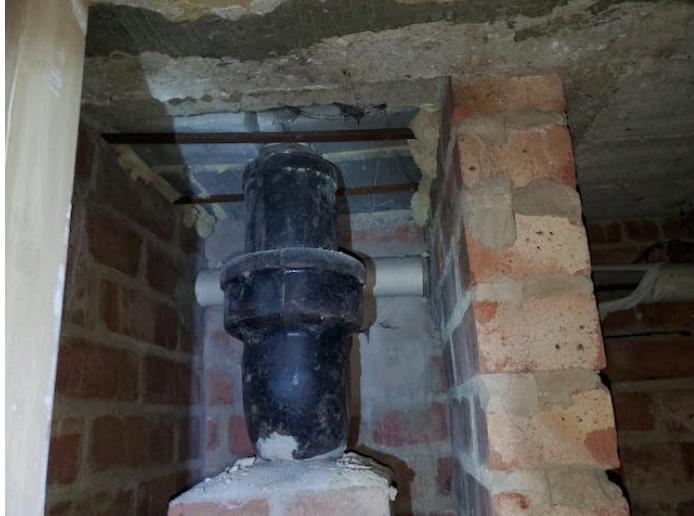
1 - 3 Boltro Road > 0 > 005 - Server Room - Void Above > Pipe insulation

Building	1 - 3 Boltro Road	Level	0
Location	005 - Server Room - Void Above	Item	Pipe insulation
Material	Paper	Extent	30 m.

Strategy / Sample Id	Sample / 005	Fibre Type	NADIS

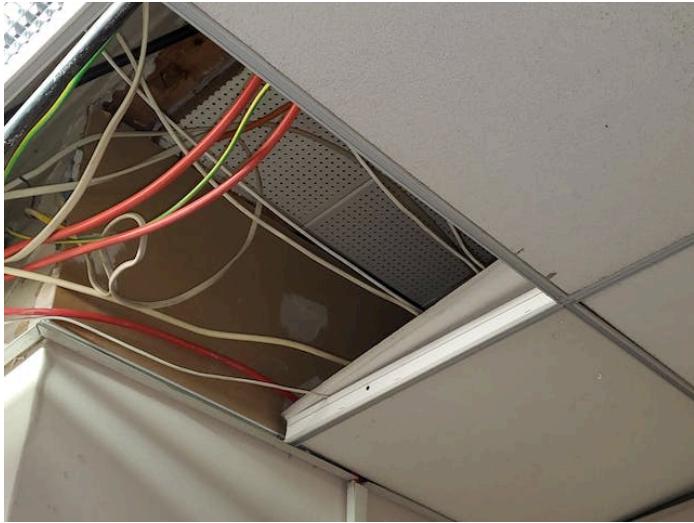
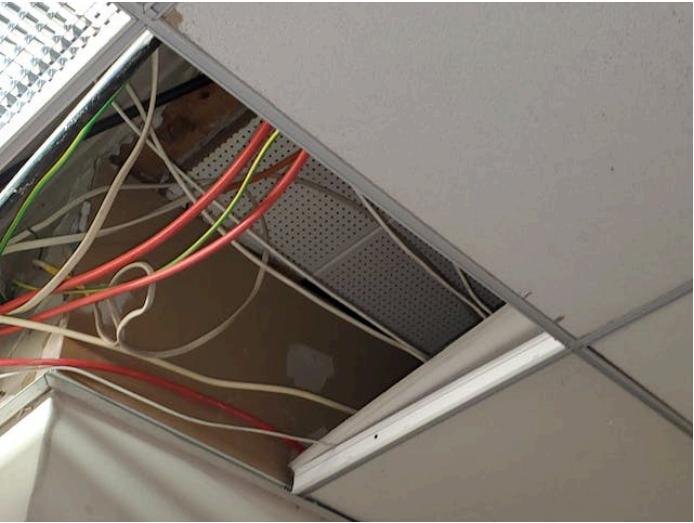
1 - 3 Boltro Road > 0 > 007 - Plant Room > Ceiling

Building	1 - 3 Boltro Road	Level	0
Location	007 - Plant Room	Item	Ceiling
Material	Fibreboard	Extent	2m. sq.

Strategy / Sample Id	Sample / 006	Fibre Type	NADIS

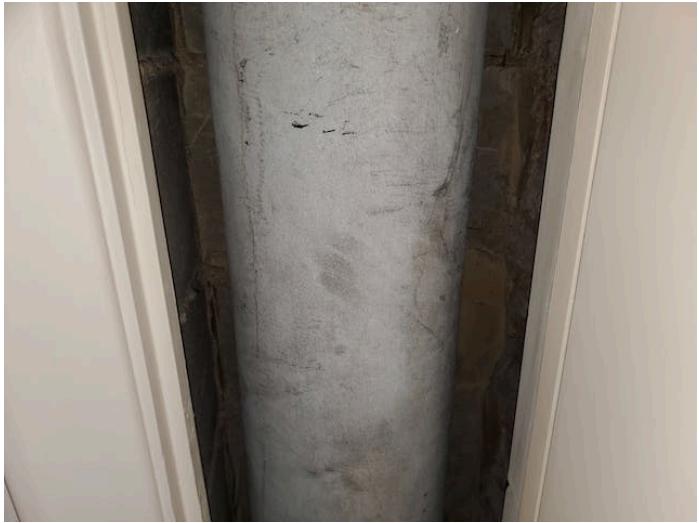
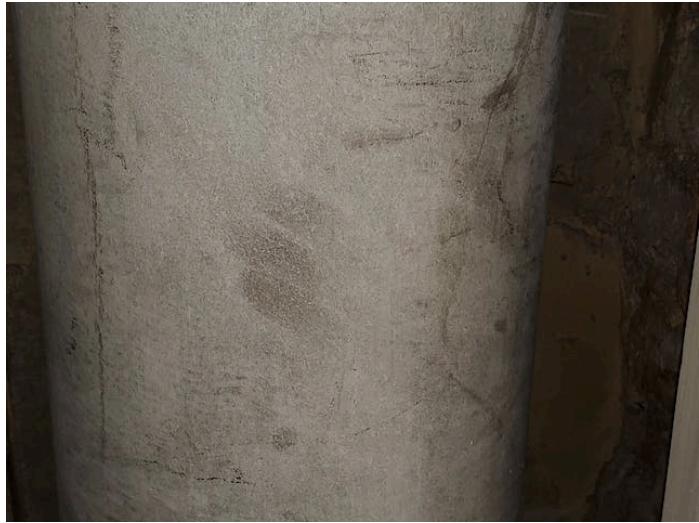
1 - 3 Boltro Road > 1 > 003 - Male WC > Flue

Building	1 - 3 Boltro Road	Level	1		
Location	003 - Male WC	Item	Flue		
Material	Cement	Extent	1 No.

Strategy / Sample Id	Strongly Presume / 003				
Recommendation	Remove

Product Type (or Debris from Product)	1	Extent of Damage / Deterioration	1
Surface Type / Treatment	1	Asbestos Type	1
Material Score	4 / Very Low

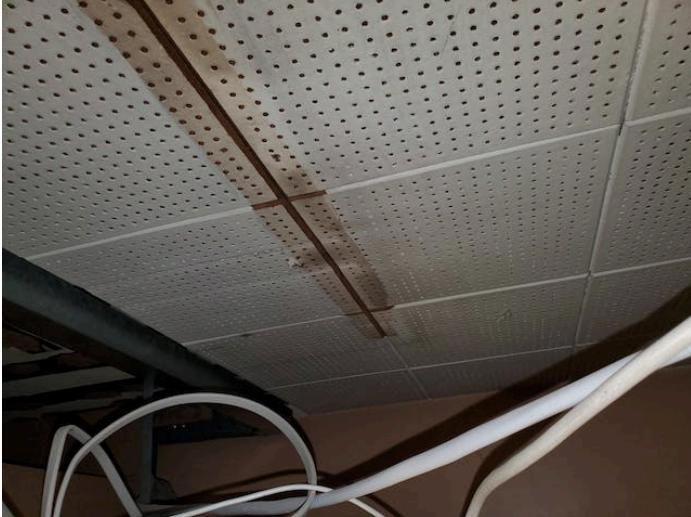
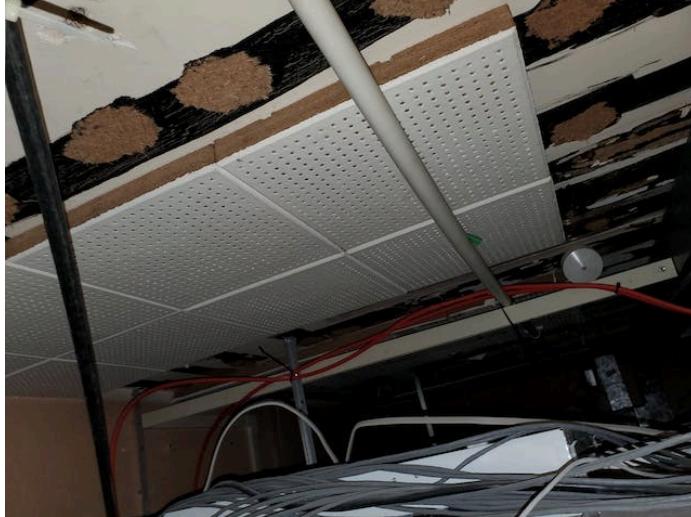
1 - 3 Boltro Road > 1 > 005 - Store Room > Ceiling

Building	1 - 3 Boltro Road	Level	1
Location	005 - Store Room	Item	Ceiling
Material	Fibreboard	Extent	10m. sq.

Strategy / Sample Id	Strongly Presume / 006	Presumed Fibre Type	NADIS

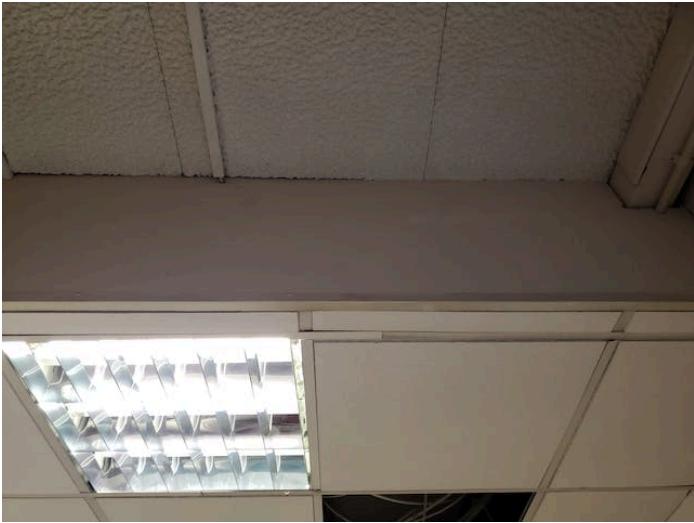
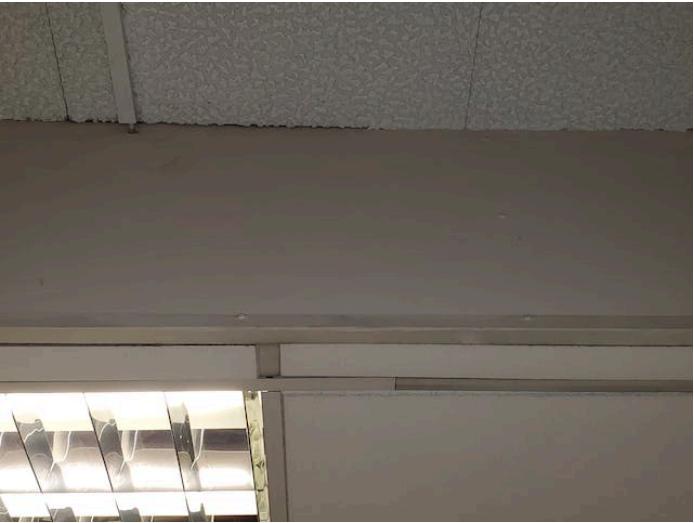
1 - 3 Boltro Road > 1 > 005 - Store Room > Upstand to suspended ceiling

Building	1 - 3 Boltro Road	Level	1
Location	005 - Store Room	Item	Upstand to suspended ceiling
Material	Insulating Board	Extent	2m. sq.

Strategy / Sample Id	Sample / 007	Fibre Type	NADIS
