## Foul and Surface Water Drainage Report

**Prince Albert, Copthorne**

**Westcoast Developments Ltd**

Reference **C3261**

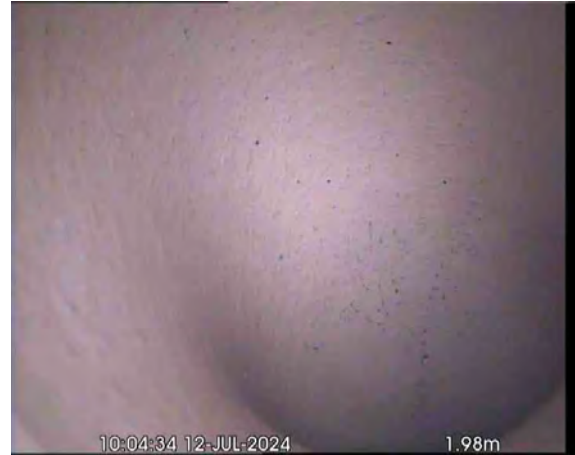
GULLYX\_be408751-b267-4dcb-87b2-47920da53df0\_20240725\_090226\_317.jpg, 00:01:01, 0.81 m  
Joint displaced, medium

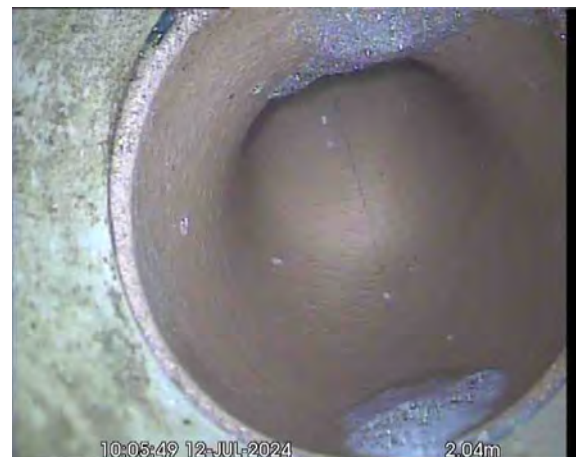
W\_CX\_b0b5a396-c87b-44df-b524-f6ae86763abc\_20240725\_090413\_863.jpg, 00:00:37, 0.99 m  
Crack, circumferential from 9 o'clock to 3 o'clock

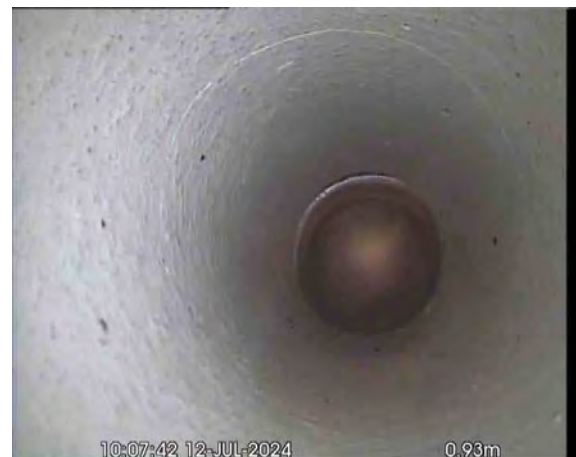
W\_CX\_6de99cdf-b413-404c-b955-bd55d3022d42\_20240725\_090601\_206.jpg, 00:00:31, 0.69 m  
Crack, circumferential from 3 o'clock to 8 o'clock

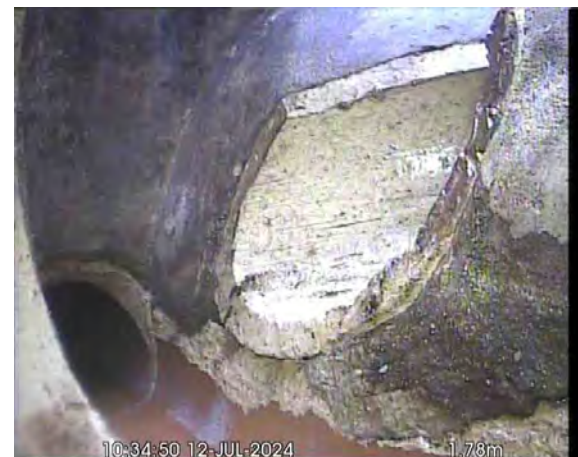
MH1X\_97e7b7b8-20ed-4a65-9726-8e0e94167fbc\_20240725\_090948\_059.jpg, 00:00:28, 0.18 m  
Crack, circumferential from 6 o'clock to 12 o'clock

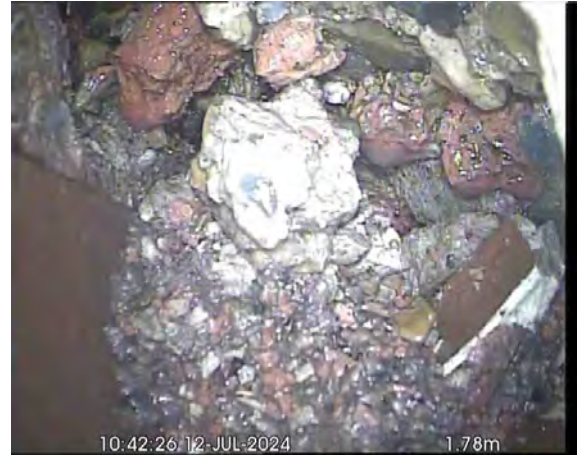
REDUNDANTX\_716789ca-25ee-4cc2-8135-a7bc7aff19d4\_20  
240725\_091212\_524.jpg, 00:00:56, 1.78 m  
Settled deposits, hard or compacted, 100% cross-sectional  
area loss

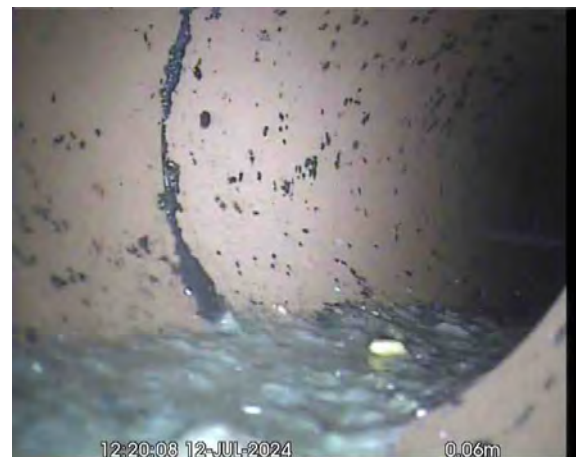
CAPPED  
OFFX\_962b07f7-60c1-43c4-ba8a-1193030da8e6\_20240725\_094225\_233.jpg, 00:00:42, 0.06 m  
Settled deposits, fine, 5% cross-sectional area loss

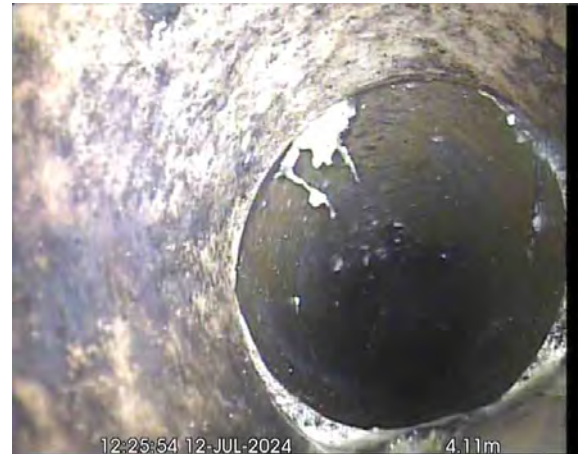
MH5X\_059f6707-2778-4d9f-998a-3e91e87c5d40\_20240725\_094727\_709.jpg, 00:01:24, 4.11 m  
Joint displaced, medium

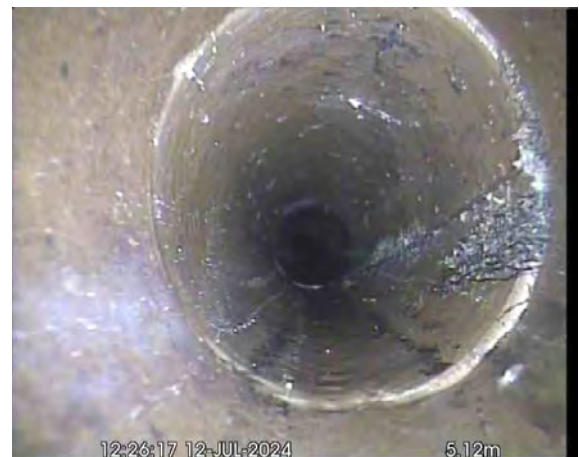
MH5X\_109efa46-164d-464f-96dd-18bcad47188e\_20240725\_094816\_811.jpg, 00:01:44, 5.12 m  
Roots, fine at joint

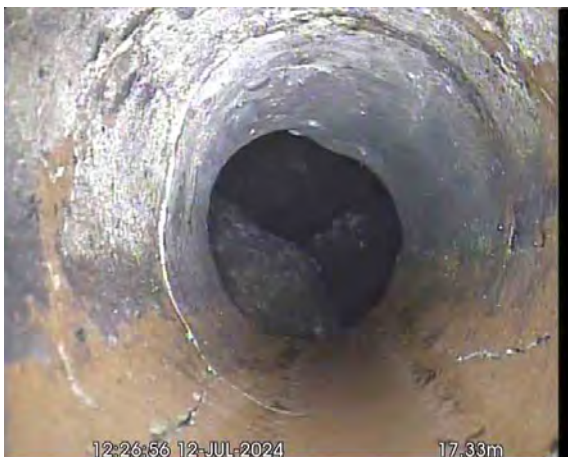
| Section | PLR | Grade | Description |
|---|---|---|---|
| 11 | MH5X | 4 | Multiple defects |

MH5X\_245e56e0-af60-4cc5-9251-72fe8d11e2b2\_20240725\_094946\_179.jpg, 00:02:23, 17.33 m  
 Fracture, multiple from 12 o'clock to 12 o'clock

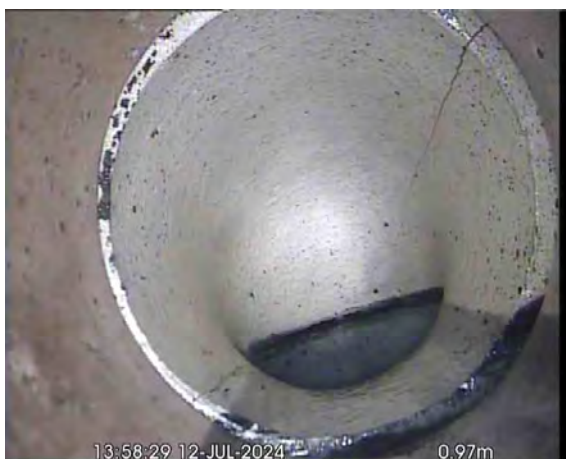
GULLYX\_36dc49d5-3dc1-4da4-862e-24eaa0b586df\_20240725\_100014\_047.jpg, 00:00:24, 0.97 m  
Crack, longitudinal at joint at 2 o'clock

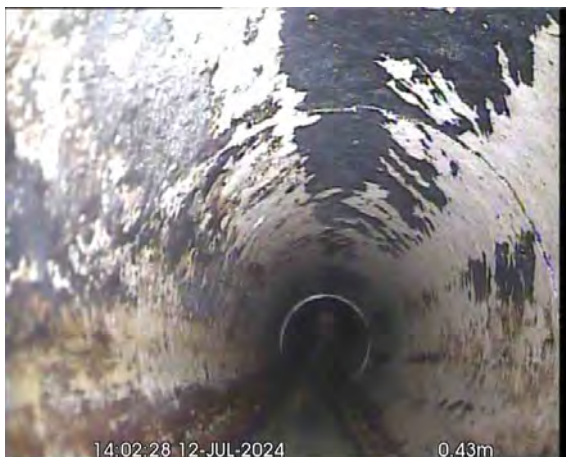
GULLYX\_2b29d929-3dfa-4401-bebe-b29732e2f259\_20240725\_101316\_226.jpg, 00:00:39, 0.43 m  
 Fracture, circumferential from 10 o'clock to 3 o'clock

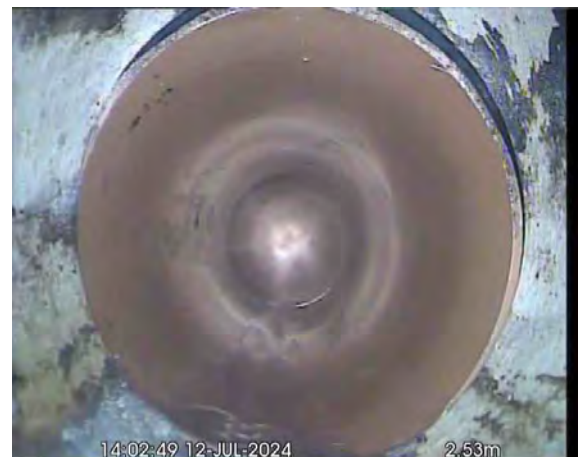
GULLYX\_a0d2ed5e-7b7e-4ae5-a077-94c7952a4929\_20240725\_101329\_585.jpg, 00:01:00, 2.53 m  
 Joint displaced, medium
