**PDF Report**

**C1018054**

**MSCC5 (General Site Surveys)**

35 Finches Park Road, Haywards Heath, West Sussex, RH16 2DA,  
United Kingdom

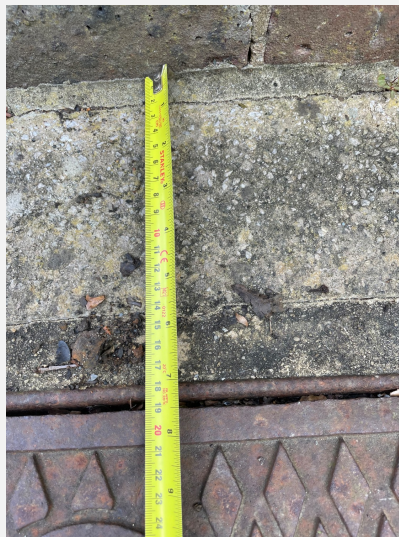
Manhole distance from wall 0.2m
