## TANYARD MANOR

Repair and Renewal of  
Roof Coverings

HERITAGE  
STATEMENT

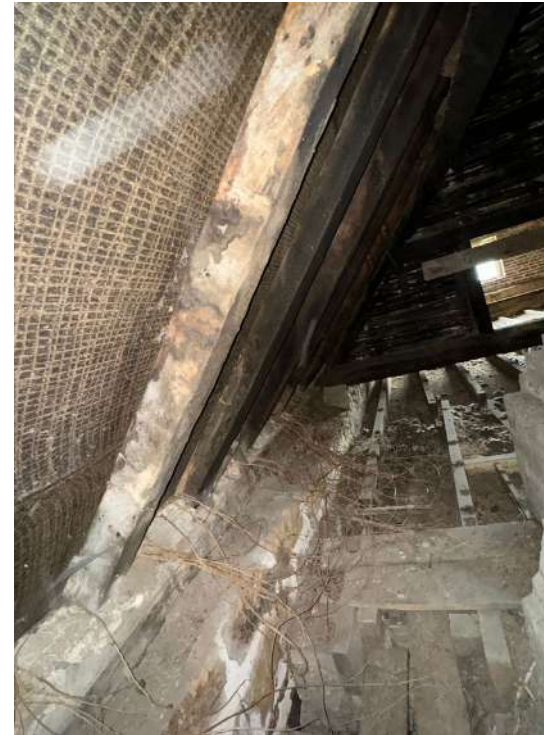
*attic space showing sarking felt underlay*

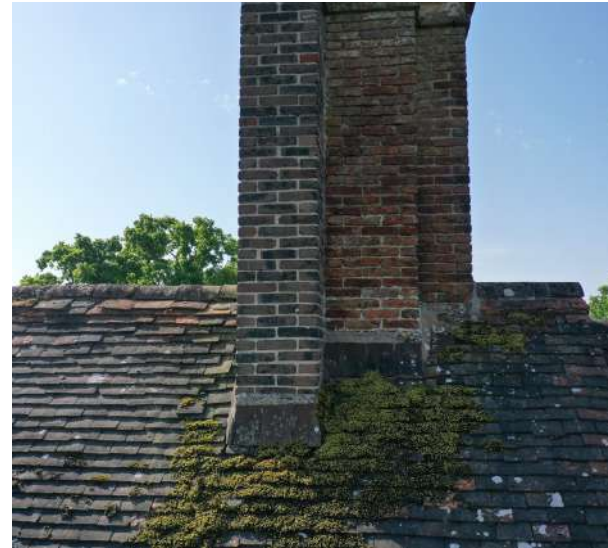
The north slope exhibits moss and lichen consistent with its shaded orientation and there is extensive evidence of spalling consistent with freeze thaw action due to water sitting on the relatively uncambered tiles, as well as cracked, broken, missing and slipped tiles. There is a missing ridge tile.

*clay peg tiles, tile and half to verges and mortar bedded abutments. Note moss and lichen growth and areas of consequent spalling*

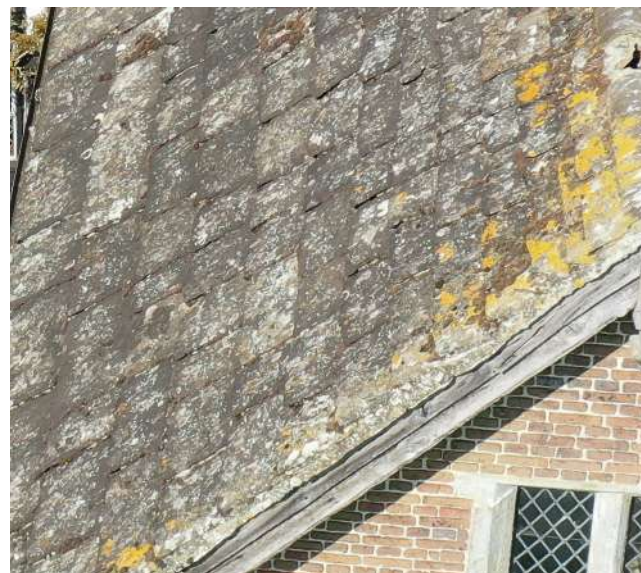
The HSS appears from external observation to be secured in a single lapped fashion whereby only one course overlaps the one below leaving perpendicular joints prone to water ingress. The earliest roofs are presumed to have used the normal double lapping system whereby the headlaps and sidelaps should be weathertight and allow for ventilation. To counter this, Welsh slate soakers, known as shadow slates, were conventionally inserted between the HSS courses at the perpendicular joints, all bedded in mortar. This method has become a widely seen and accepted good practice approach, which is understood to have evolved in response to reliance on set-aside or salvaged slates as a result of new material becoming scarce; the batten gauge effectively becoming wider to economise on the use of the slates across the roof resulting in a single lapped course.

*single lap diminishing HSS roof covering*

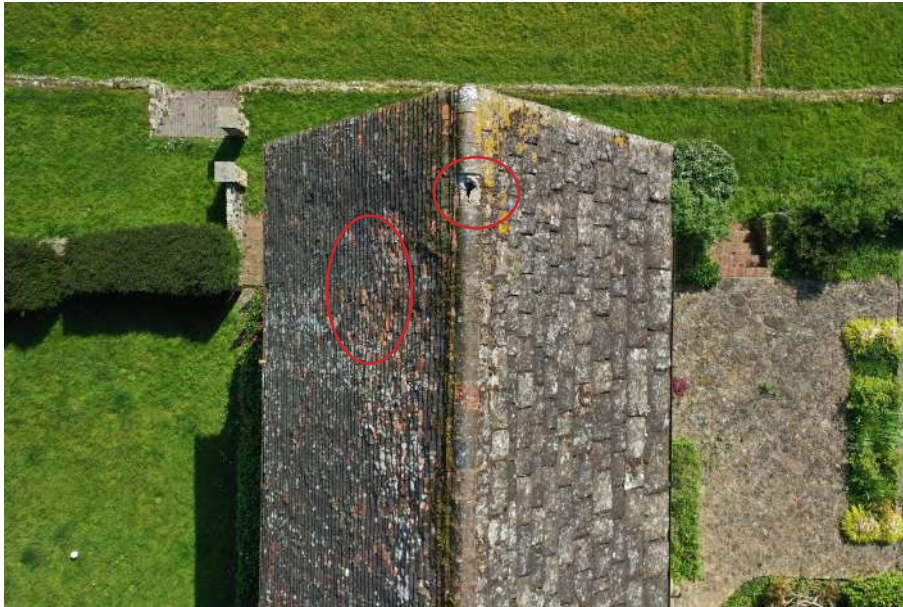
*missing tiles and spalling*

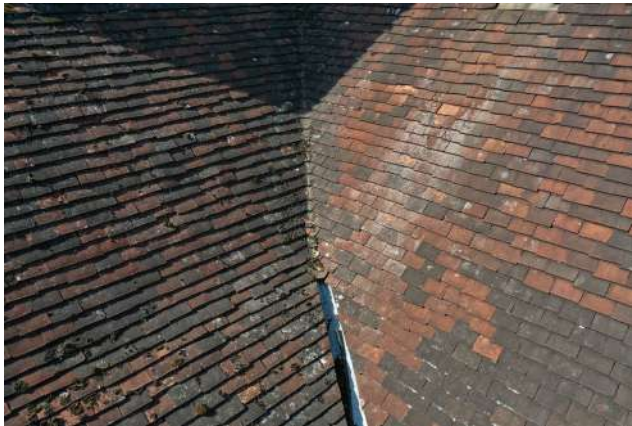
*slipped peg tile to C17th range*

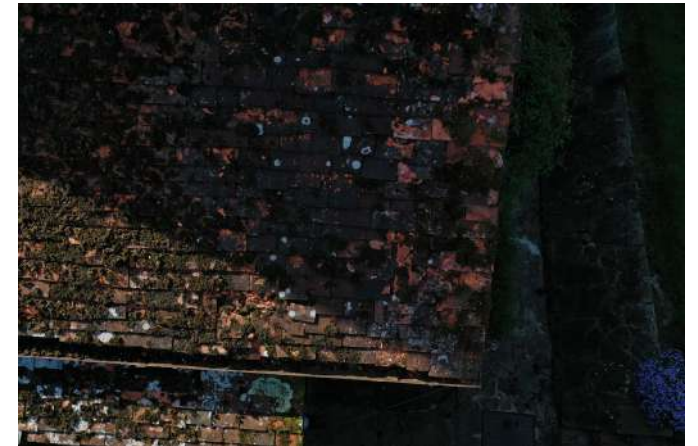
*spalling due to moss build up to north lean-to*

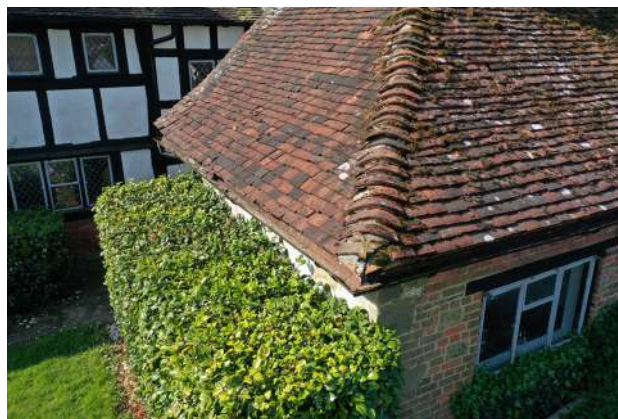
The usual defects are apparent including spalled, cracked, missing and slipped tiles, especially to the eaves suggestive of decayed tilt fillet due to failed rainwater goods. There is evidence of the loss of mortar beds to bonnet tiles and ridge tiles.

*bonnet tiles to hip with mortar lost to bedding*
