EXPOSURE TIMBER FRAMES - FIRST FLOOR - WALLS - DRESSER

107 HIGH STREET, LINDFIELD, HAYWARDS HEATH, RH16 2HR

AS IMPLEMENTED PHOTOGRAPHIC DOCUMENTATION

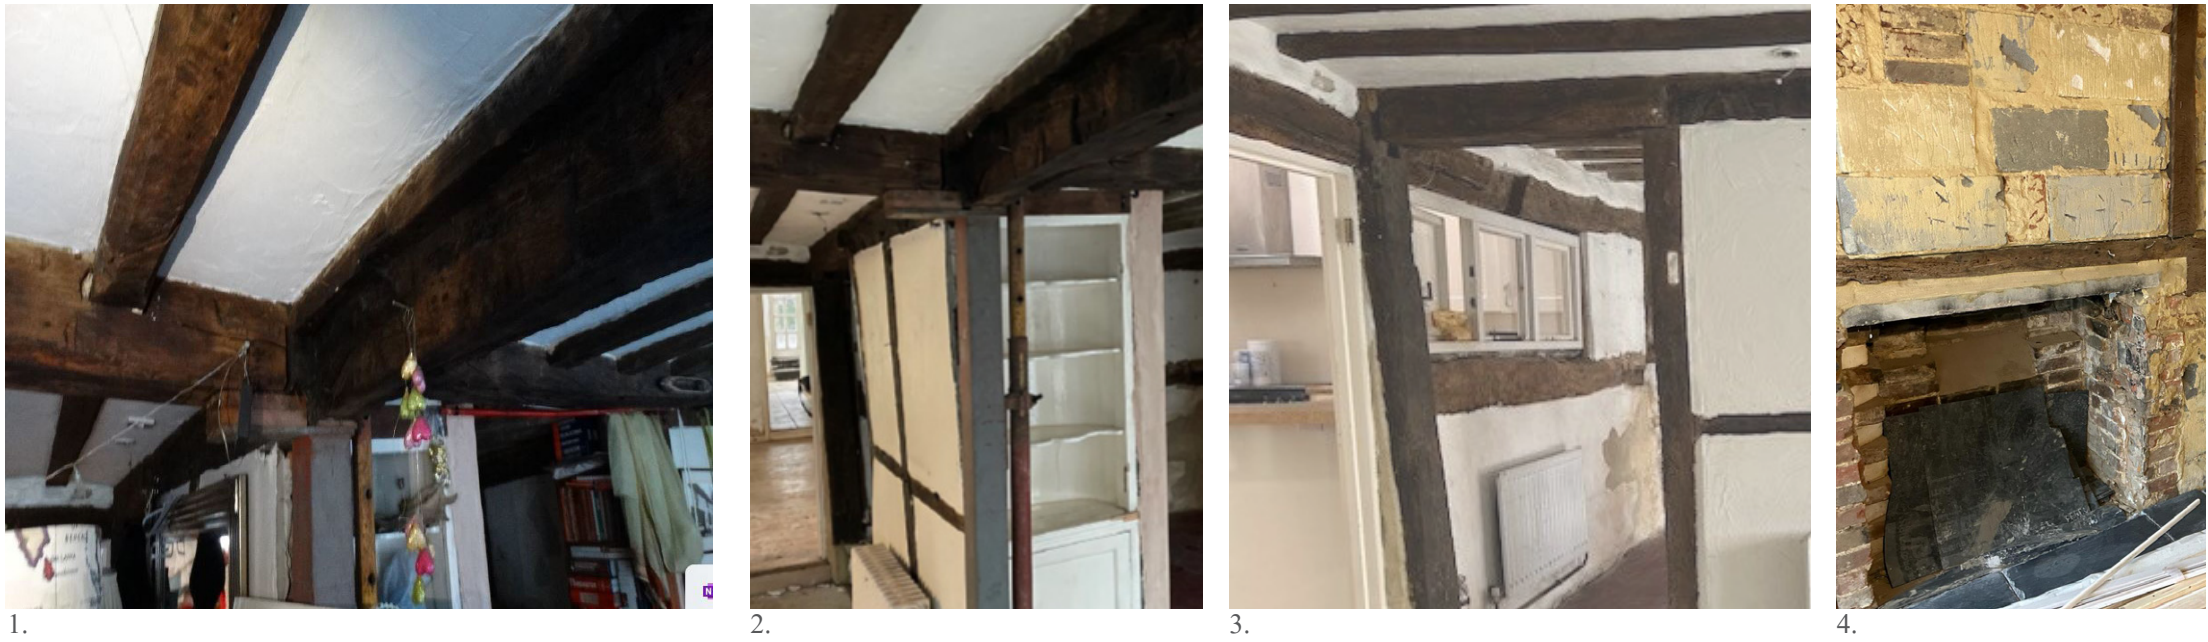
### PRE CONSTRUCTION - PHOTOGRAPHIC DOCUMENTATION

As a secondary intervention supporting these works, a later partition wall and steel post which previously interrupted the space have been removed and replaced with a crafted timber post designed to better integrate with the historic frame. This element is discussed earlier within this document and contributes to the improved readability of the ceiling structure without altering its historic character.

- Key
- Figure 1. Pre-construction view of the timber frame and plaster ceiling
  - Figure 2. Pre-construction steel post supporting timber frame ceiling
  - Figure 3. Pre-construction partition wall supporting timber frame ceiling
  - Figure 4. Under Construction Chimney original
  - Figure 5. Proposed / as-built Living room showing exposed timber frame and repaired ceiling
  - Figure 6. Proposed / as-built Living room showing exposed timber frame
  - Figure 7. Proposed / as-built Steel post replaced with traditional gunstock post in seasoned oak
  - Figure 8. Proposed / as-built View of chimney on west wall

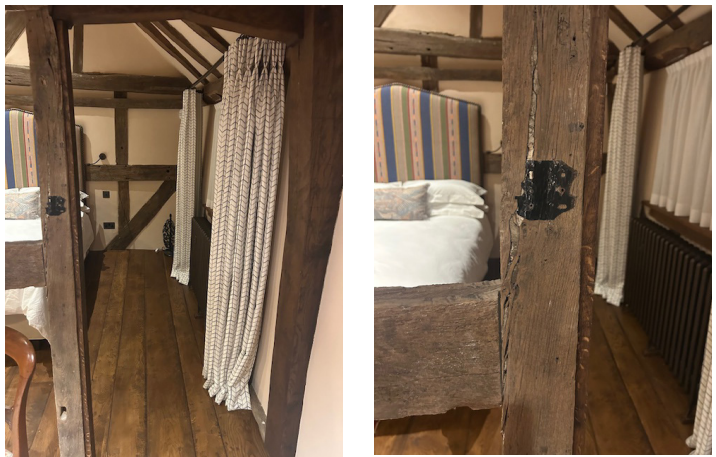
The non-original infill to the partition wall between two rooms was removed, the addition of doors was not implemented. Original timber frame retained. Historically the opening that is present was indeed present. There are stains on the original oak frame that indicate the location of a butterfly door hinge, and thus the installation of a door. The infill panels were infilled with modern finishes that broke away when the stair was removed up to the attic – works that had permission. The original frame has been retained in all it's beauty to ensure the legibility of the secular rooms in this area, but infill panels of modern materials removed. It is proposed that the lime plaster infill panels will be reinstated within the timber frame.

Photographs of the historic door frame hinge stain in the northern bedroom proving there was a door

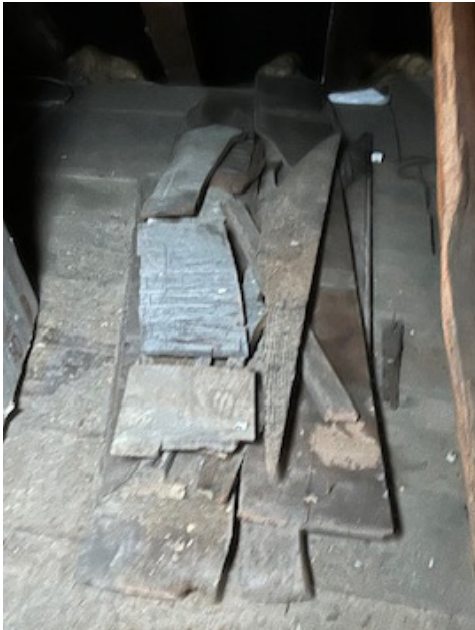
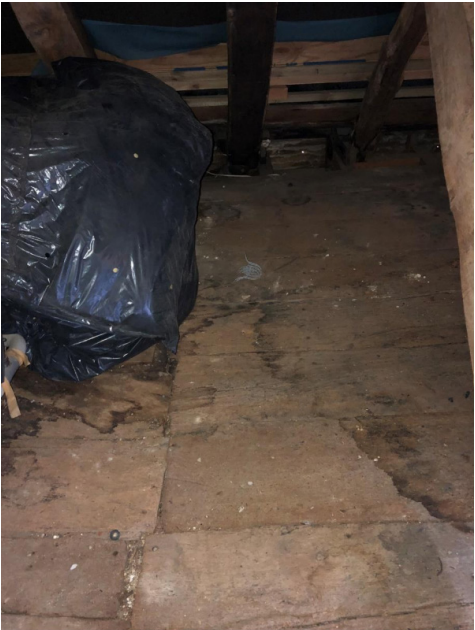
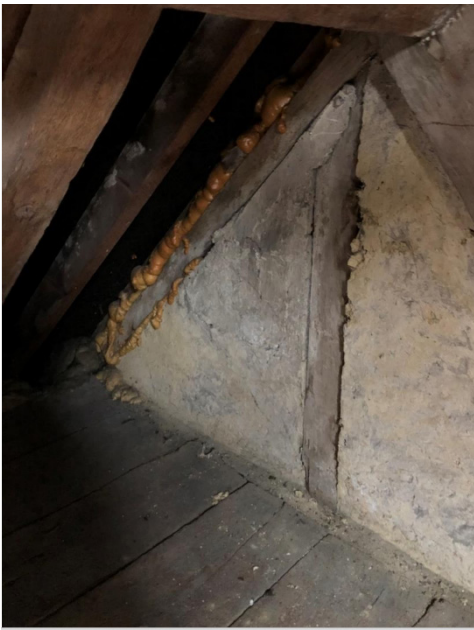
The 17th century floor boards above the south-east bedroom were excessively loose and instable located in the loft. The previous owner confirms many areas of the old flooring in the attic were in a very poor condition. A high percentage were badly stained and rotten. Furthermore, the Desbrulais report confirms in the photograph this attic area was already raised suggesting non-original elements being in place below the loose laid boards, perhaps the reason why they were loose laid in the first place.

Pre-construction photographs of attic floorboards in poor condition

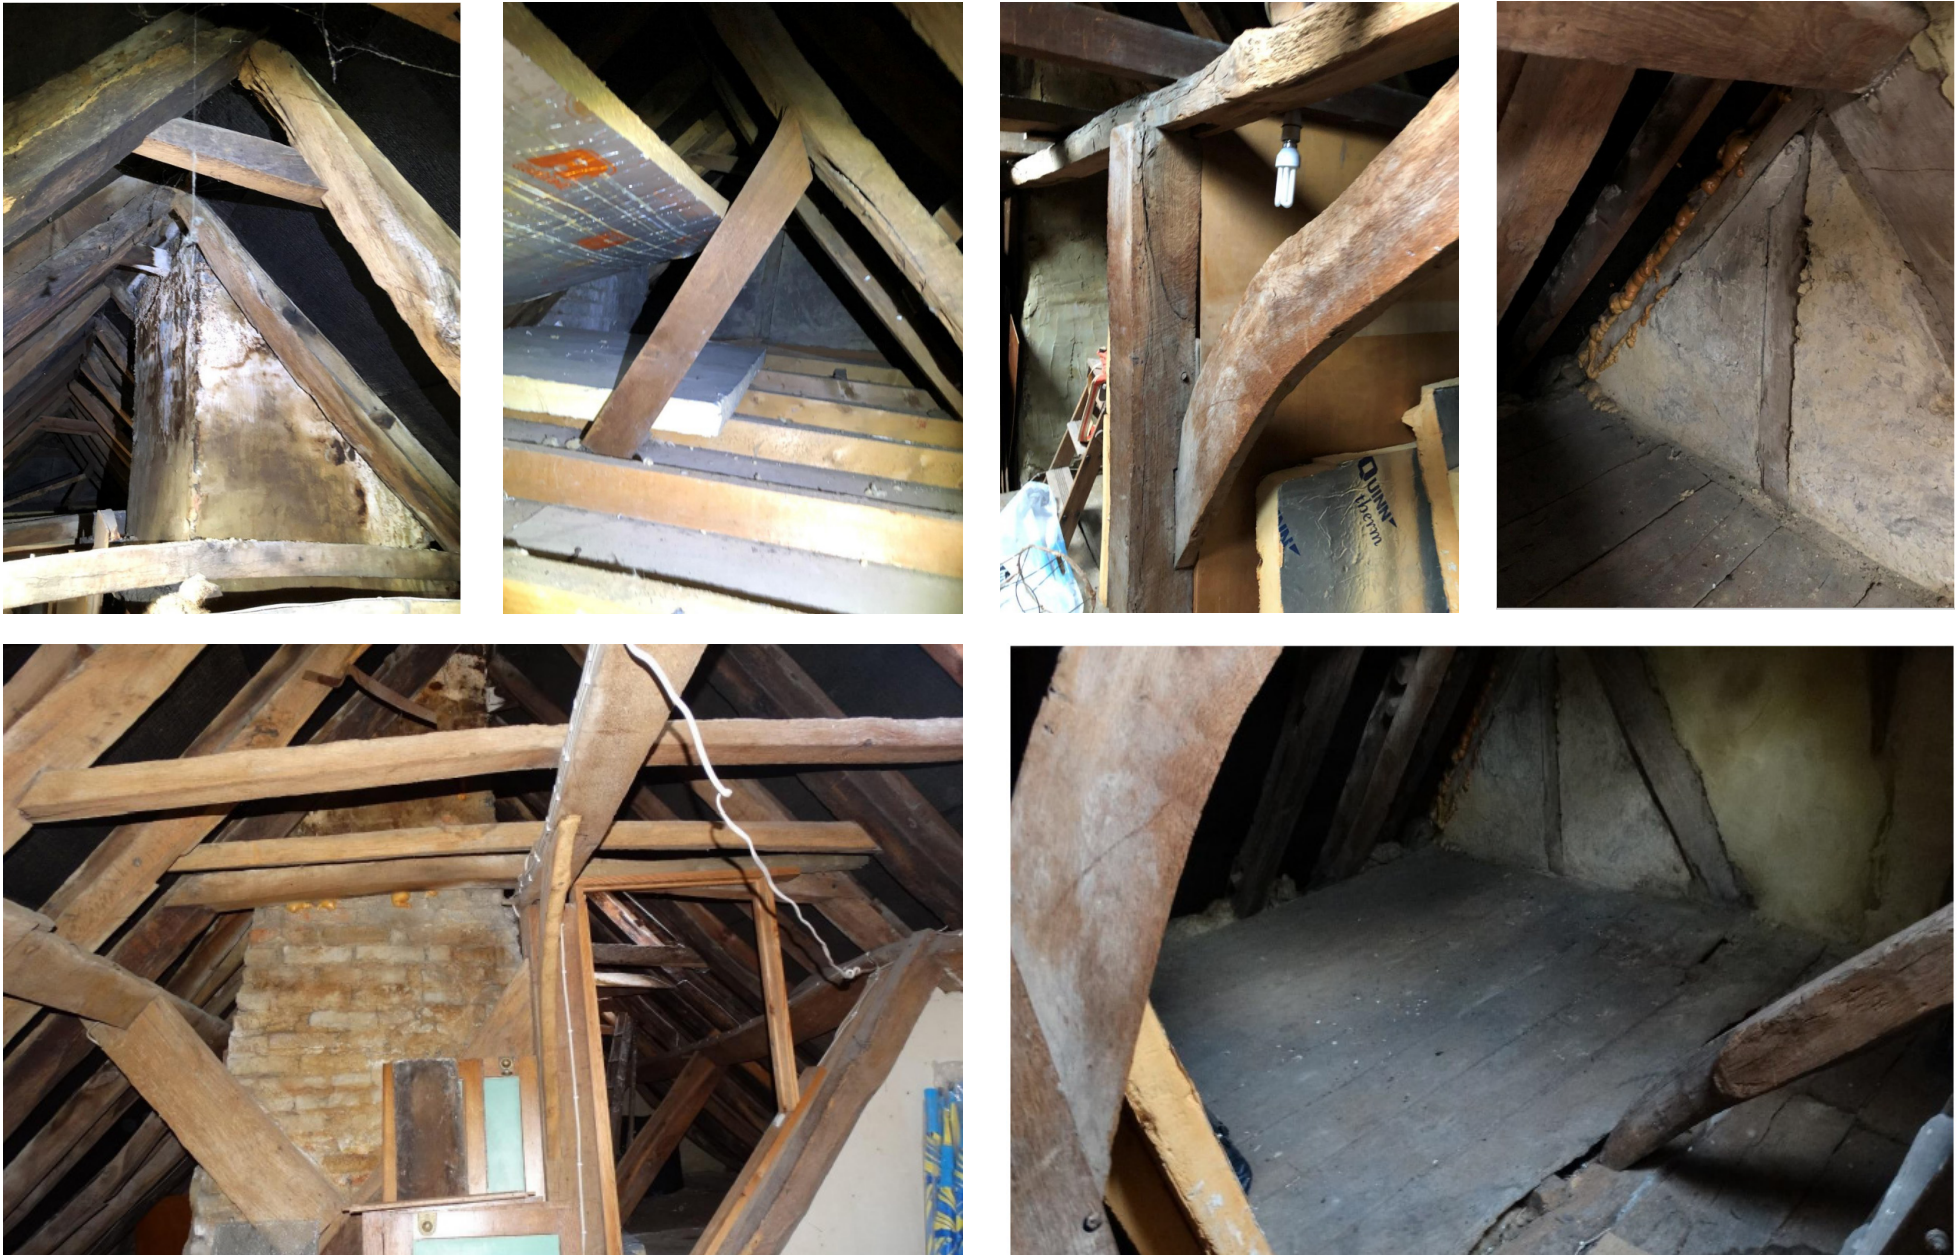
For comparison, the adjacent photographs are of the attic before any works were undertaken by the current owner.

It is noted that the timber frame was unaltered and untreated.

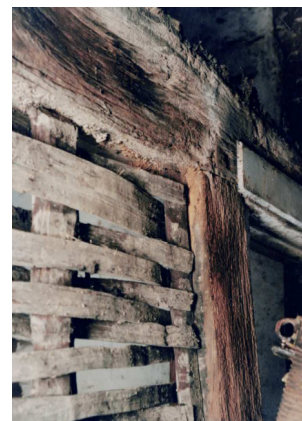
Visible rot and damage observed in the structural support joists within the basement pre construction.

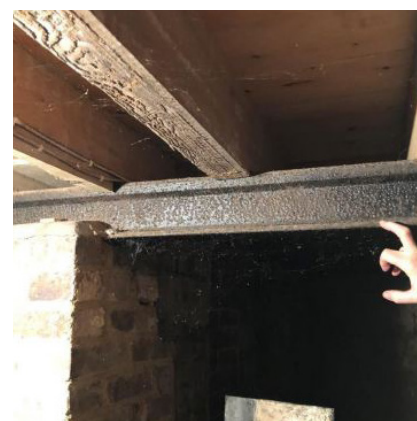
Pre-construction basement, railway steel member used for structural support, now replaced as per Structural Engineer proposal

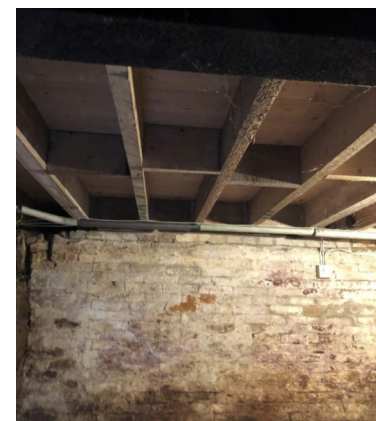
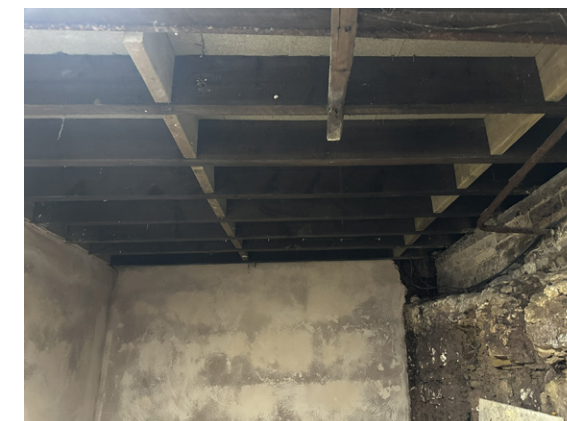
Basement, new softwood joists replacing rotten ones, brick wall finished with lime plaster, floor not altered.

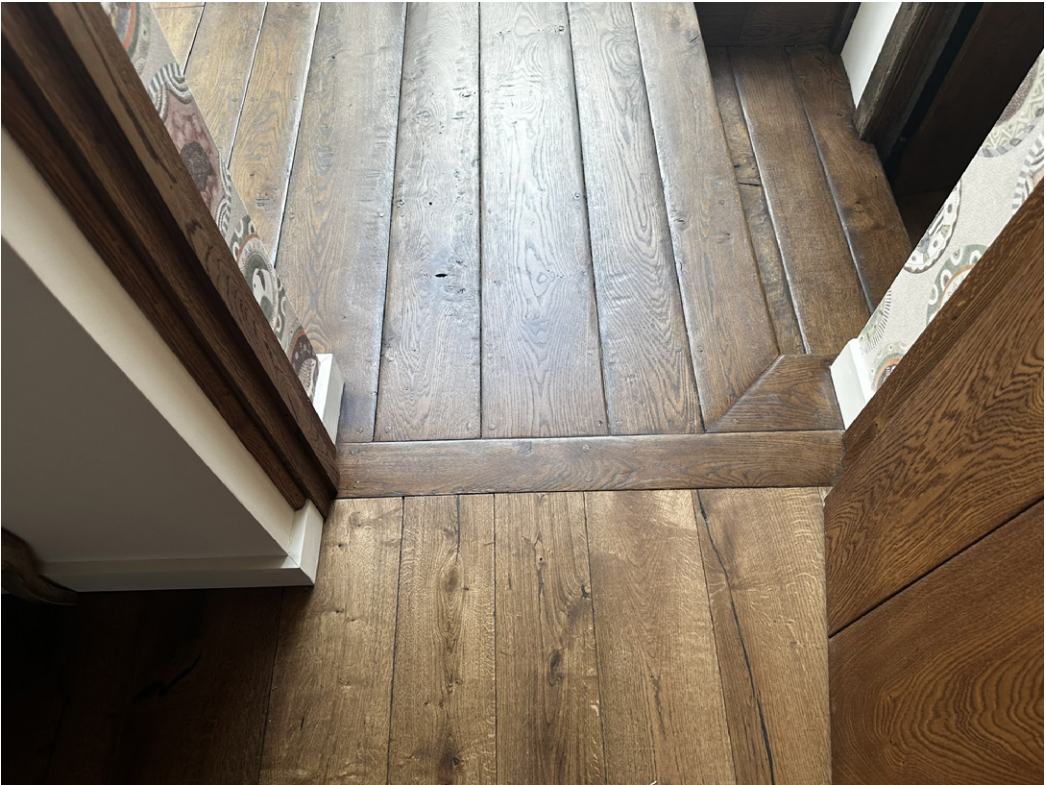
The floor boards have been retained and new traditional flooring overlaid using traditional methods. The existing floor boards substantially undulate and no floor in the original part of the building is level. If the new flooring was laid straight onto joists on a new substrate, it would be flat, but it’s not. The original joists and floorboards exist underneath and the extent of fixings into the floorboards is akin to the number required to lay a carpet over the floorboards. The owner is willing to lift areas of the new floor finish to demonstrate the presence and authenticity of the original floorboards below it which are being preserved in situ.

As-built oak flooring
