## INSPECTION REPORT

| <b>Project Name</b> | St Marks Church of England Primary School |
| <b>Project Address</b> | Brantridge Lane, Haywards Heath, West Sussex RH17 6EN |

| ROOFING CHECKLIST | |
|---|---|
| Roof Name / Ref: | Flat Roof |

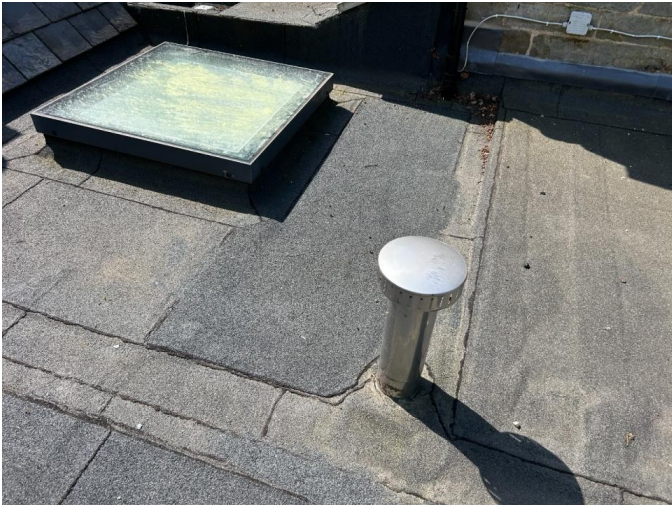
| ROOFING CHECKLIST | |
|---|---|
| Roof Overview - 22/06/2026 15:41 | Remedials carried out to area of severe Blisters - 22/06/2026 15:41 |

Remedials have been completed to the area of severe Blistering as recommended following the previous Inspection.

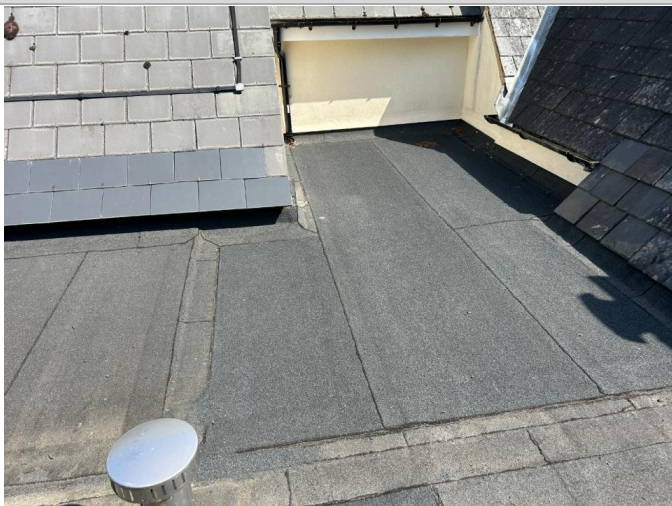
Remedials carried out to area of severe Blisters - 22/06/2026 15:41

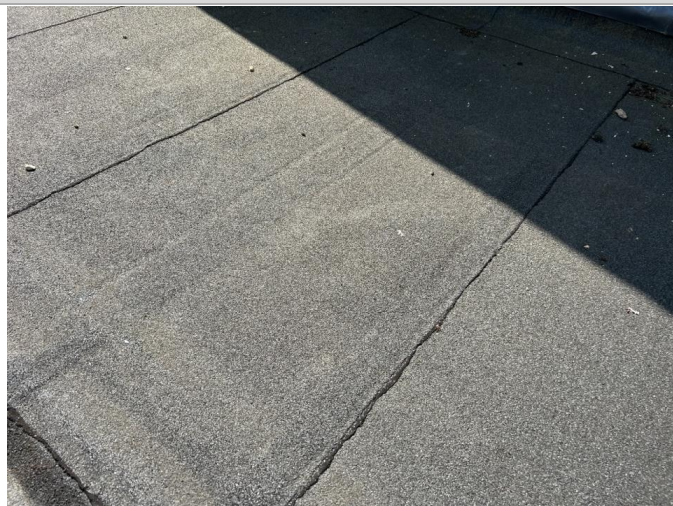
Blister still present, not stressing Laps - 22/06/2026 15:41

Other minor Blisters are still present. Blisters are still not stressing any Laps.

Agreed with Steve Dixon that the Blister to the area of Remedials is to be star cut and Overlaid, as a Goodwill gesture 2 remaining Blisters as Photos will be star cut and overlaid.

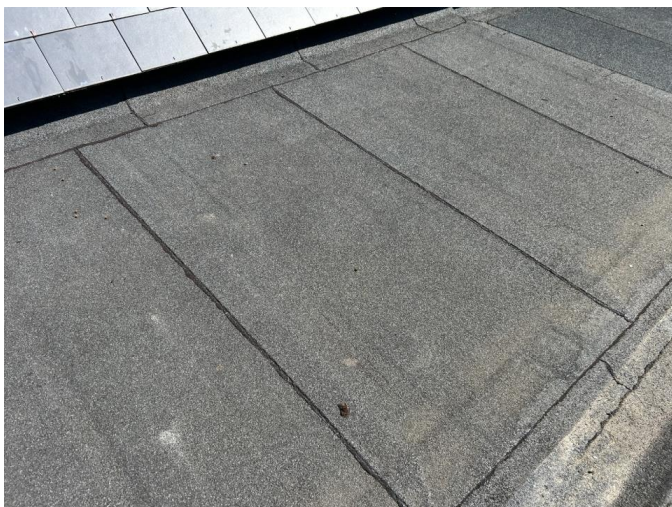
Blister still present, not stressing Laps - 22/06/2026 15:41

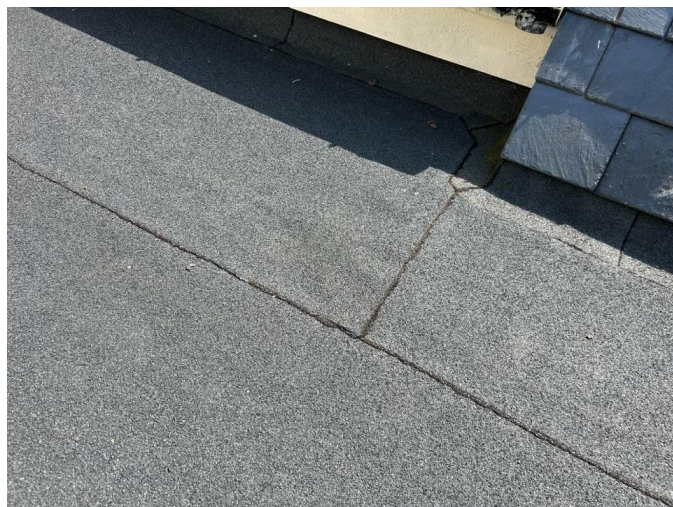
Blister in the area of Remedials - 22/06/2026 15:41

A blister is present in the area of the remedials, its suspected that this was minor at the time of repairs and was missed.
