**APPENDIX B**

**Photographs**

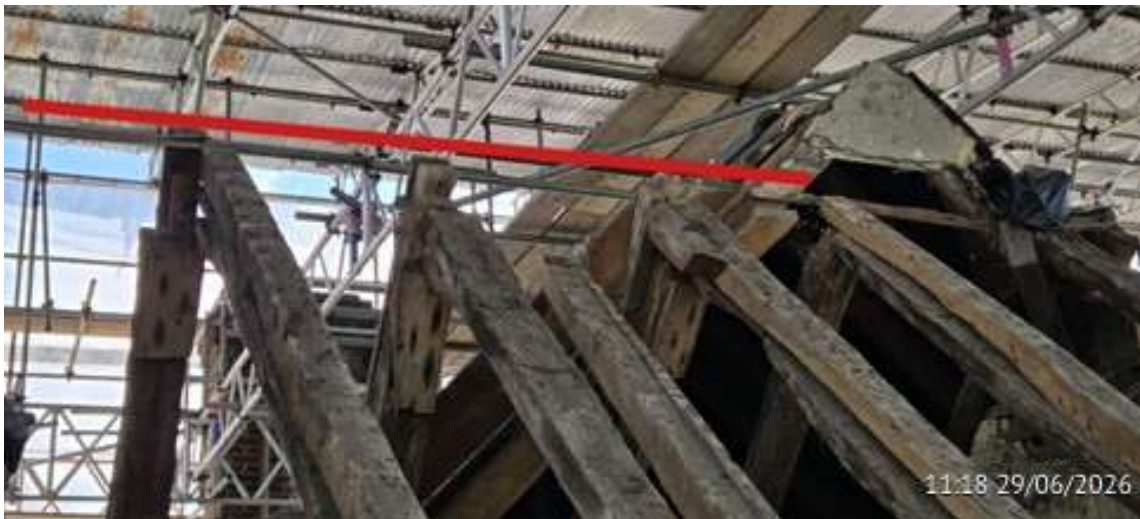
Photograph 17: Ridge beam missing in bay 5

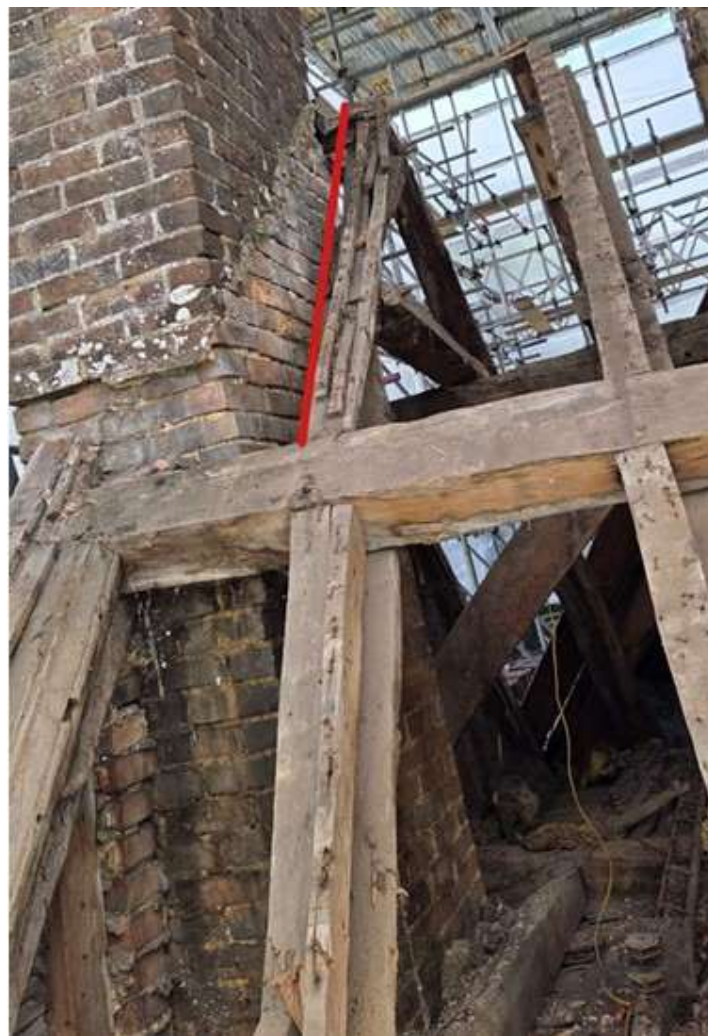
Photograph 18: Rafter formed from multiple firring pieces

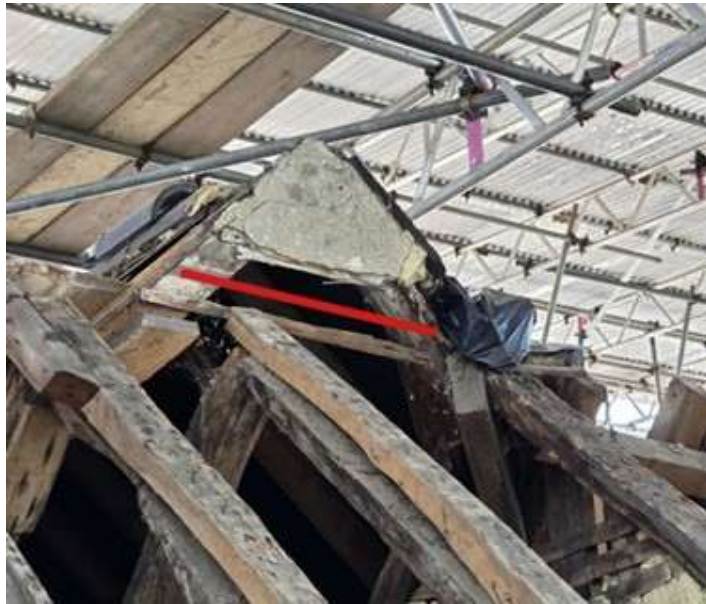
Photograph 19: Interface between Main Range roof and East Range roof

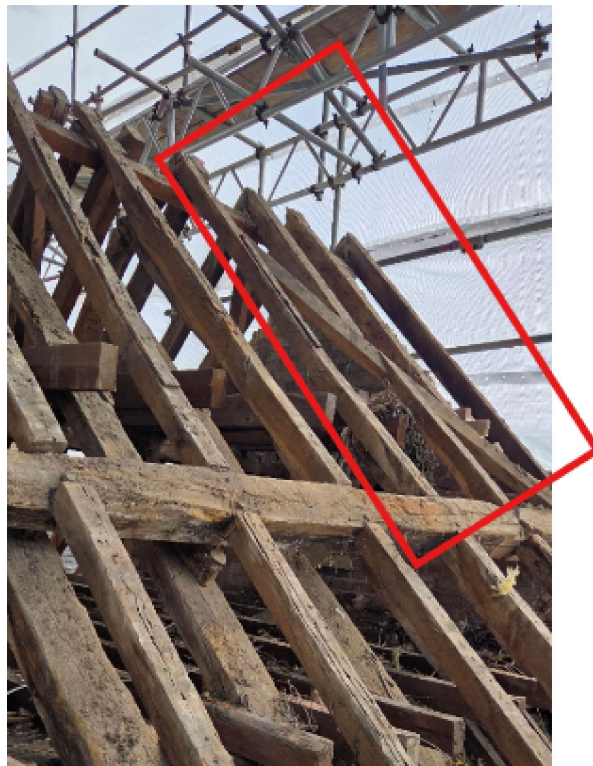
Photograph 20: Discontinued rafters in bay 1

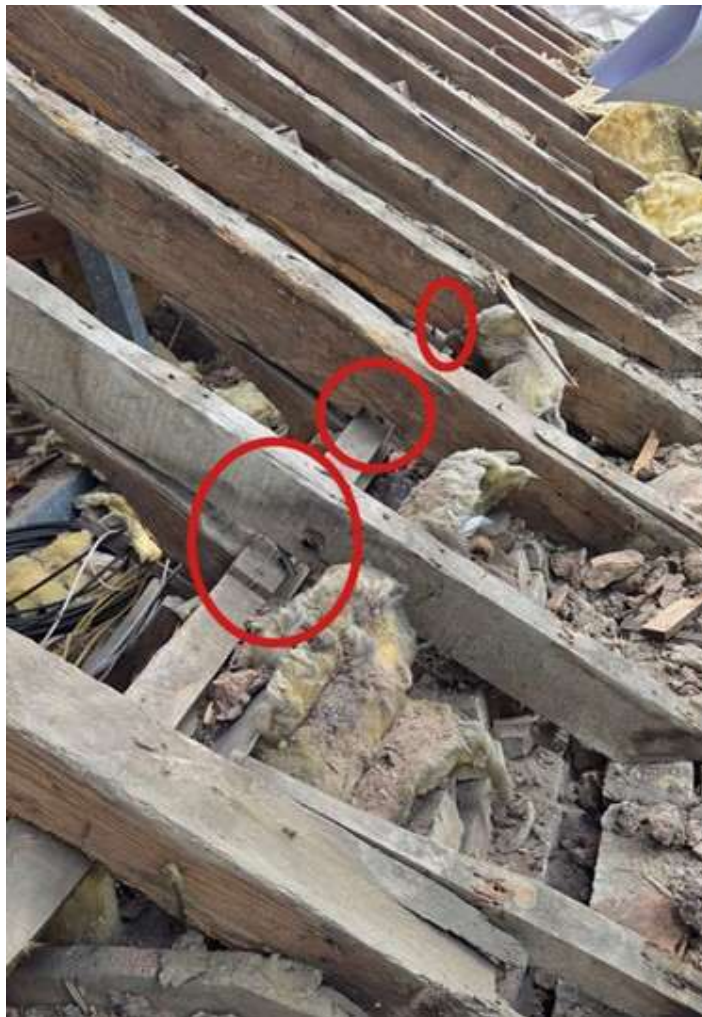
Photograph 21: Gap between rafters and edge purlin

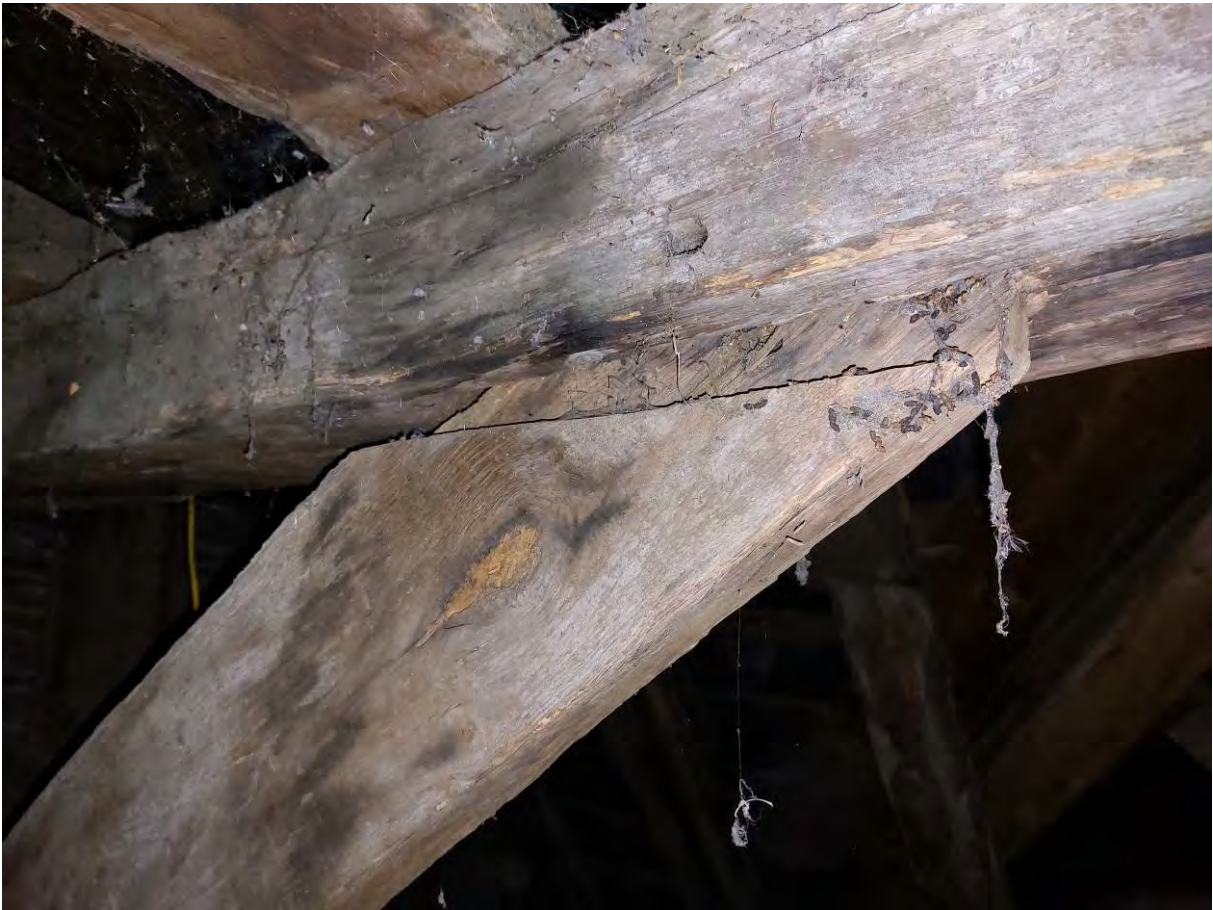
Photograph 7: Dropped brace to be wedged back in place
