# TREE RISK ASSESSMENT REPORT

**Of one oak tree in the front garden of  
Rutherford House, The Street, Bolney, West Sussex, RH17 5PG**

| <b>Document reference:</b> | MDJAC-DAS24105-TRAR-01 |

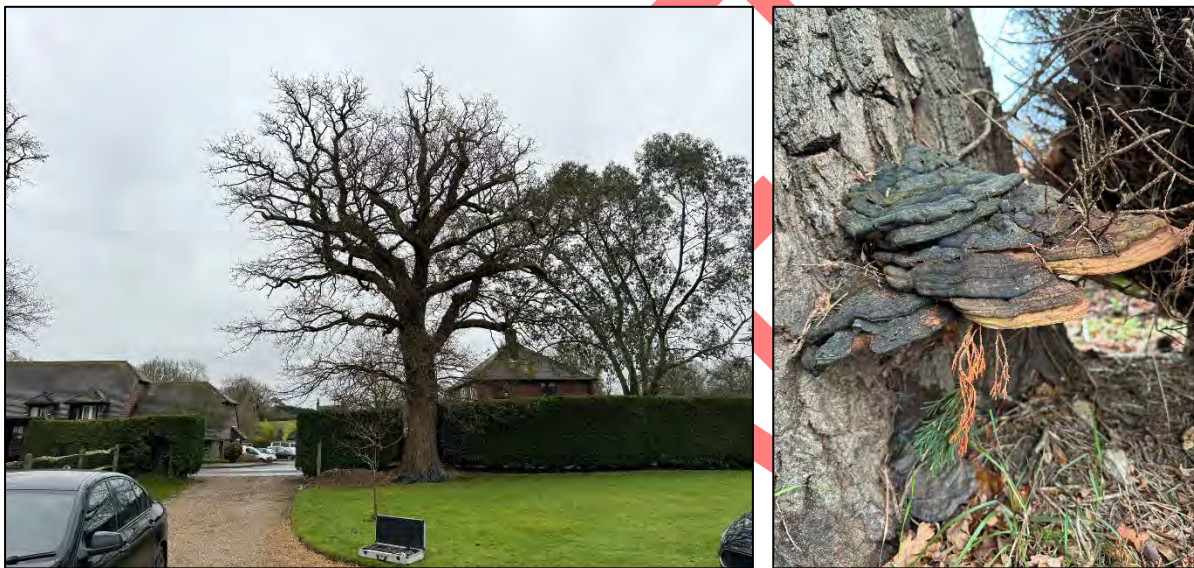
5.3.2. Physiologically, it is clear that there is a reduction in vitality, evidenced by the reduced bud density within the upper central and southern aspects of the canopy. Whilst the remainder of the canopy did comprise what appeared to be live buds, their density was found to be below what would be expected of a vigorous specimen.

5.3.4. Assessment of the base of the tree shows extensive fruiting of a decay fungus, which I have identified as *Ganoderma adspersum* based on appearance, morphology, location and size. *Ganoderma adspersum* is a root and basal decay fungus that causes a white rot (Boddy, 2021).

*Photograph 1: below left, looking eastwards from Rutherford House towards the subject tree. Note: dieback is evident in the central and south portions of canopy on the right hand side of the image; and*

*Photograph 2: below right, showing mature fruiting bodies of *Ganoderma adspersum* on the east side of the tree's base.*

1. **Priority P2 (within 6 months): fell the tree to ground level, or a 3m stump; and**
2. **Plant at least one replacement tree of a large-growing, long-living species such as oak, beech, London plane or lime, to provide a long-term replacement.**

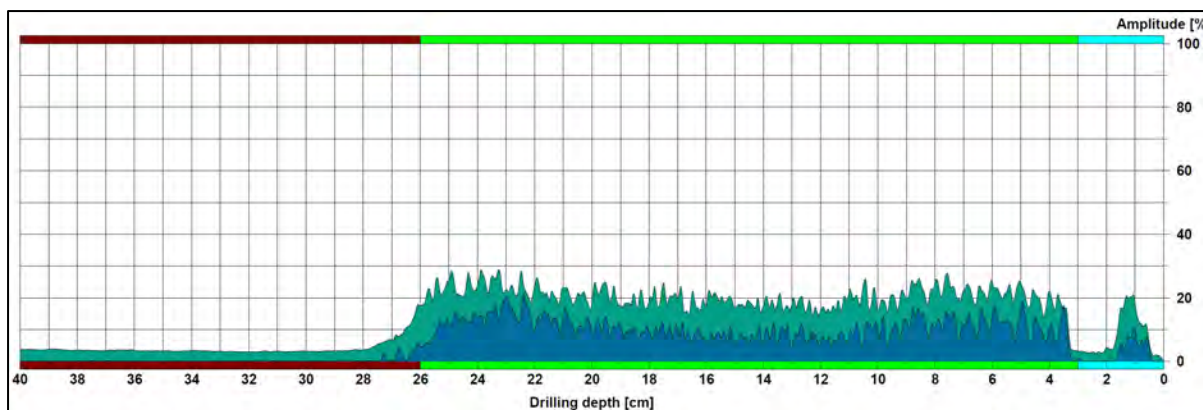
5.3.7. I carried out nine drilling profiles at 100mm above ground level to provide a comprehensive assessment of the basal condition. Regrettably, this confirms that extensive basal decay is present, with a

residual wall of 'sound' wood measuring approximately 20cm on average. The diameter of the basal flare at 100mm is approximately 1470mm and therefore, a 20cm residual wall represents approximately 27% of the basal radius in the affected directions; the remainder of the radius is shown to be extensively decayed, as summarised below.

*Figure 4: showing the readings from the assessment at 100mm on the north side of the tree.*

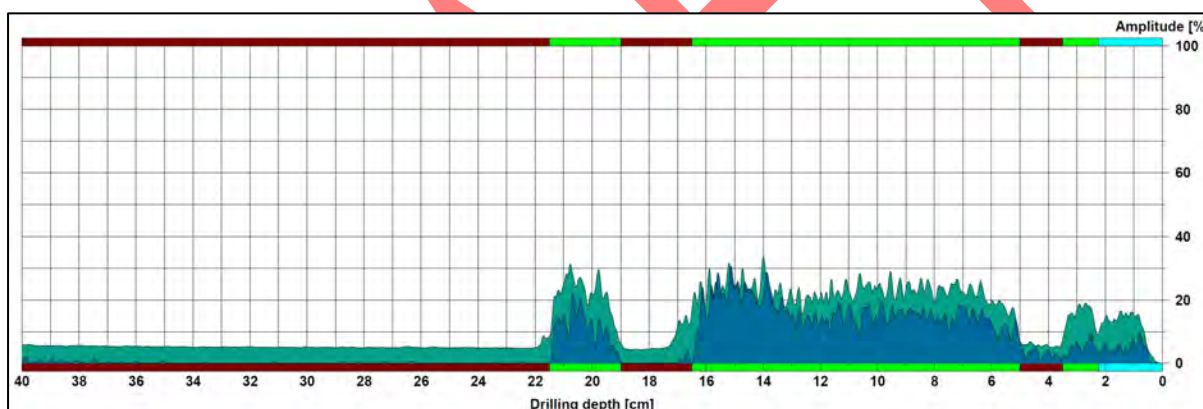
*Figure 5: showing the readings from the assessment at 100mm on the east side of the tree.*

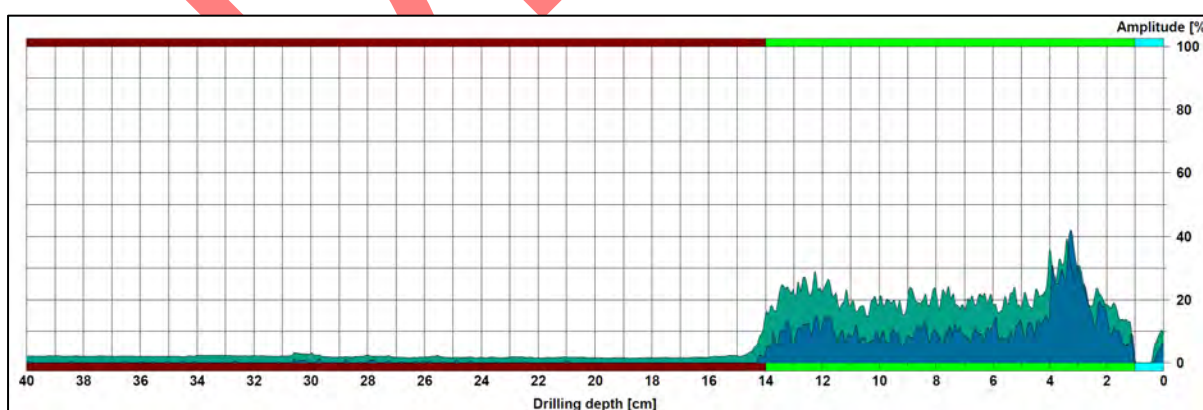
*Figure 6: showing the readings from the assessment at 100mm on the south-west side.*

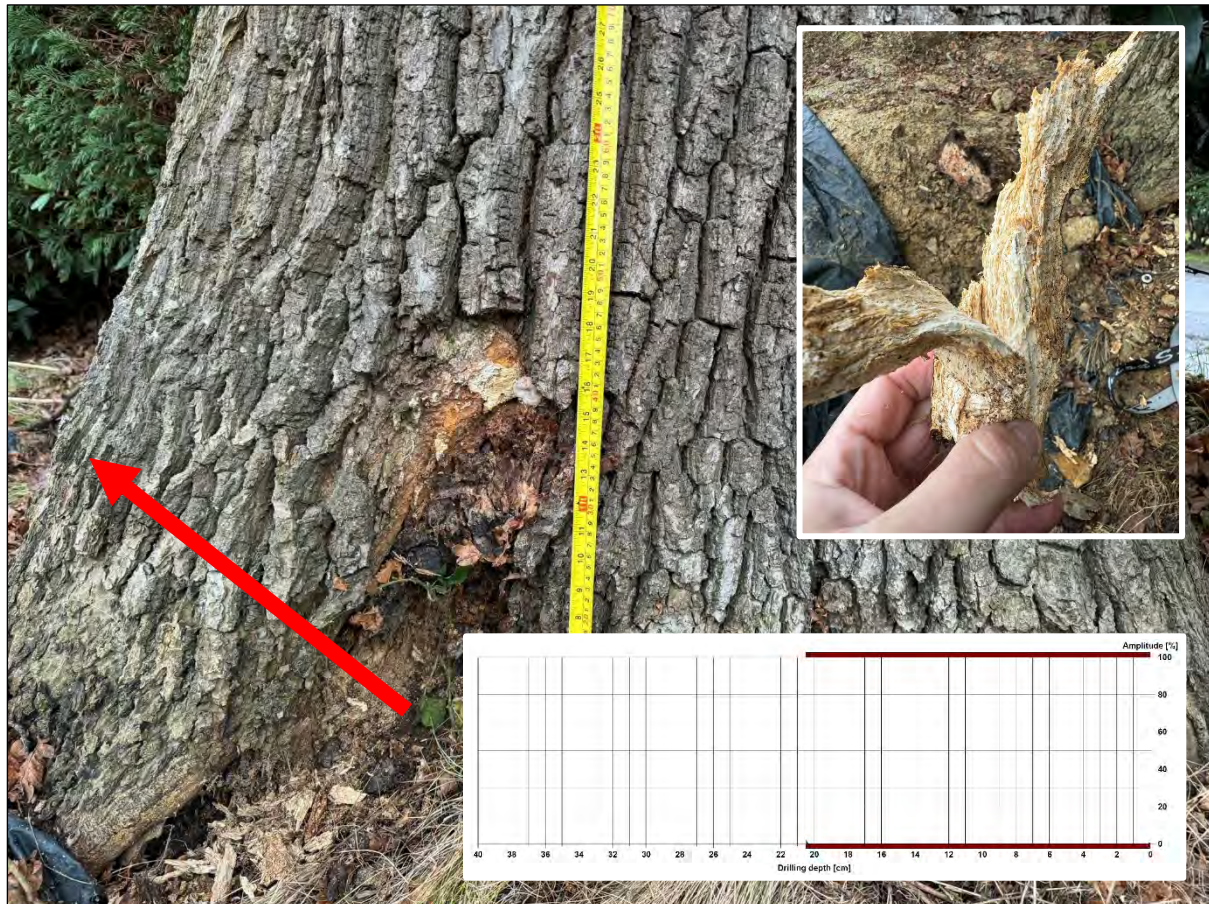
5.3.8. Whilst assessing the south and south-west aspect of the base, I noted a depression at the base of the buttress root on the west side with a small amount of exposed sapwood that was bright white in colour, consistent with extensive white rot. Upon drilling this section, north to south (perpendicular with the buttress root), no material resistance was noted.

*Figure 7: photograph of the western buttress root, showing the direction of drilling profile 9 (in red), the results (bottom right), and a section of degraded wood pulled out by hand, showing very little lignin content (top right).*

5.3.9. These results are significant as they confirm that the decay is at an advanced level at the base of the trunk. As this fungus is known to also affect structural tree roots, I would expect the decay shown above to be the above ground section of an area of decay that affects many of the buttress roots that provide anchorage to the soil, particularly those on the west and east sides. Therefore, in my opinion it is foreseeable that a failure might arise from or close to ground level as a result of deterioration of the wood quality in this area.

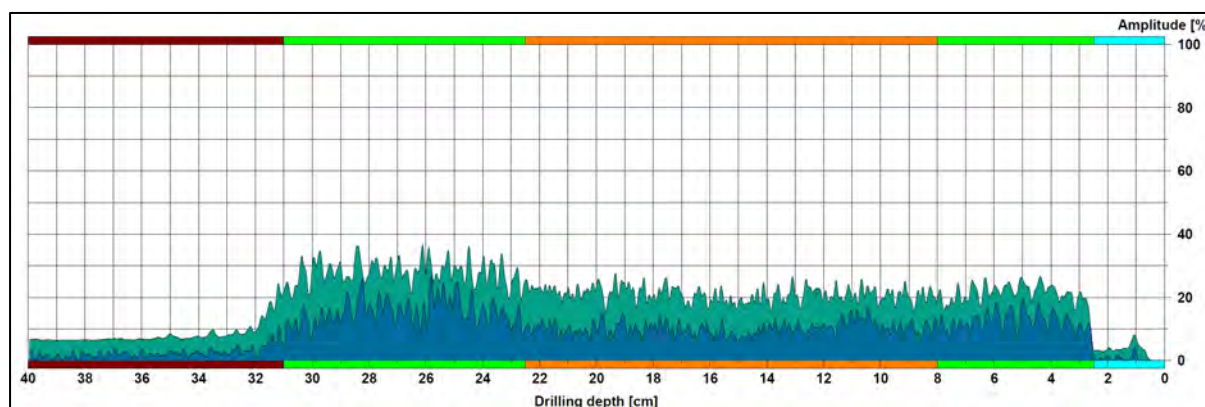
5.3.10. Further assessments were undertaken at 600mm and 1200mm above ground level, to ascertain how far up the stem the decay extends. Whilst generally the quality of wood is much improved at 600mm, the extent of the principal decay column, which is likely to be conical in shape, can be seen. Only the western and southern aspects are free from extensive decay, and even these show some suggestion of the early signs of degraded wood. A full set of results is provided at **Appendix 3**.

Figure 8: showing the readings from the assessment at 600mm on the north side of the tree.

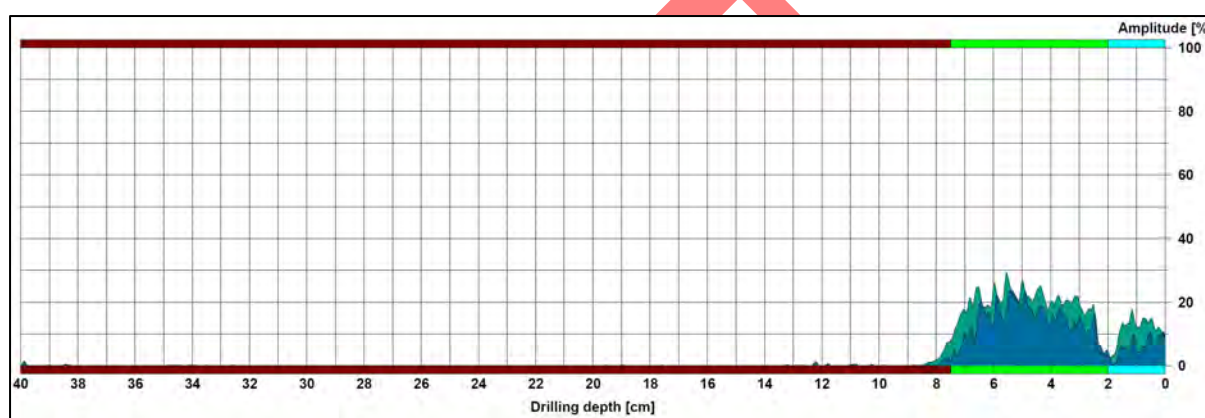
Figure 9: showing the readings from the assessment at 600mm on the east side of the tree.

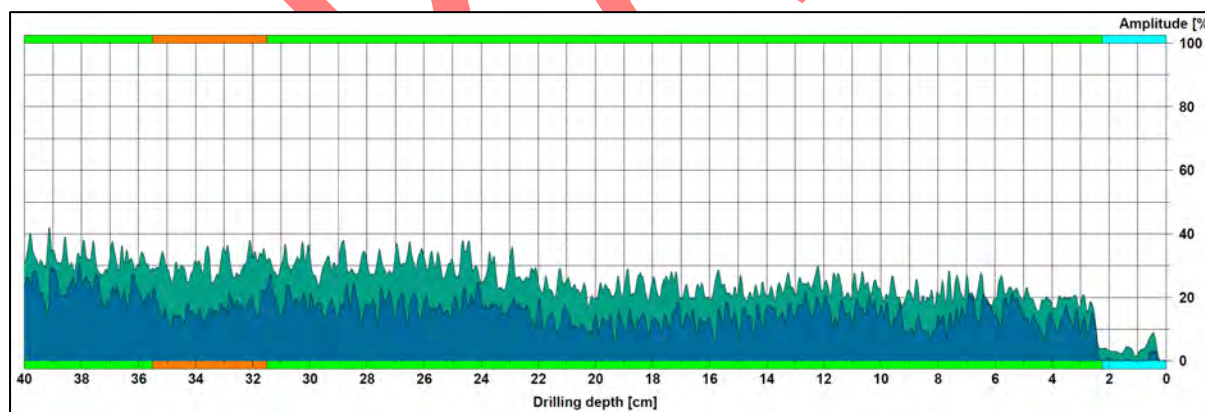
Figure 10: showing the readings from the assessment at 600mm on the west side of the tree.

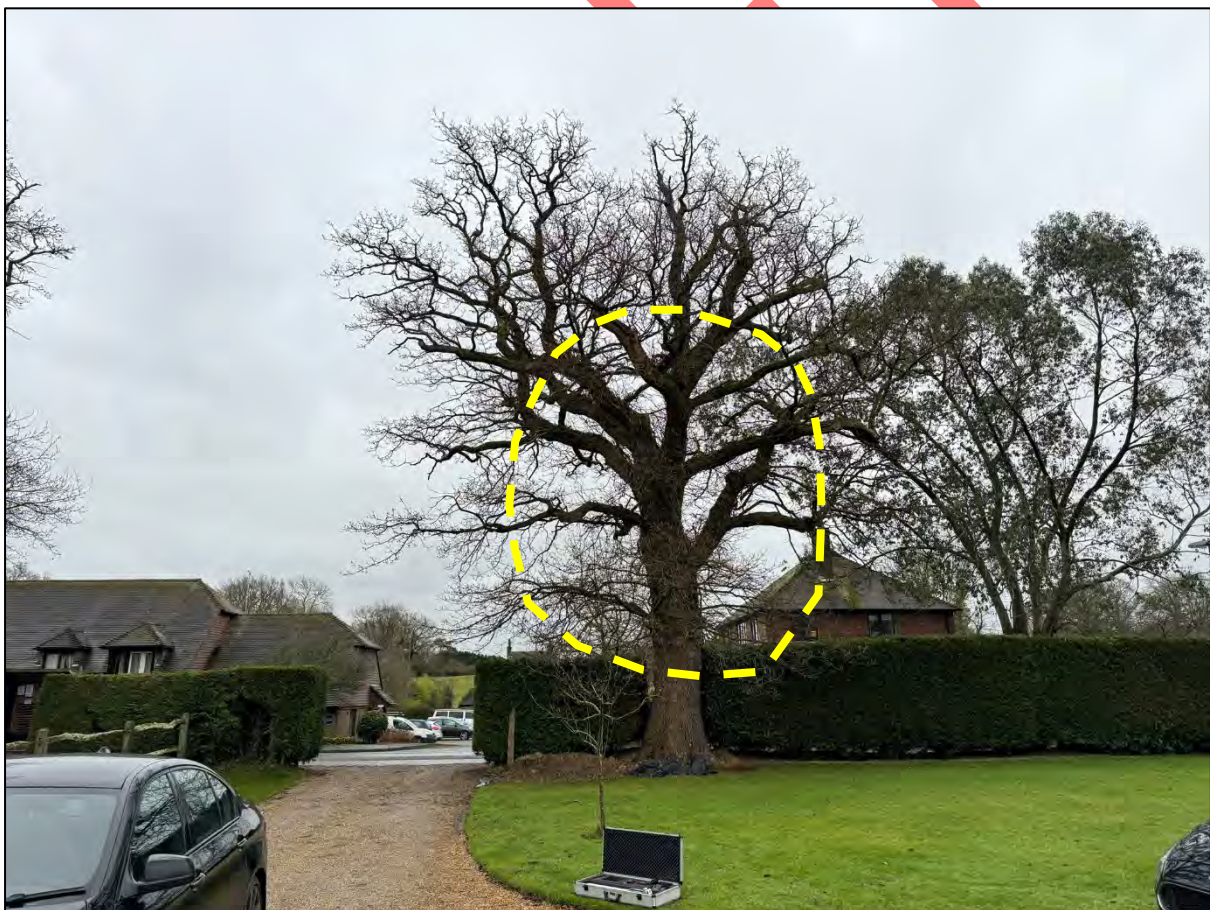
5.3.14. I have considered the potential of significantly reducing the size of the tree to retain some of the trunk wood for habitat and biodiversity benefits. However, any pruning would need to be substantial, and would remove much of the remaining live canopy, at least temporarily. An illustrative potential pruning line is provided below for context.

*Photograph 3: showing a hypothetical pruning line that may enable retention of the tree.*

5.3.15. Unfortunately, the removal of much of the live canopy would likely expediate the tree's decline as oak does not generally tolerate heavy pruning well; particularly when vitality already appears to be reduced. Therefore, the above pruning would, in my opinion, result in an increased rate of basal and root decay as a result of the tree having to focus resources on regenerating growth within the canopy and thus,

it would not be able to allocate sufficient resources to fight off the advancing decay. Accordingly in risk-mitigation terms, I see little alternative to the removal of the tree.
