Foul and Surface Water Drainage Report

2 Reservoir Place, Ashurst

Reference **C3547**

Project Name: 2 Reservoir Place
Project Description: CCTV survey, trace and plot
Project Status: Complete
Project Date: 14/02/2025
Inspection Standard: MSCC5 Sewers & Drainage GB (SRM5 Scoring)

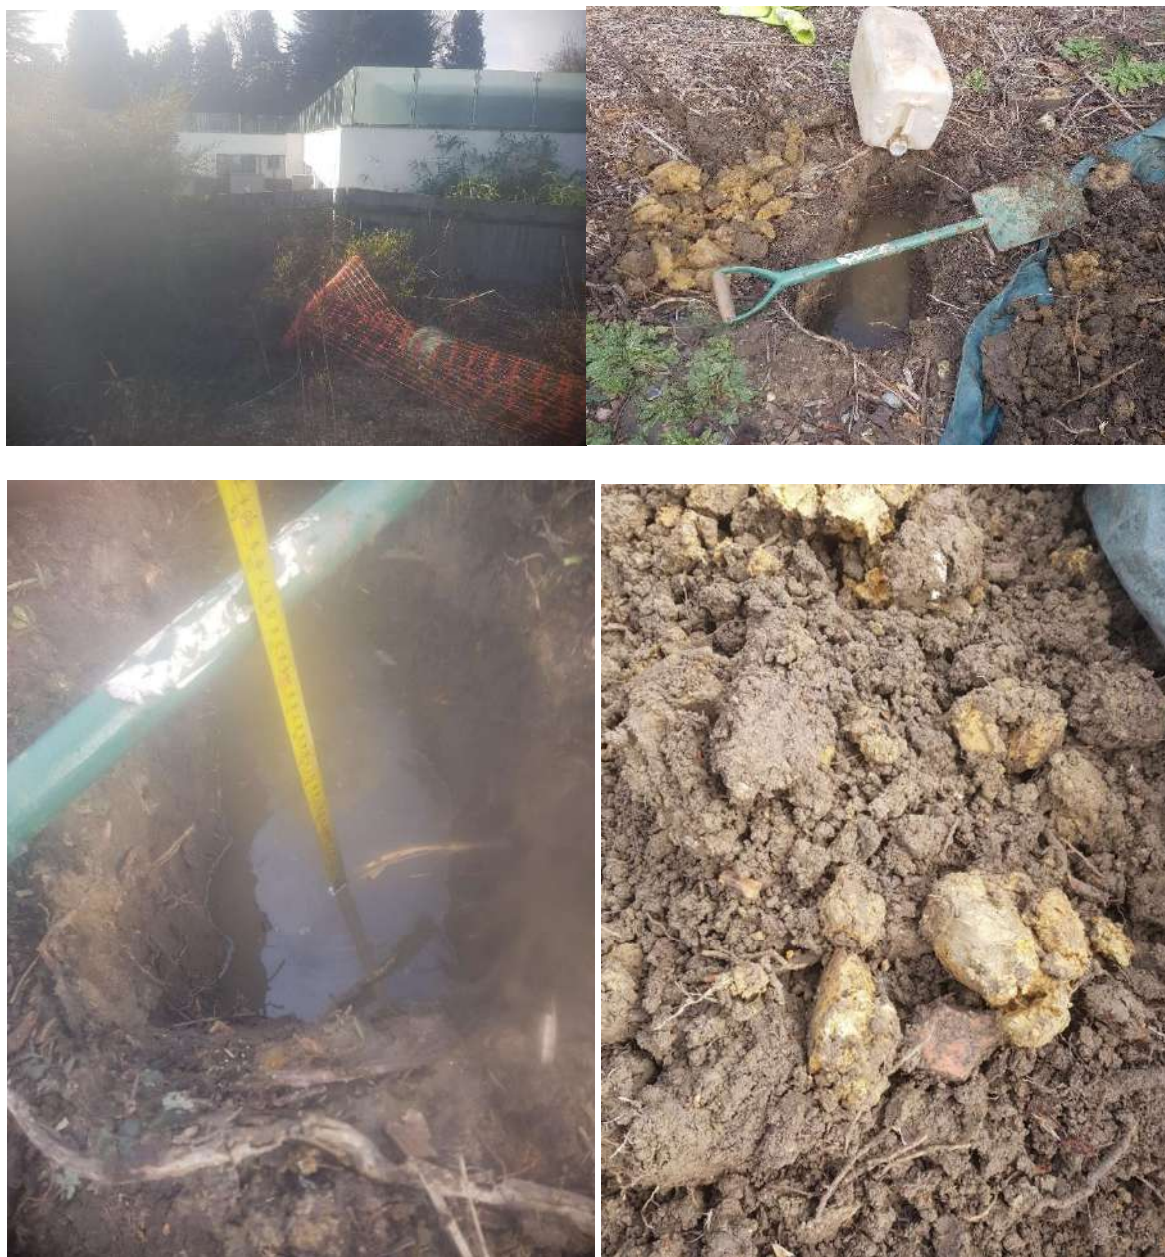
Fig 5. Soakaway test (site photographs)

- 3.3.1 No intrusive ground investigation testing has been conducted on-site however, a trial hole for infiltration testing was excavated to a depth of 1m BGL. During the infiltration testing, it was confirmed that the proposed site is underlain by clay soils, which is consistent with the information provided by BGS maps.
- 3.3.2 The nearest borehole logs indicate site being located within the area underlain by Clay, Yellow Clay Sand soils.
- 3.3.3 Due to the very low permeability, the test was deemed a **fail**. The only viable option for stormwater disposal is a deep borehole soakaway reaching the sand layer at approximately 16m. This solution is necessary due to the absence of existing Surface Water sewers and the lack of a watercourse in the vicinity of the proposed development site.

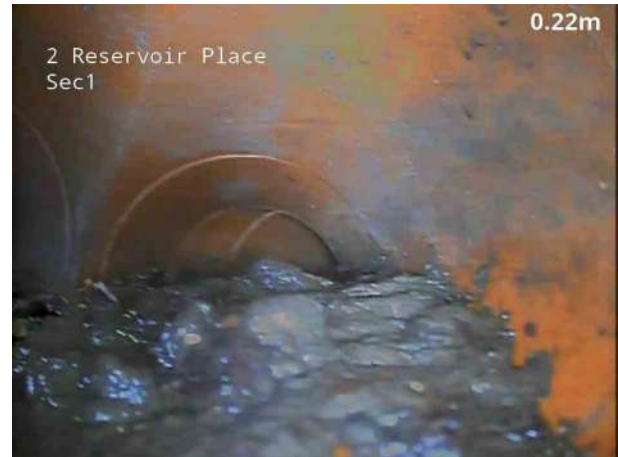
2, 00:00:06, 0.30 m
Settled deposits, fine, 50% cross-sectional area loss, change

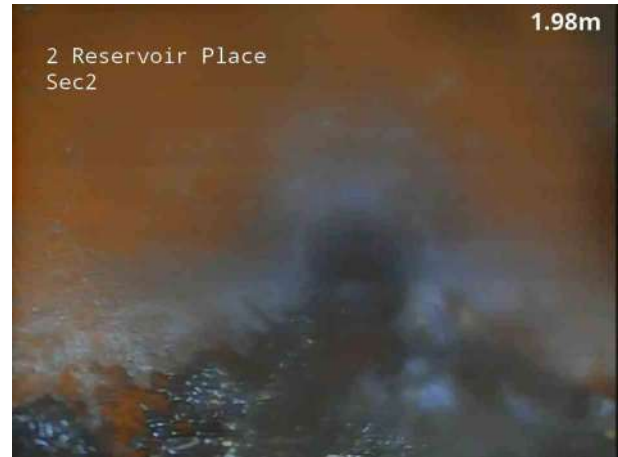
2, 00:00:43, 2.00 m
Settled deposits, fine, 5% cross-sectional area loss, change

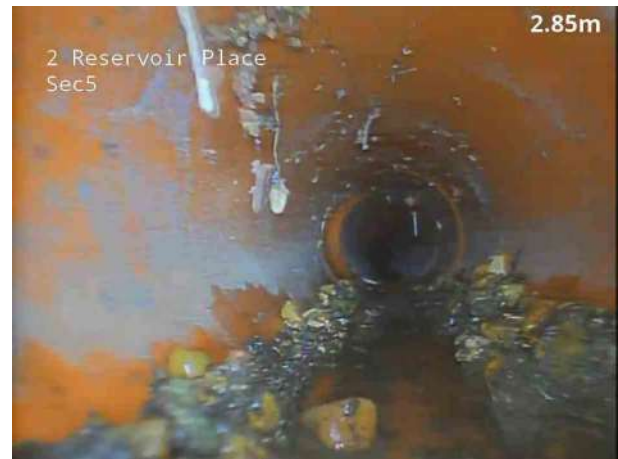
2, 00:00:19, 2.80 m
Settled deposits, coarse, 10% cross-sectional area loss

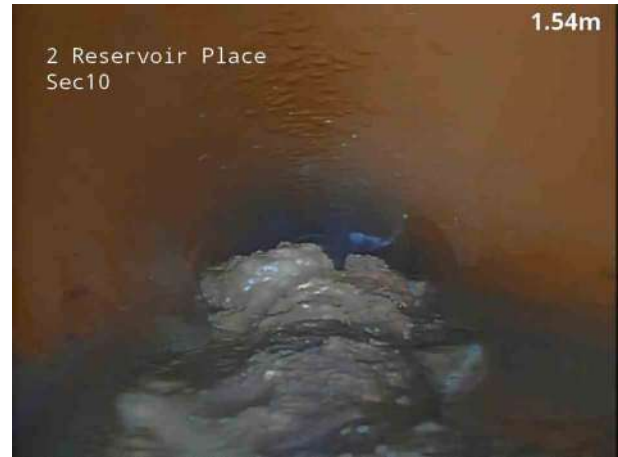
2, 00:00:14, 1.60 m
Attached deposits, fouling from 5 o'clock to 7 o'clock, 25% cross-sectional area loss

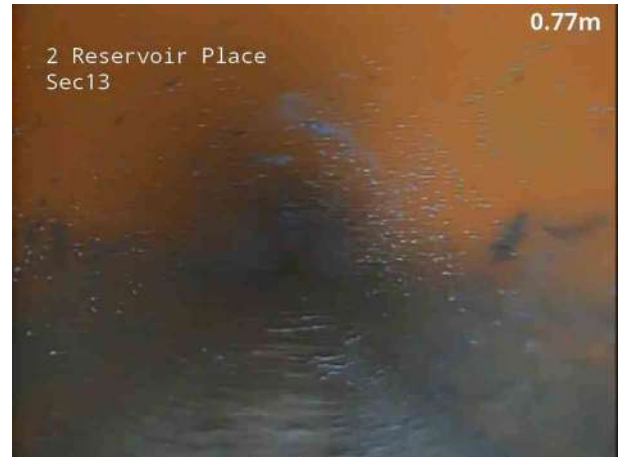
2, 00:00:11, 0.80 m
Attached deposits, fouling from 5 o'clock to 7 o'clock, 5% cross-sectional area loss, start, Scale

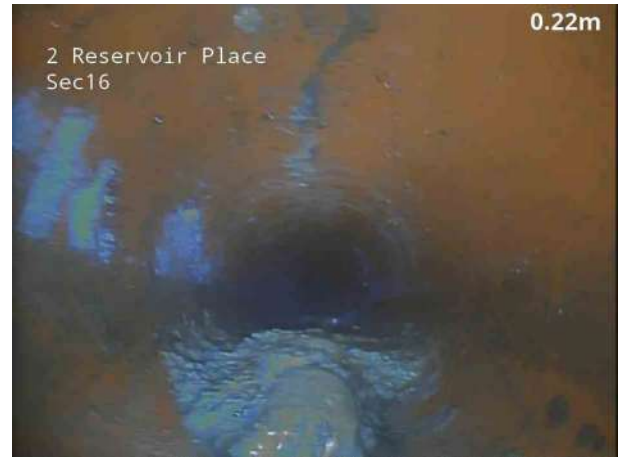
2, 00:00:09, 0.30 m
Settled deposits, other, 5% cross-sectional area loss, start
