*Project ref: TV241020*

SITE: 45 The Broadway  
Haywards Heath  
West Sussex  
RH16 3AS

# ***CCTV Survey Report***

*Sewer Inspection, Cleaning and Repair*

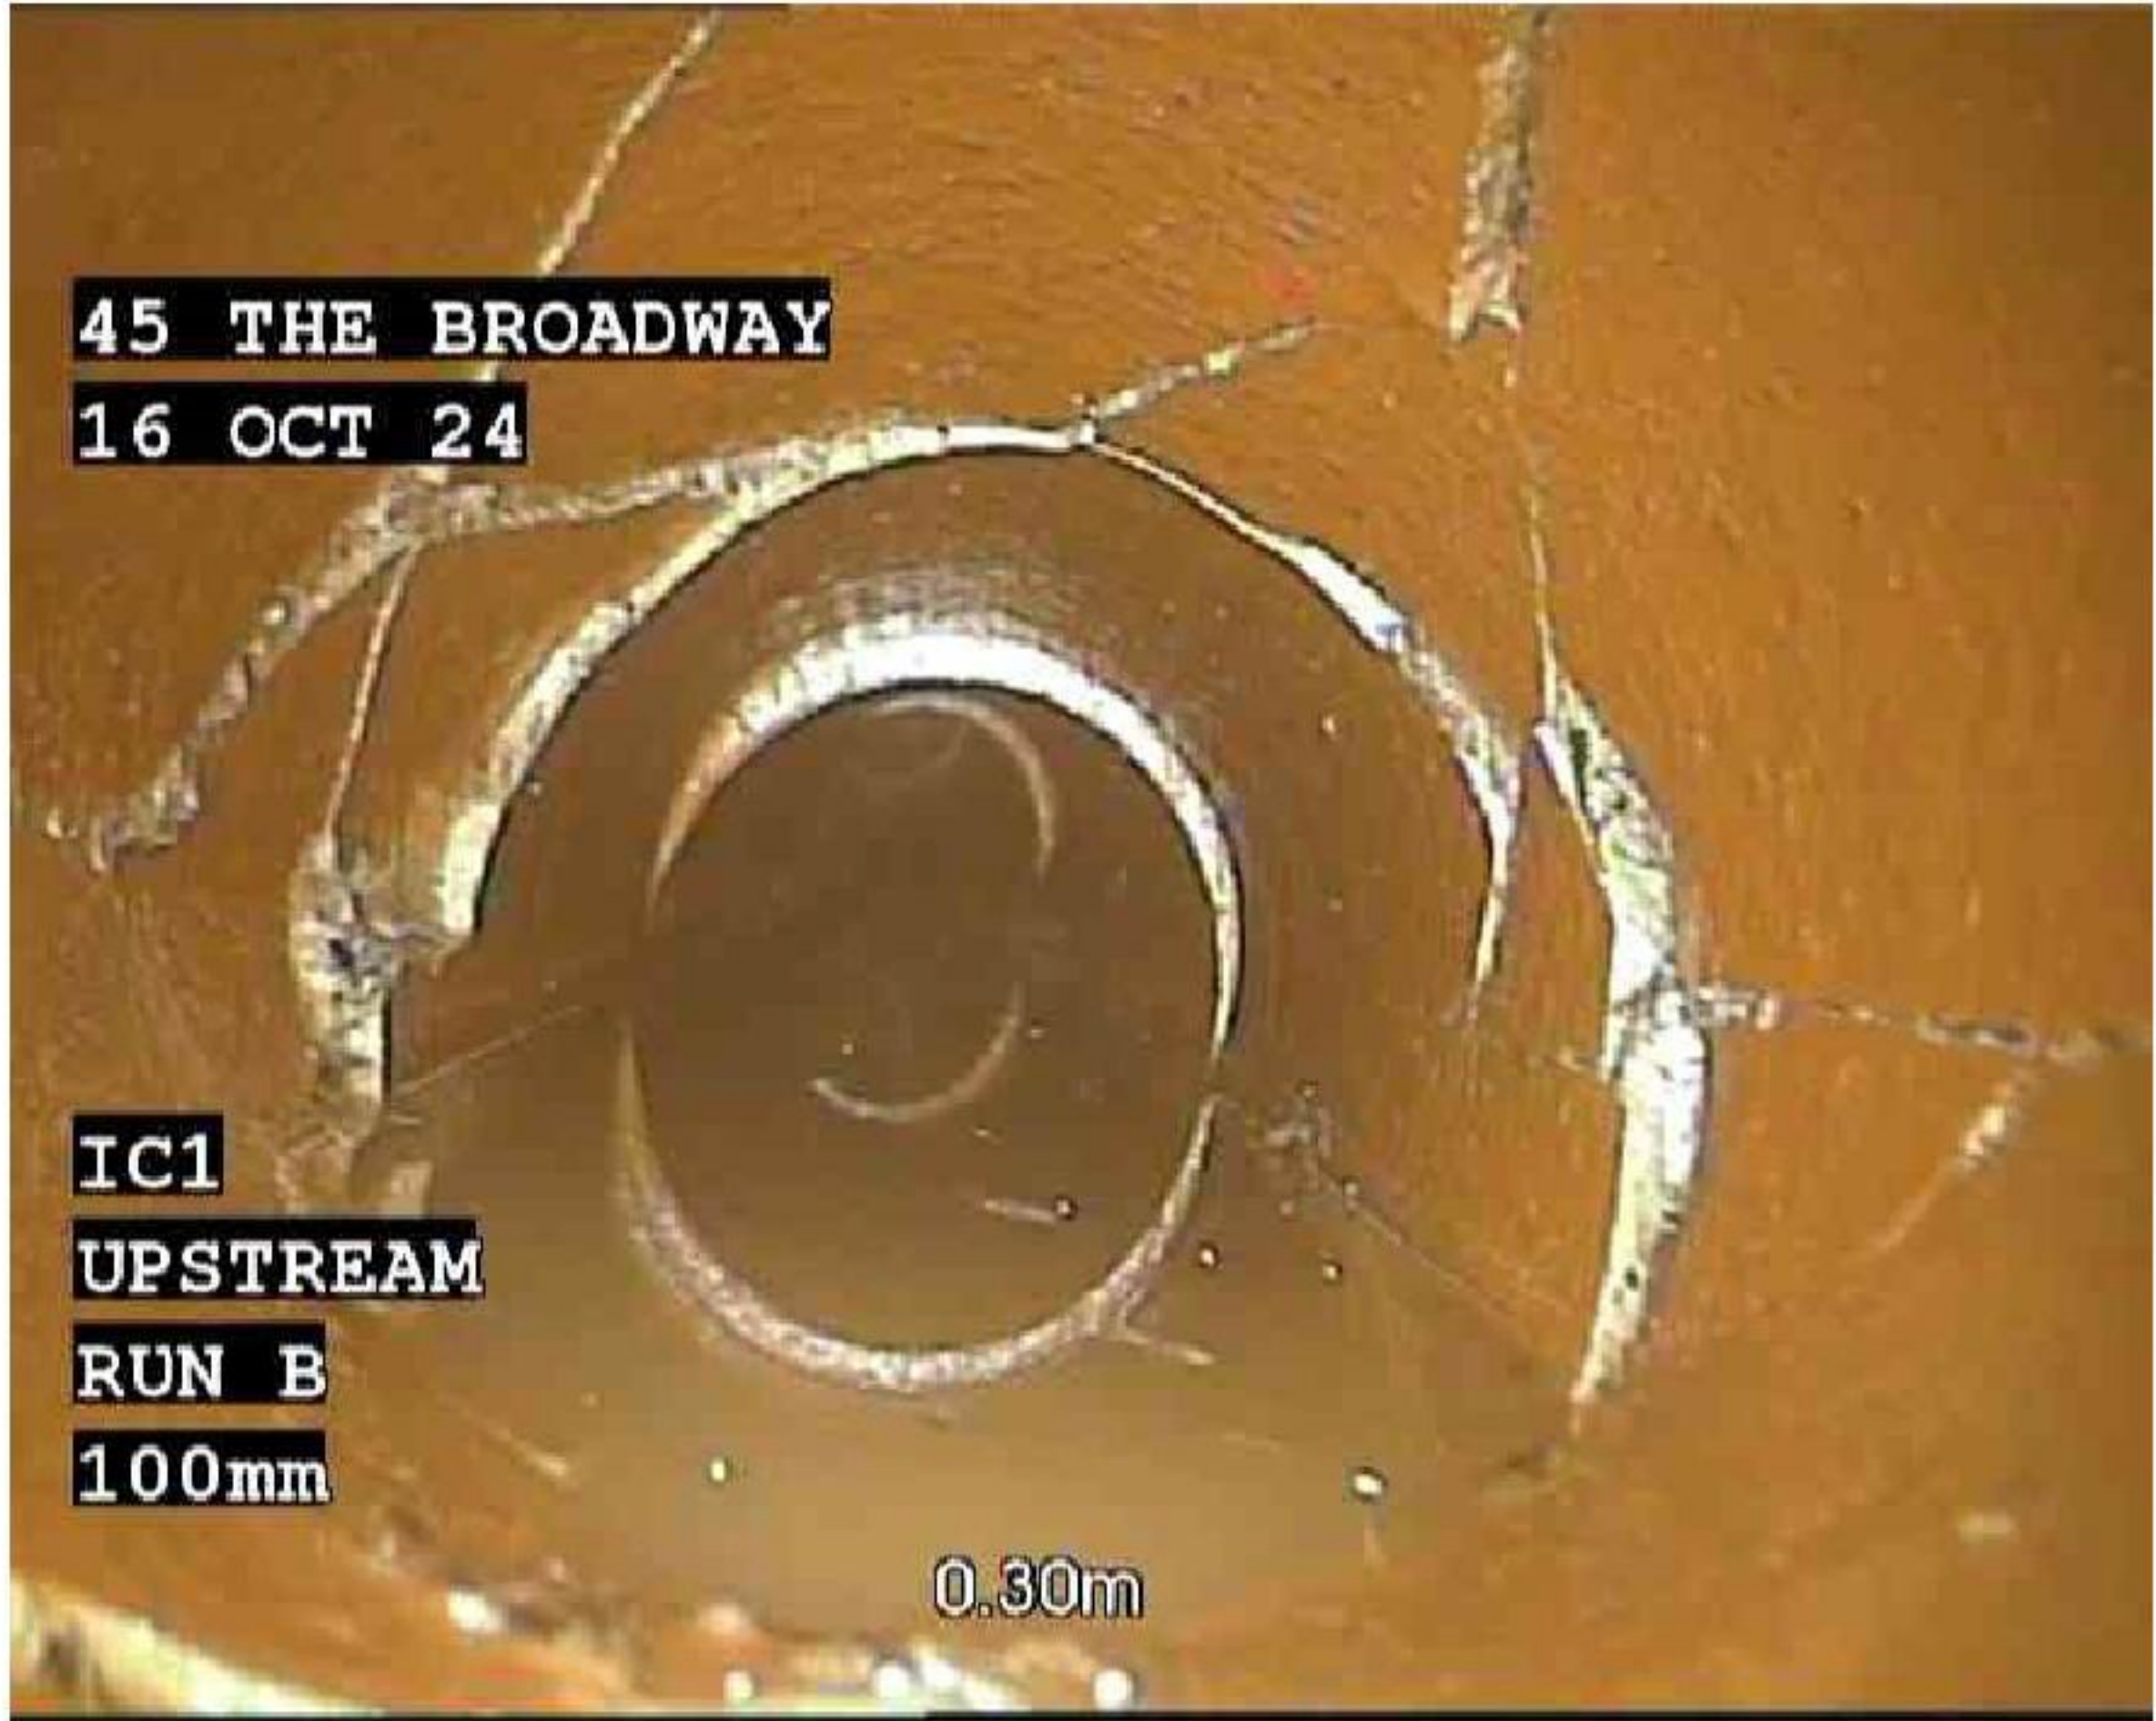
| Section | PLR | Grade | Description |
|---|---|---|---|
| 2 | IC1-BX | 4 | Fractures, multiple at joint from 7 o'clock to 5 o'clock |

1, 00:00:01, 0.30 m  
Fractures, multiple at joint from 7 o'clock to 5 o'clock

| <b>Recommendations:</b> | Repair defect(s) by lining | | | | |

| Section number | Upstream manhole | Flow direction | Downstream manhole | Recommendations |
|---|---|---|---|---|
| 2 | IC1-B | Upstream | IC1 | Consider repairing defect(s) by lining if pipework is to remain |

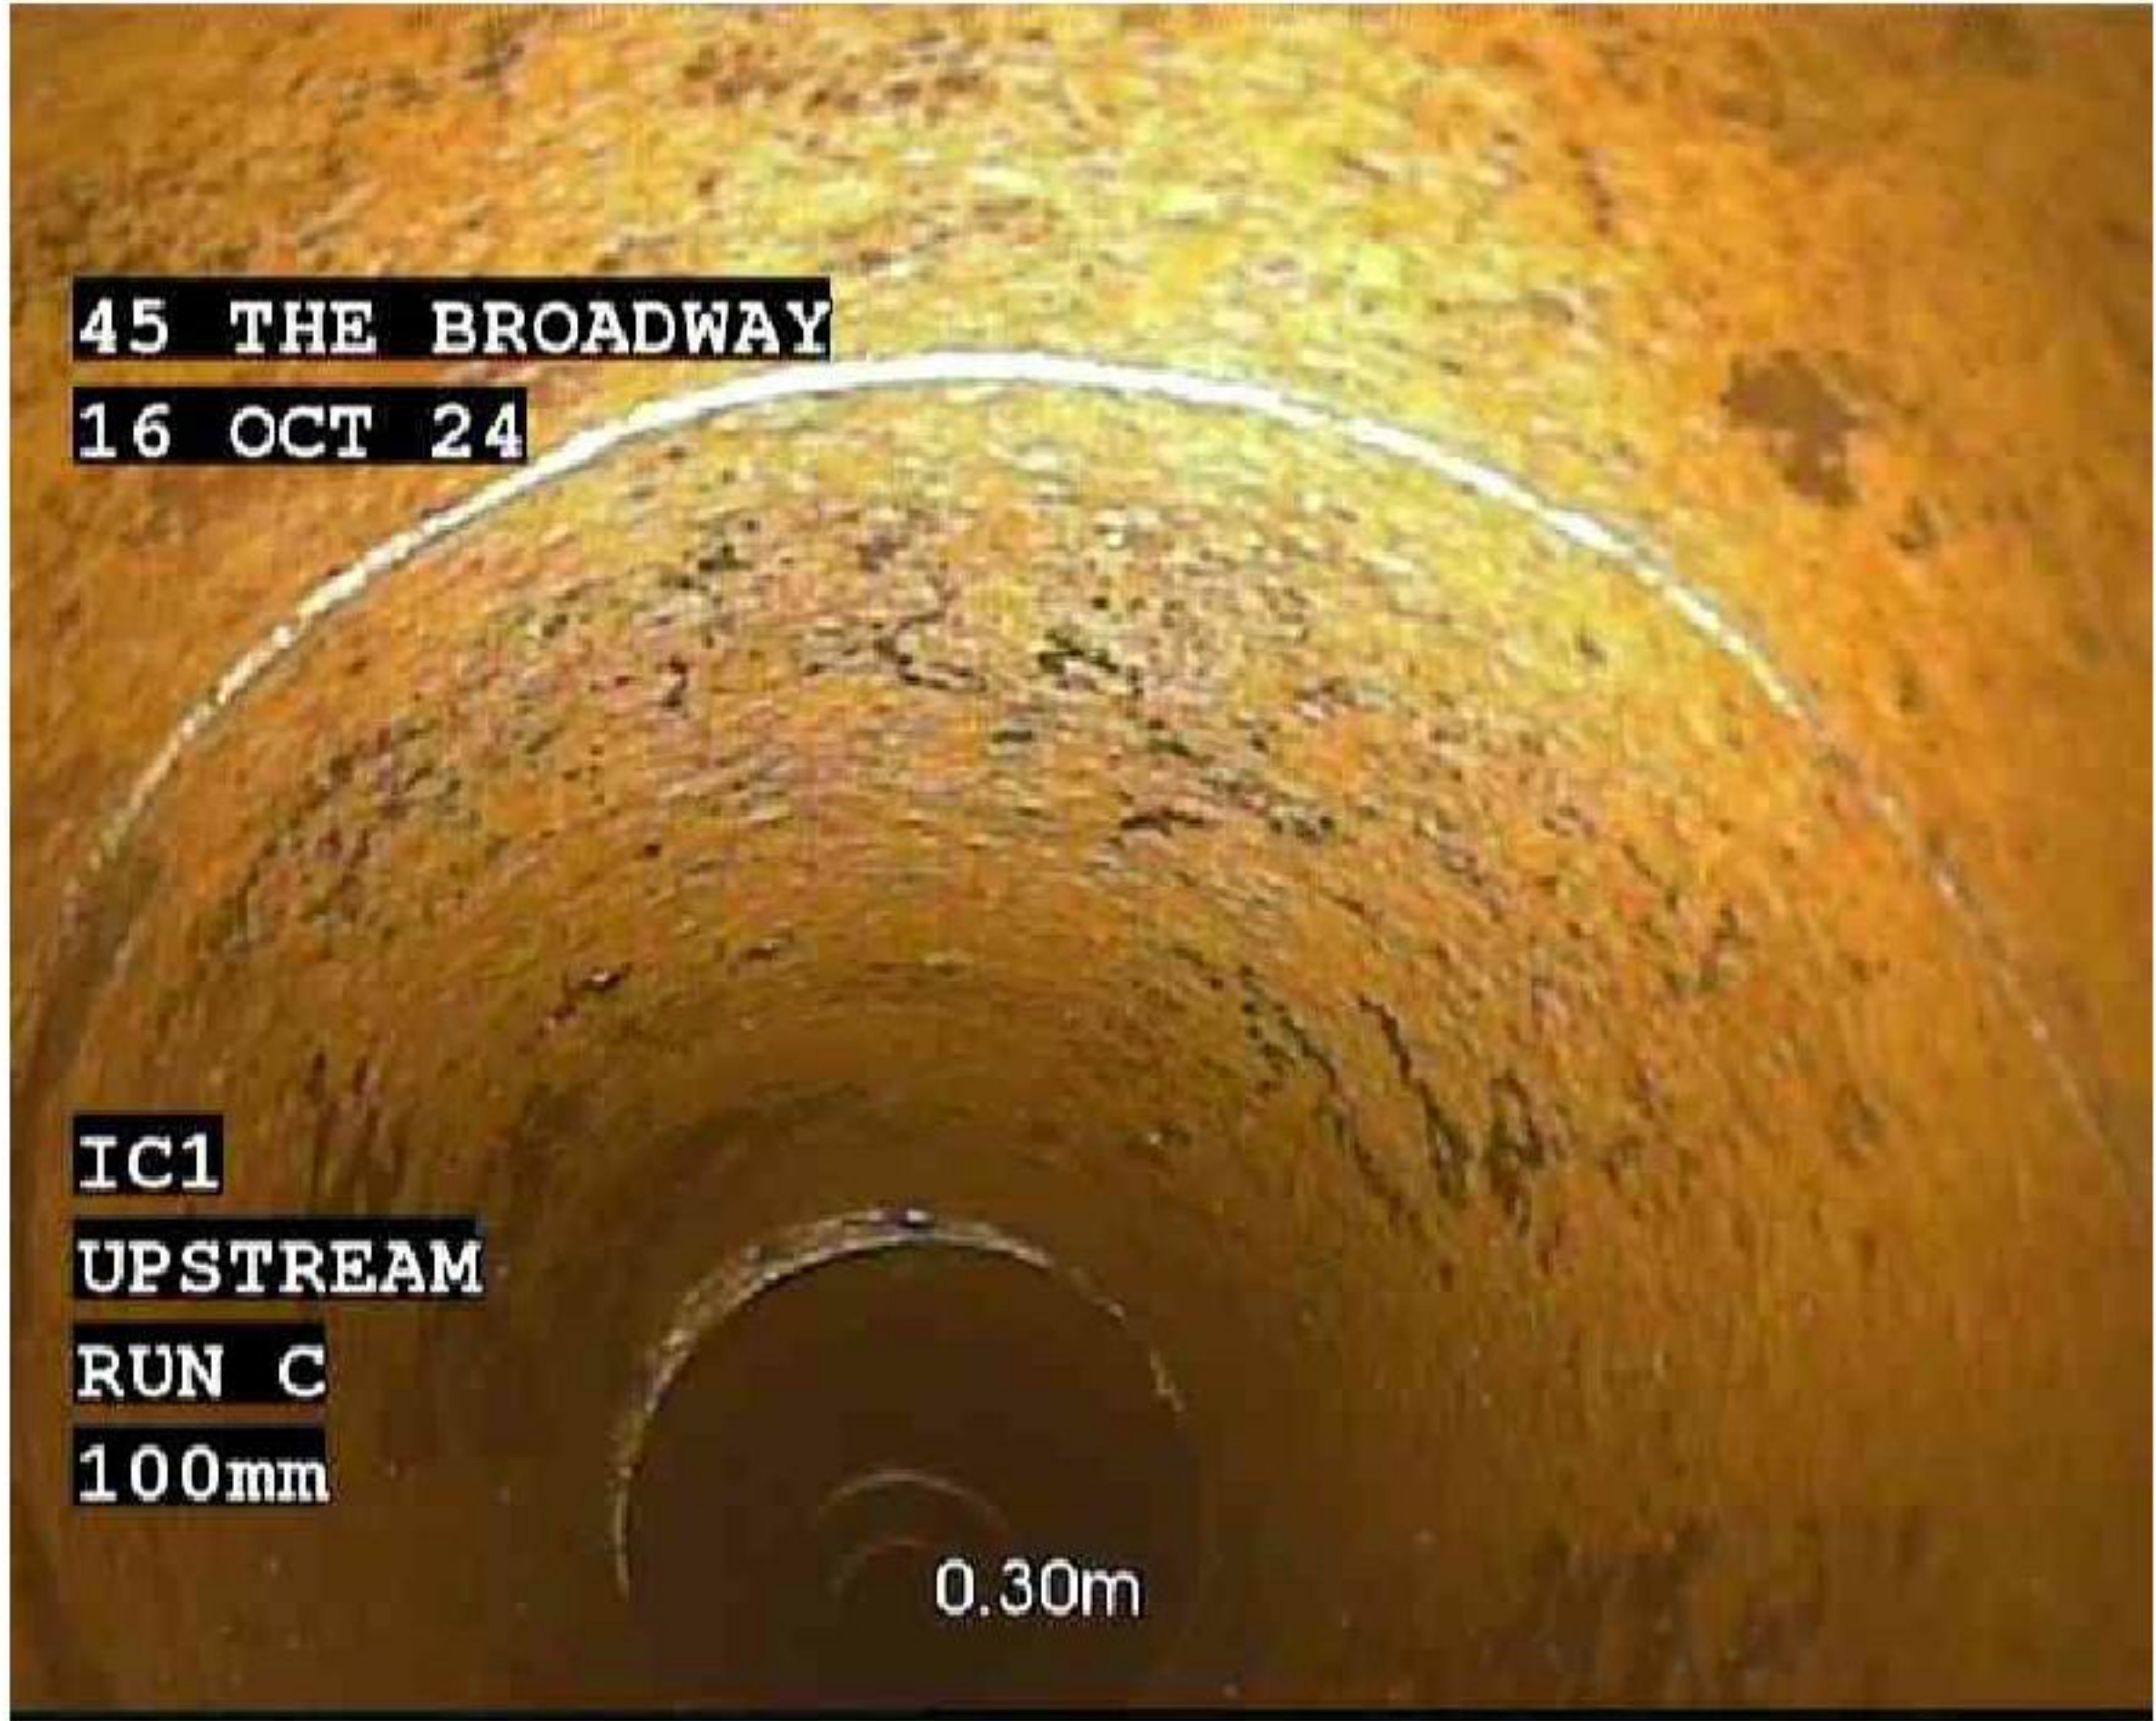
1, 00:00:01, 3.00 m  
Crack, circumferential from 09 o'clock to 03 o'clock

| Section number | Upstream manhole | Flow direction | Downstream manhole | Recommendations |
|---|---|---|---|---|
| 3 | IC2 | Upstream | IC1 | Consider repairing defect(s) by lining if pipework is to remain |

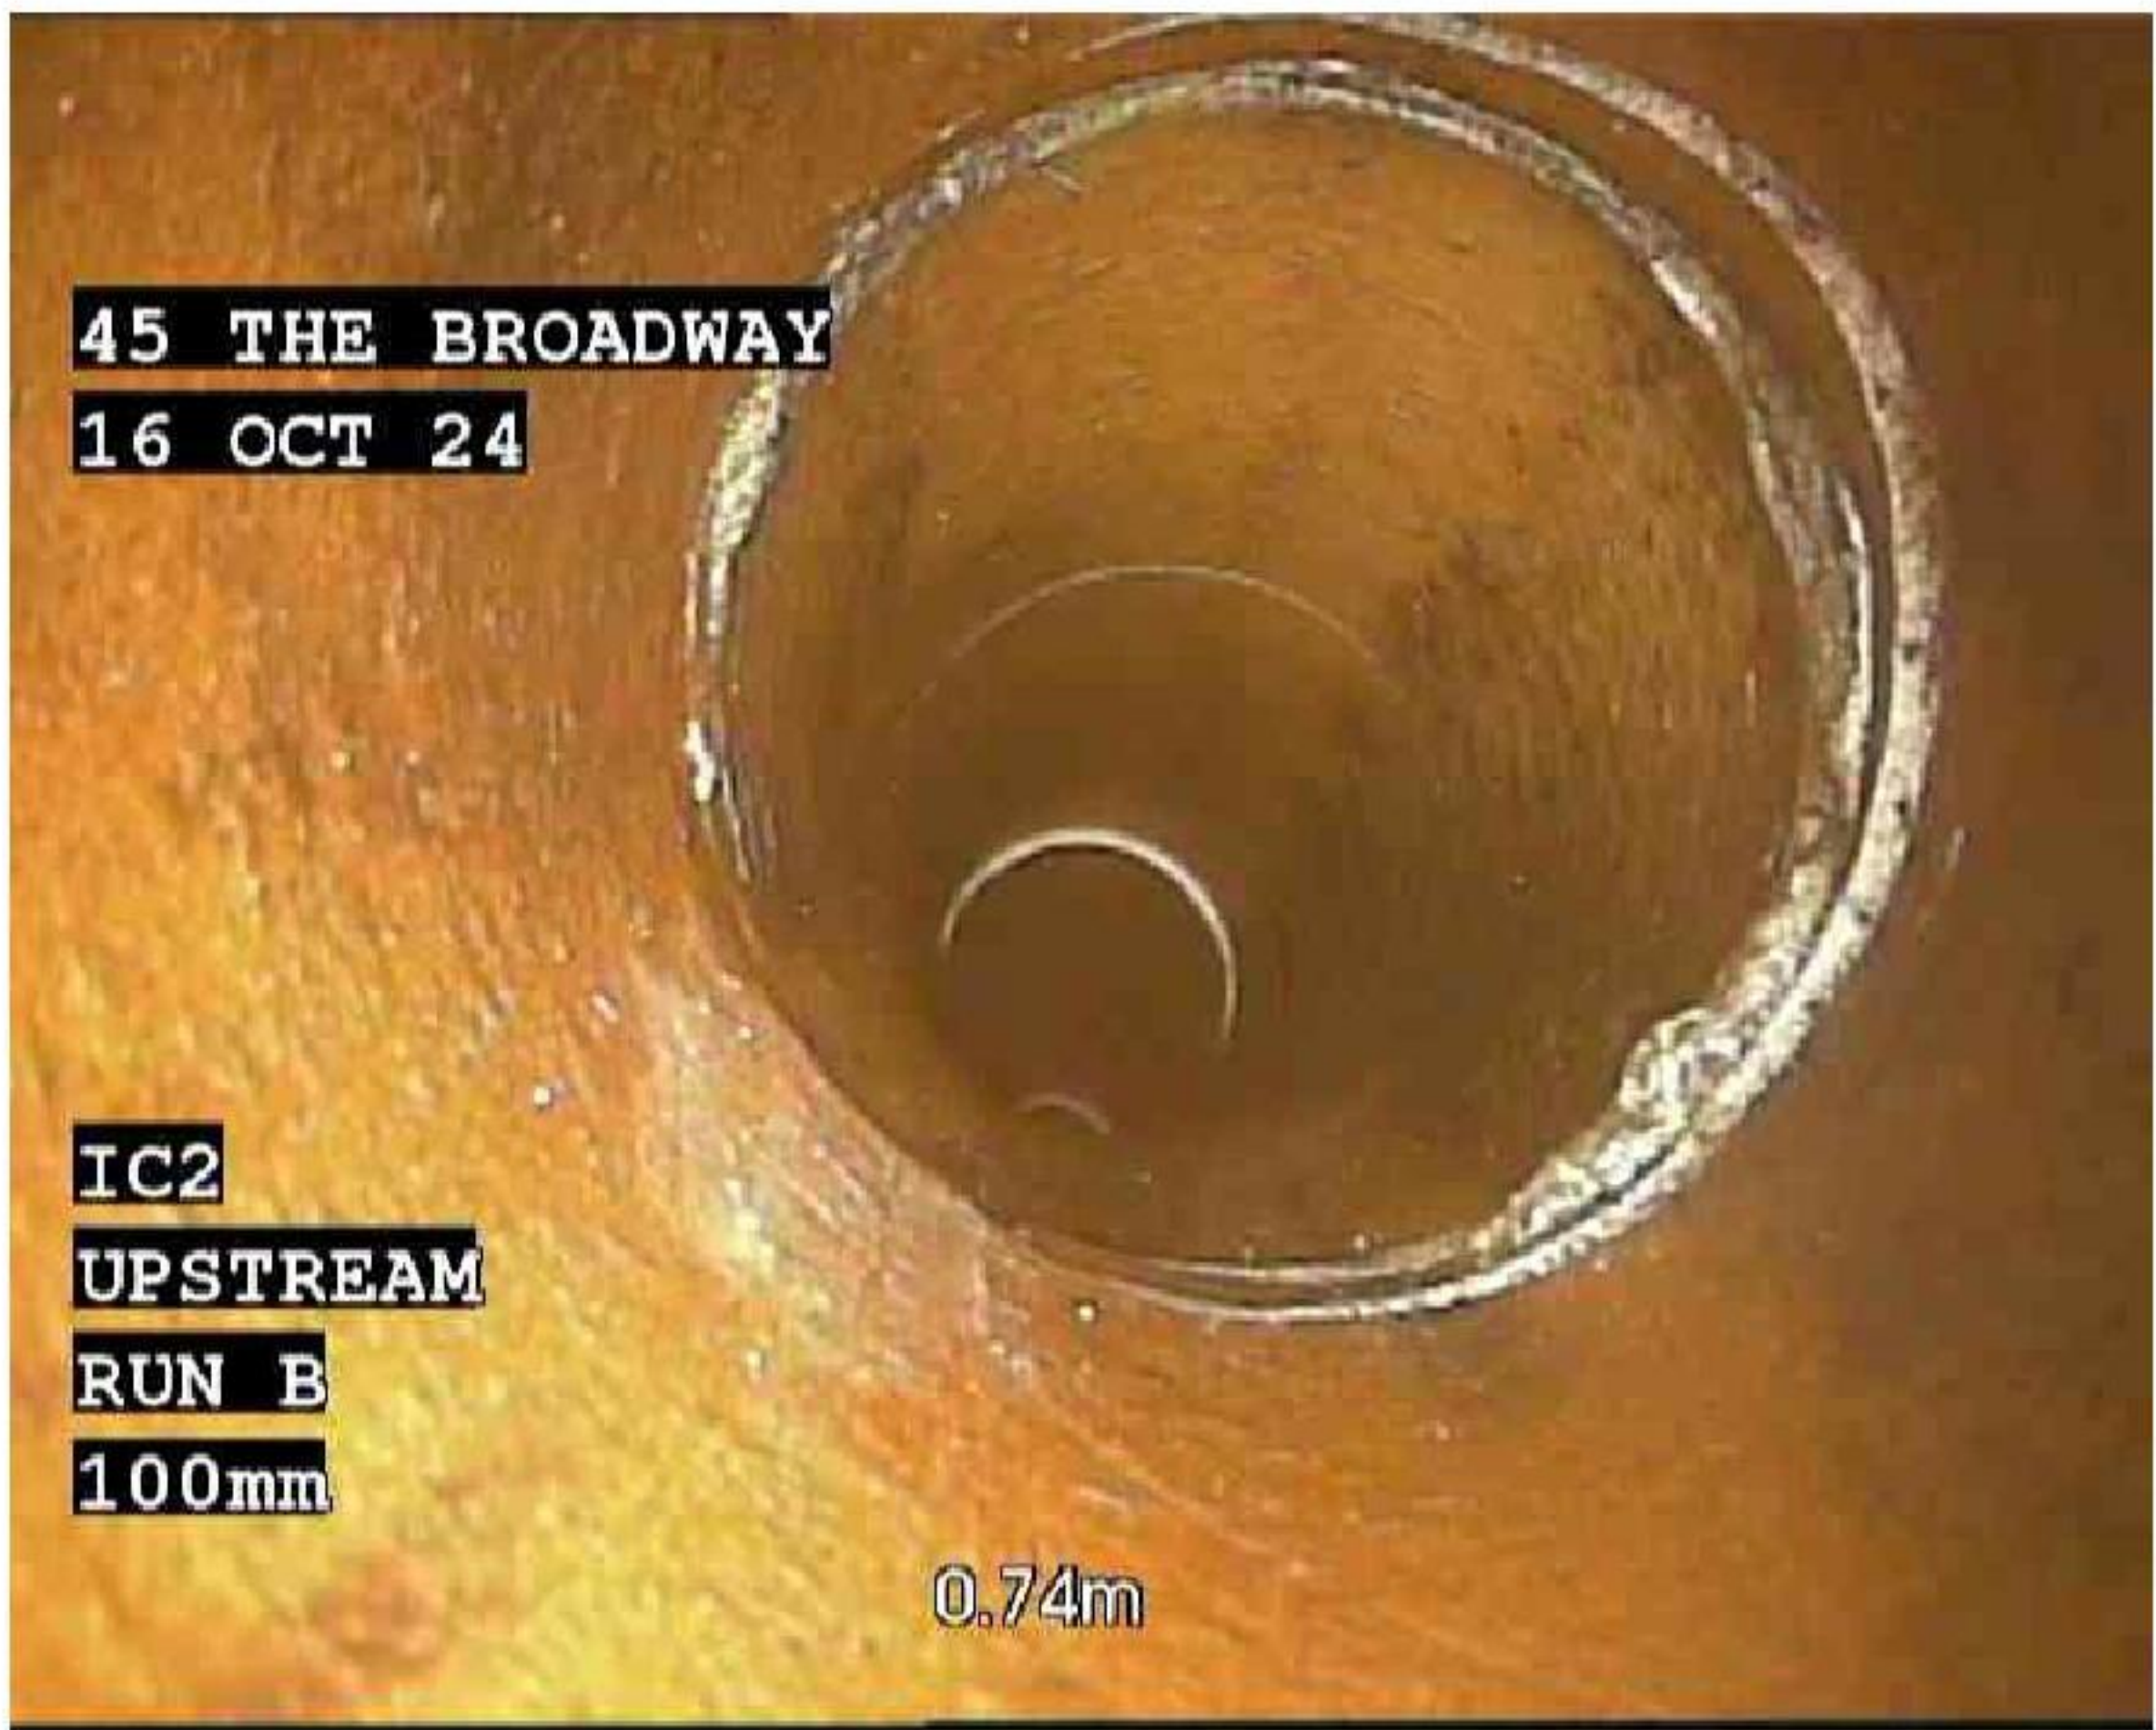
1, 00:00:07, 0.74 m  
Crack, circumferential at joint from 11 o'clock to 6 o'clock

| Section number | Upstream manhole | Flow direction | Downstream manhole | Recommendations |
|---|---|---|---|---|
| 4 | IC2-C | Upstream | IC2 | Consider repairing defect(s) by lining if pipework is to remain and be reused |

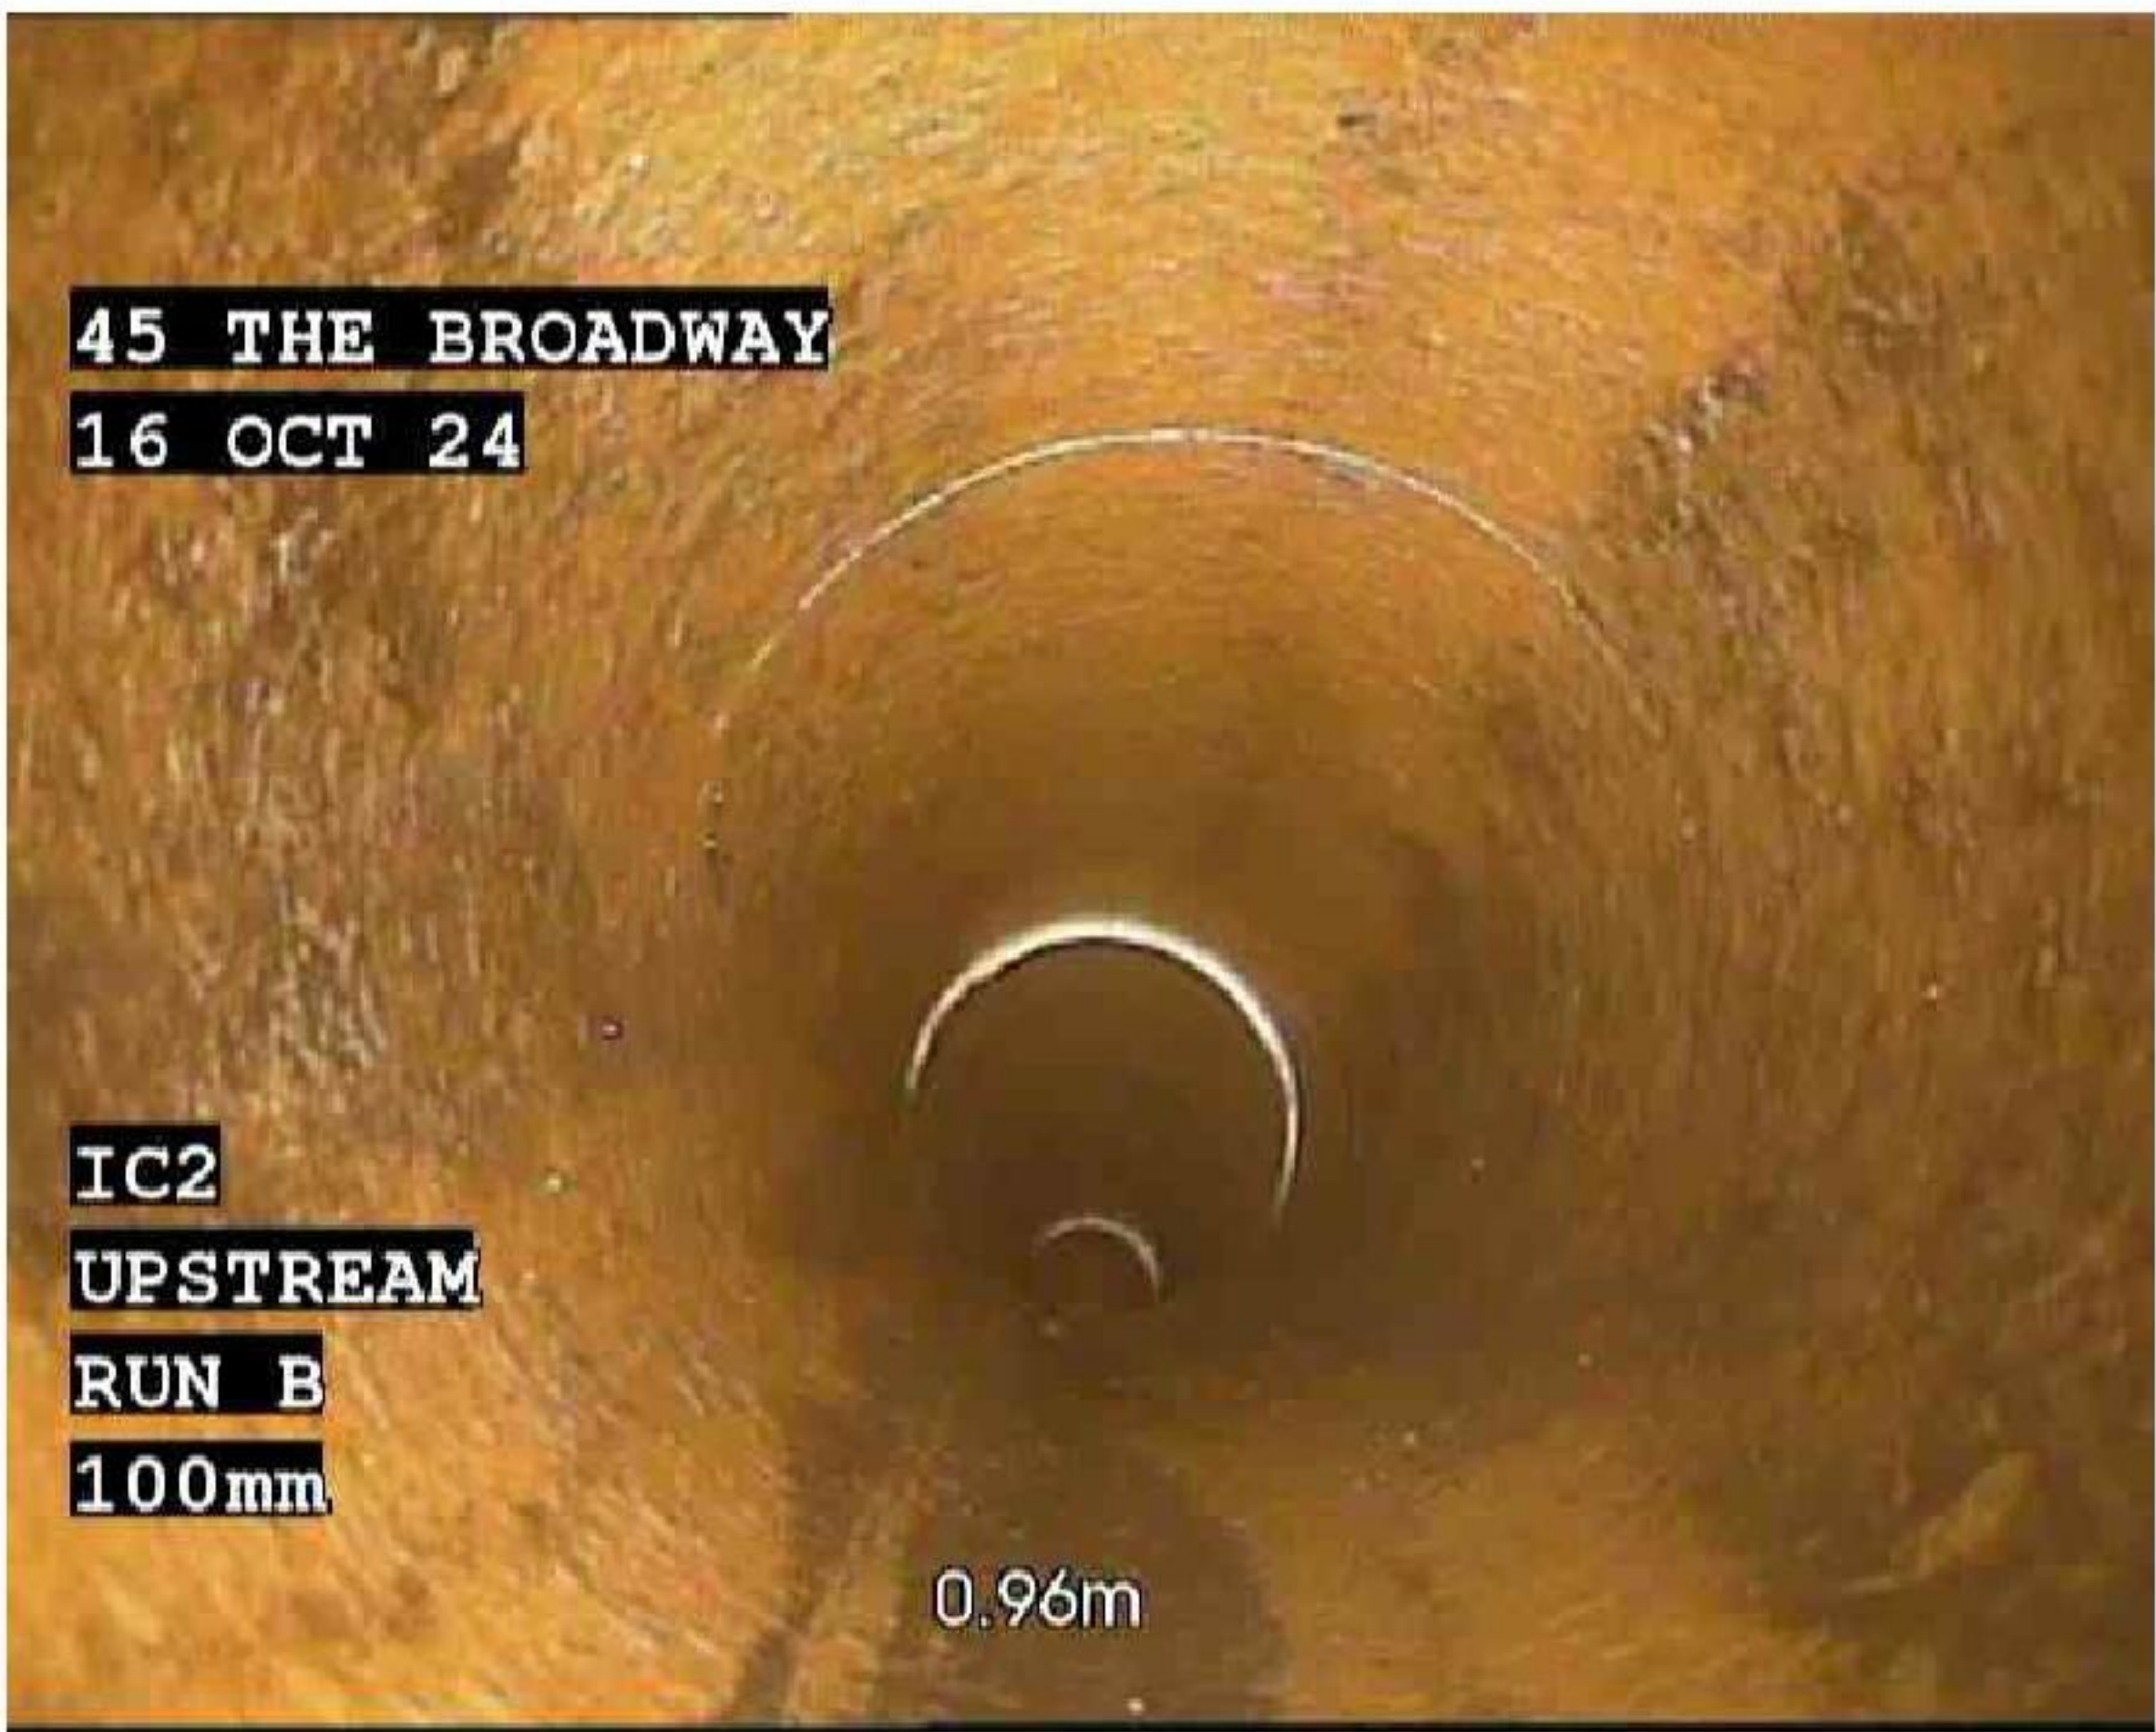
2, 00:00:09, 0.96 m  
Crack, circumferential at joint from 10 o'clock to 2 o'clock

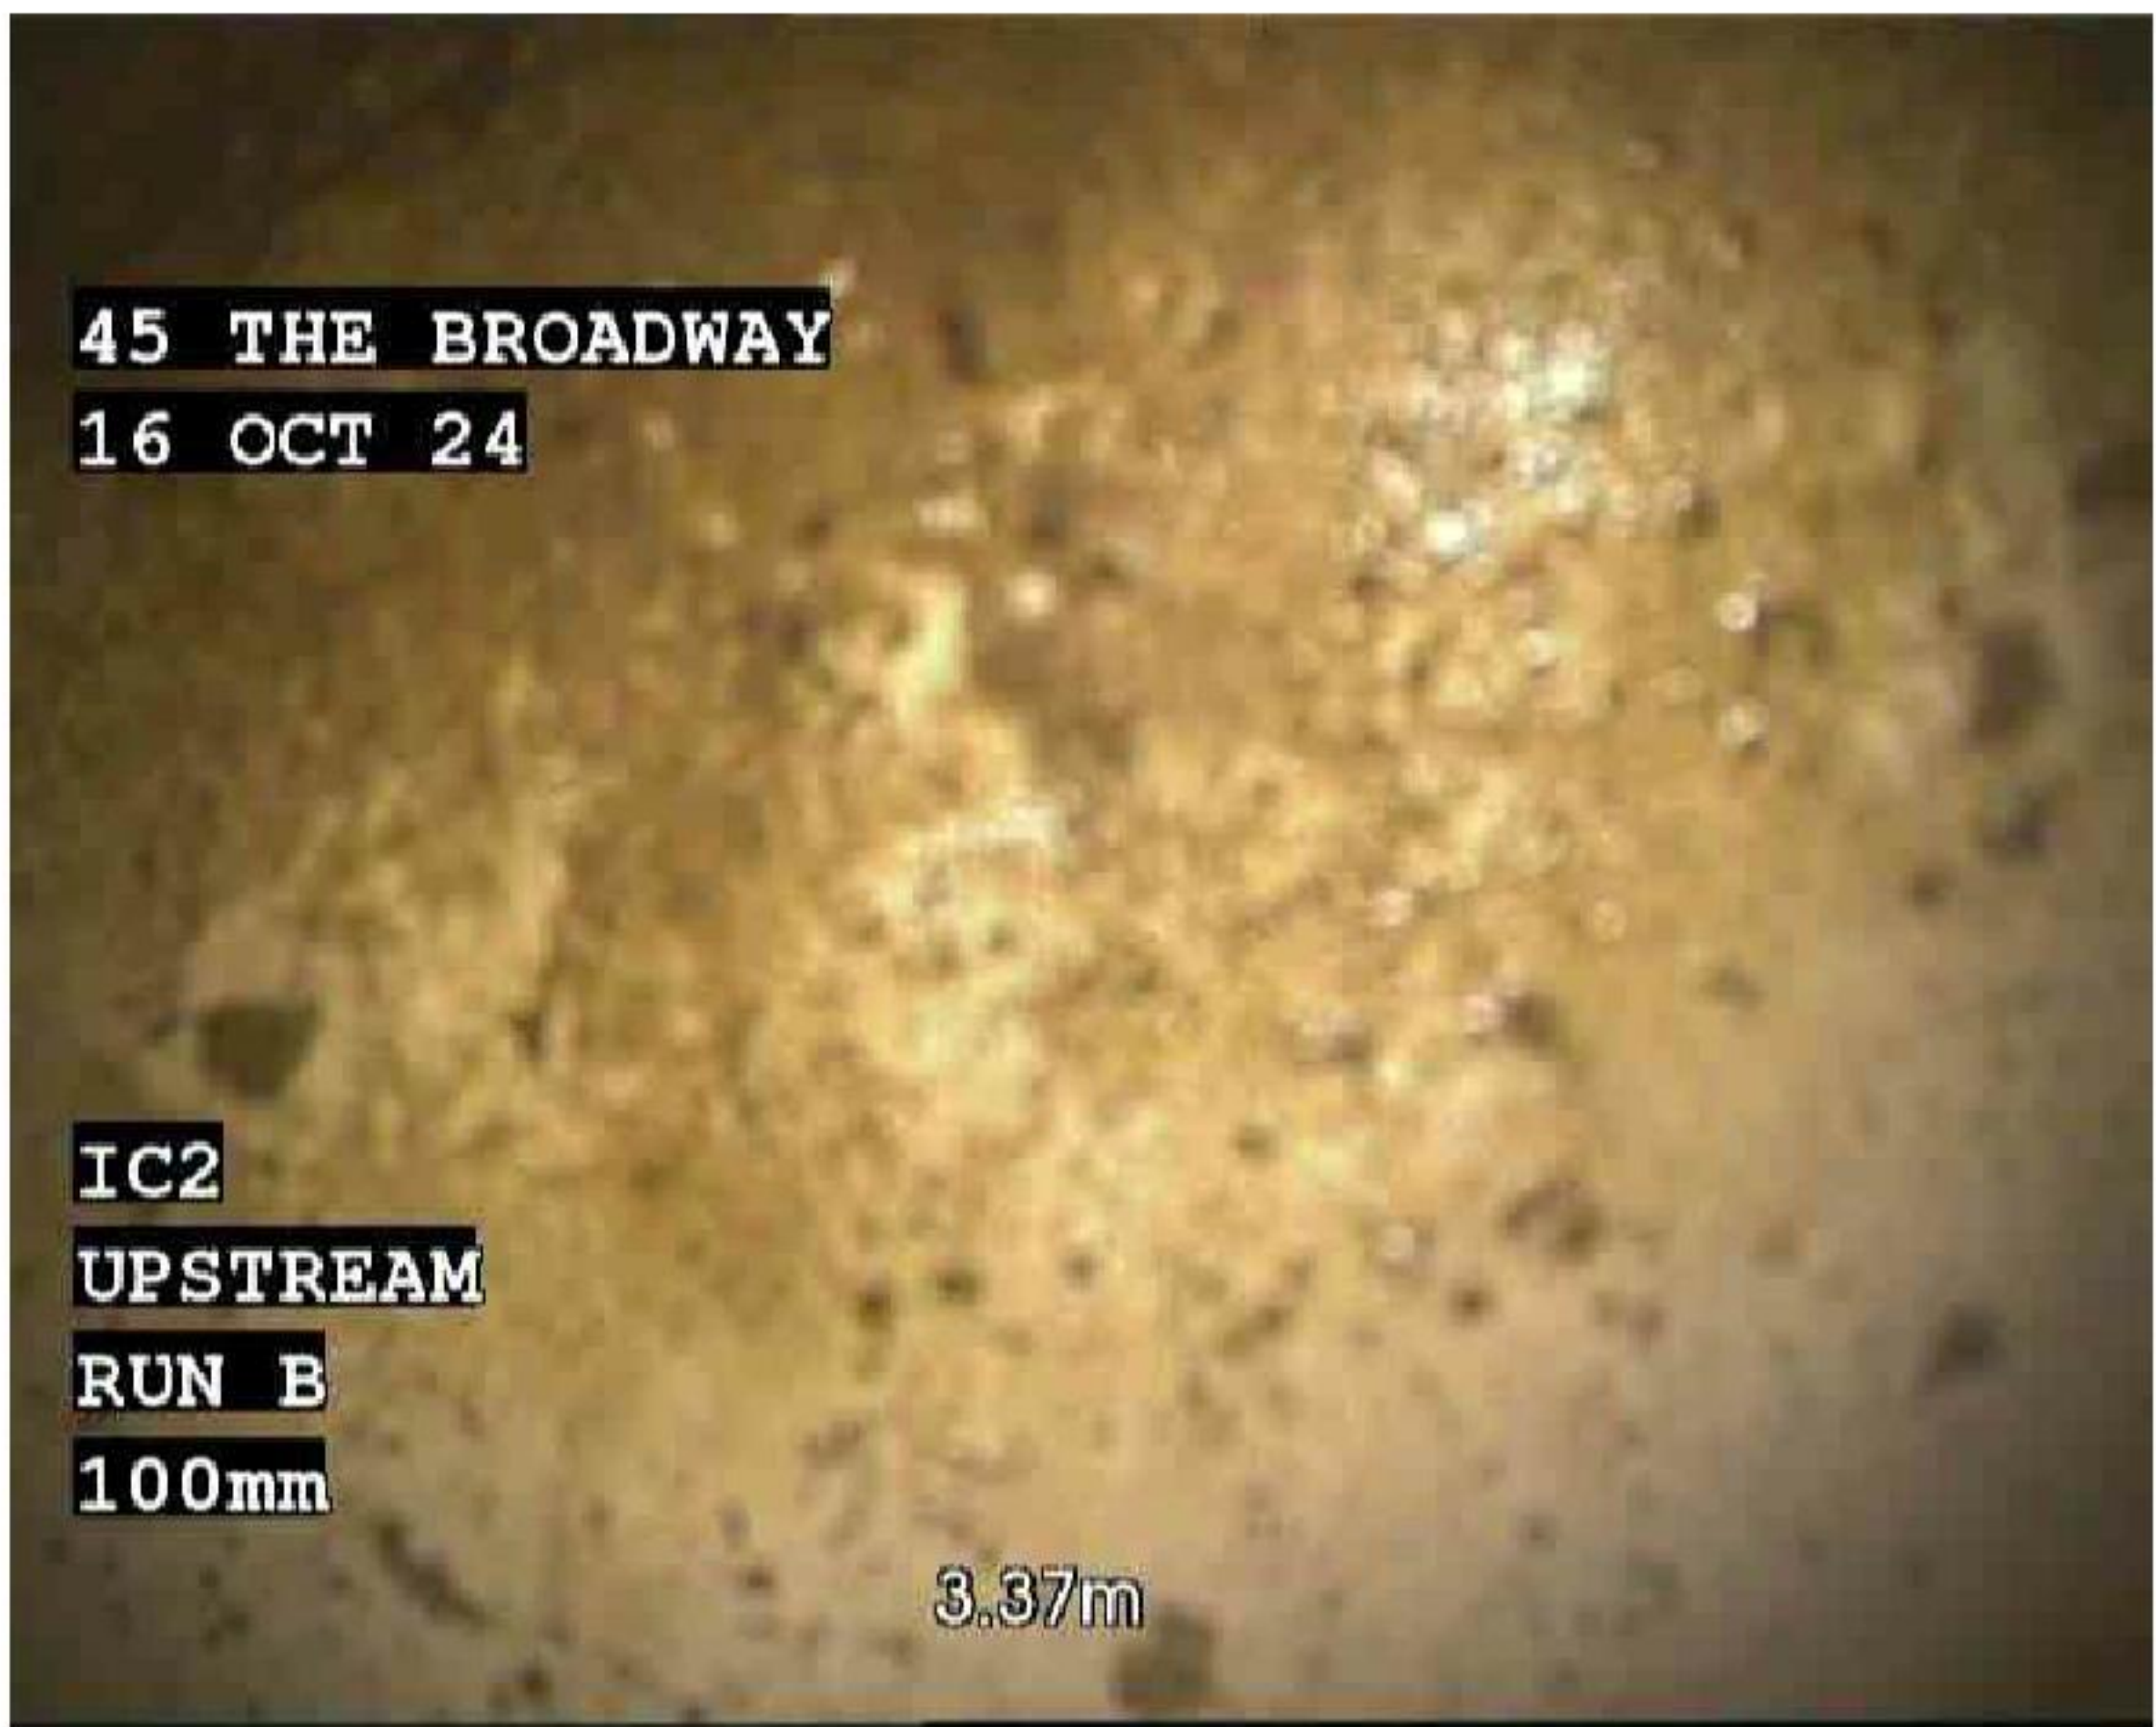
| Section | PLR | Description |
|---|---|---|
| 4 | IC2-CX | Survey abandoned |

3, 00:00:27, 3.37 m  
Survey abandoned, Redundant - capped off

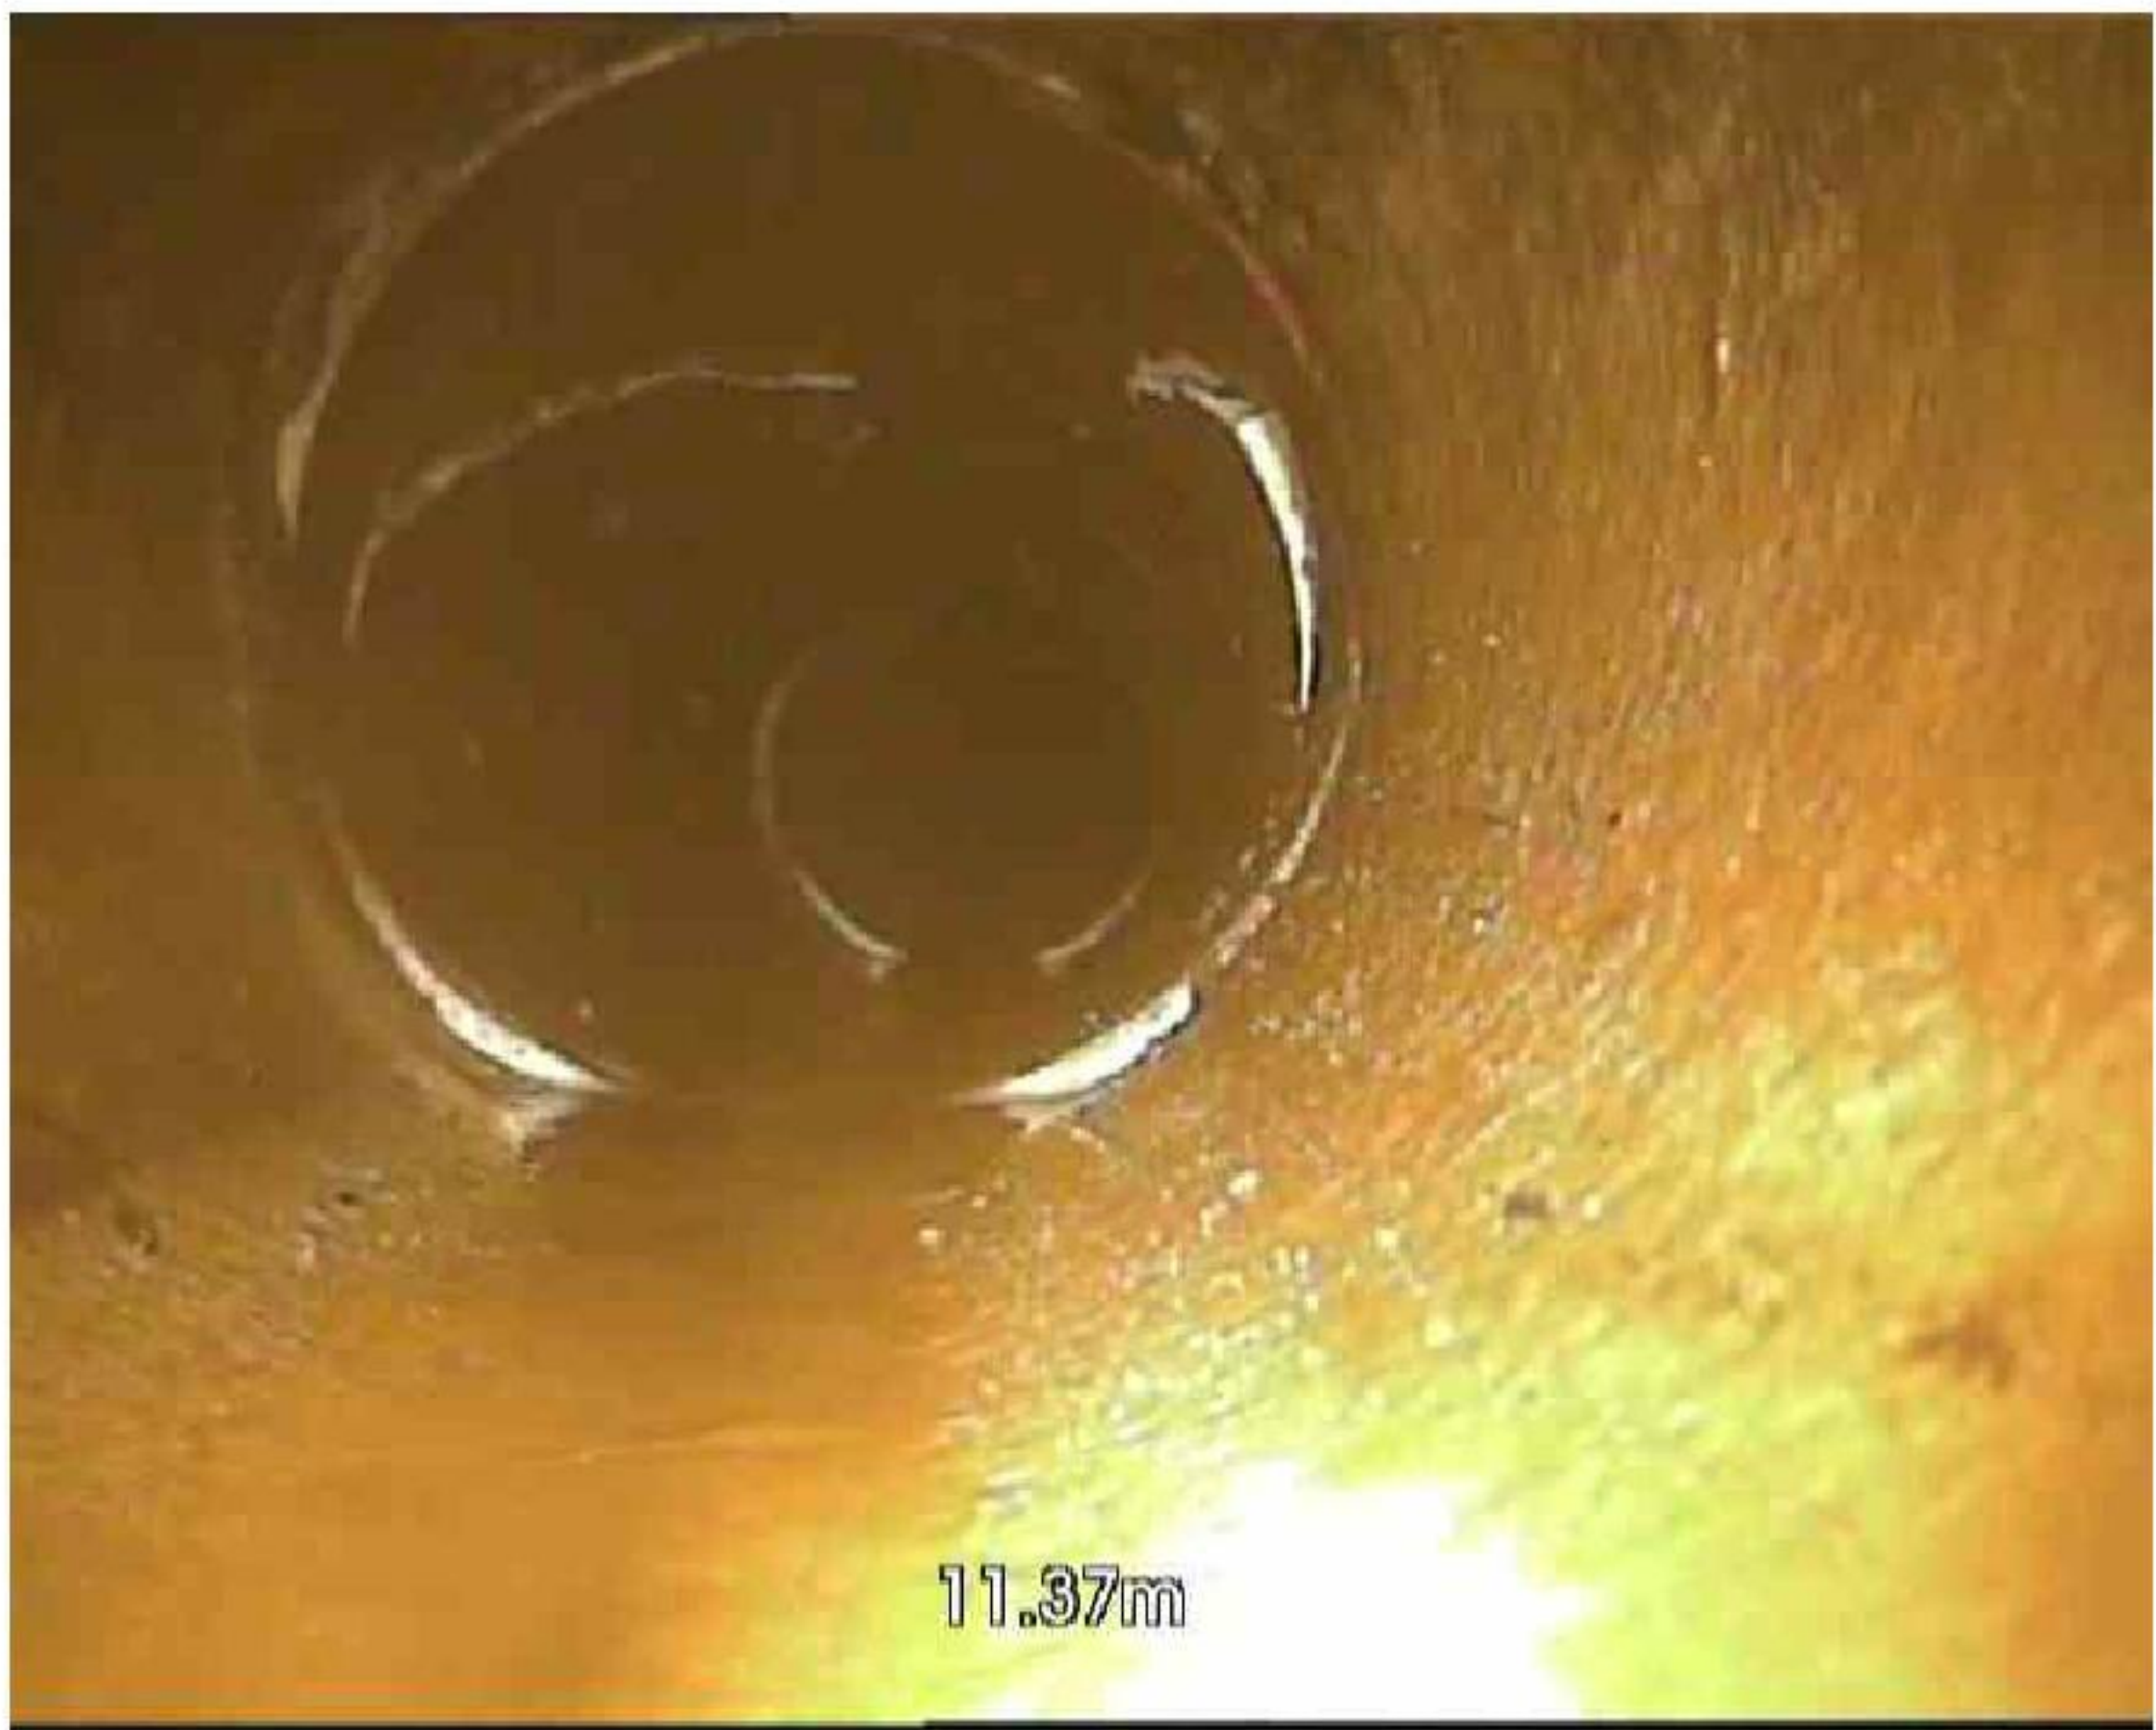
| Section | PLR | Grade | Description |
|---|---|---|---|
| 6 | IC1X | 4 | Broken pipe at joint from 9 o'clock to 3 o'clock |

1, 00:01:25, 11.37 m  
Broken pipe at joint from 9 o'clock to 3 o'clock

| <b>Recommendations:</b> | Repair defect(s) by lining | | | | |

| Section number | Upstream manhole | Flow direction | Downstream manhole | Recommendations |
|---|---|---|---|---|
| 6 | IC1 | Downstream | IC5 | Repair defect(s) by lining |
