*Project ref: TV241020*

SITE: 45 The Broadway  
Haywards Heath  
West Sussex  
RH16 3AS

# ***CCTV Survey Report***

*Sewer Inspection, Cleaning and Repair*

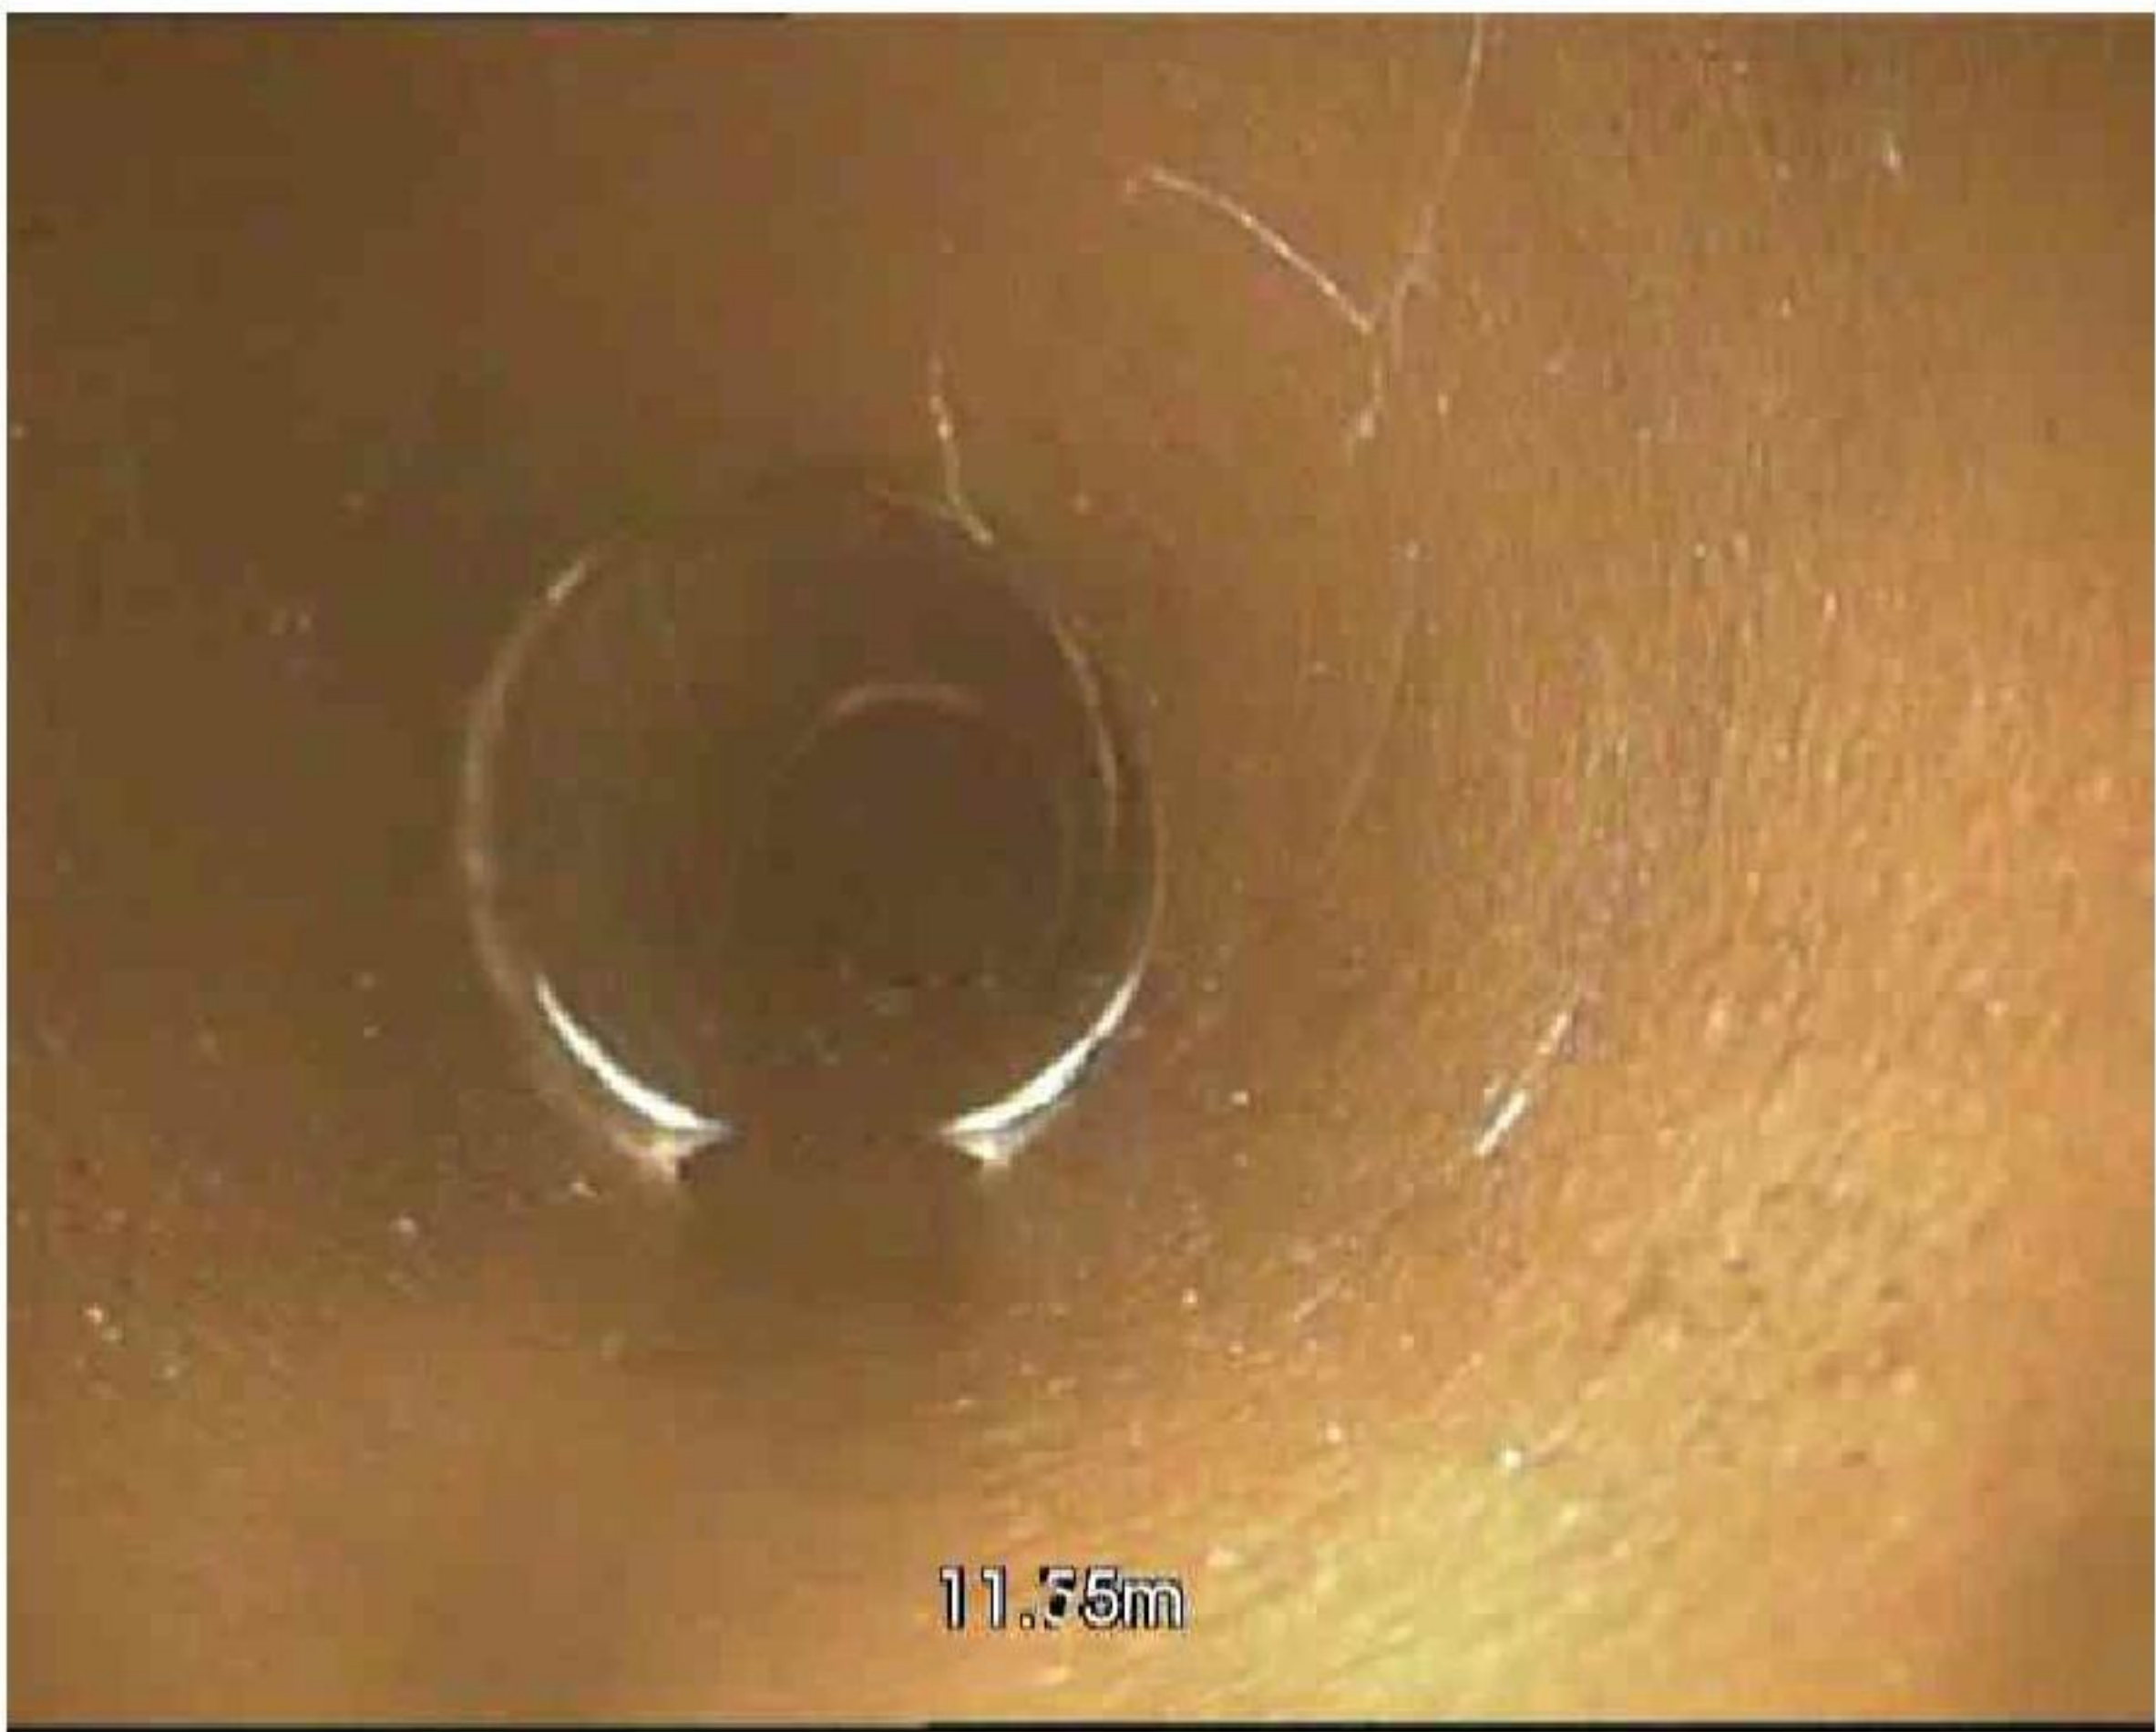
2, 00:01:28, 11.55 m  
Crack, longitudinal at 01 o'clock

| Section number | Upstream manhole | Flow direction | Downstream manhole | Recommendations |
|---|---|---|---|---|
| 6 | IC1 | Downstream | IC5 | Repair defect(s) by lining |

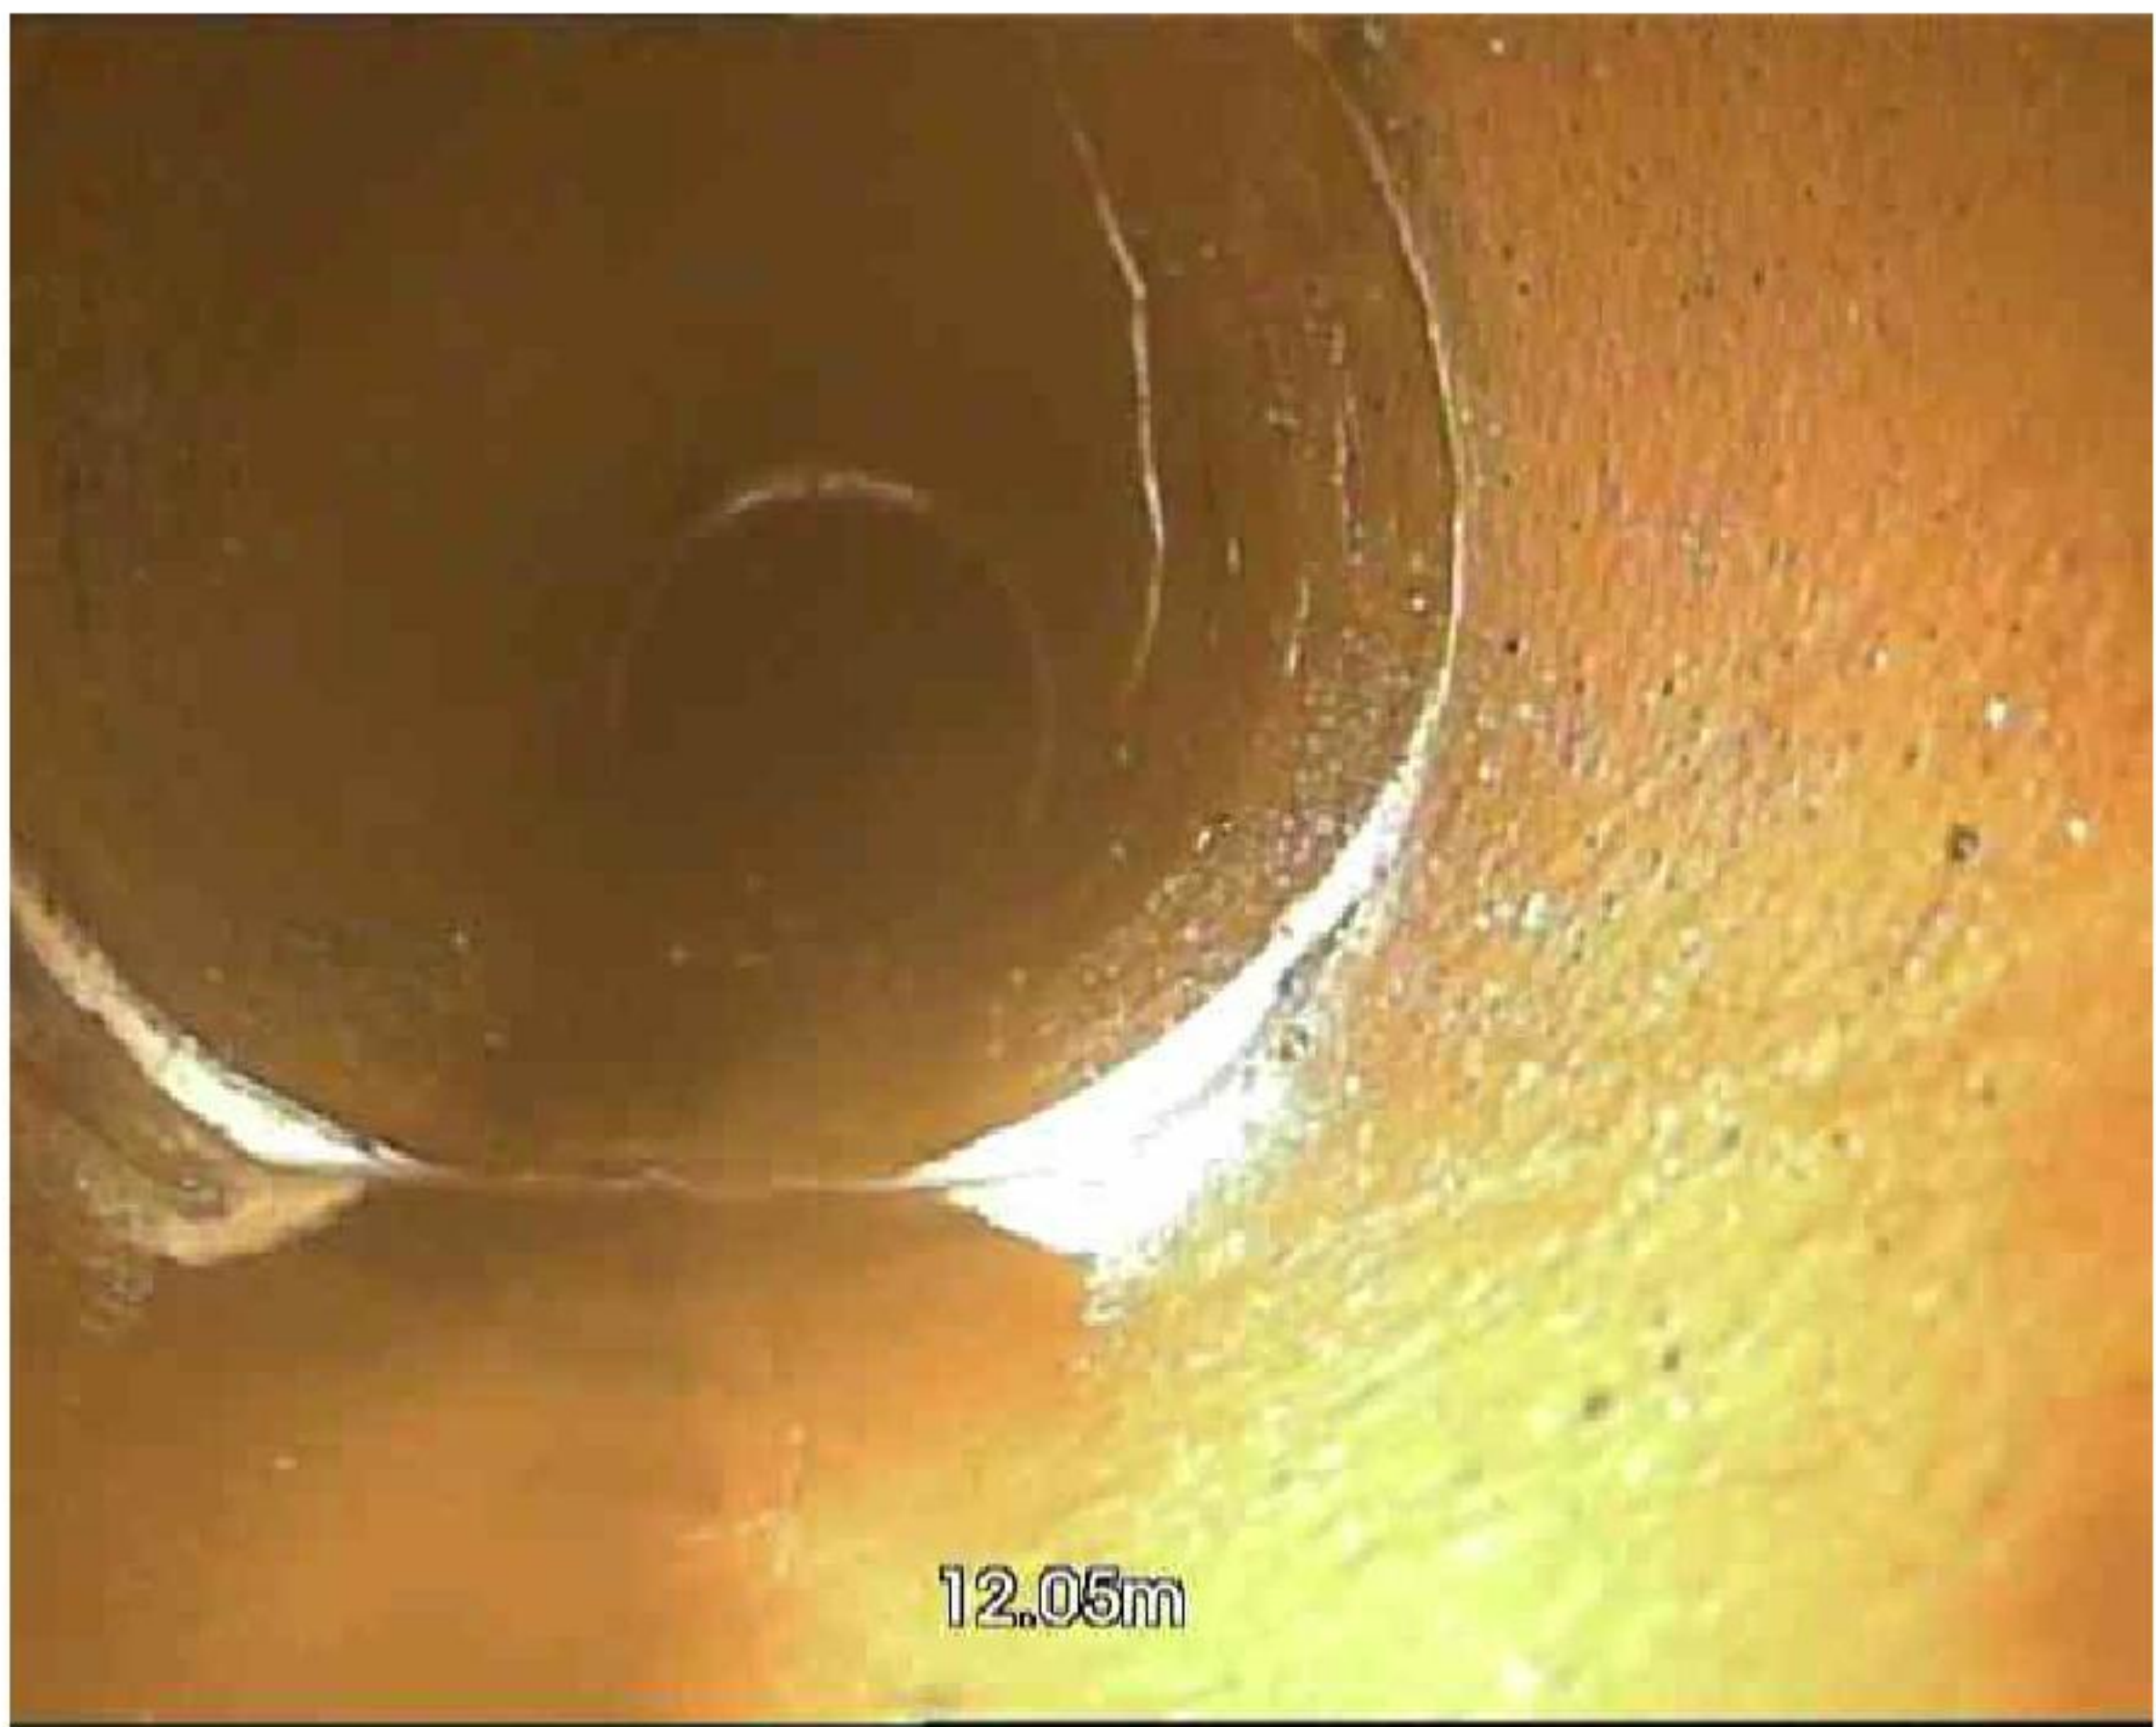
3, 00:01:30, 12.05 m  
Crack, circumferential at joint from 1 o'clock to 5 o'clock
