## Arboricultural Safety Inspection

Trevelyan Place  
Haywards Heath  
West Sussex  
RH16 3AZ

**Ref: TP08042026**

**Date:** 8<sup>th</sup> April 2026

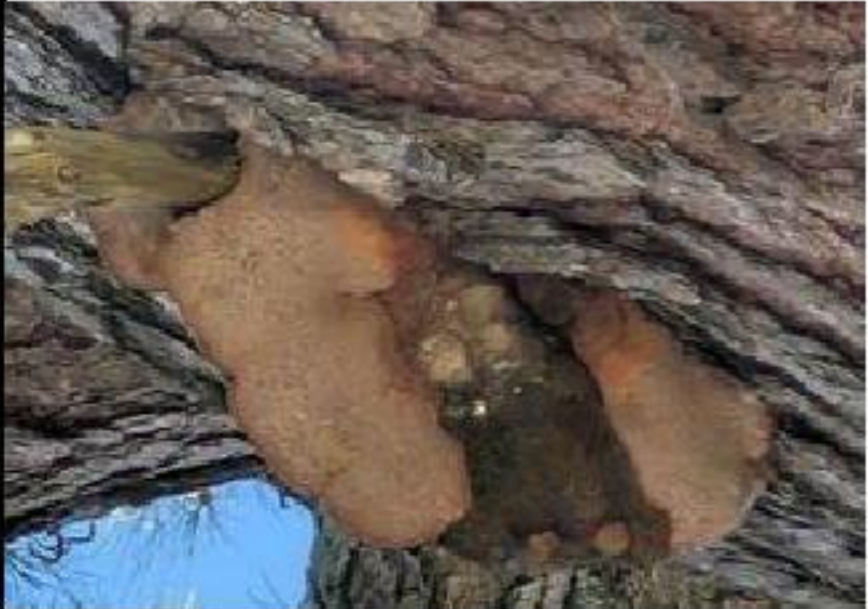
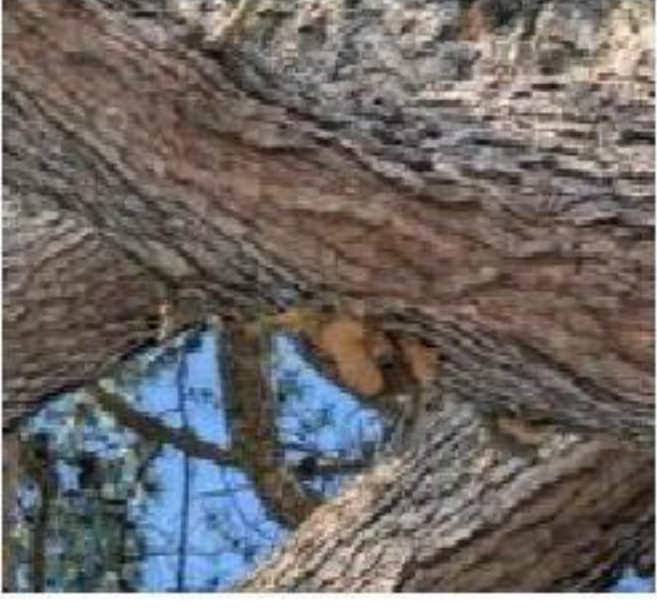
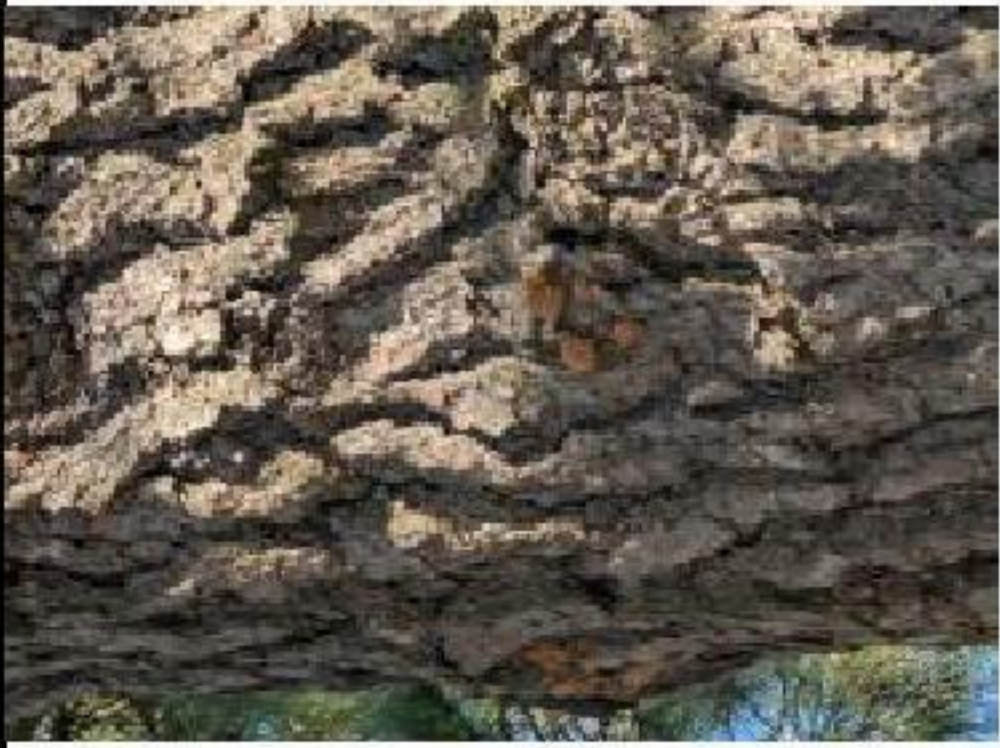
Two trees, T028 and T047, were assessed as High/Imminent risk, where the identified structural defects make failure probable within the next 12 months,

**T028: *Porodaedalea pini*** is a perennial, woody bracket fungus commonly associated with conifers, particularly pine. Fruiting bodies are typically tough, dark reddish-brown to black, often forming clusters along the stem, sometimes adjacent to wounds. The pore layer is golden to yellow-brown, and the fungus produces a selective white pocket rot of heartwood, creating characteristic spindle-shaped white pockets within reddish-brown decayed wood. It is a parasitic fungus capable of colonising living trees and persisting after tree death.

| Tree Number | Tree Tag | What 3 Words | Species | Description | Measurements | Survey Notes | Overall Condition | Risk Category | Inspected | Inspect Period | Recommendations | Photo | Photo |
|---|---|---|---|---|---|---|---|---|---|---|---|---|---|
| T028 | 0121 | ///await.like.worker | Black pine<br>( <i>Pinus nigra</i> ) | Open space and dwellings | Height (m): 19<br>Crown Radius (m): 7<br>Life Stage: Mature<br>Life Exp.: Not Recorded | Fungal brackets present on the lower-mid stem on the south-east side at approximately 6 m, with additional brackets on two major scaffold branches to the north-east and south.<br>A branch on the southern side has also split and partially failed.<br>The tree forms a twin, non-codominant stem from approximately 3.5 m.<br>Fungus: Porodaedalea pini<br>Pests and Diseases: None found | Decaying stem | High/Imminent | 08-Apr-2026 | Not Recorded | The tree has perennial bracket fungi consistent with Porodaedalea pini at around 6 m and higher in several locations on the main stem and branches, indicating a selective white pocket rot of the heartwood that typically extends several meters and causes significant loss of stem strength with a brittle, low-warning failure mode, and because the tree stands within falling distance of residential flats, an intolerably high-occupancy target, the confirmed mid-stem decay presents an unacceptable level of risk, and neither tomography nor crown reduction would alter or reduce that risk, making removal the proportionate management option<br>Timescale: 08-Apr-2026 (Urgent) | | |

- T028 (Tag 0121 *Pinus nigra* requires urgent attention as per the recommendations
- All other maintenance actions are scheduled within 3 months to ensure timely intervention due to the impact of overhanging branches and deadwood, including two dead third-party trees.
