HAVELOCK FARM, WAKEHURST  
STAGE 4 – STRUCTURAL ENGINEER’S REPORT

HAVELOCK FARM, WAKEHURST

STAGE 4 – STRUCTURAL ENGINEER’S REPORT

| SFK Document No: | | 24079/R04 | | |

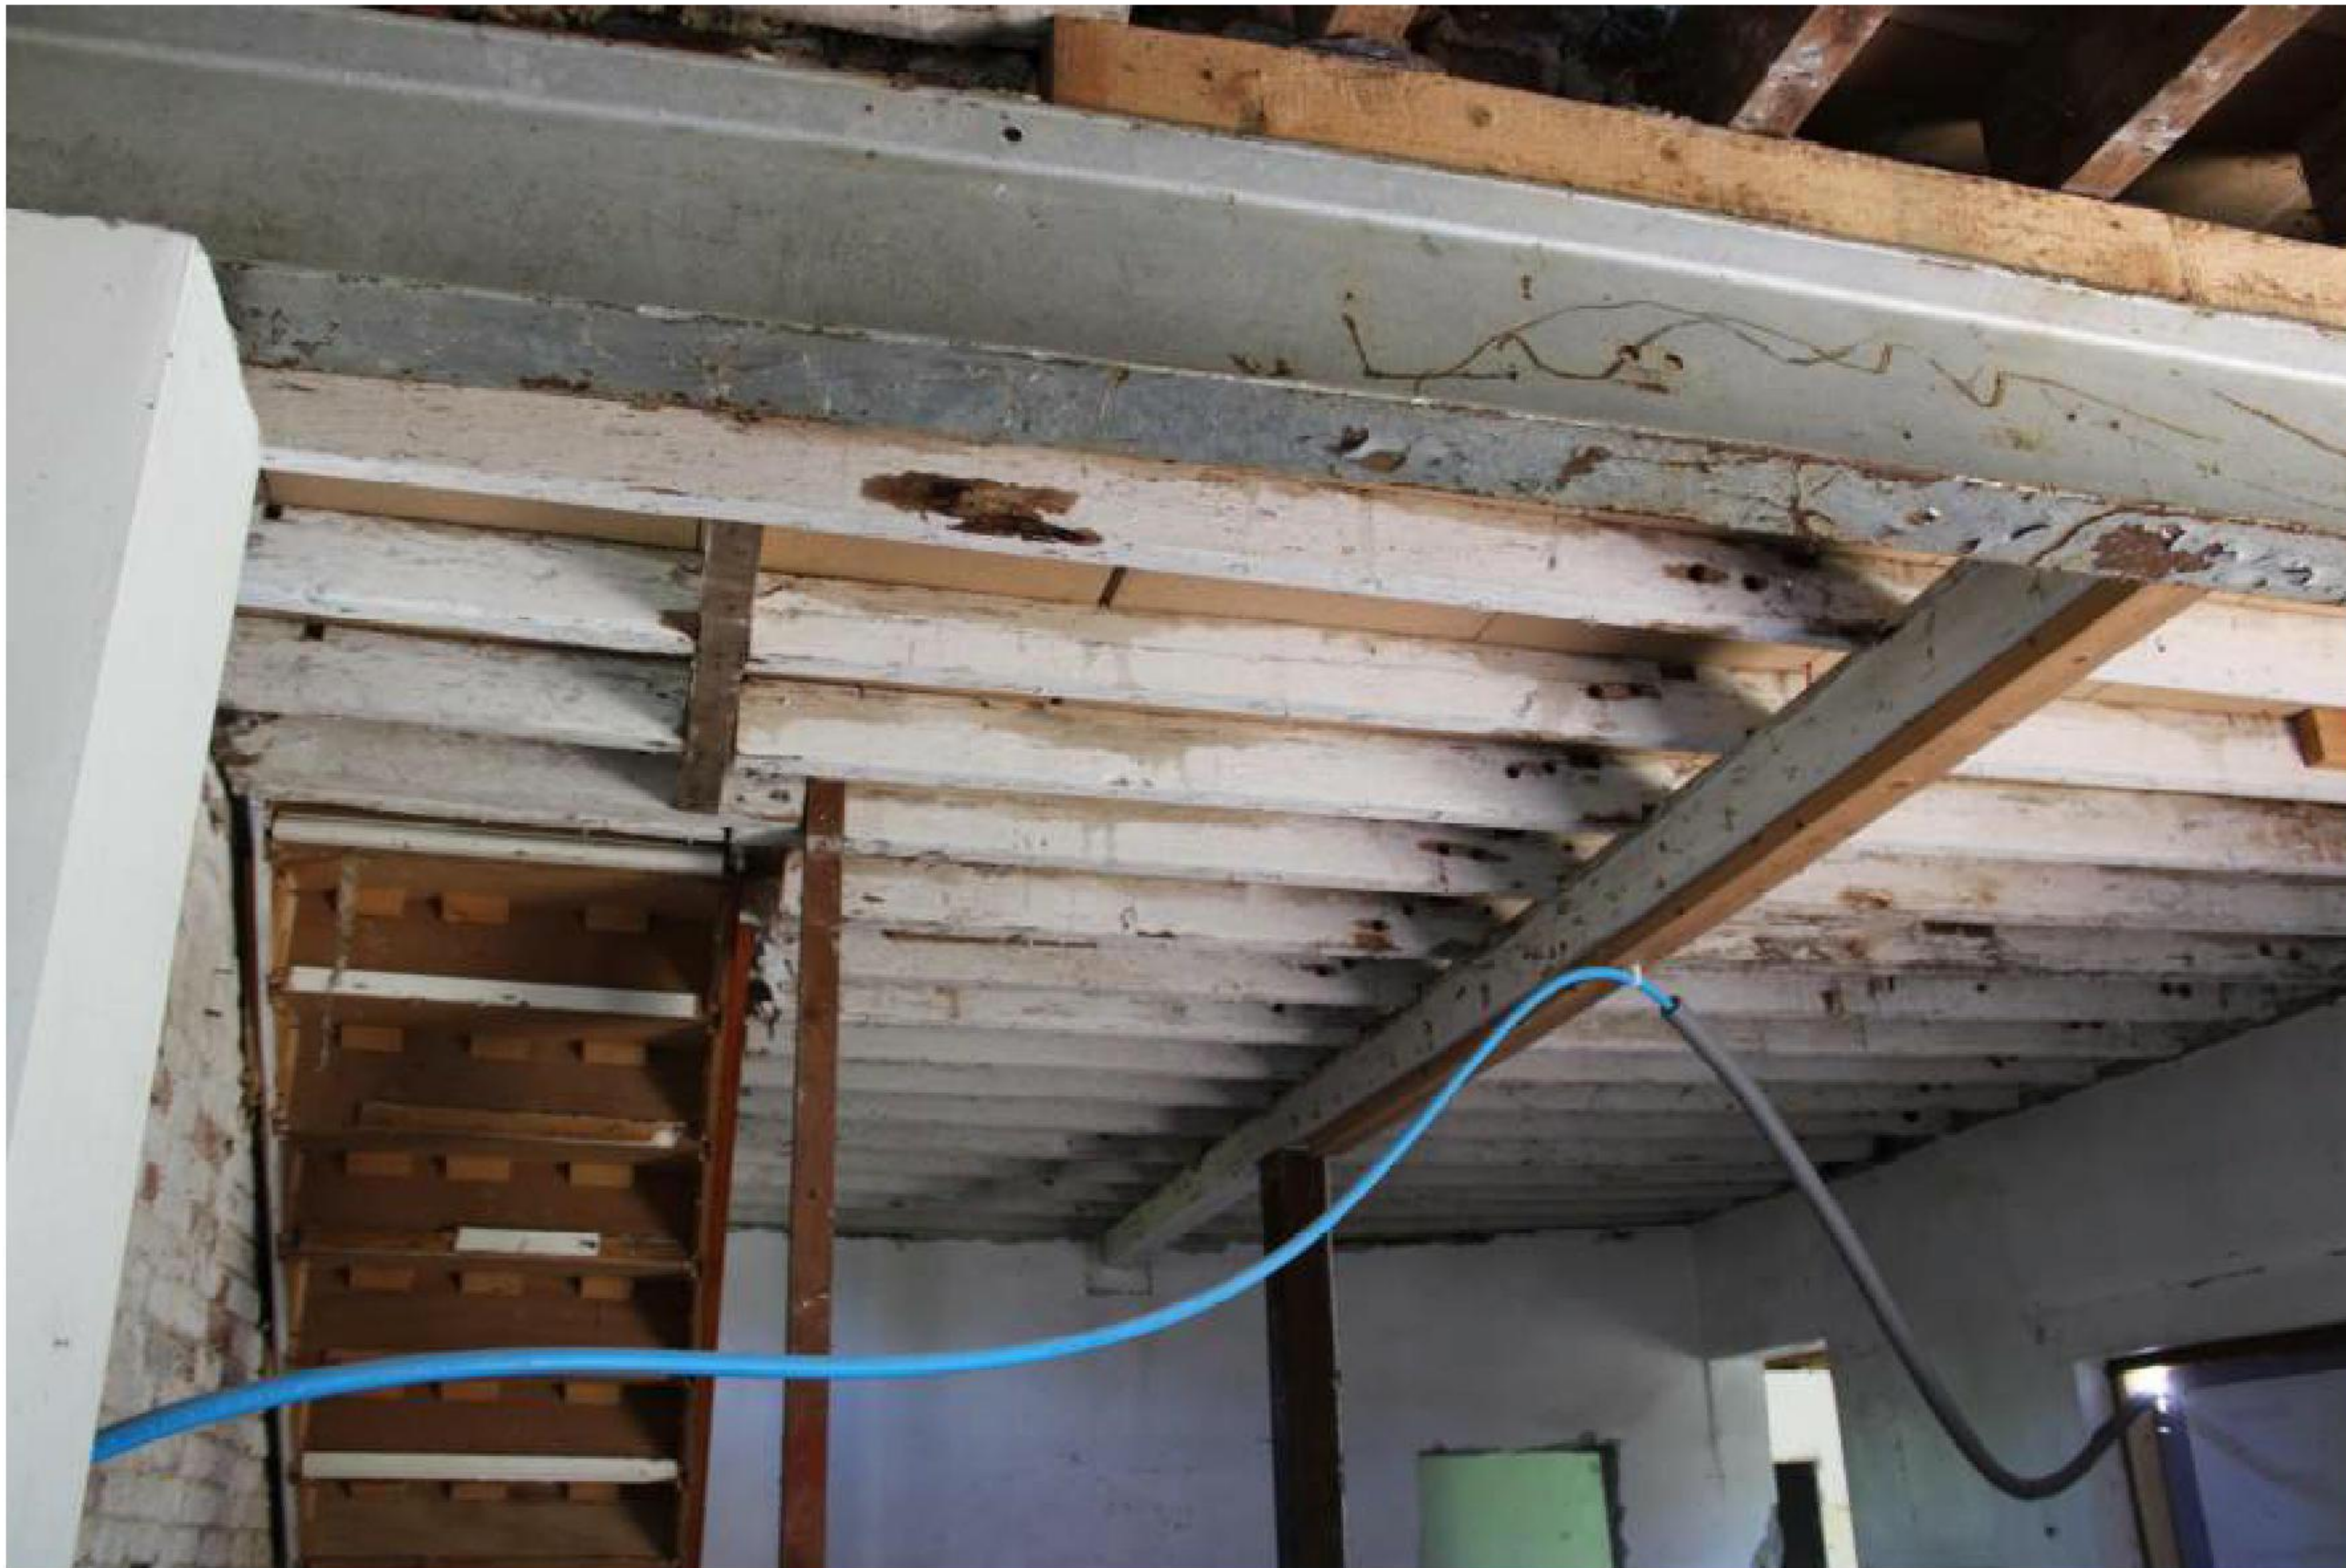
The East Range has a pitched tiled roof with gable ends, supported by three timber trusses, rafters, and a brick cross-wall, which is supported on the existing steel beam (Figure 3). The Bothy roof is supported by rafters and two timber frames comprising collar tie beams and principal rafters. The rafters are in reasonable condition, as are the purlins. Collar ties are present between the chimney and the brick cross-wall. The existing steel beam is in reasonable condition.

Figure 3 Existing Steel Beam supporting brick wall above and timber beam, which is also supported off the timber column.

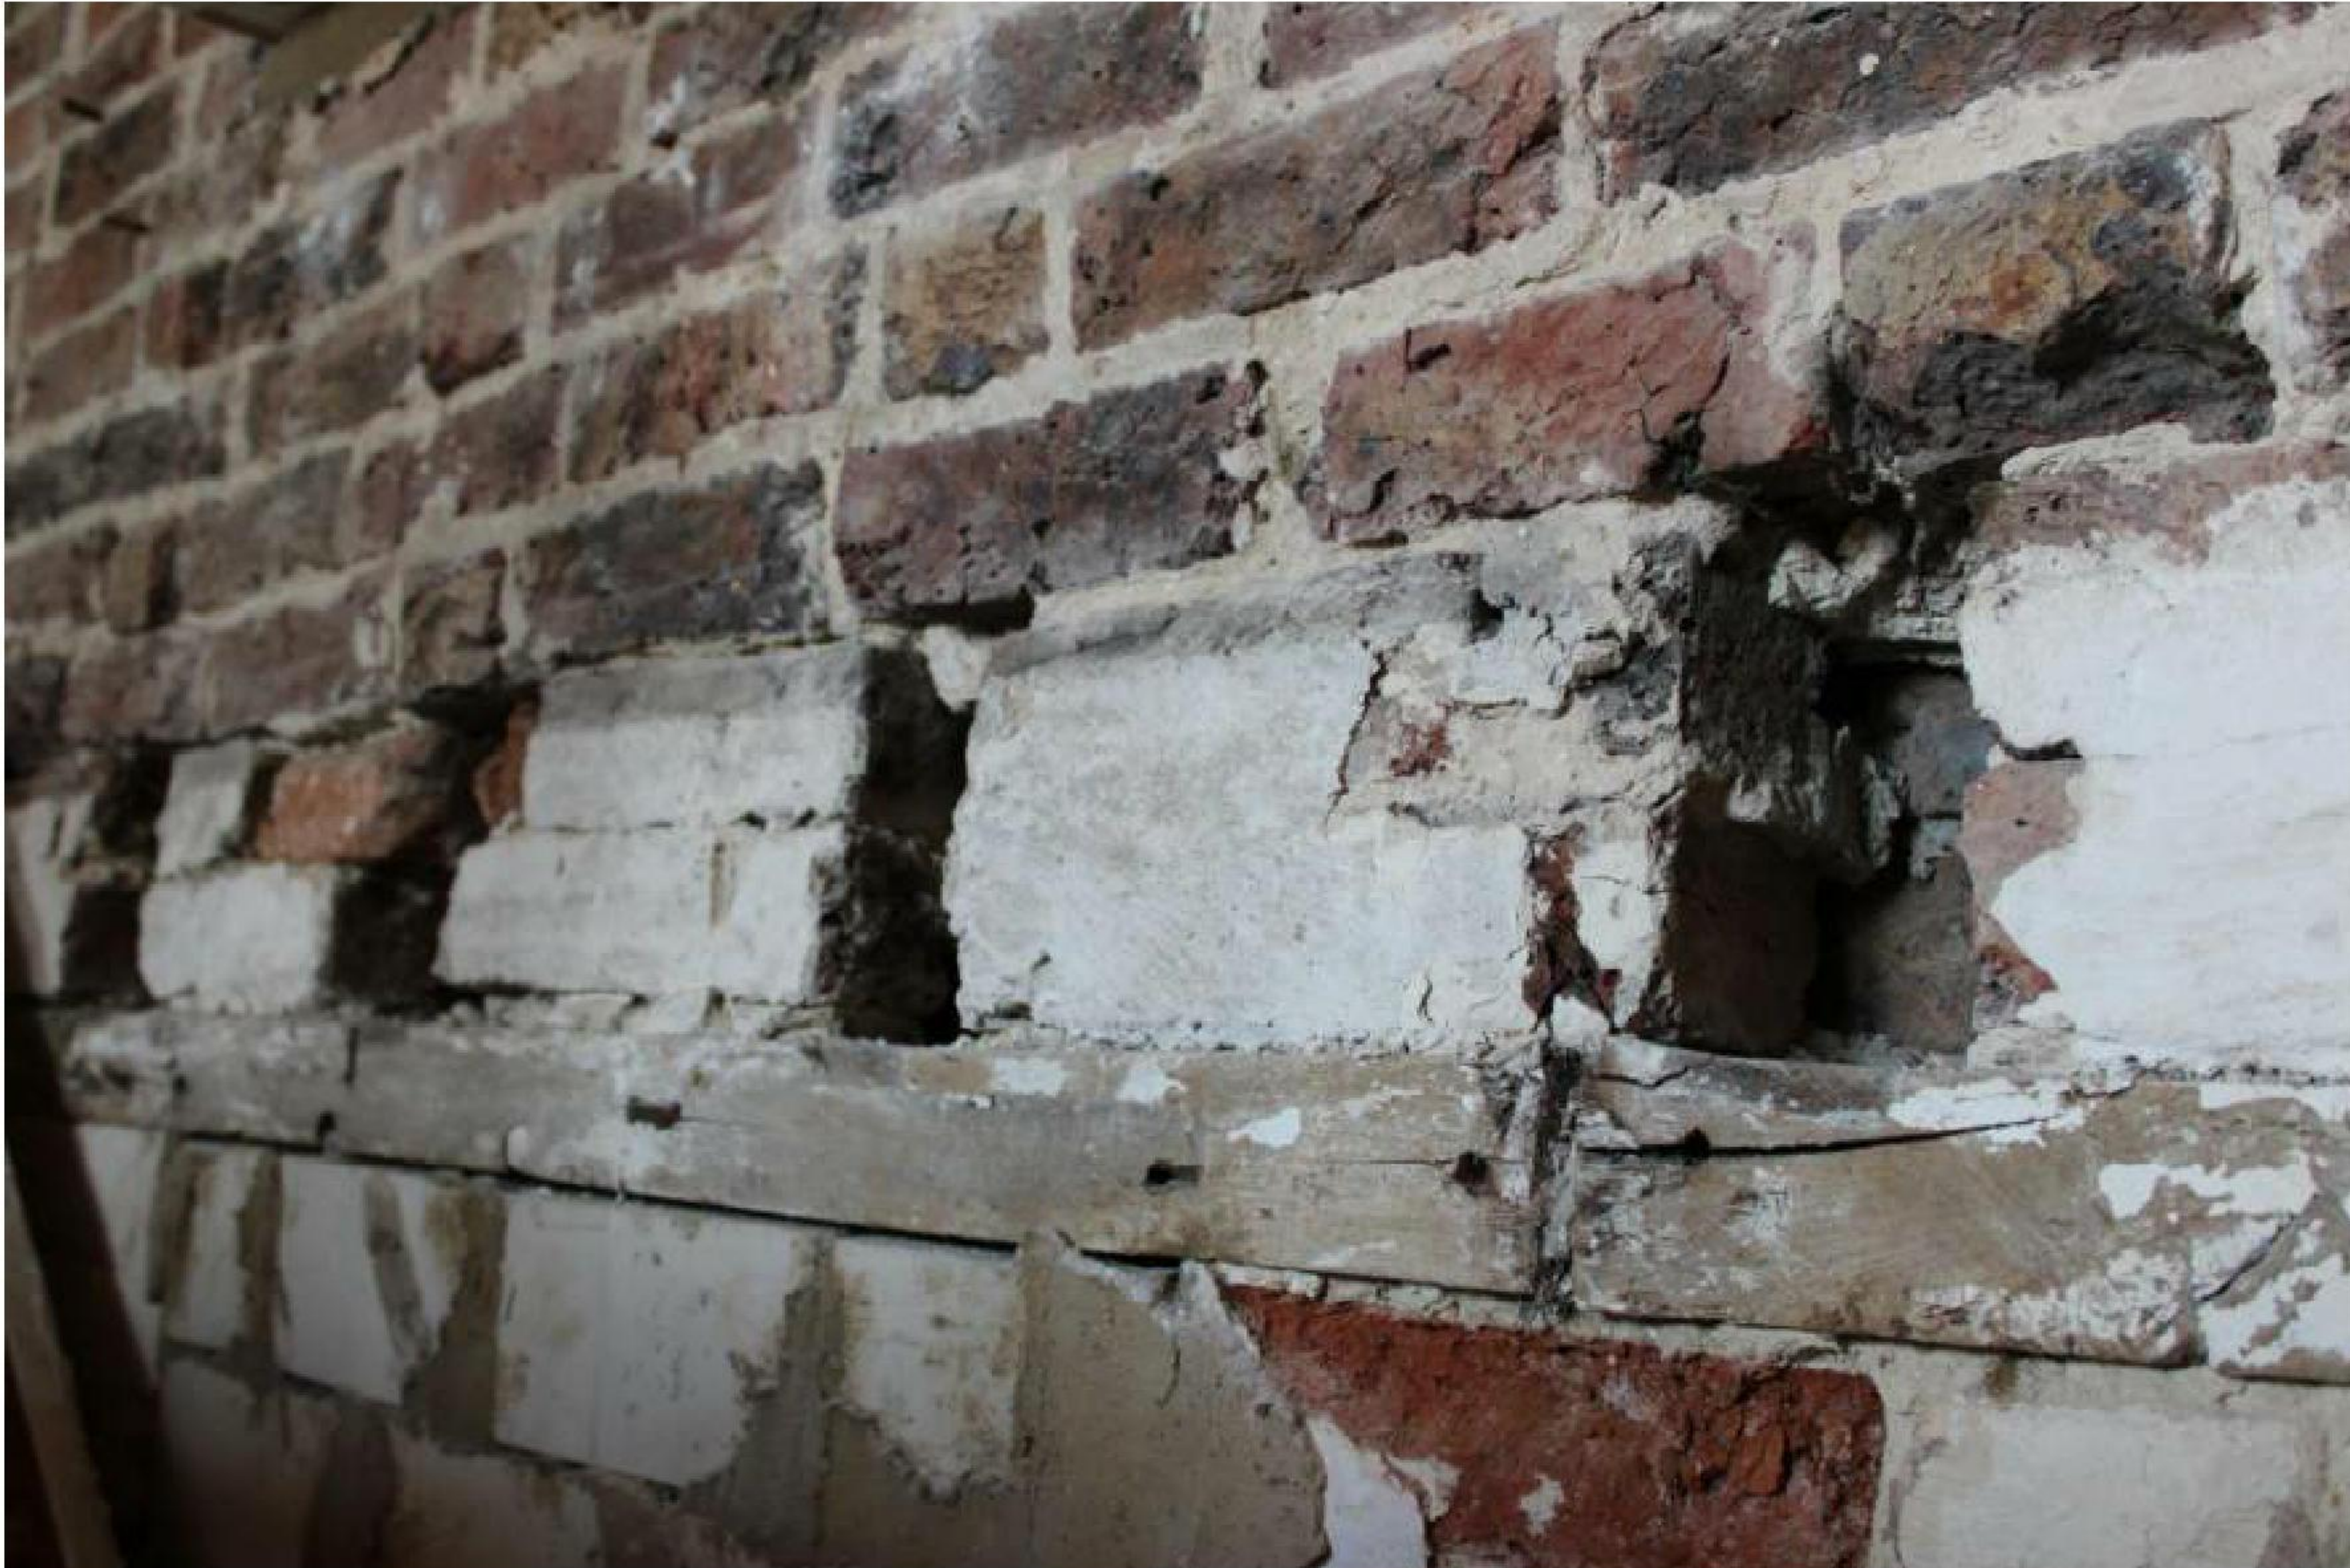
At first floor level, the joists within the East Range are generally in reasonable condition, although some have been notched on the underside. These joists are supported off a timber beam, which is supported by the south gable wall, a timber column, and the existing steel beam (Figure 3). The bricks in the east wall at joist bearing locations are in poor condition (Figure 4). Significant decay was noted to the bottom section of the timber column (Figure 5).

Figure 4 Bricks at joist bearing locations in poor condition.

The first floor will be adapted to suit the proposed use by installing a new floor structure with new joists designed to accommodate the proposed office loads. Courses of existing brickwork within the current joist bearing depth are in poor condition and will be locally rebuilt in sections. The existing timber wall plate will be removed due to risk of decay, and new floor joists will be supported on joist hangers built into the rebuilt masonry. Horizontal restraint straps will be provided at 2.0 m centres to act as horizontal ties; these will comprise 1200 mm long galvanised mild steel straps fixed tightly against the masonry. A new stud wall will be constructed on top of the existing steel beam, replacing the previous brick wall which provided lateral stability. A new steel spine beam will replace the existing timber beam, which is in poor condition, and existing timber posts will be replaced with new steel posts. Additional new steel beams will be installed within the Bothy to accommodate the proposed office loading and staircase, along with a new steel frame within the party wall opening.

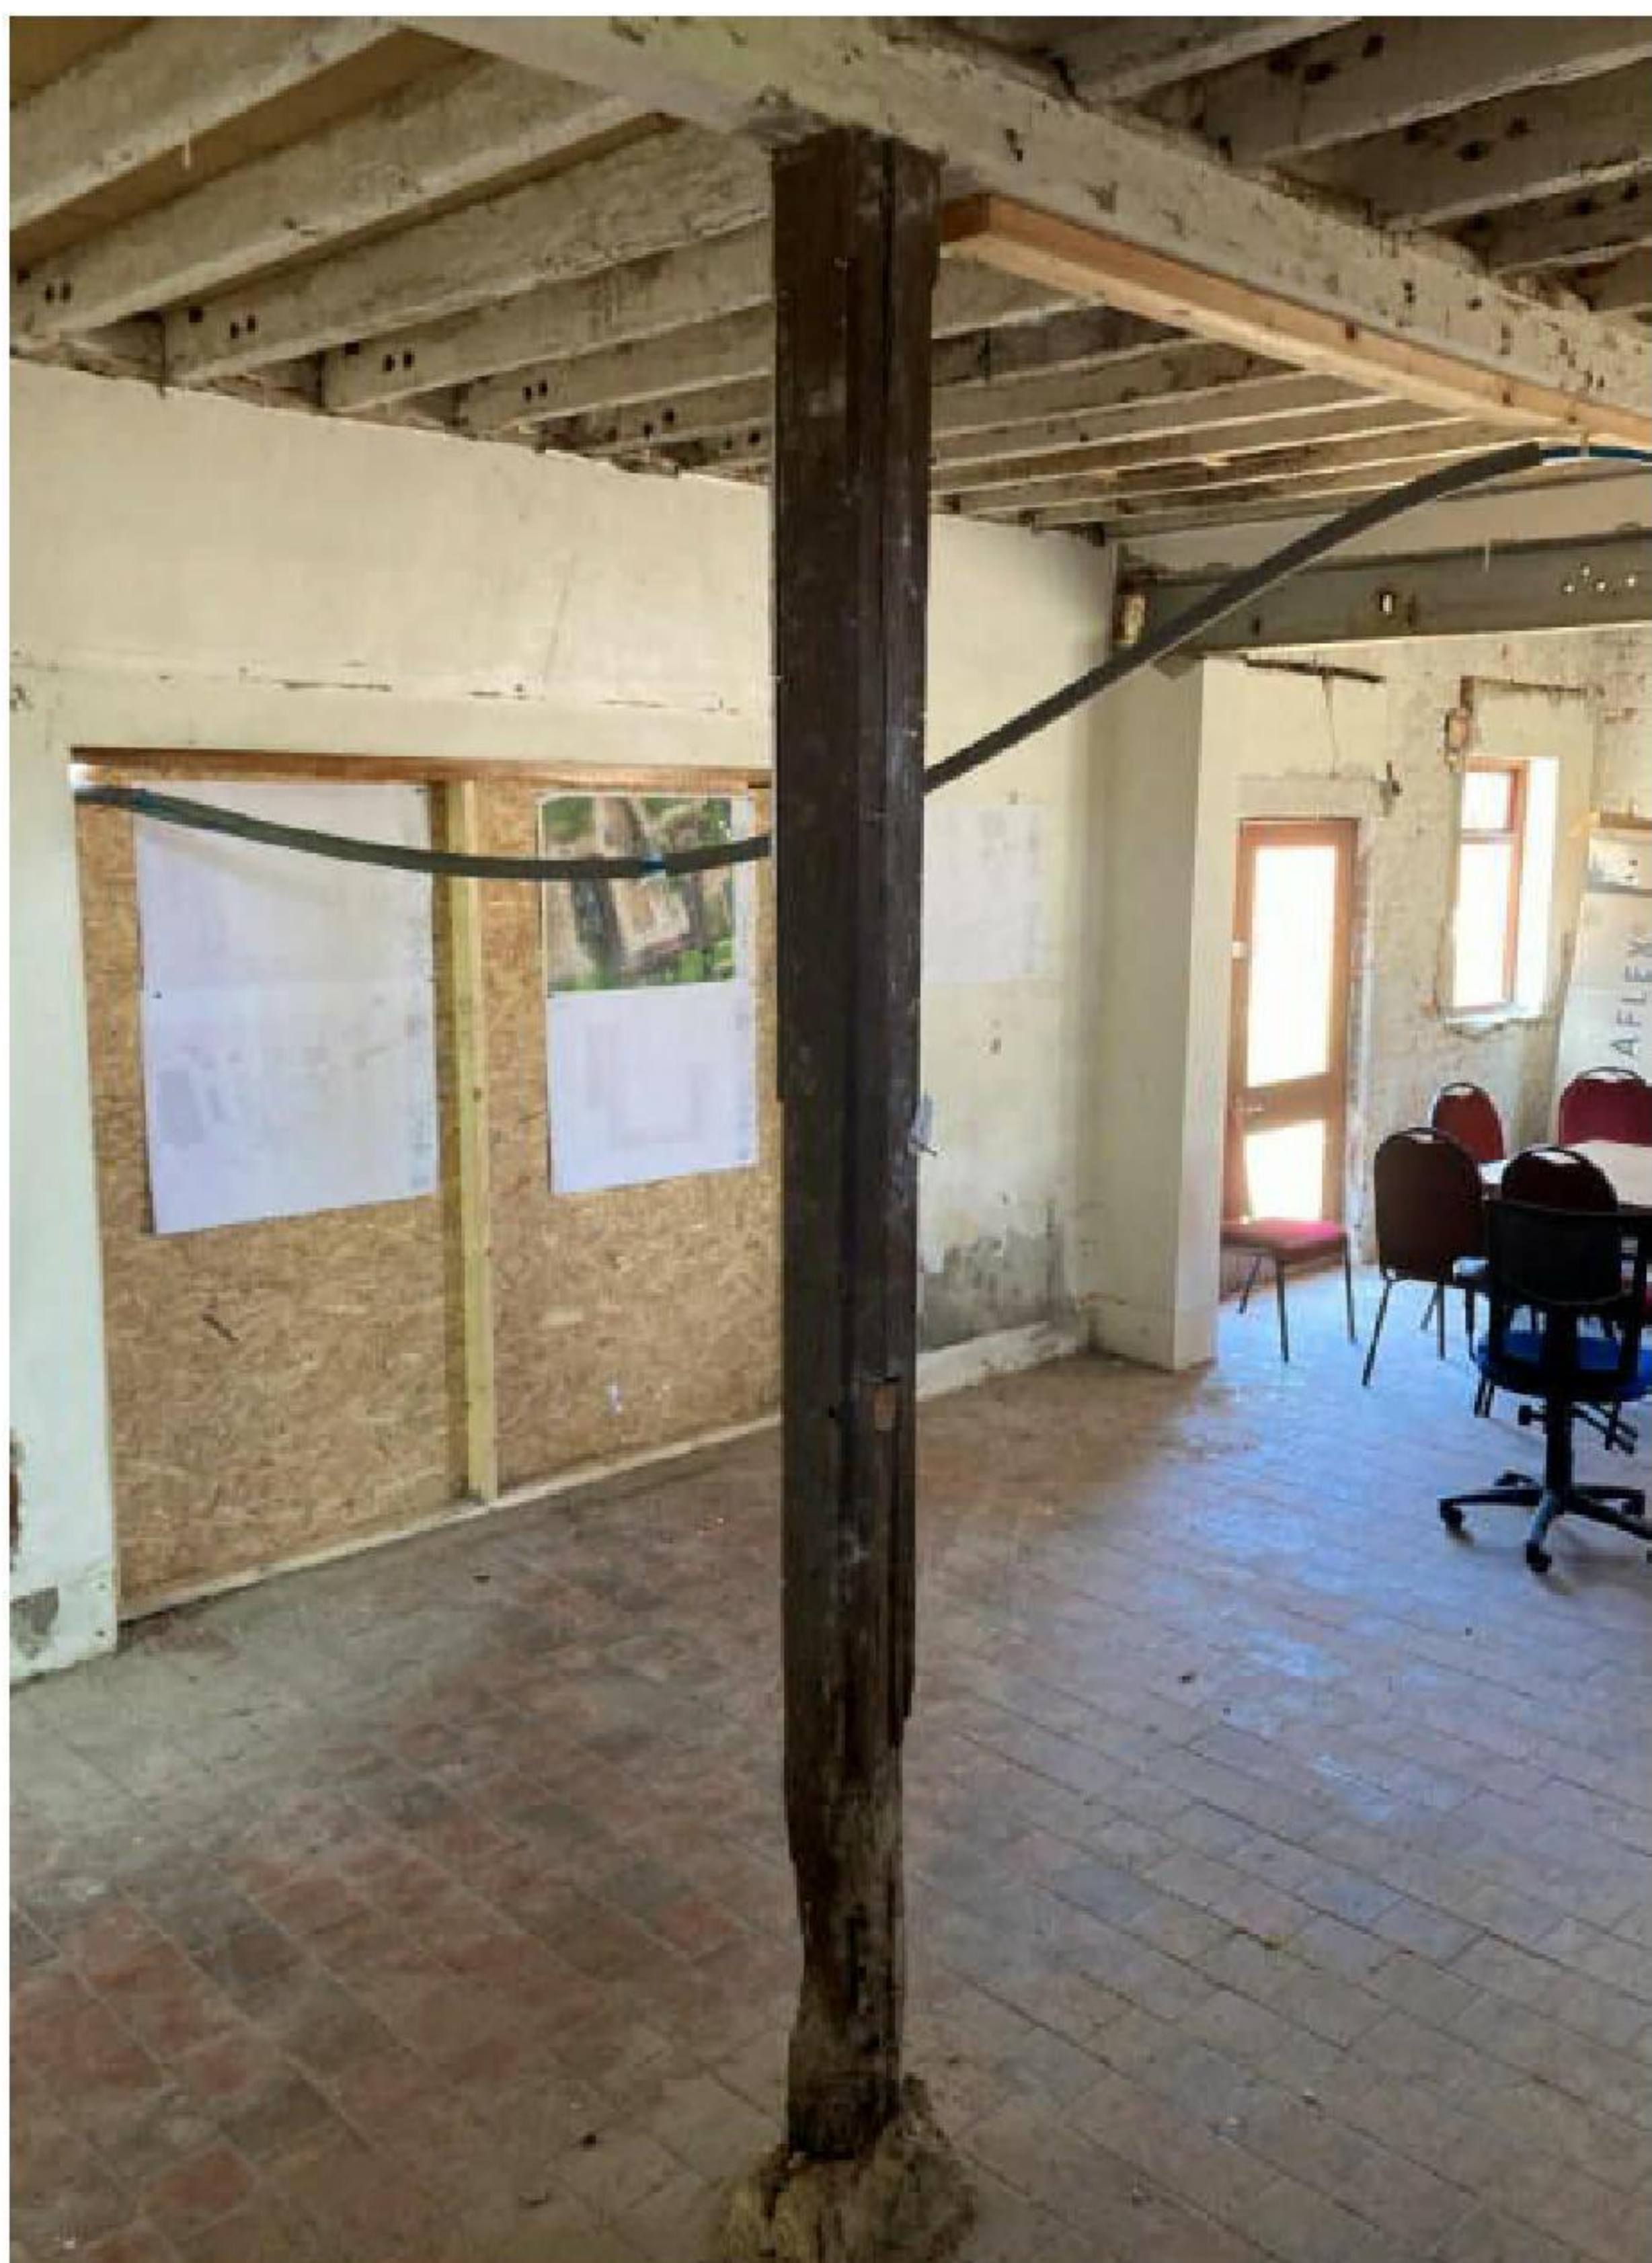
Figure 5 Significant decay at bottom section of timber column.

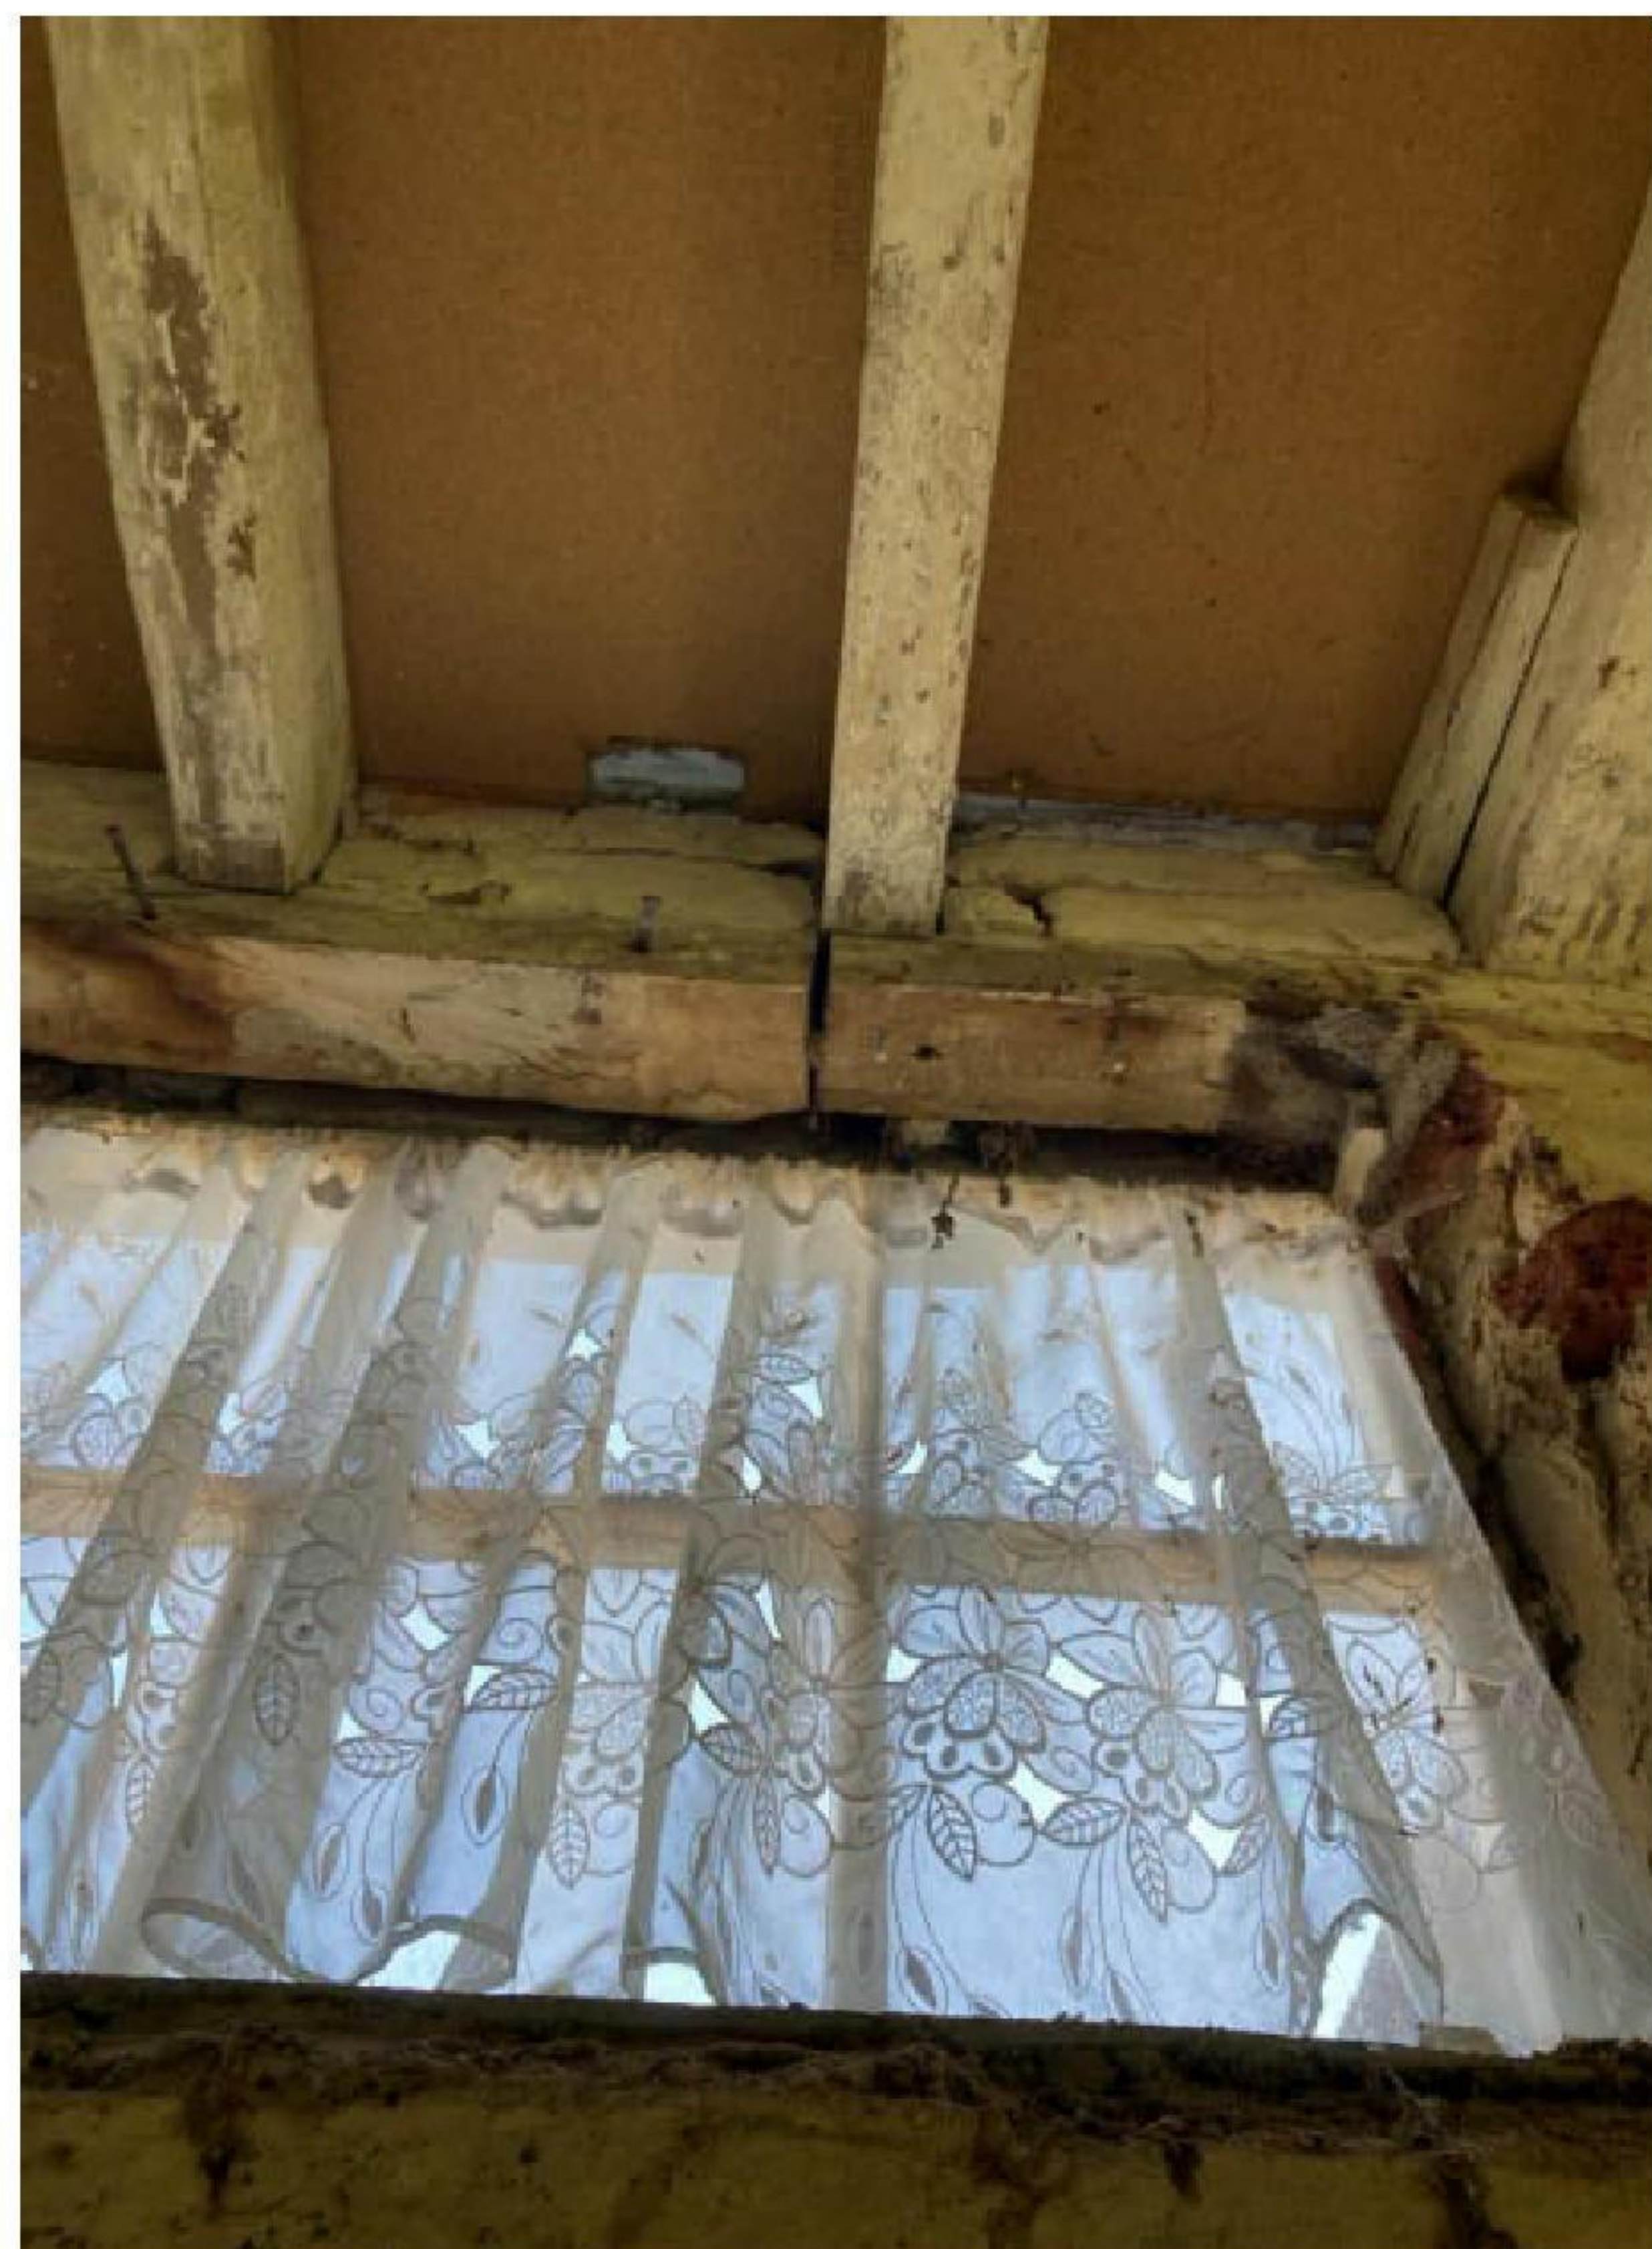
Figure 6 Splice in timber lintel.

The timber wall plates, which act as lintels above some windows within the East Range, are generally in reasonable condition. One of the timber lintels is spliced (Figure 6). A concrete lintel to the south wall of the East Range, with a timber beam above, shows some deflection but no cracking and appears to be undersized (Figure 7).

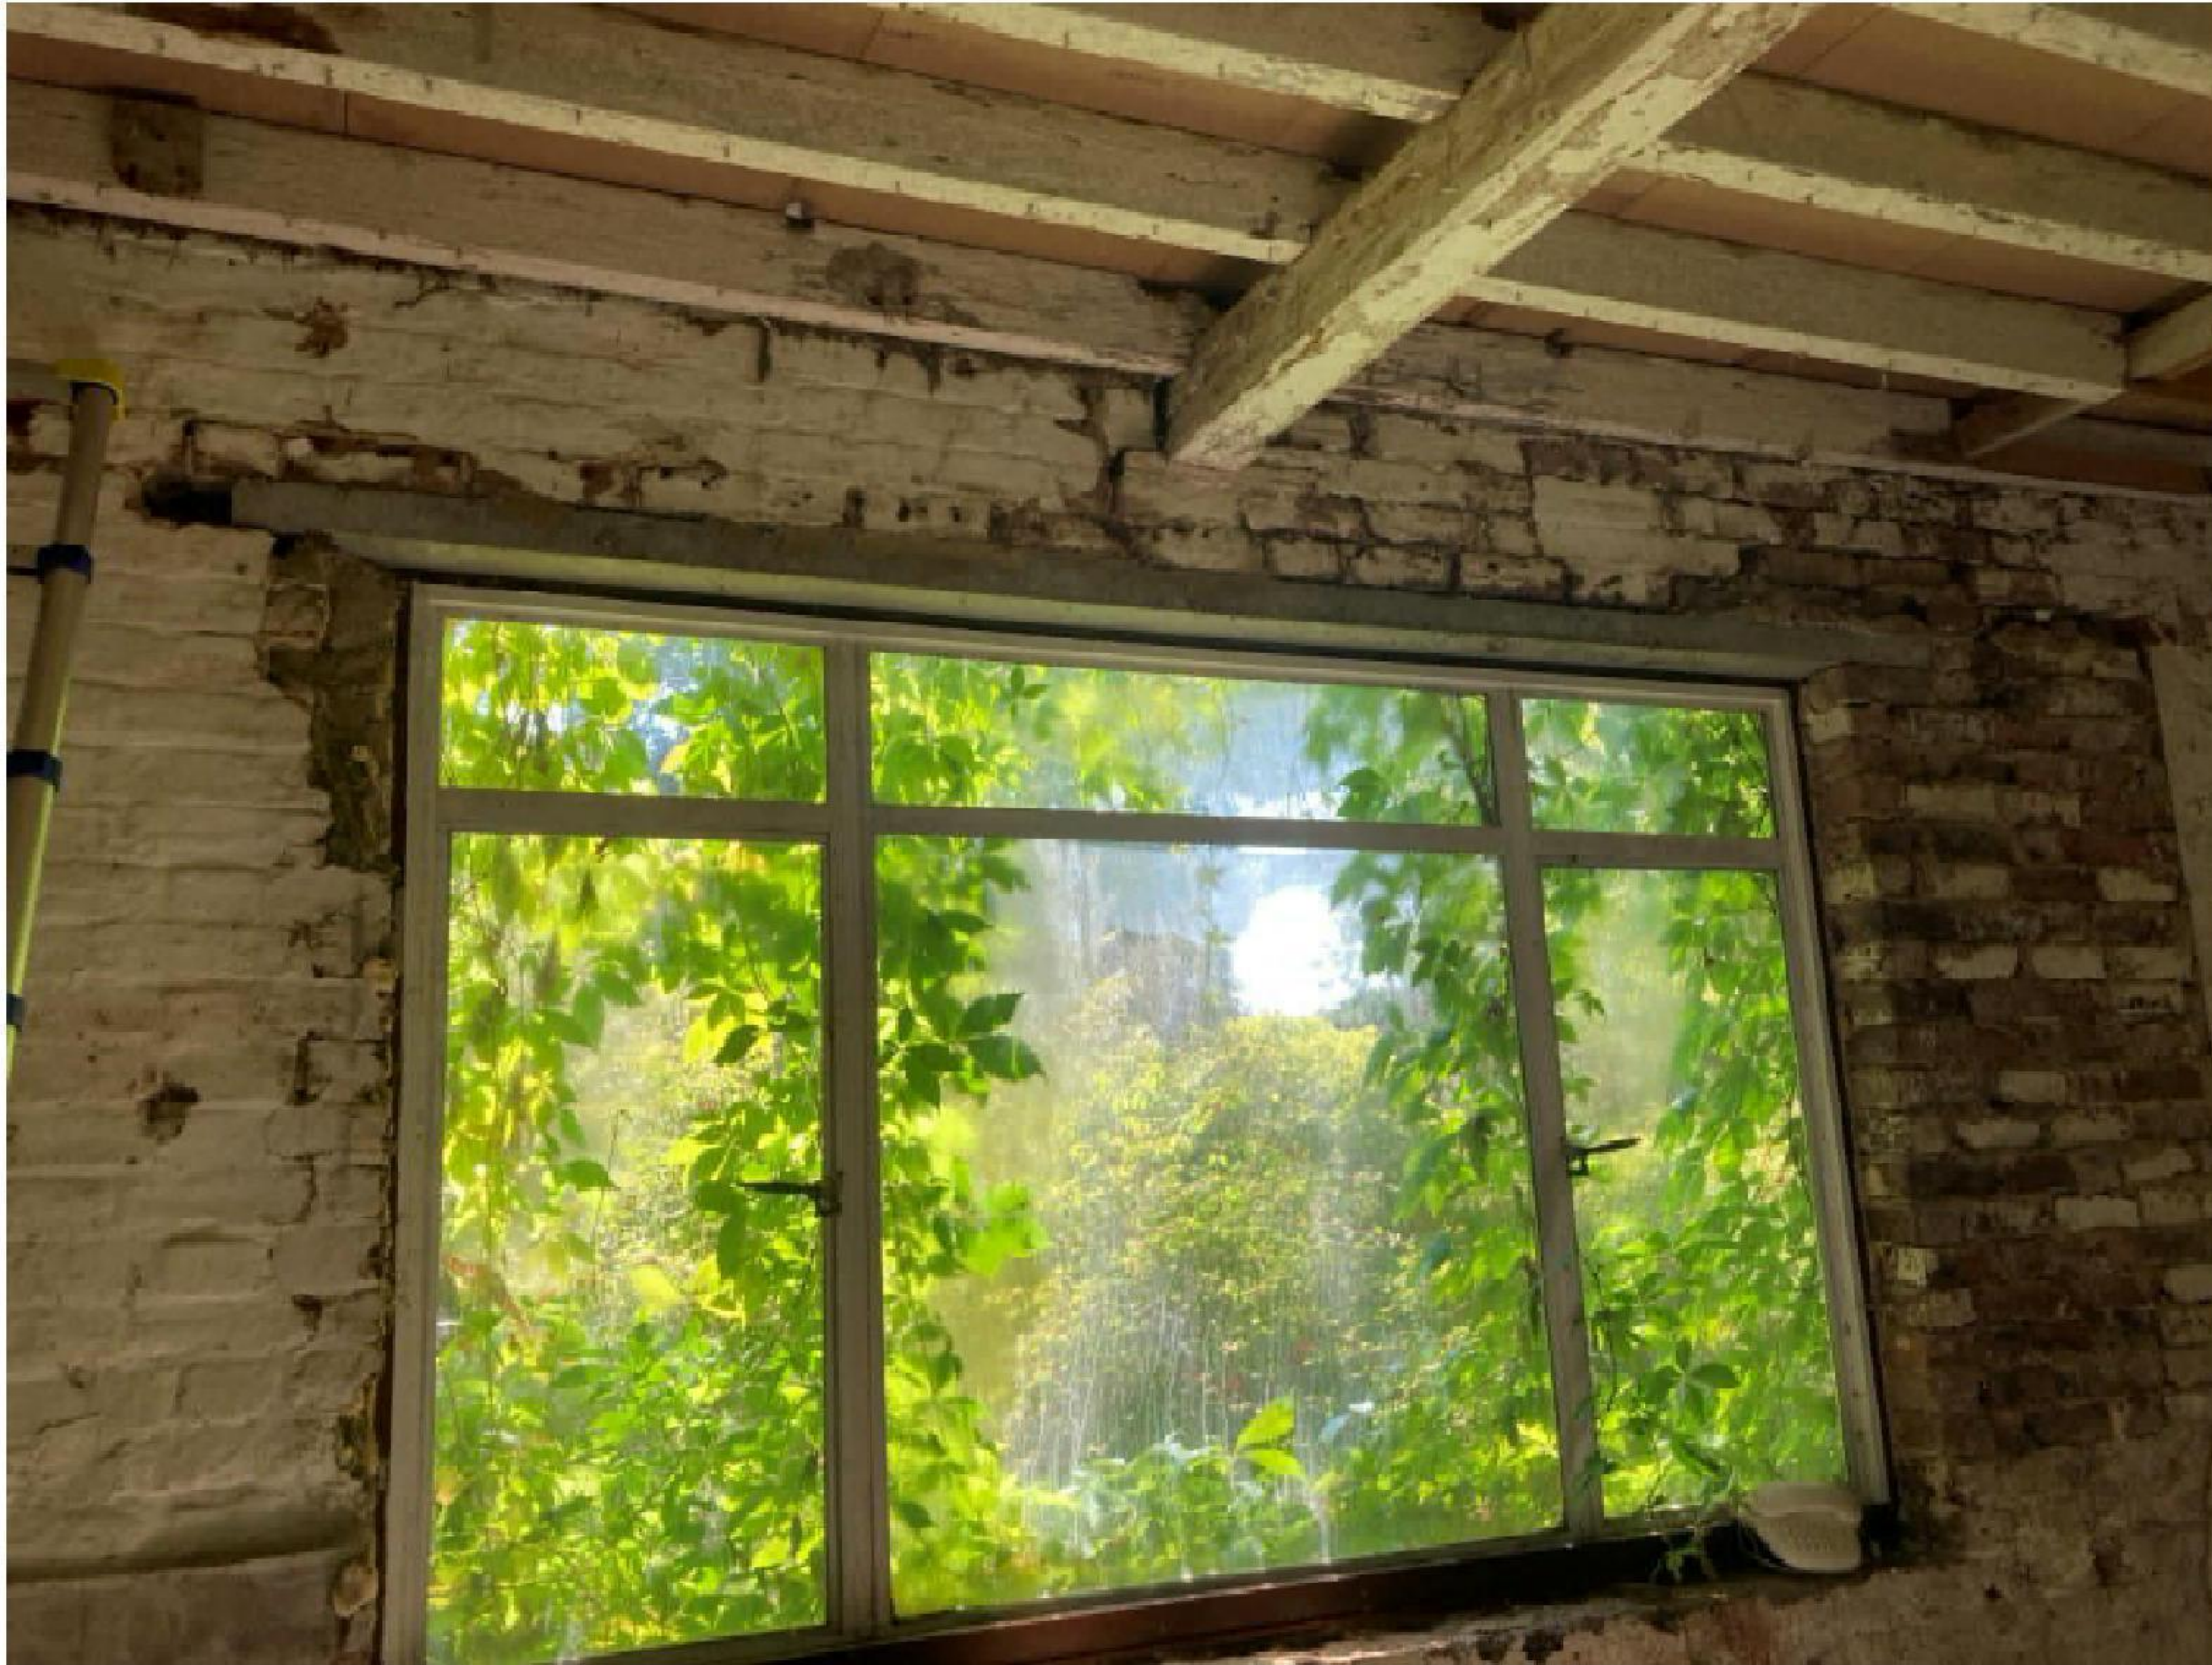
Figure 7 Concrete lintel in the East Range.
