HAVELOCK FARM, WAKEHURST  
STAGE 4 – STRUCTURAL ENGINEER’S REPORT

HAVELOCK FARM, WAKEHURST

STAGE 4 – STRUCTURAL ENGINEER’S REPORT

| SFK Document No: | | 24079/R04 | | |

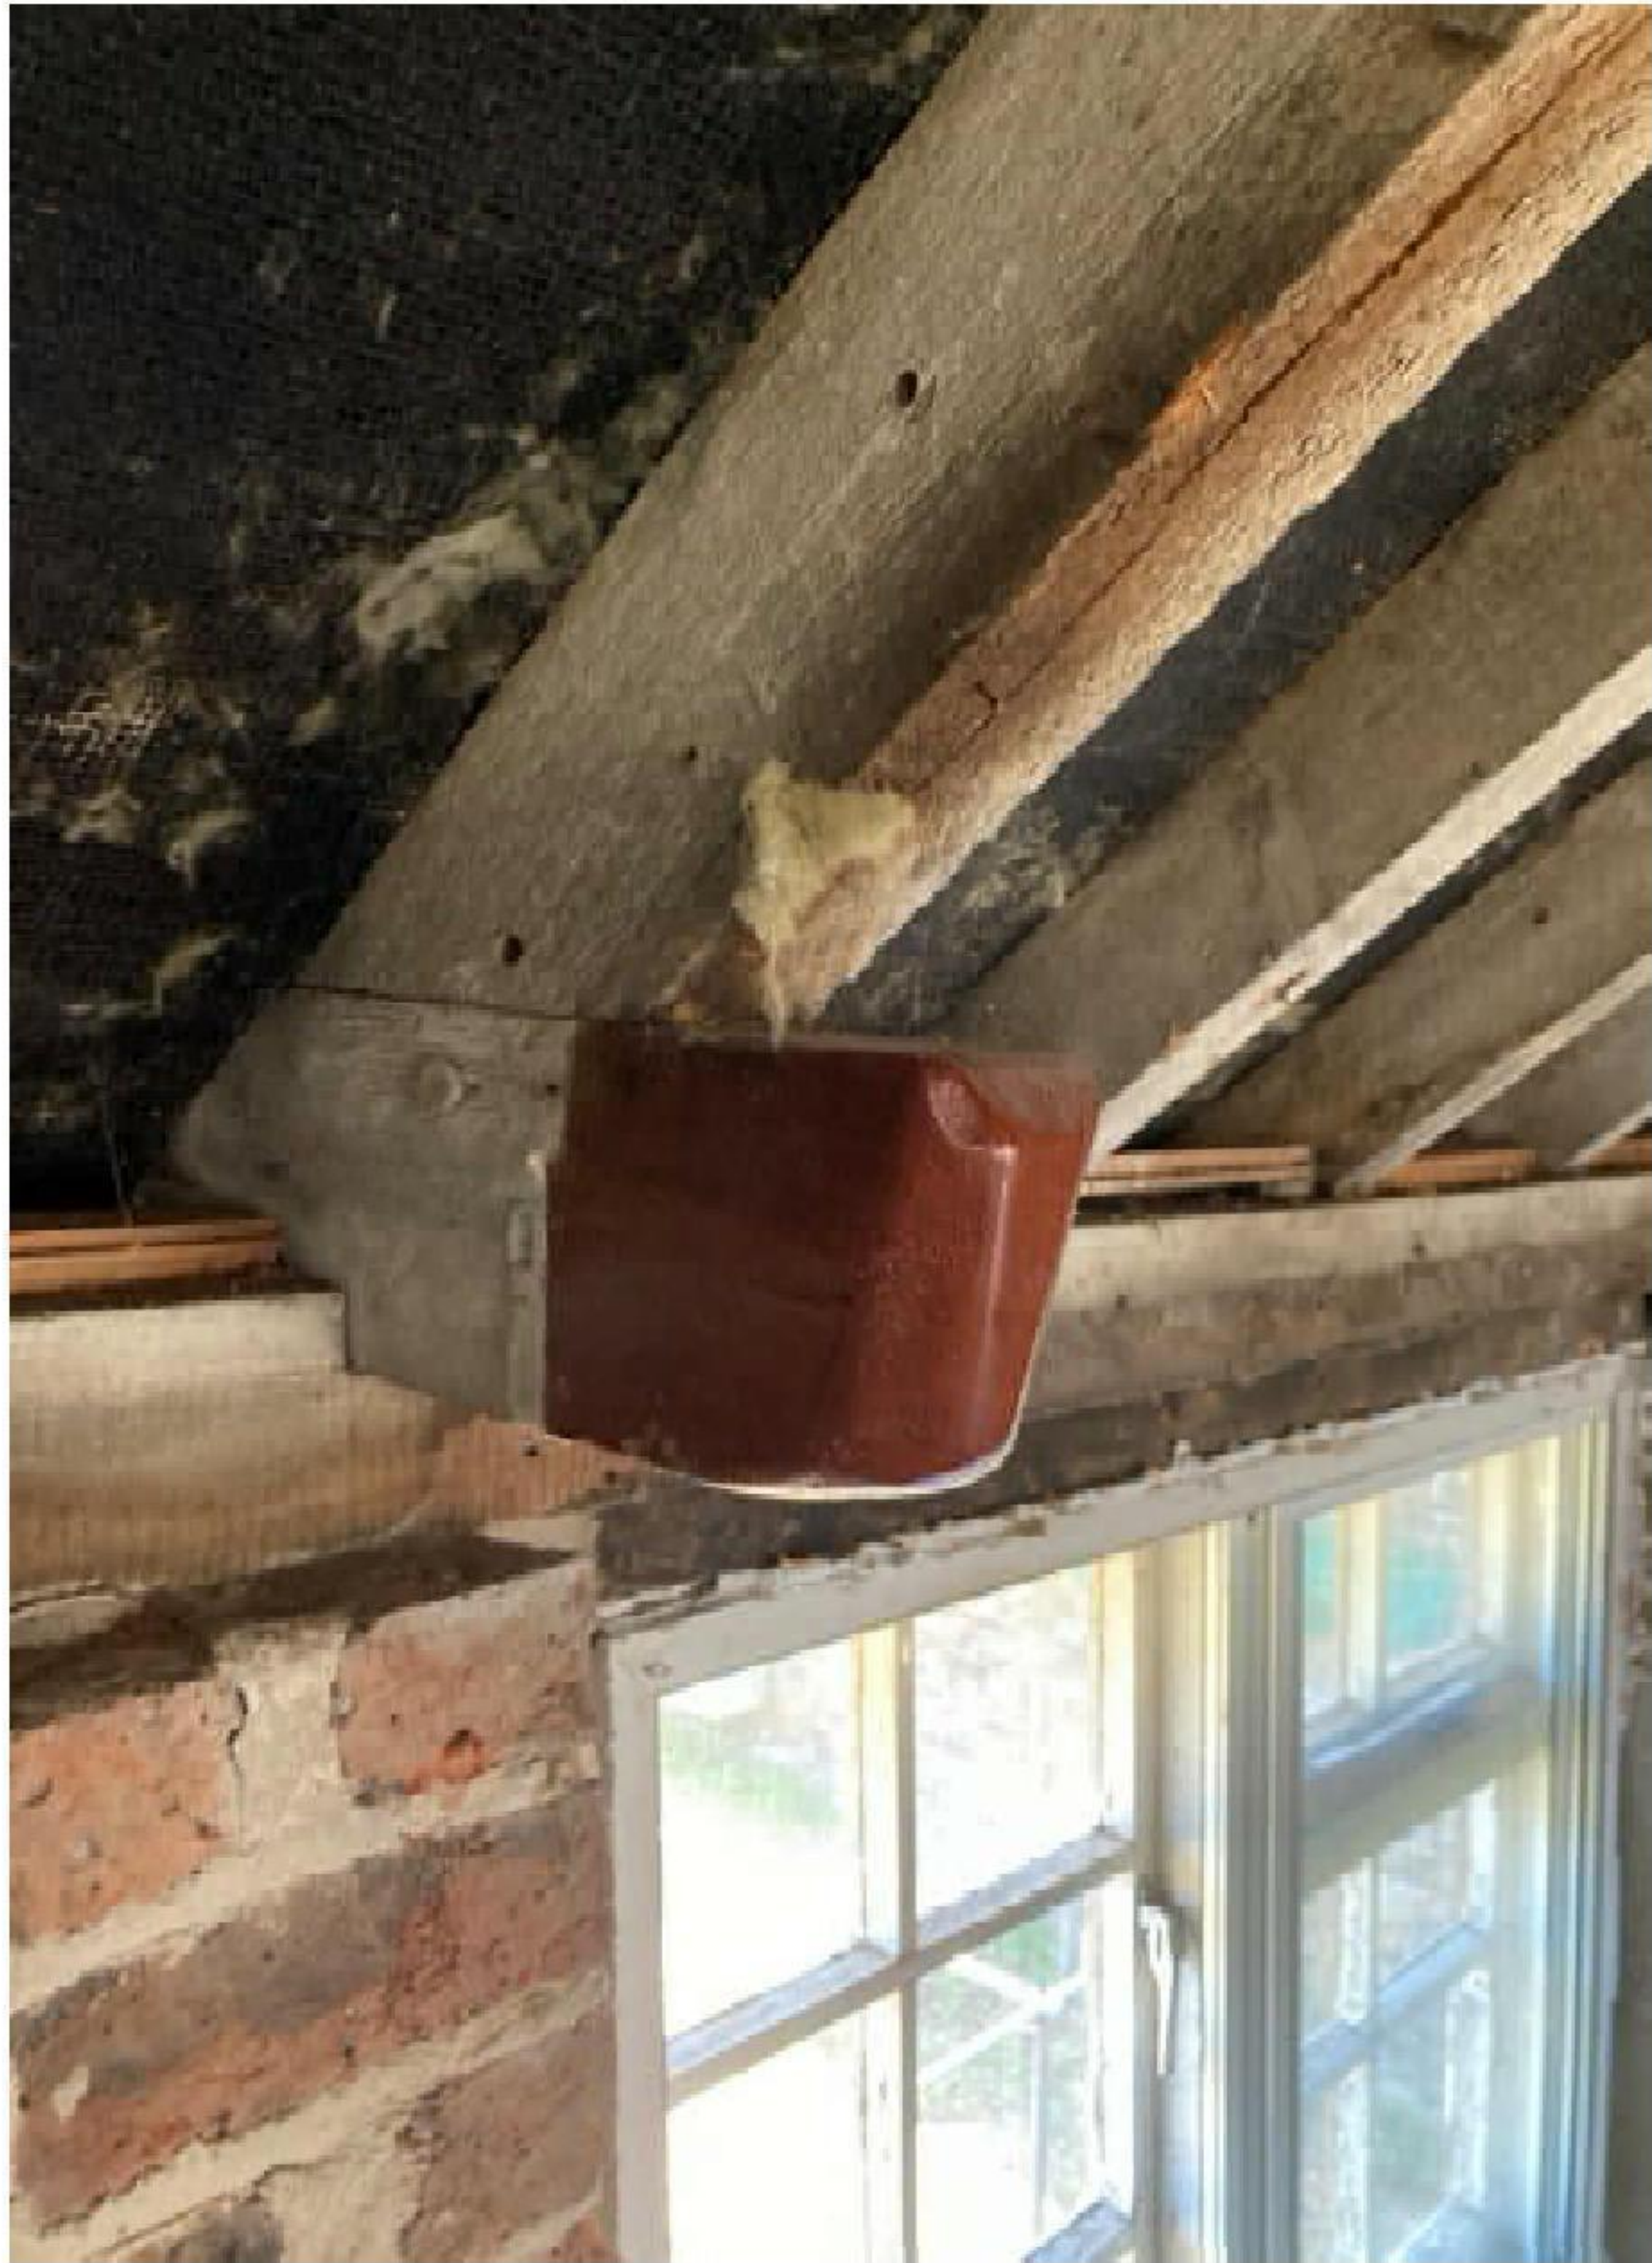
The East Range roof trusses comprise structural members typically connected by pegged mortice and tenon joints. Truss 1 has been altered, with the bottom chord and a collar tie cut (Figure 8), and a strut removed to accommodate the staircase. The bottom section of the west timber post has been cut (Figure 9). Struts have also been removed from Trusses 2 and 3, leaving exposed half joints (Figure 10). Other than missing members, the timber condition in the trusses is reasonably good.

Figure 8 Collar tie removed on Truss 1.

The proposed roof works will ensure the roof structure is suitable for the proposed loads and long-term use of the building. Existing rafters will be retained, with defective rafters replaced as necessary. New purlins will be added alongside the existing purlins to carry the proposed loads, and new collar ties will be installed at every other rafter above the purlins. Existing trusses will be reinstated and repaired, and sarking boards will be provided to improve overall lateral stability. At the Bothy roof, steel beams will be added to the principal rafters, with new timber beams added to the collar ties.

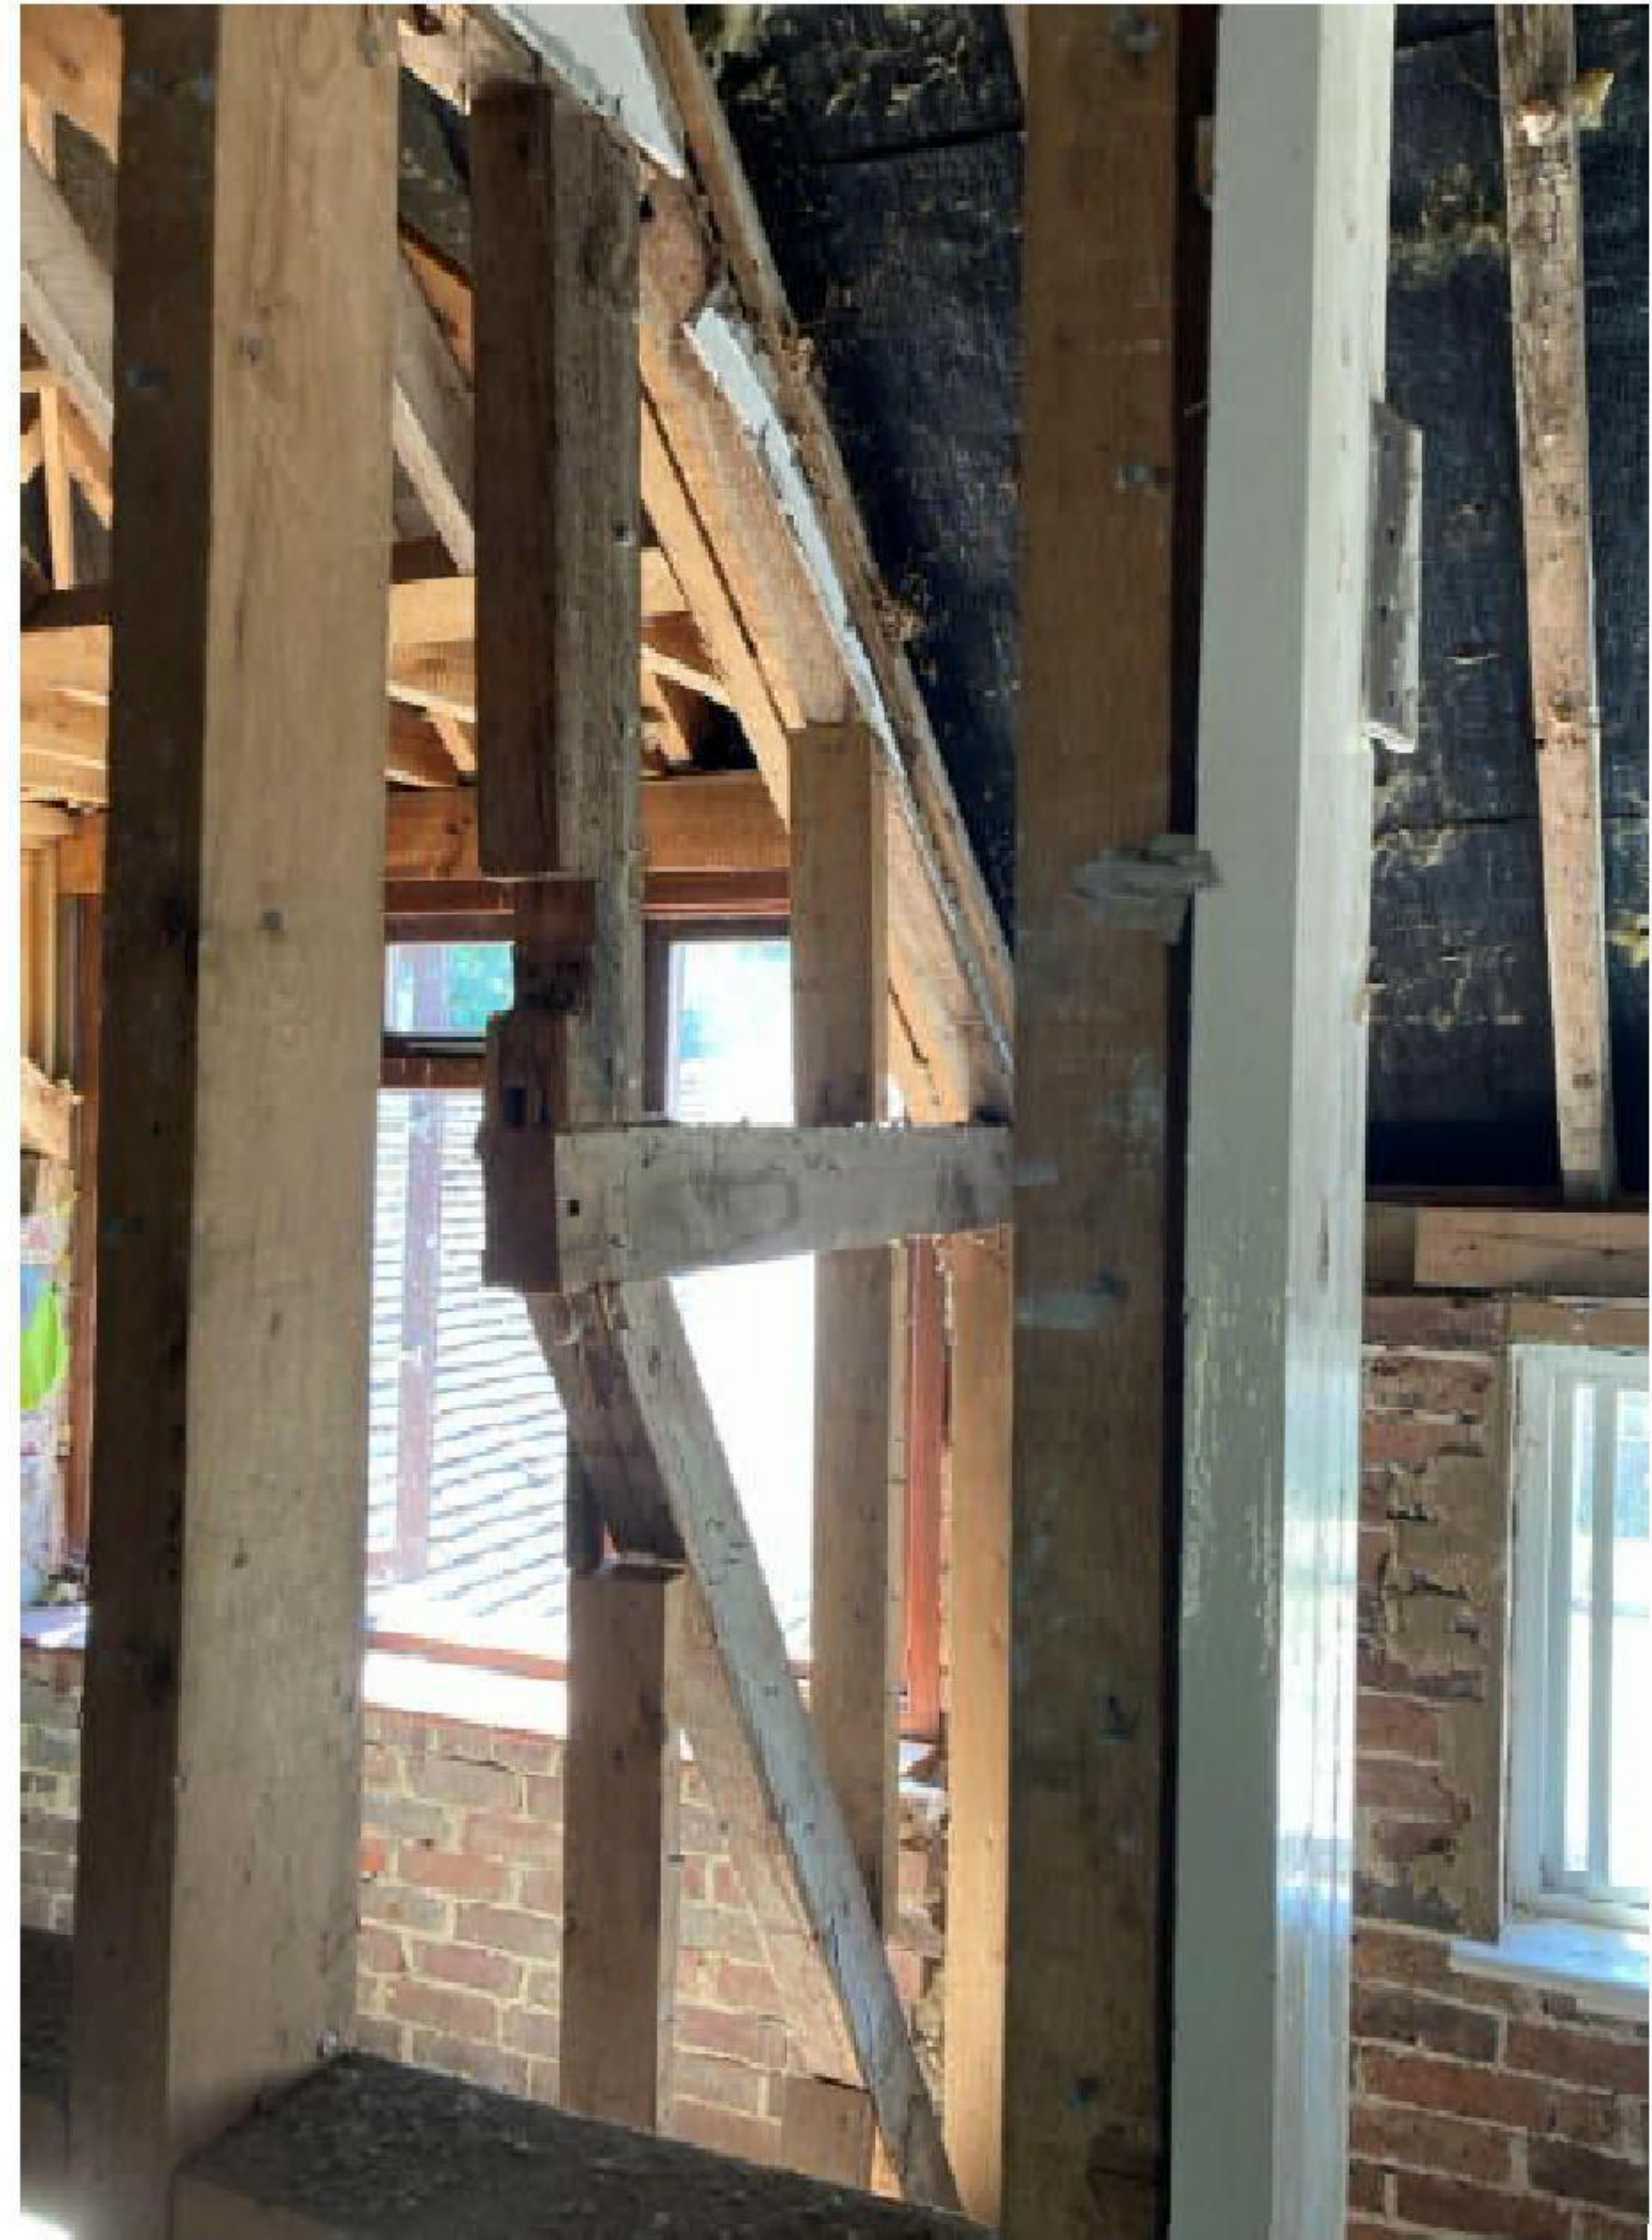
Figure 9 Bottom section of the west timber post removed on Truss 1.

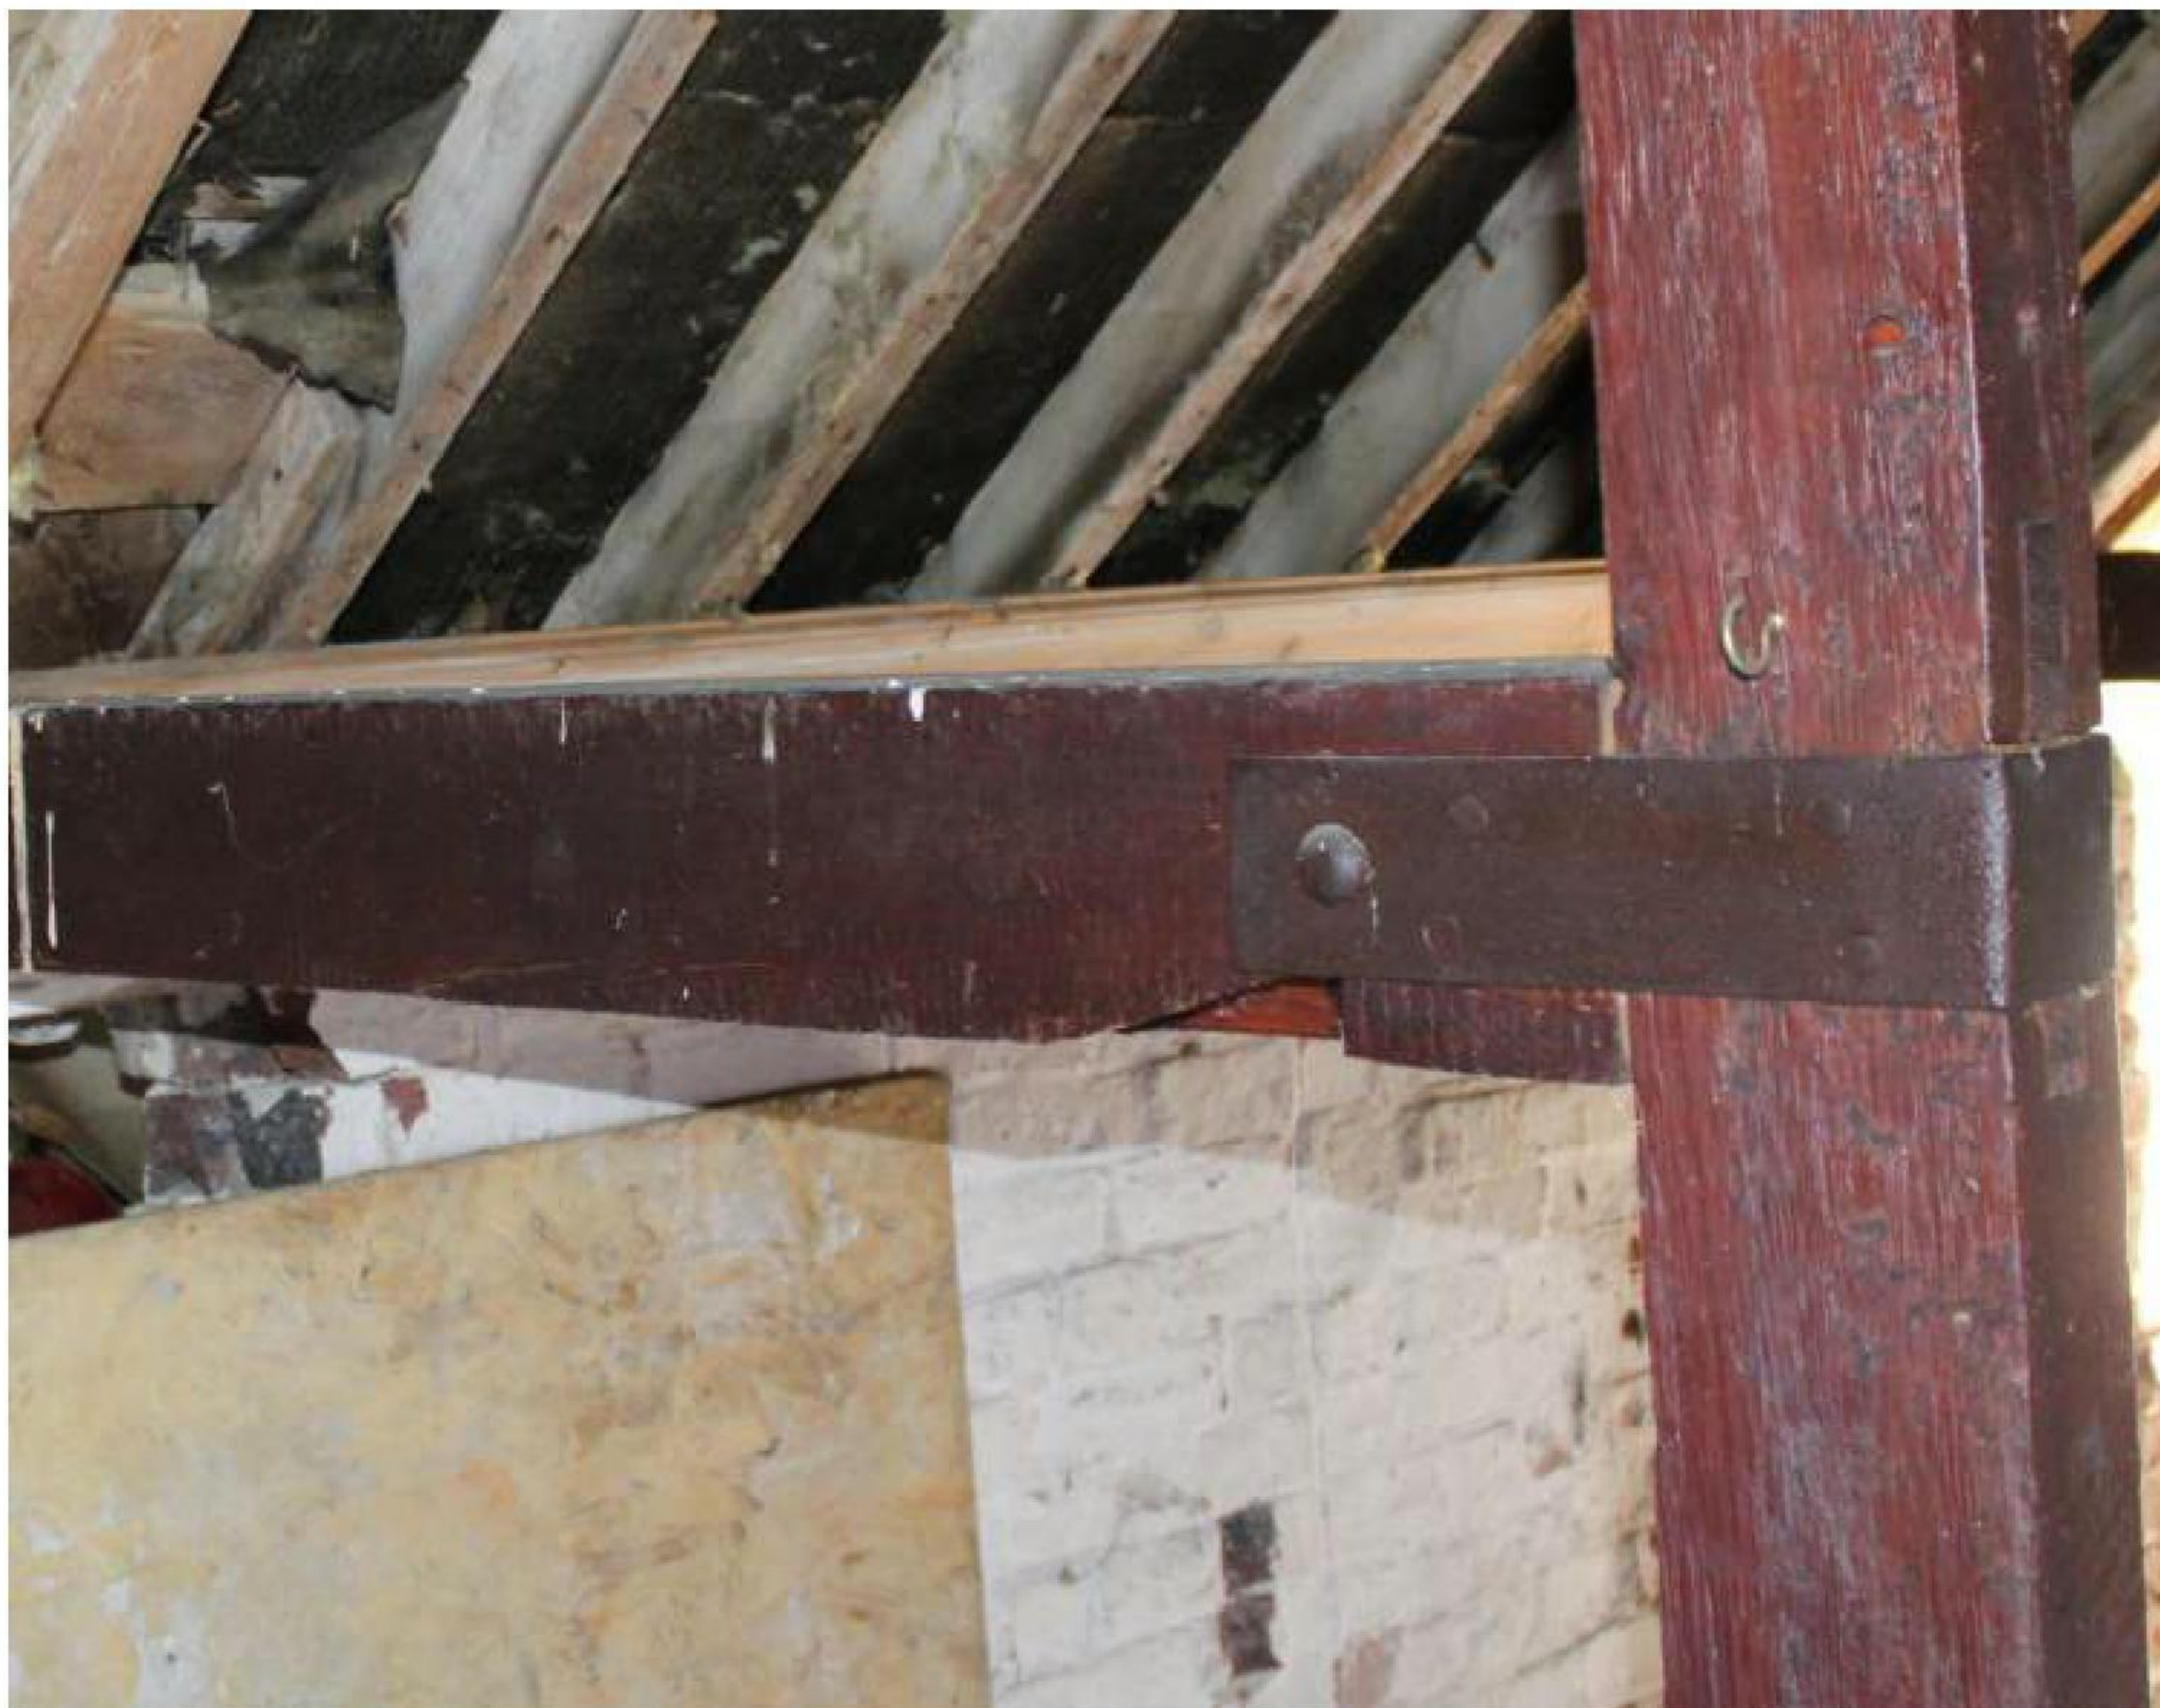
Figure 10 Exposed half joint on Truss 3.

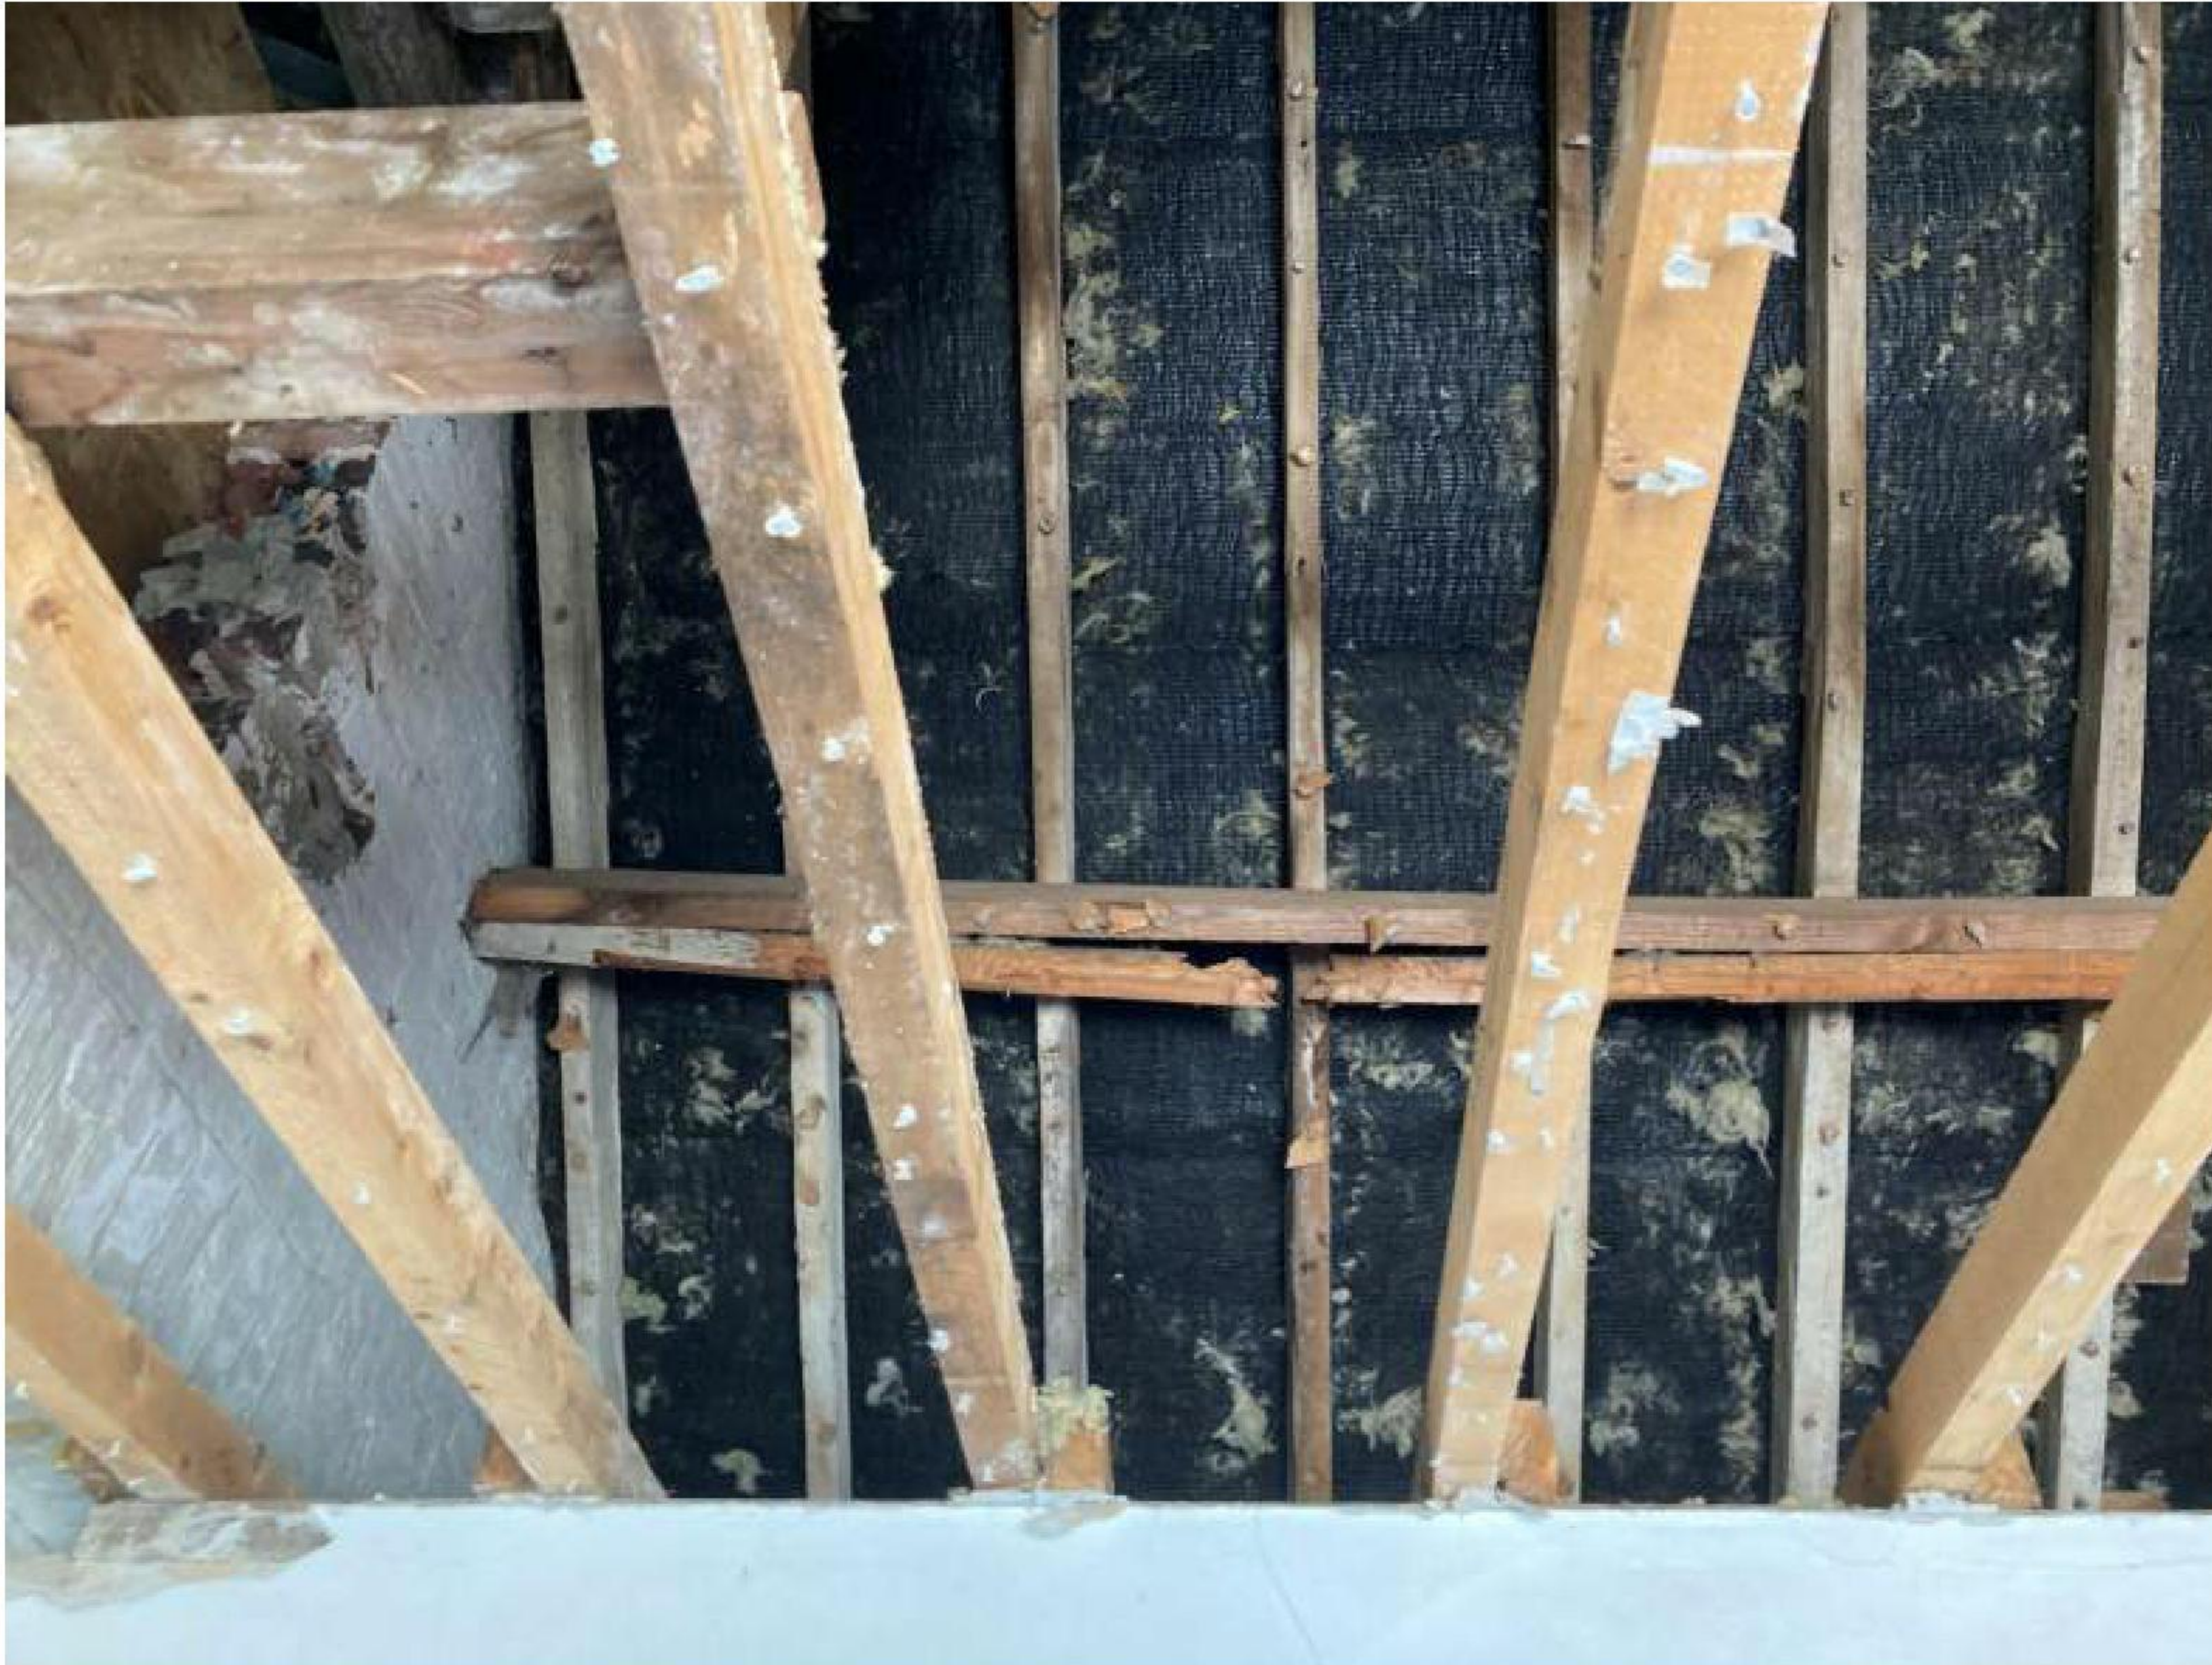
The South Range has a pitched tiled roof with gable ends, supported by eight timber trusses, rafters, and brick cross-walls. All the common rafters are generally in reasonable condition, although some are water stained. The purlins are generally in reasonable condition, but some show some deflection indicating they may be underdesigned. The purlin on the south side between the East Range and Truss 1 is broken and appears to have been strengthened, as there is another purlin installed alongside it (Figure 12). The wall plates in the South Range are generally in reasonable condition. The wall plates also act as a lintel for the windows.

Figure 12 Broken purlin with additional purlin alongside in South Range East.

The proposed roof works are designed to ensure the roof structure is suitable for the proposed loads and use of the building. Existing rafters will be retained. All existing timber trusses are underdesigned for design code requirements. New timber trusses with new timber struts will be installed to South Range East. New steel trusses with new timber struts will be installed to South Range West but retaining the adjacent timber trusses for their historic value and appearance. New purlins will be added alongside the existing purlins to support the proposed loads, and sarking boards will be provided to improve lateral stability.

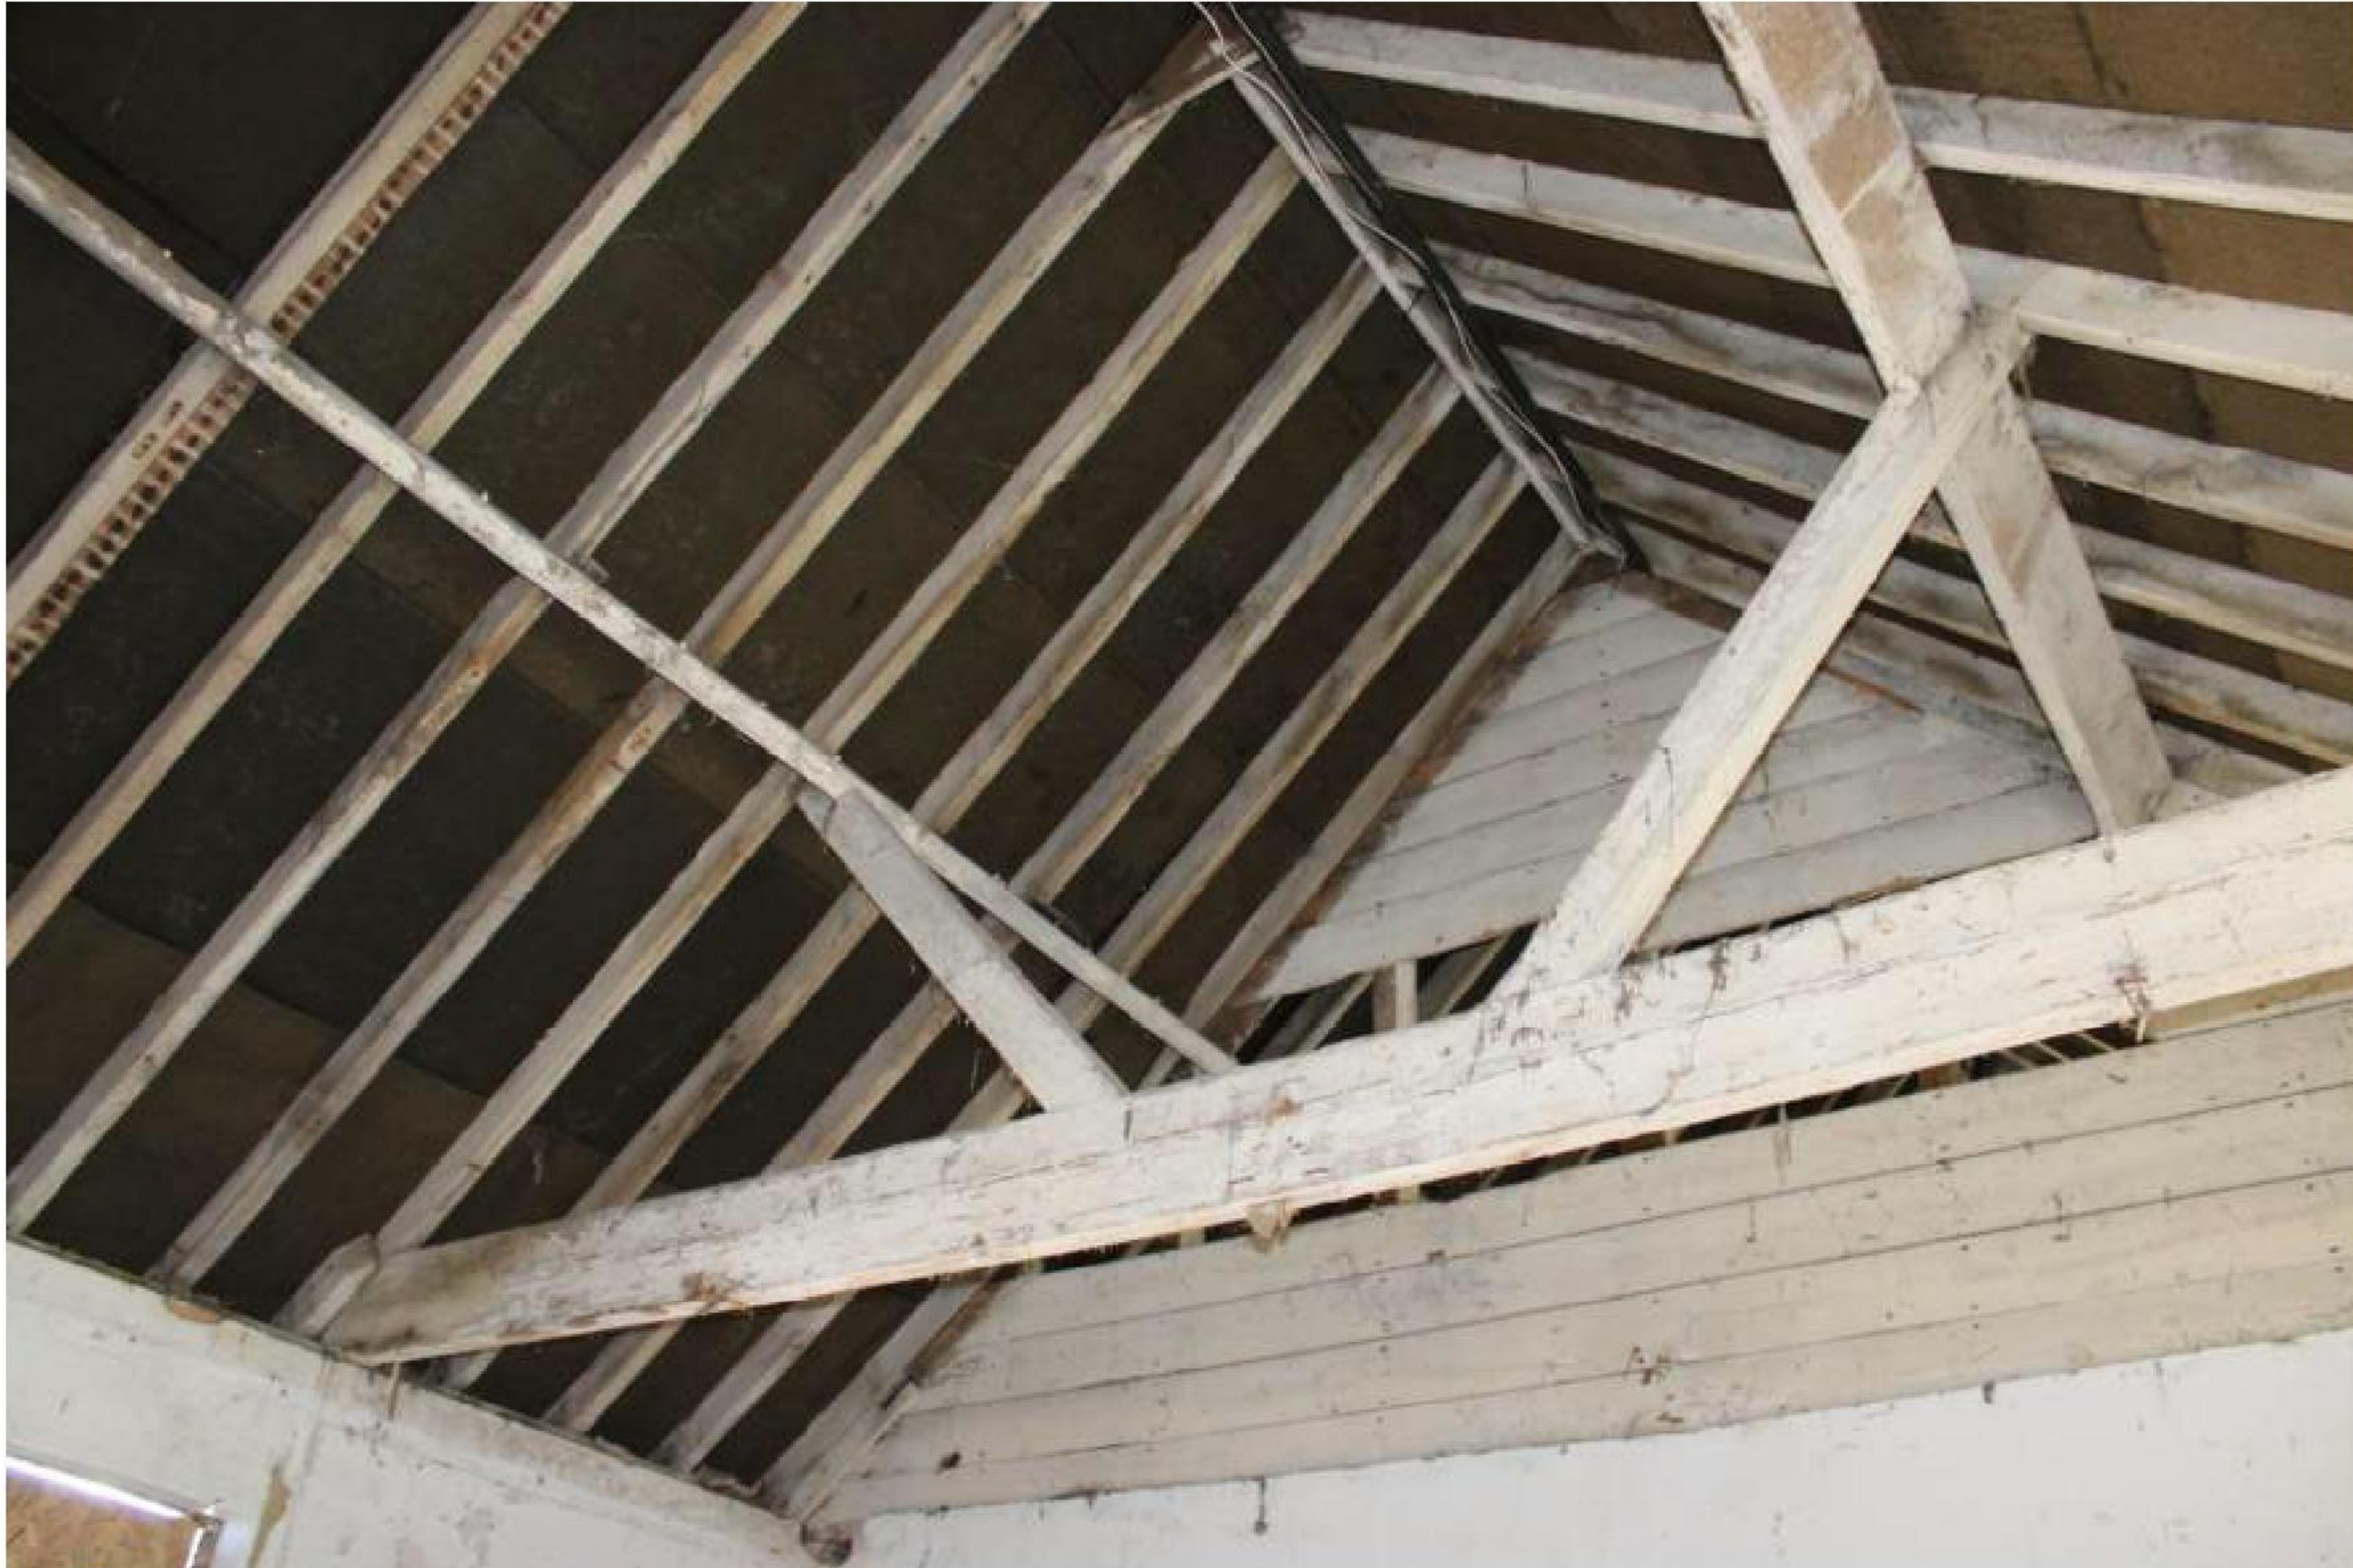
Each truss has a single raked queen strut on either side, supporting the purlins from the bottom chords. Trusses 1 to 4 are in South Range East. The timber is of regular size and geometry with no decay observed (Figure 13). The raked struts are in reasonable condition, and the timber is softwood. Trusses 5 to 8 are in South Range West. The timber has irregular geometry, suggesting possible reuse, with bends and curvature in both vertical and horizontal planes. The softwood is generally of poor quality. The raked struts are in reasonable condition, but minor splits and surface decay were observed on the bottom chords (Figure 14). South Range West has existing sarking boards nailed to the underside of the rafters (Figure 14). Many of the boards were missing but the presence of nails suggests the South Range was fully boarded.

Figure 13 Truss 4 in South Range East.
