HAVELOCK FARM, WAKEHURST  
STAGE 4 – STRUCTURAL ENGINEER’S REPORT

HAVELOCK FARM, WAKEHURST

STAGE 4 – STRUCTURAL ENGINEER’S REPORT

| SFK Document No: | | 24079/R04 | | |

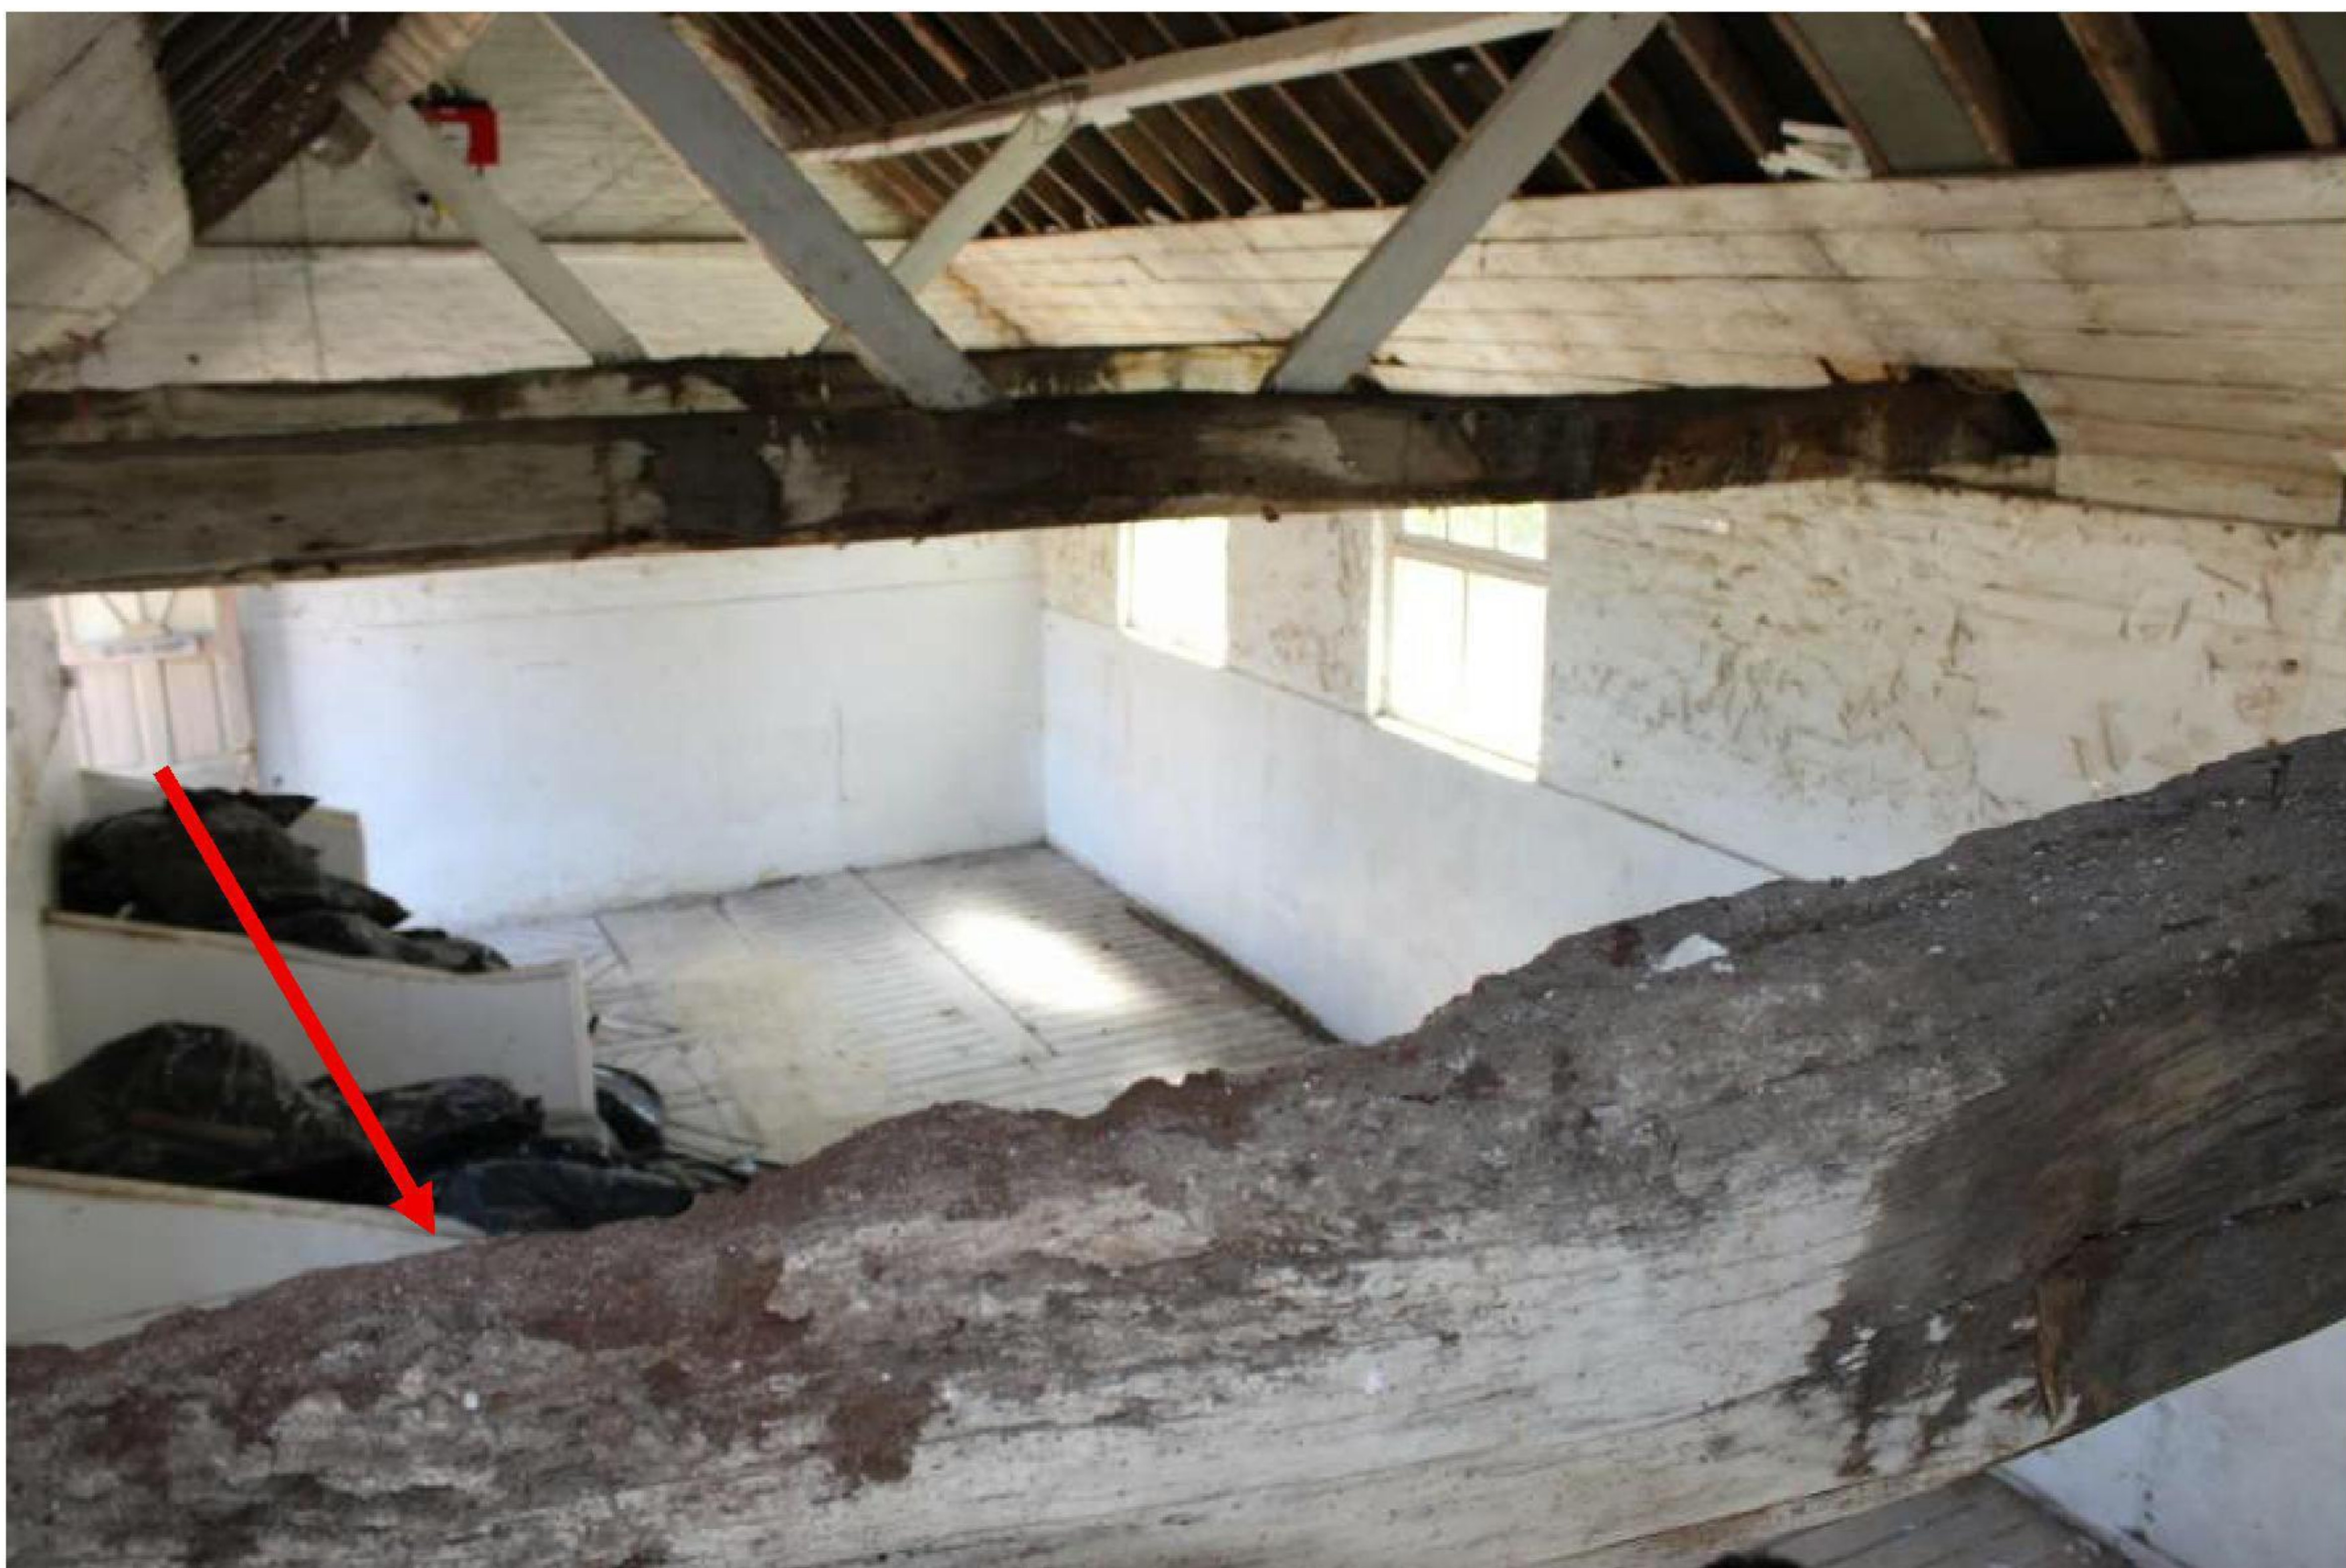
Figure 14 Top surface decay on the north side of the bottom chord of Truss 7 (as denoted by red arrow, Truss 5 is located furthest away in this photo). Some sarking boards are present on the roof.

The proposed roof works are designed to ensure the roof structure is suitable for the proposed loads and use of the building. Existing rafters will be retained. All existing timber trusses are underdesigned for design code requirements. New timber trusses with new timber struts will be installed to South Range East. New steel trusses with new timber struts will be installed to South Range West but retaining the adjacent timber trusses for their historic value and appearance. New purlins will be added alongside the existing purlins to support the proposed loads, and sarking boards will be provided to improve lateral stability.
