AN ARCHAEOLOGICAL INTERPRETIVE STUDY FOR  
KEYSFORD BARN, TREEMANS ROAD, HORSTED KEYNES,  
WEST SUSSEX, RH17 7EA.

Report number: ASL 354-25

*This three bay threshing barn was built in the late 16<sup>th</sup> – early 17<sup>th</sup> century [Period A] with some significant alterations carried out during the early-late 19<sup>th</sup> century [Period B] and in the 20<sup>th</sup> century [Period C].*

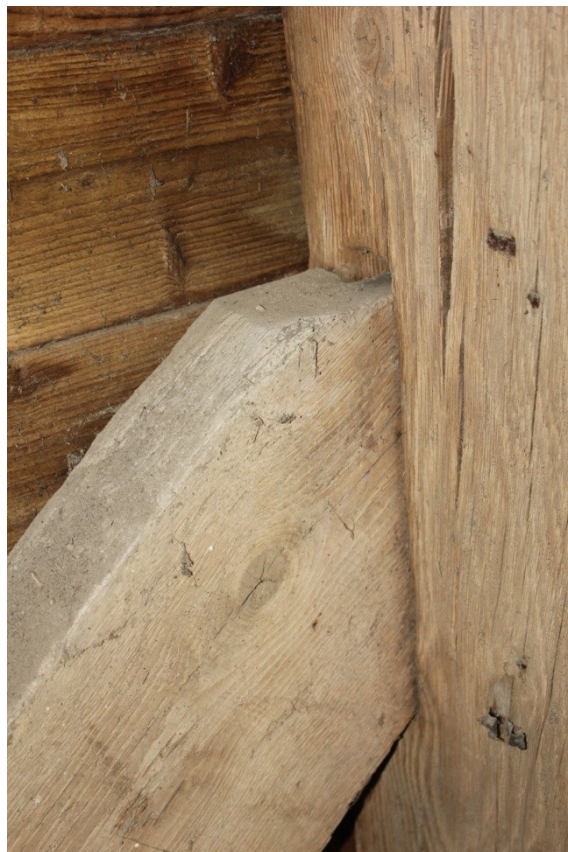
- 3.4 The walls to all sides are covered with modern, feather-edged weatherboarding which has not been painted and is nailed into place with flat nails. The building is fully foot braced to all corners with head braced trusses. However, the brace design is unusual in that they have straight cut mortices and tenons, not angled and the slightly curved braces have shoulders (Plate 3).

**Plate 3. Curved brace with shoulder at the mortice and tenon joint.**

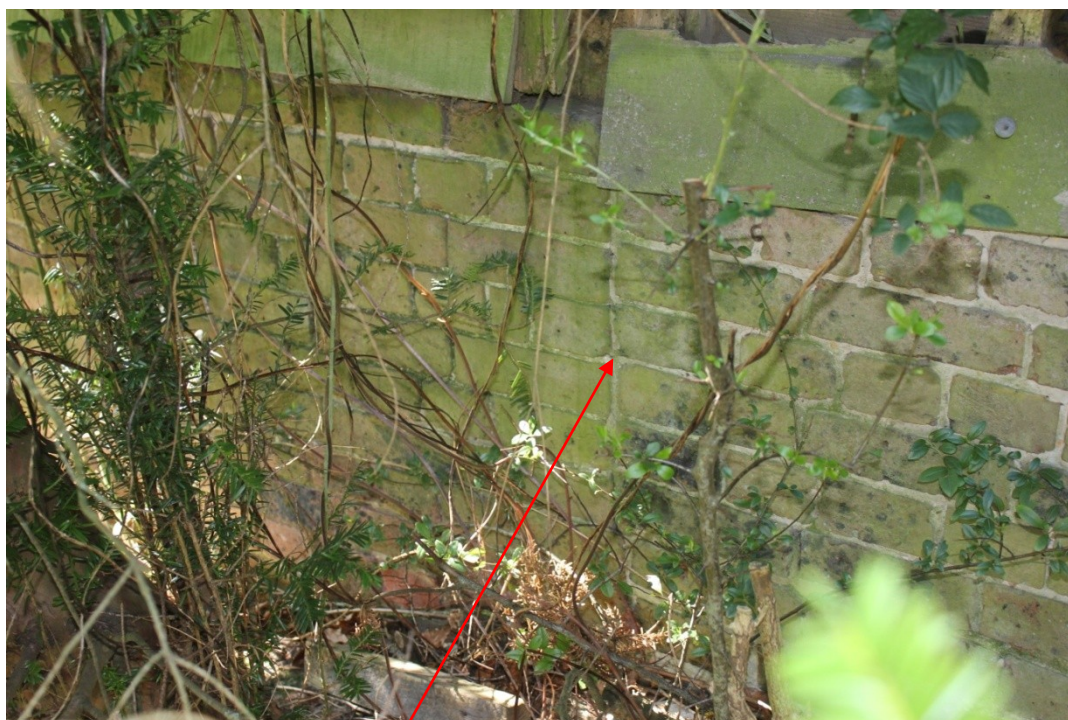
- 3.7 The east elevation of the Barn currently has no doorway, as discussed above, and the posts are covered with attached fillets. There is an iron coach strap in the south post of the Midstrey, usually indicative of 19<sup>th</sup> century repairs. The Midstray elevation is covered by 20<sup>th</sup> century weather-boarding (Plate 6) and the brickwork below this is also from this period. A butt joint is visible with the earlier brick to the south side of the Midstray proving that the wagon-way was in-filled in Period C (Plate 7).

**Plate 7. Butt joint in the brickwork of the eastern Midstray.**

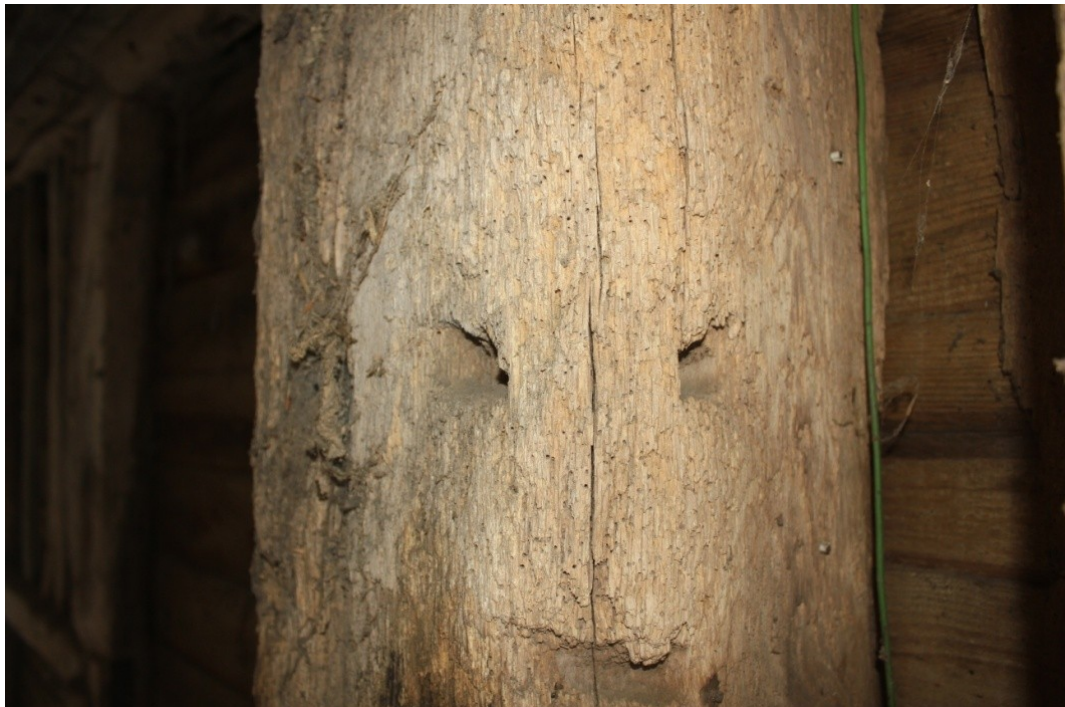
- 3.9 Internally throughout the Barn there are a set of two pegholes drilled at angles on the corners of each post (Plate 9) for reasons unknown, at approximately chest height or slightly lower in some. It is possible that these were for securing ropes as there is some wear to the back edges of the holes.

**Plate 9. Holes drilled through the corner of a post, possibly for tying rope.**

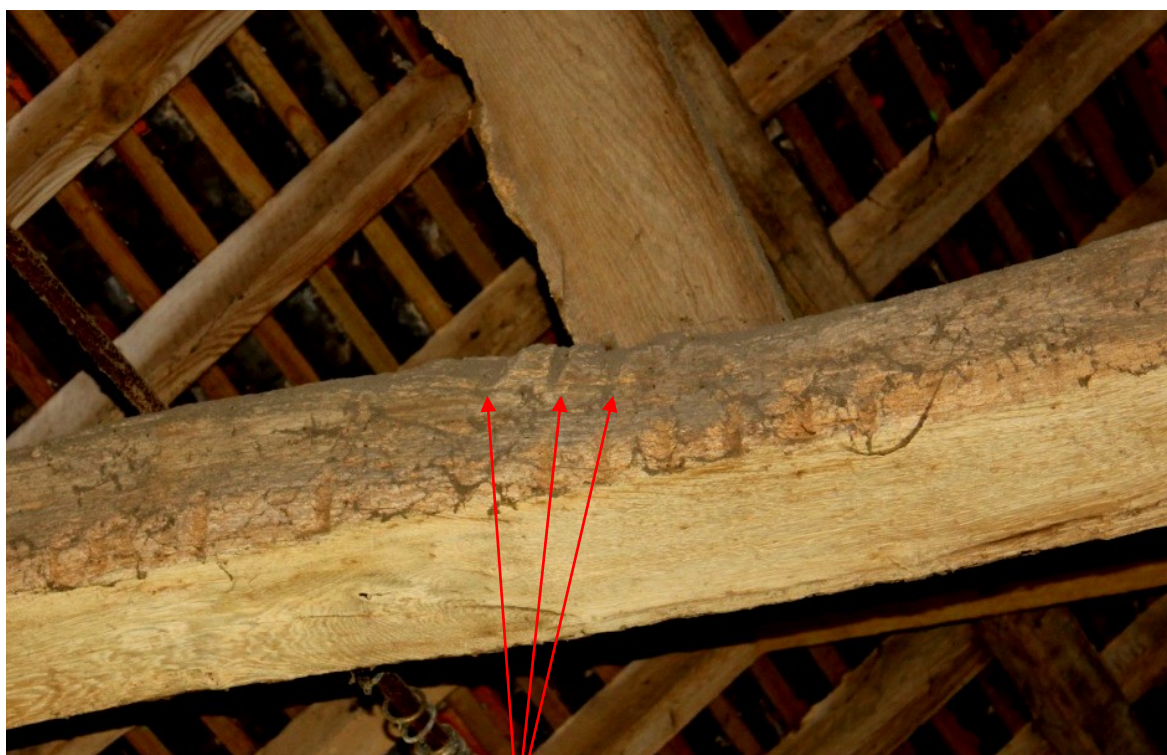
The south face of Truss B has some deep rope wear marks on the west side of the tiebeam (Plate 12), most likely connected to winching of objects such as straw or hay bales up onto the floor. This may explain the open space here and why the floor did not extend across the whole bay, which is evident in the presence of an empty mortice in the side girts which mark the north end of the floor (Plate 13) The mortice is also a haunched tenon. It's likely there was also a ladder in this space for accessing the floor. The Raking shores are a Period B additions so are discussed in Section 4 below.

**Plate 12. Rope wear on the Truss B tiebeam.**

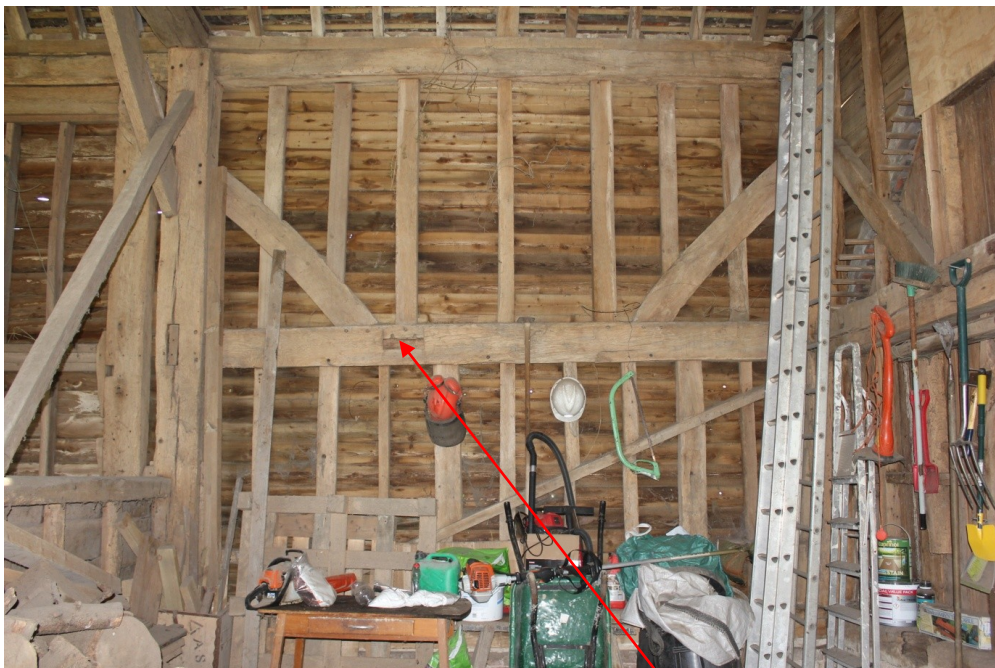
**Plate 13. The east wall of the south bay with empty mortice for the floor plate.**

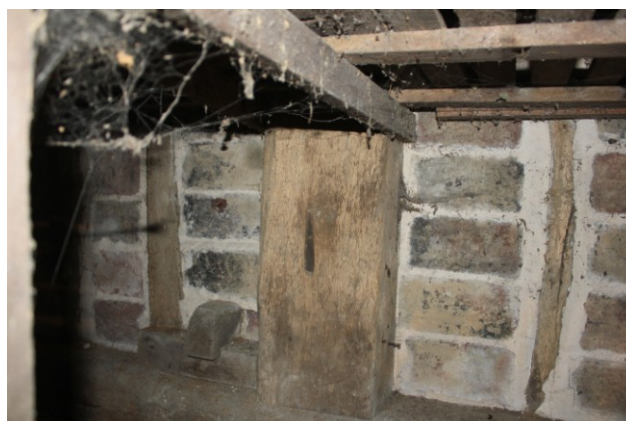
The northern end wall of Truss D has an intermediate post which has a taper burn mark at the base of the post (Plate 17). There are no other intermediate posts within the building so it is not clear why this wall has one. There are also a pair of foot braces extending from the intermediate post to the mid-tiebeam.

**Plate 17. Taper burn mark at the base of the intermediate post in Truss D.**

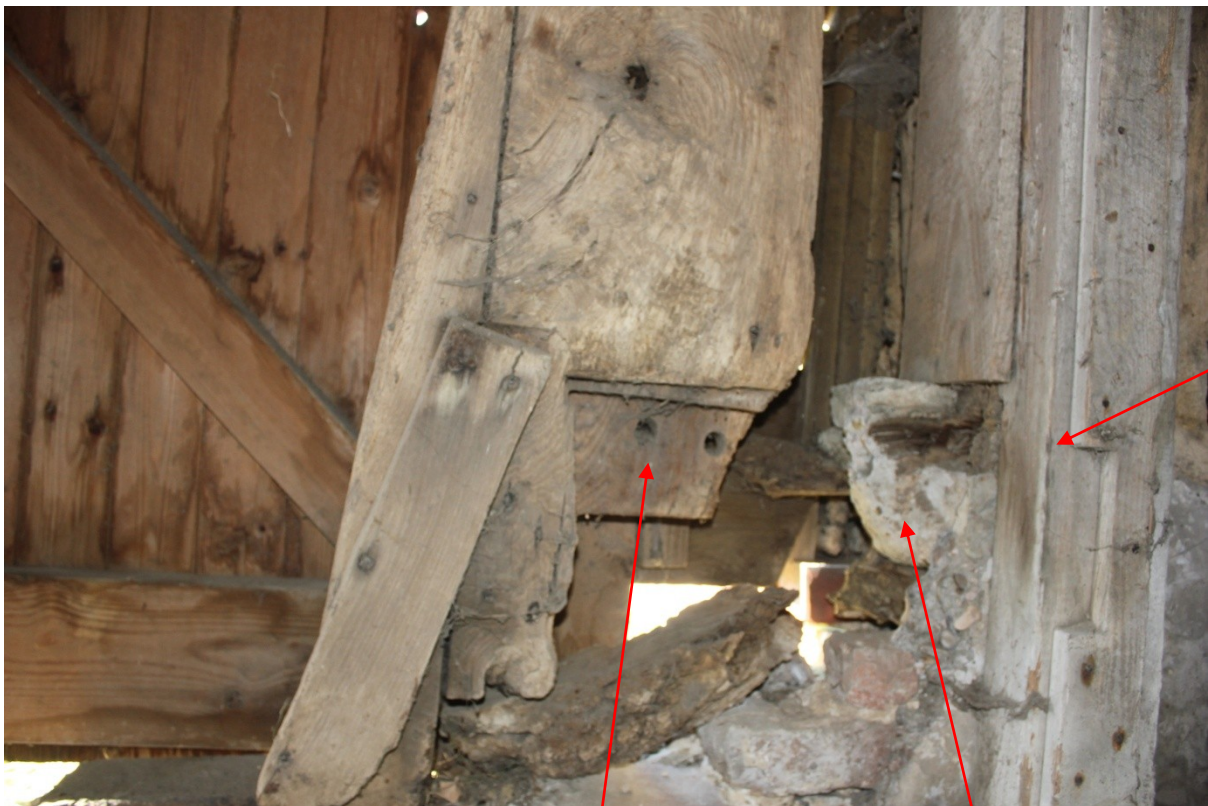
**Plate 19. Substantial posts of the internal frame were tenoned to the cill beam (now rotted).**

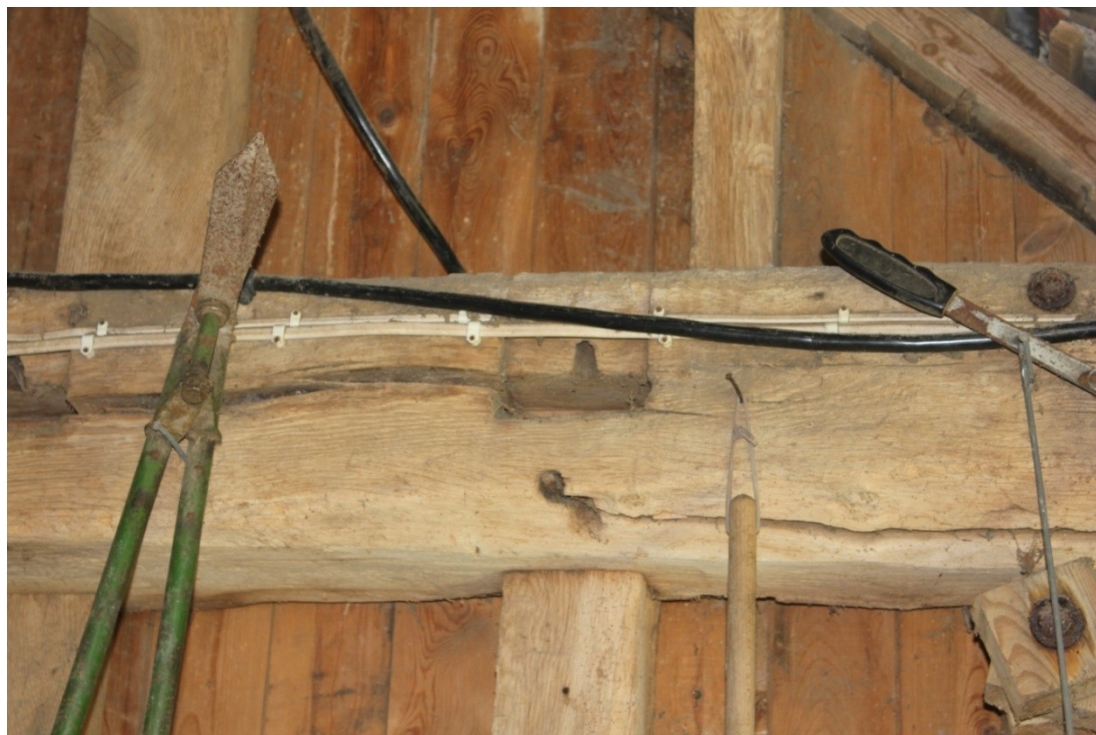
The southern bay was partially floored with haunched tenons joints present in the southern end girt (Plate 21). The corresponding girder is missing as the floor has been removed. However, the empty haunched tenon mortices for the girder are present in the side girts so the floor length could be measured. The bay also had a floor to ceiling empty space present within the first bay, between the end of the floor and the Midstray partition, separated by a mid-tiebeam (also missing).

**Plate 21. Empty haunched tenon joints in the end girt of Truss A.**

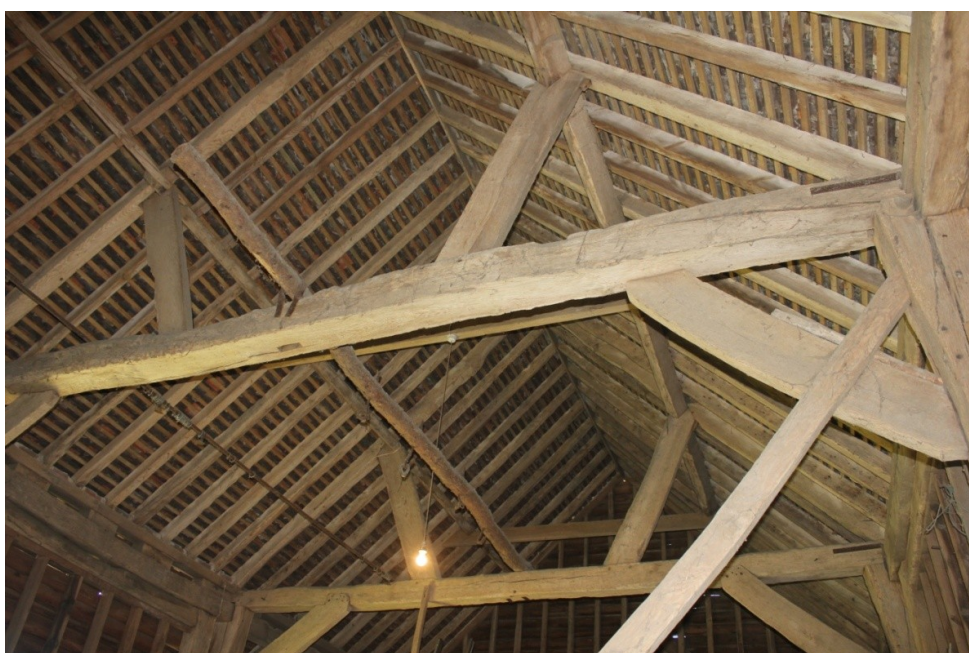
The roof is very level (Plate 23) and has clearly been re-built at least twice and not all the principal rafters are in their original positions and have been re-set. In addition, the original roof was fully hipped and the pitch was steeper, previously set at 52° but this is now 44°. It is likely the roof was altered due to rotten rafter ends, where the ends of the rafters (where they were suitable for re-use) were cut to size. Due to the significant amount of adaptations, little survives of the Period A roof so the majority of this structure is discussed in Section 5 below.

**Plate 23. The level roof structure with Truss B in the foreground looking towards Truss C.**

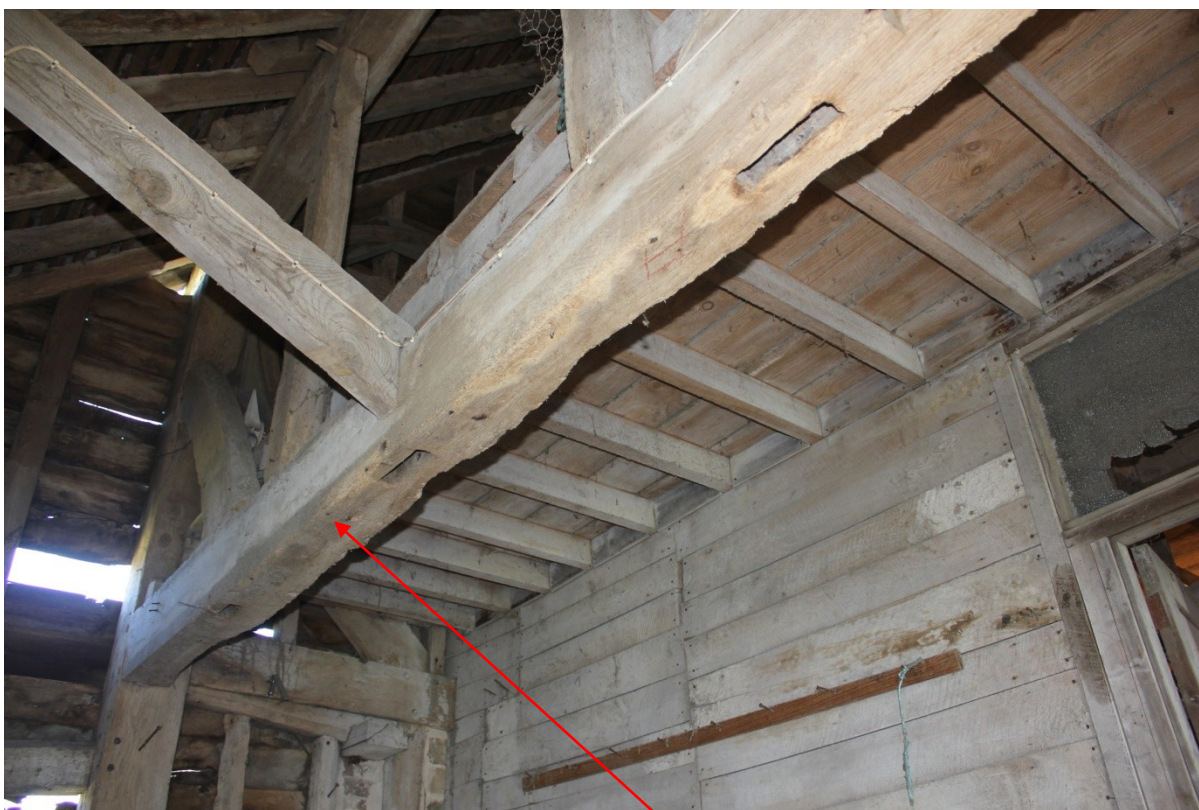
There are a series of nail holes running the length of Posts C and D which are either for an internal boarded partition wall or for an external wall prior to the outshot being built. It is not clear if this outshot did replace an earlier one but the lack of weathering on the outside face of the Period A frame suggests there may have been one from the outset. However, there were two windows inserted into the original Period A west wall utilizing the wall studs (Plate 25; now missing), mirroring the inserted windows in the southern bay to some extent although all of the timbers are missing here. The mortises for the cills and shadow marks of the removed window heads can be clearly seen so it is perhaps more likely that this represents an external wall with inserted windows. The wall paneling and windows were removed, most likely at a later date during this period when this end of the Barn was altered to house animals.

**Plate 25. Mortices for missing wall studs and shadow line of missing window head.**

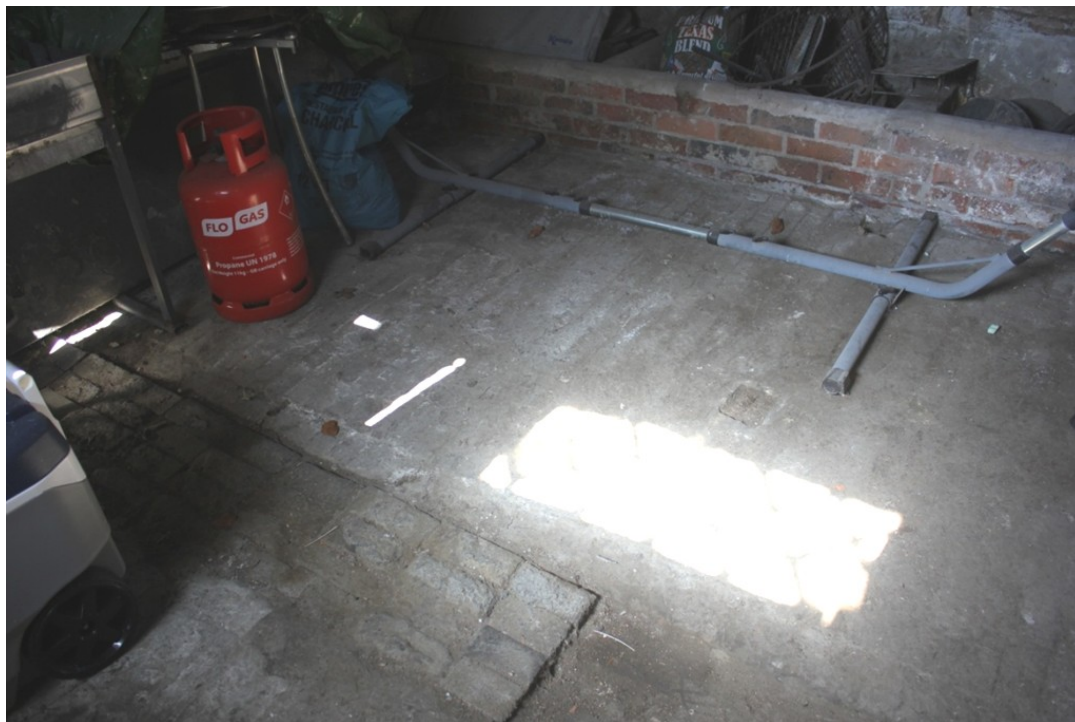
**Plate 29. The brick flooring in the outshot covered by cementitious slurry.**

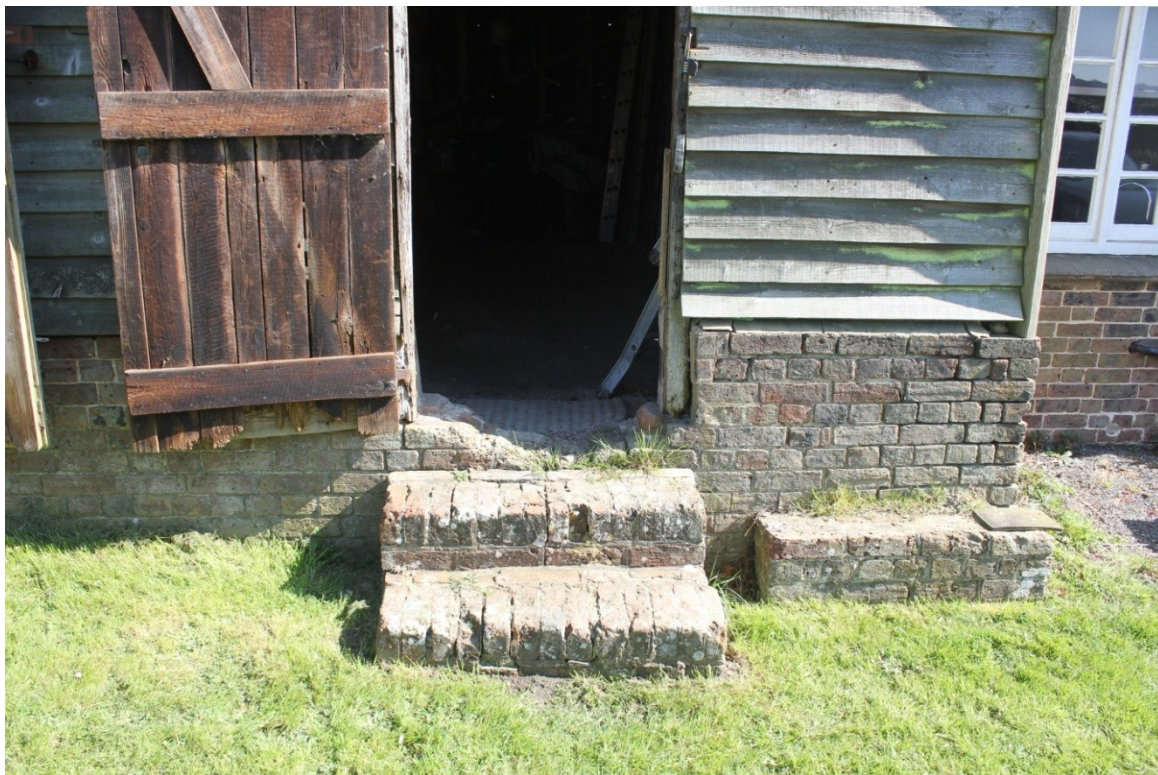
**Plate 33. Under-built brick plinth in the west side of the Barn.**

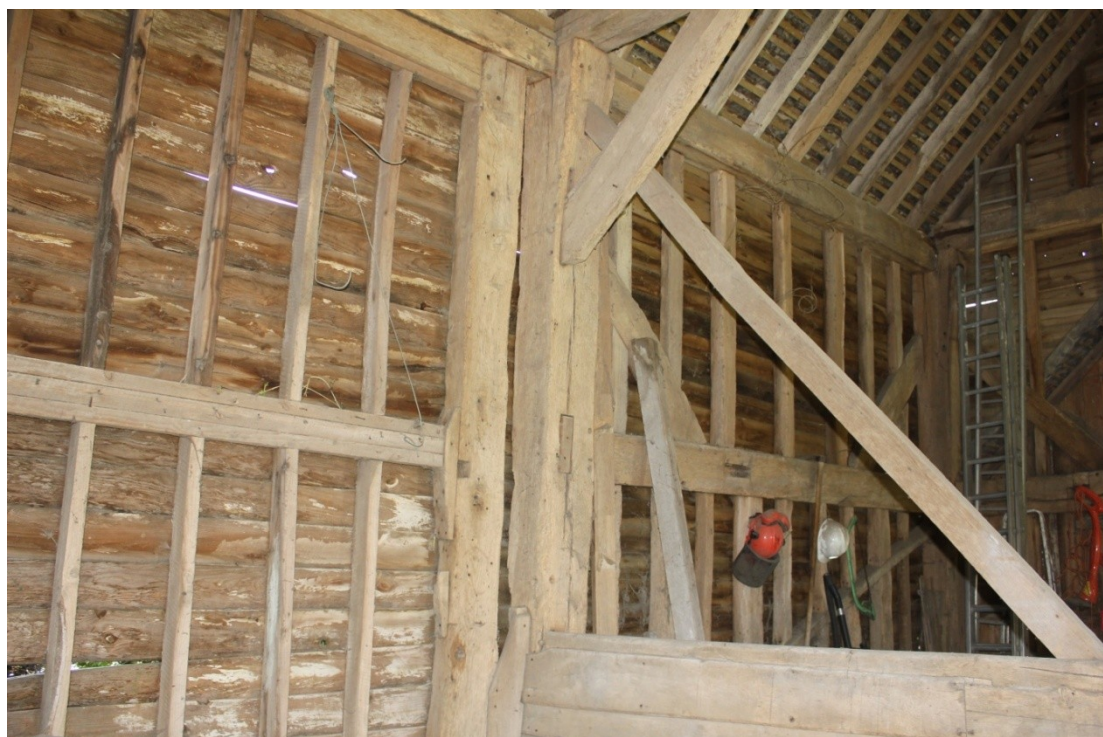
**Plate 34. Raking shore morticed into Post BB.**

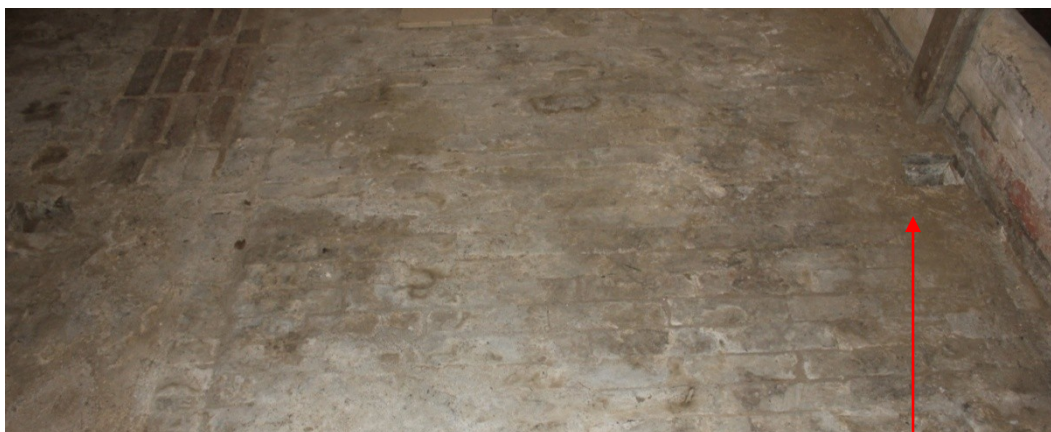
The floor of the northern bay was laid with brick during this period which has since been covered with cementitious slurry partly covering it (Plate 41). There are two empty sockets set into the floor for missing uprights, which would have divided the area into four stalls. This would have been an earlier partition which pre-dates the 20<sup>th</sup> century alterations at this end of the Barn.

**Plate 41. Brick flooring in the northern bay of the Barn with empty sockets within.**

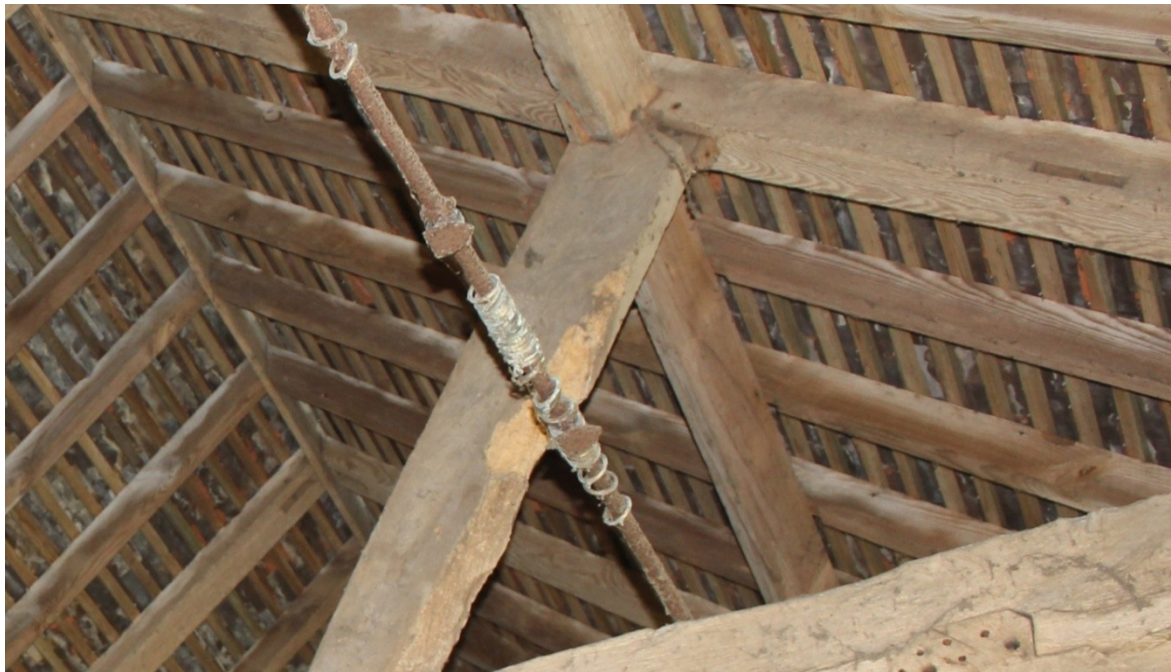
**Plate 44. Queen post turned and re-cut with a wedge inserted.**

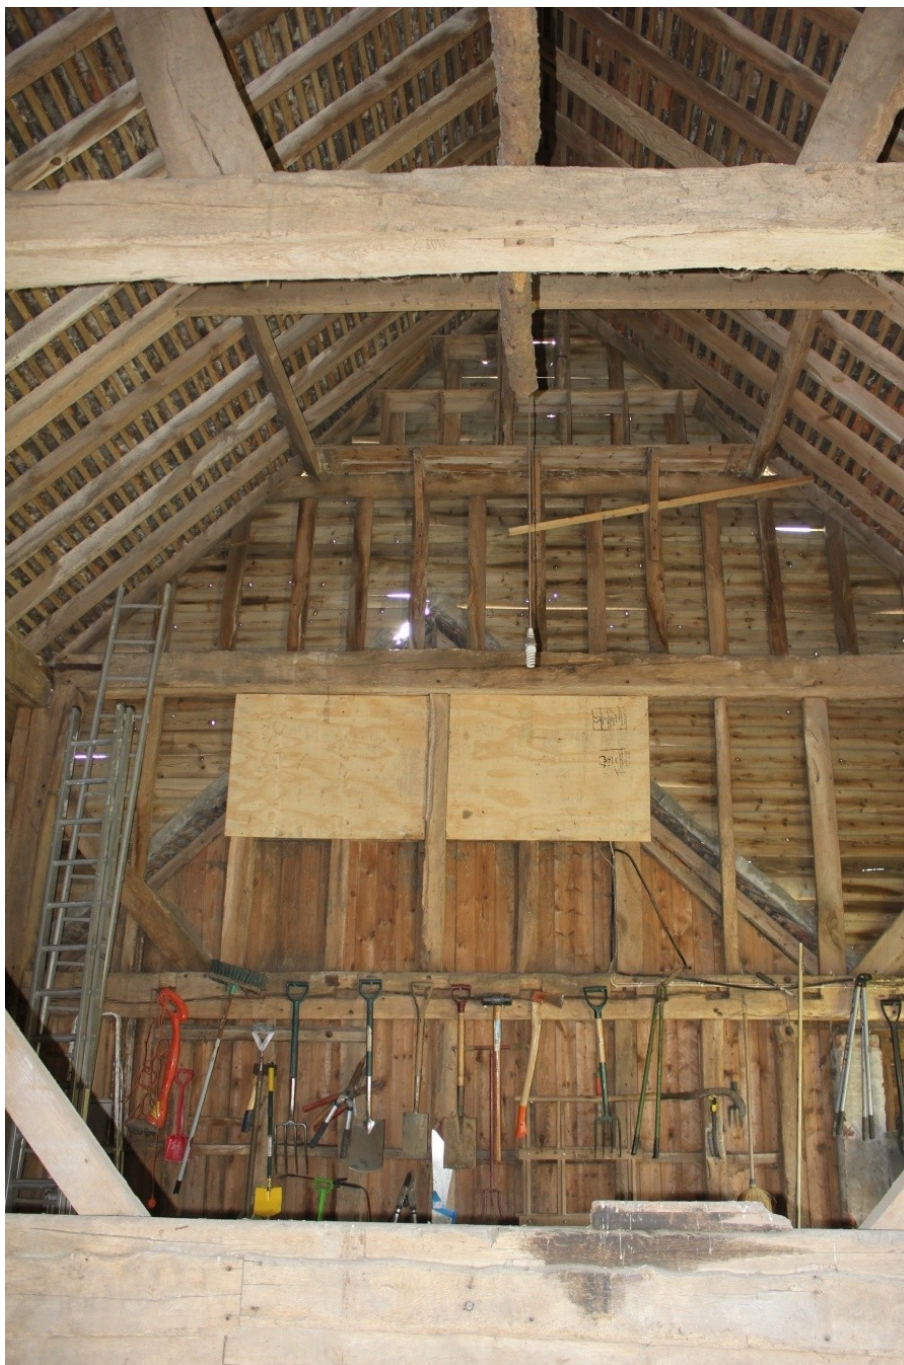
The stub gables are also a re-build and the roof purlins in the southern bay have been replaced by softwood timbers (Plate 46) and it appears that the original purlins have been moved across (and rotated) to the second and third bays.

**Plate 46. Softwood purlins in the southern bay.**

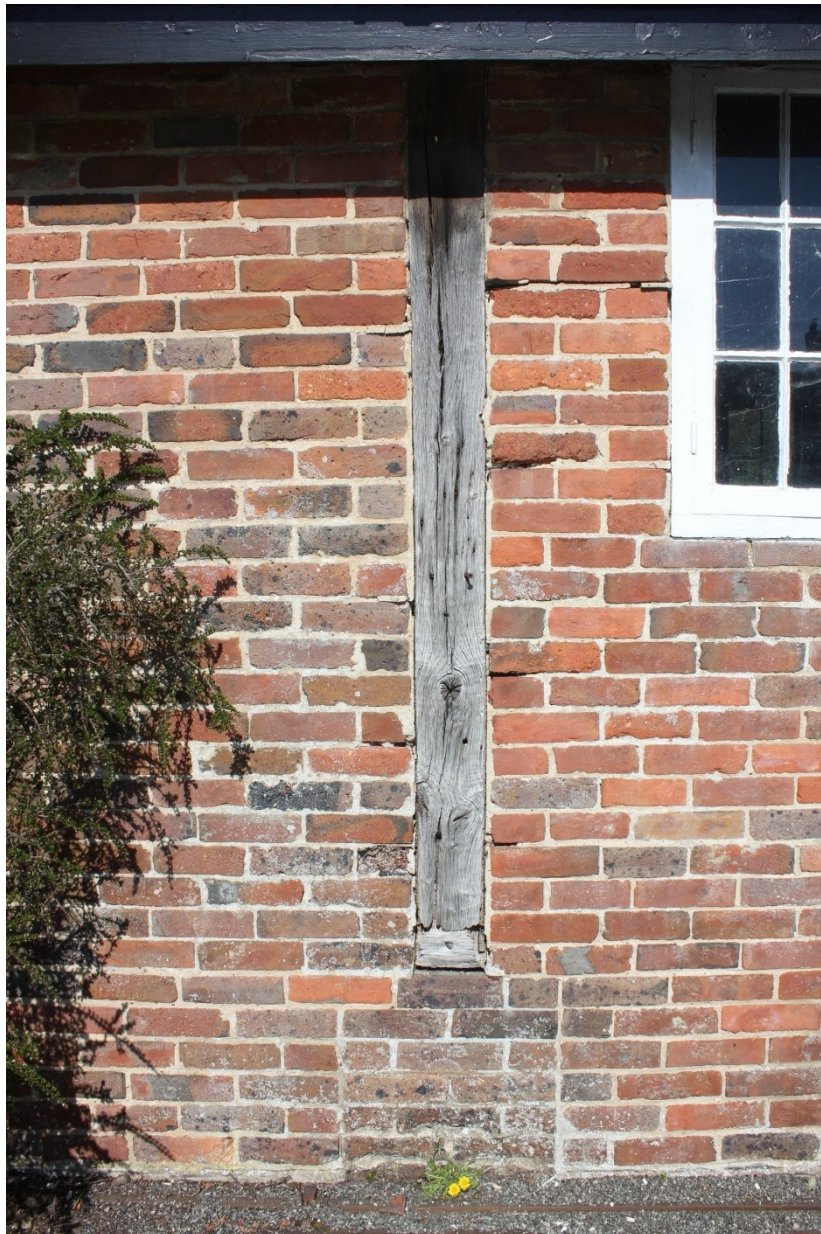
**Plate 49. Bay post pad replaced by brickwork at a different date to the infill.**

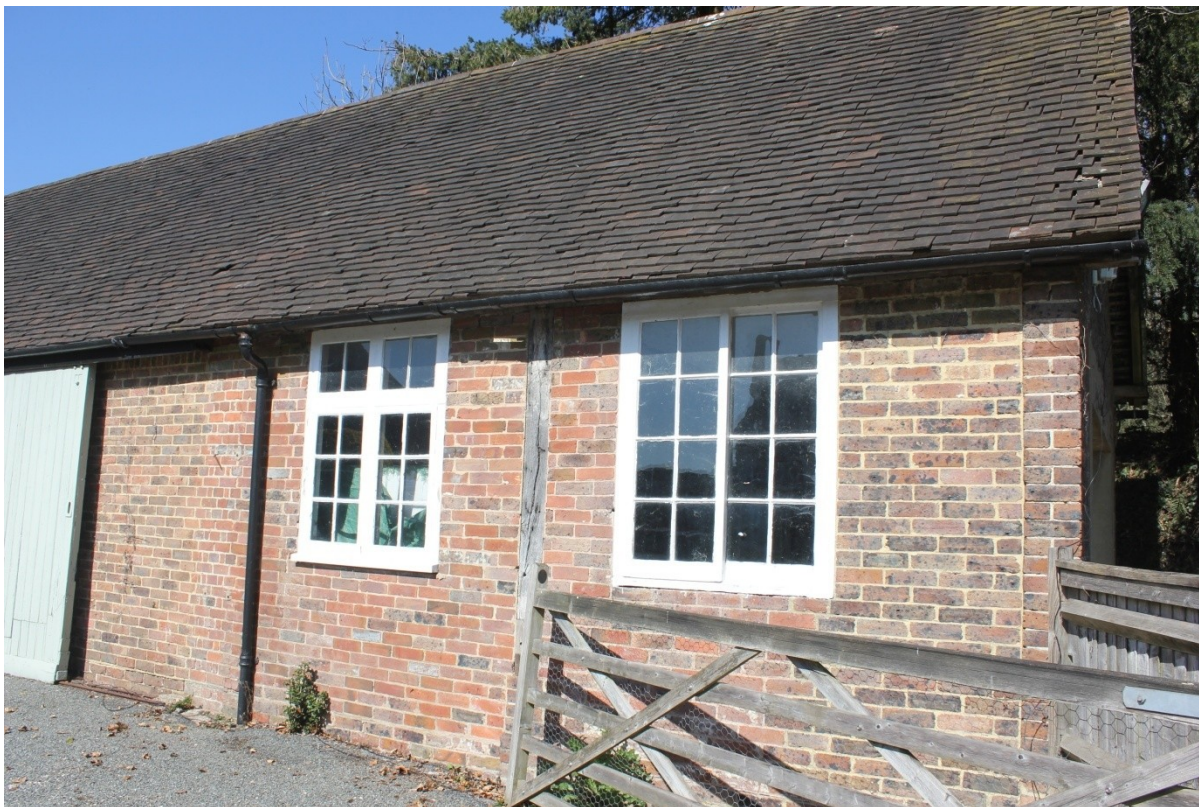
The posts sit on brick plinths (similar to the brick in the 20<sup>th</sup> century south outbuilding to the Barn) and the infill brickwork has clear butt joints, re-used bricks and cementitious mortar. There are at least five bays although these have been modified with a large double/triple garage building and sliding garage doors in the middle of late 20<sup>th</sup> century date. There are further adjustments to the brickwork to the east side of the garage where there is a damp proof course and one post has been removed. There are areas of patched brick repairs and infill with cementitious mortar (Plate 50).

**Plate 50. Infilled patched brickwork repairs at the eastern end of the outbuilding.**

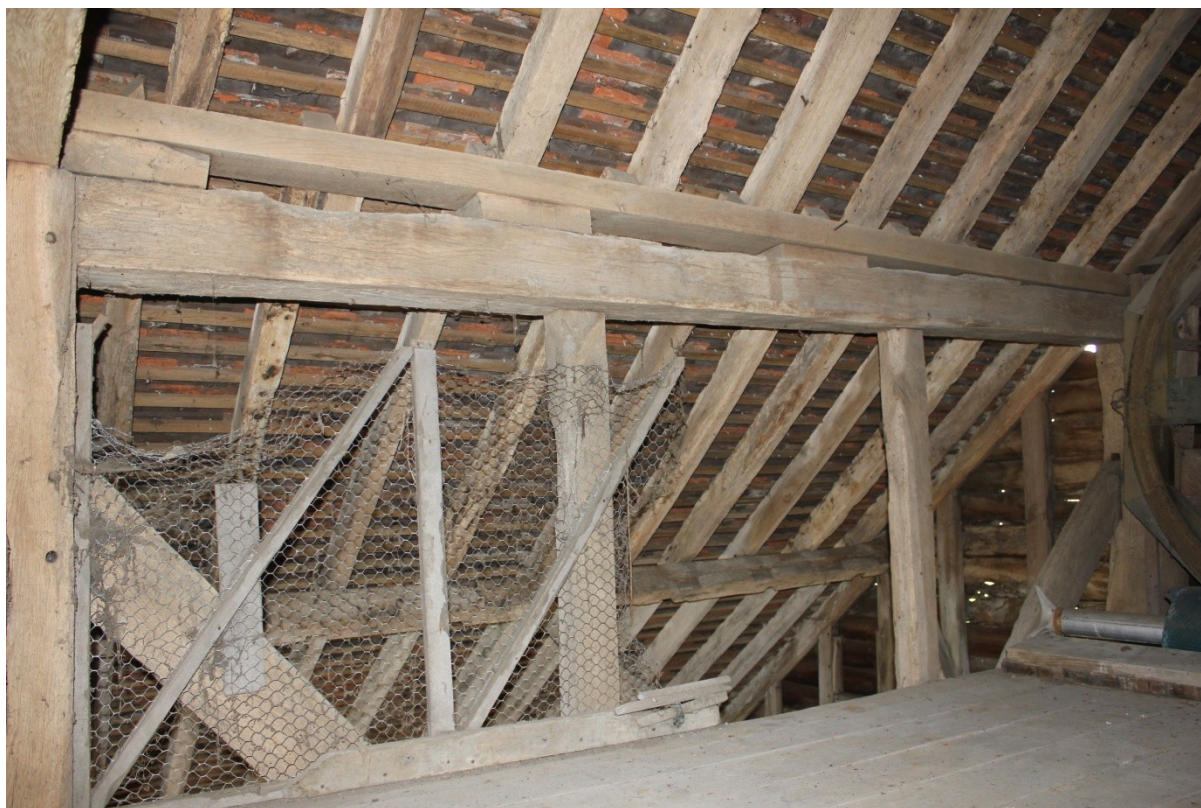
The roof is very level and was re-built during this period when the gables and common rafters were replaced along with new battens and re-covering (Plate 59). The roof purlins in the first bay were also replaced by softwood timbers and the original purlins were moved across (and rotated) to the second and third bays when the roof was re-built. In addition, the original wallplates had second sets of modern wallplates positioned over the top of the original timbers with packing pieces in-between to level the roof (Plate 60).

**Plate 60. New top wallplates and packing pieces to level the roof.**
