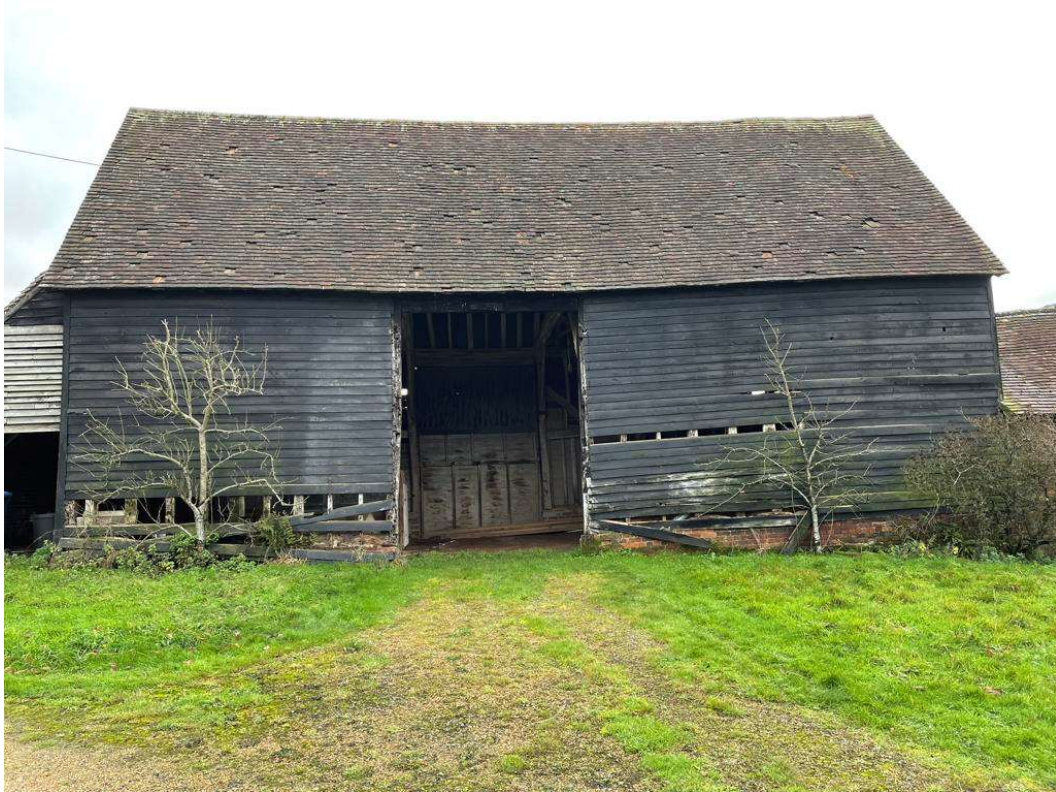
View on front of main barn showing brickwork plinth and timber weatherboarding

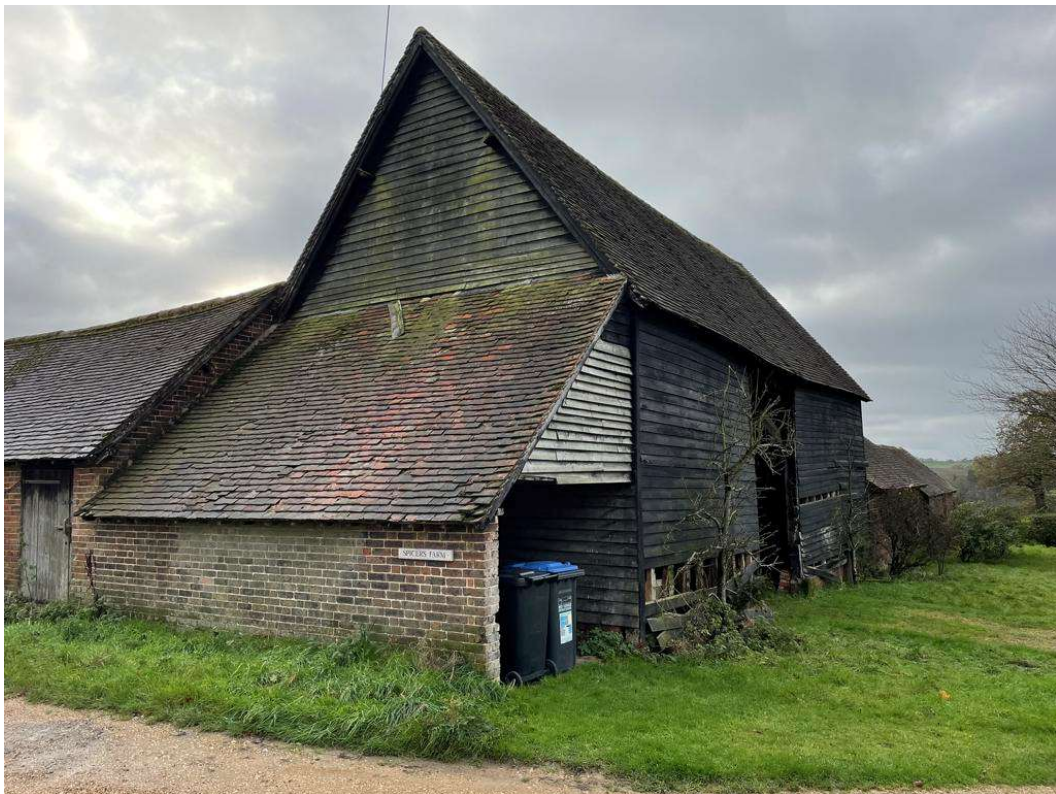
View on lean-to structure to left end of main barn

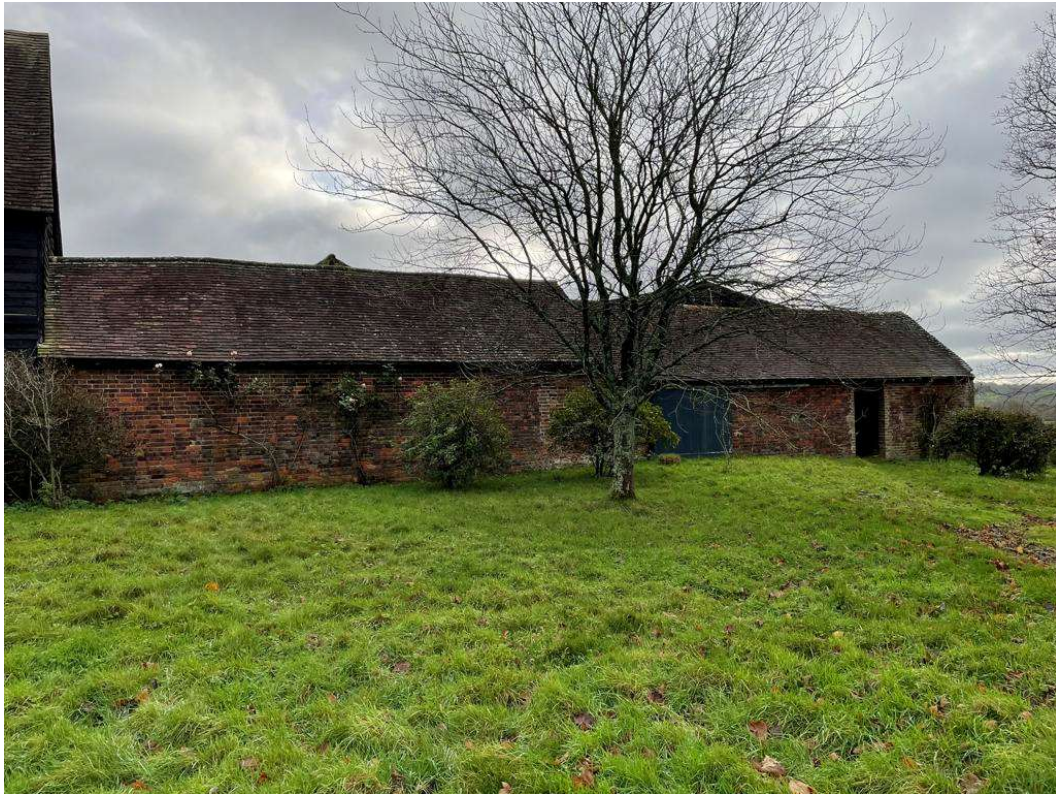
View on brick barns adjoining main timber barn

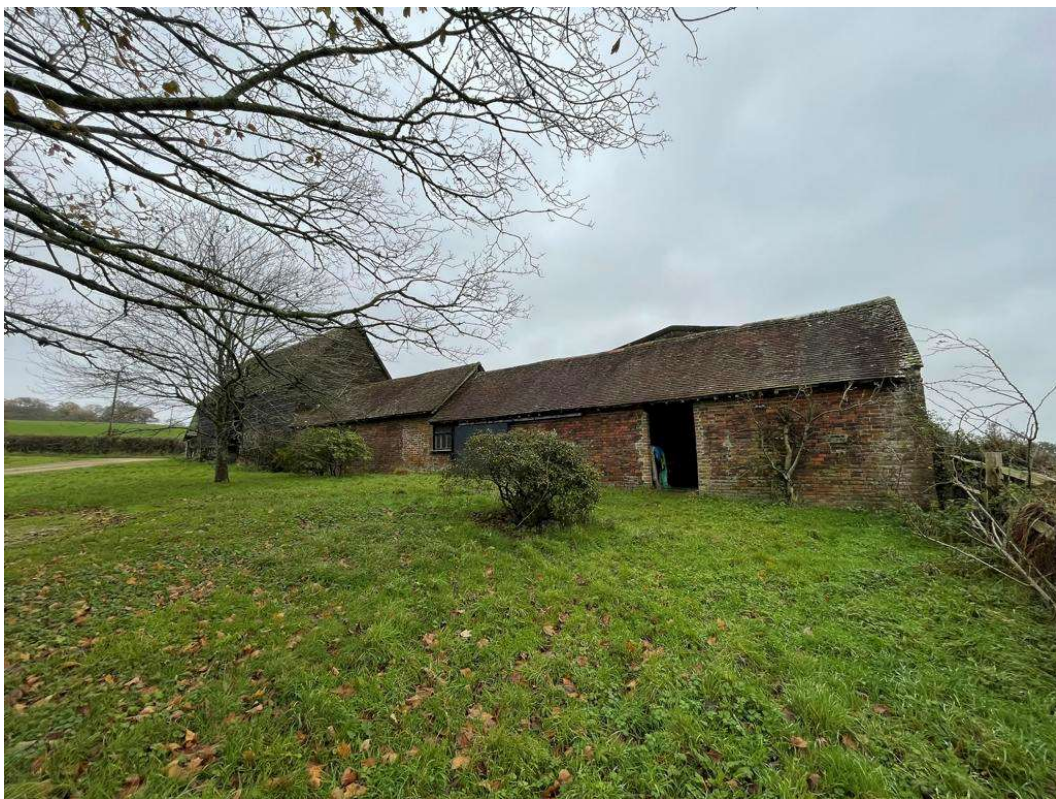
View on barns from south west

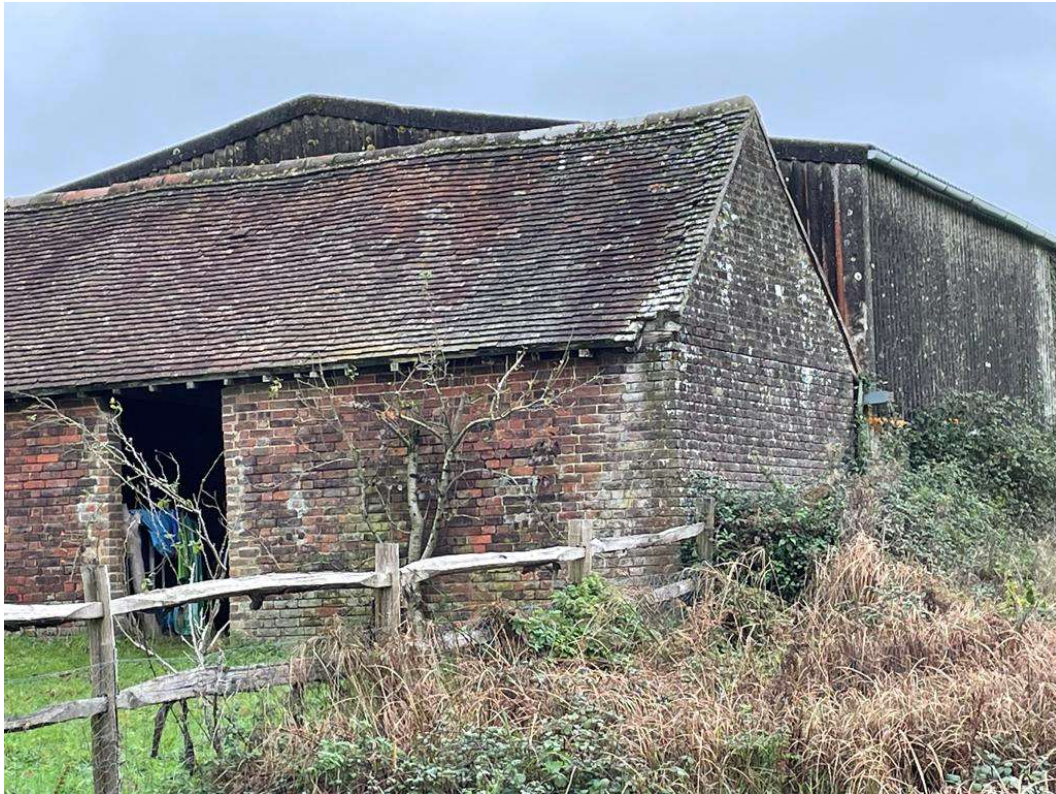
View on southern end of southmost barn

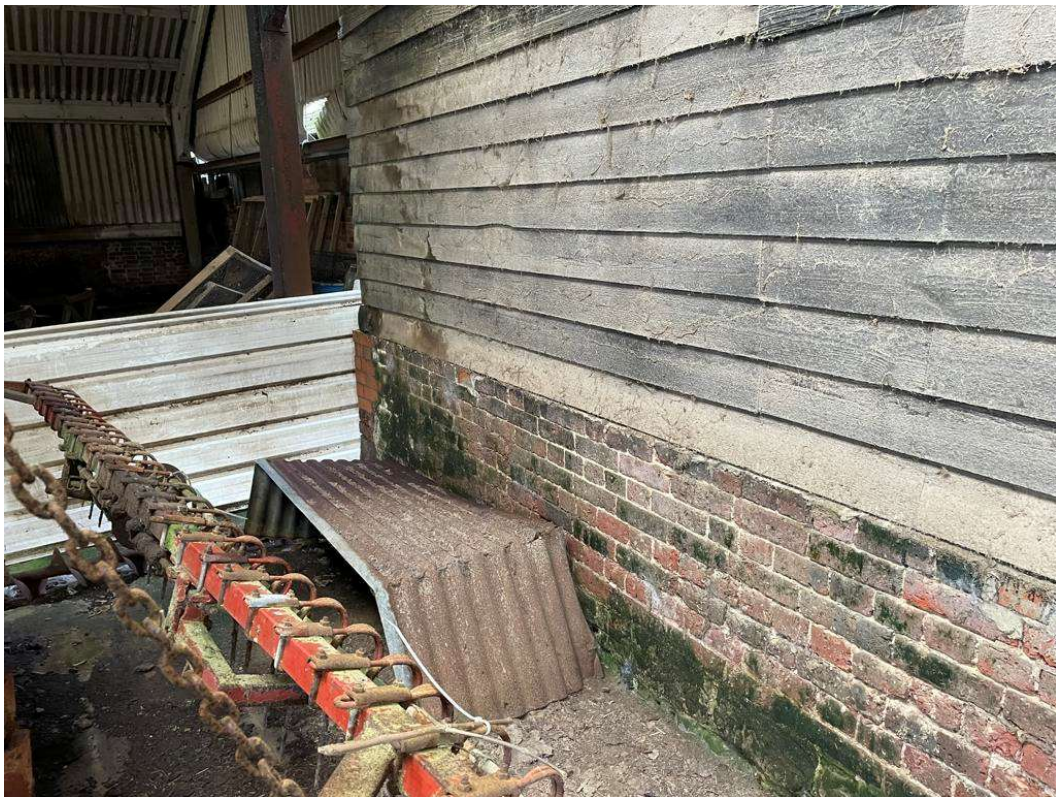
View on rear of main barn at stagger

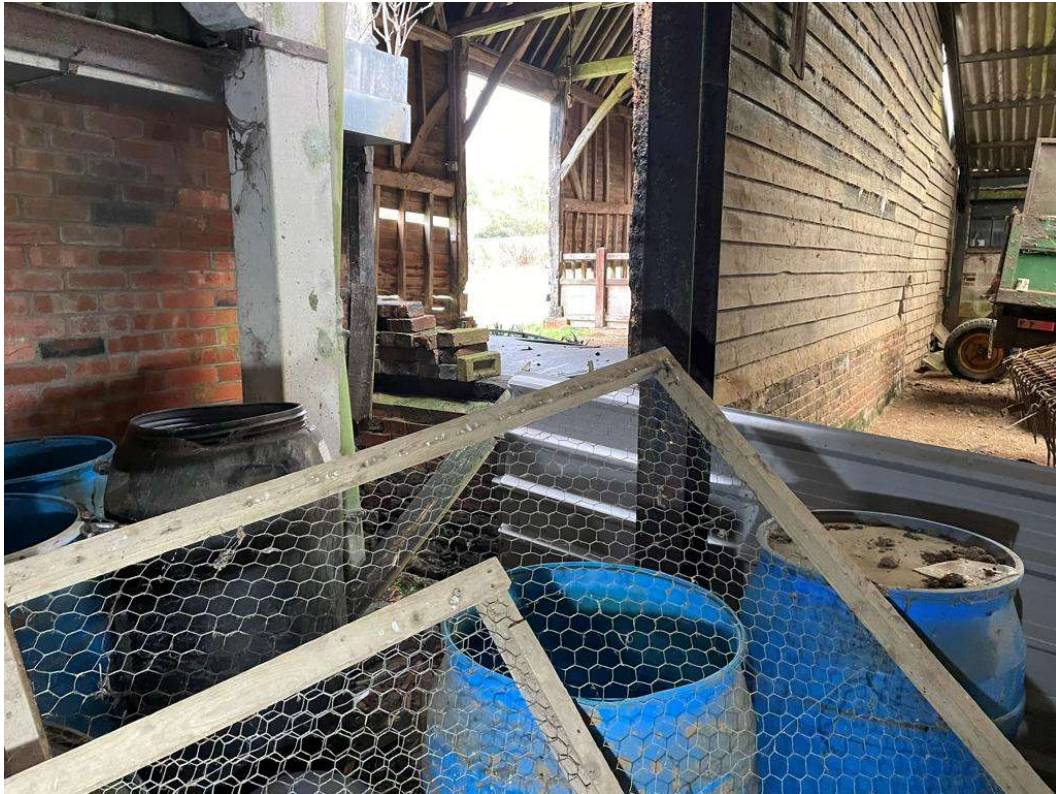
View on rear right corner of main barn from concrete barn showing stagger and brickwork wall of barn

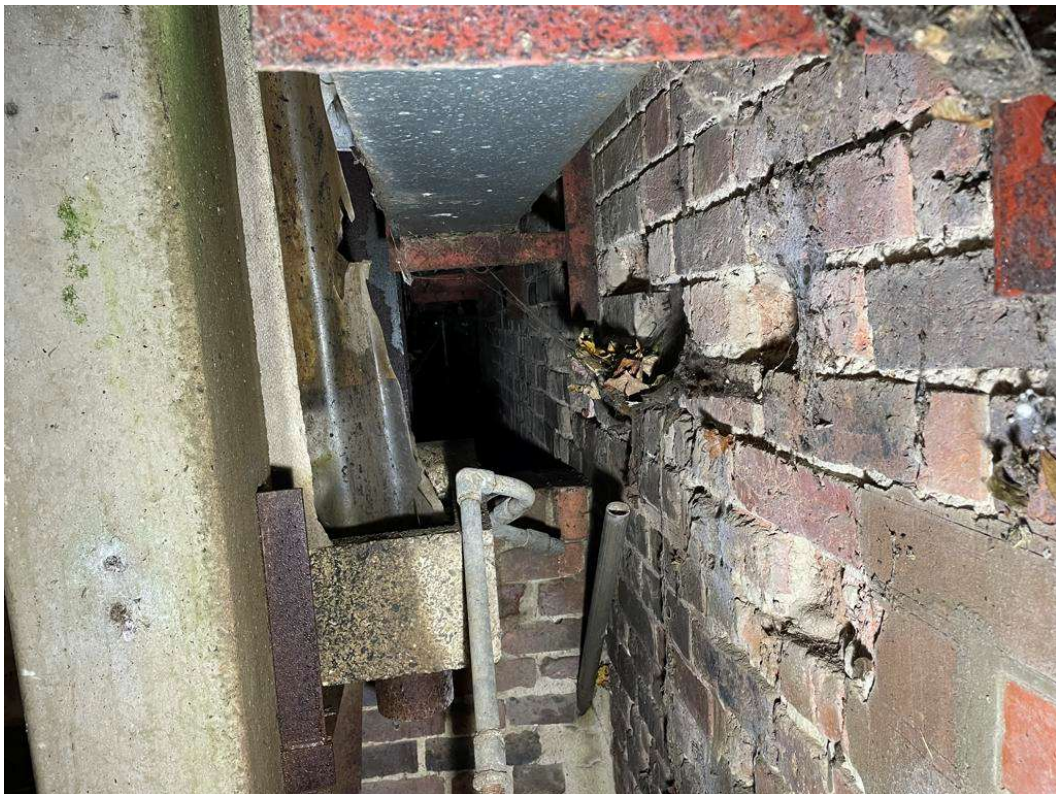
View on underside of valley gutter and rear wall of brickwork barns

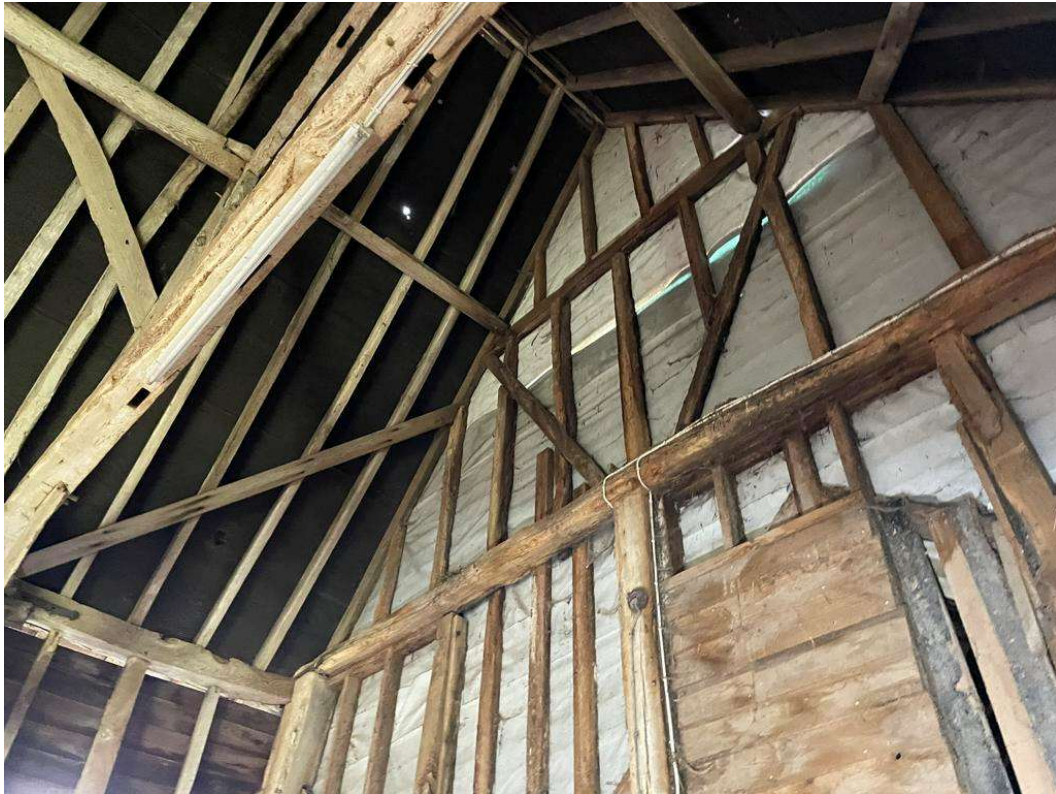
View on main barn gable end showing tie beam and gable framing

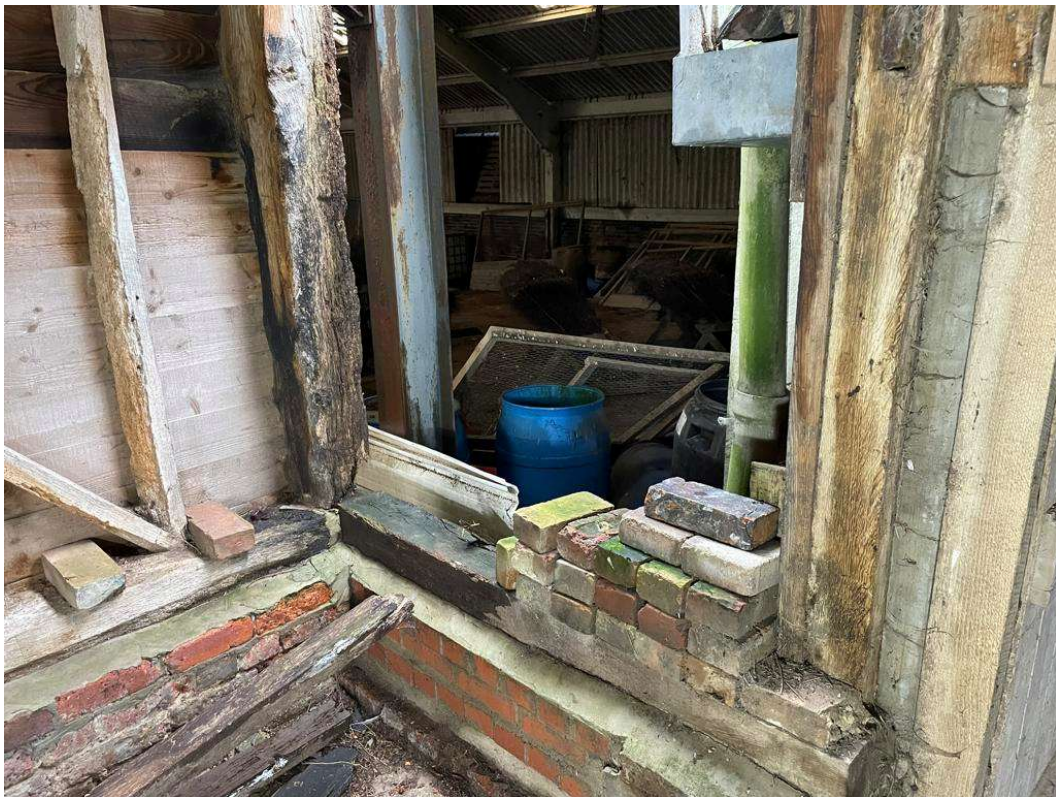
View on rear right corner showing weather damage and decay to corner post and sole plates.

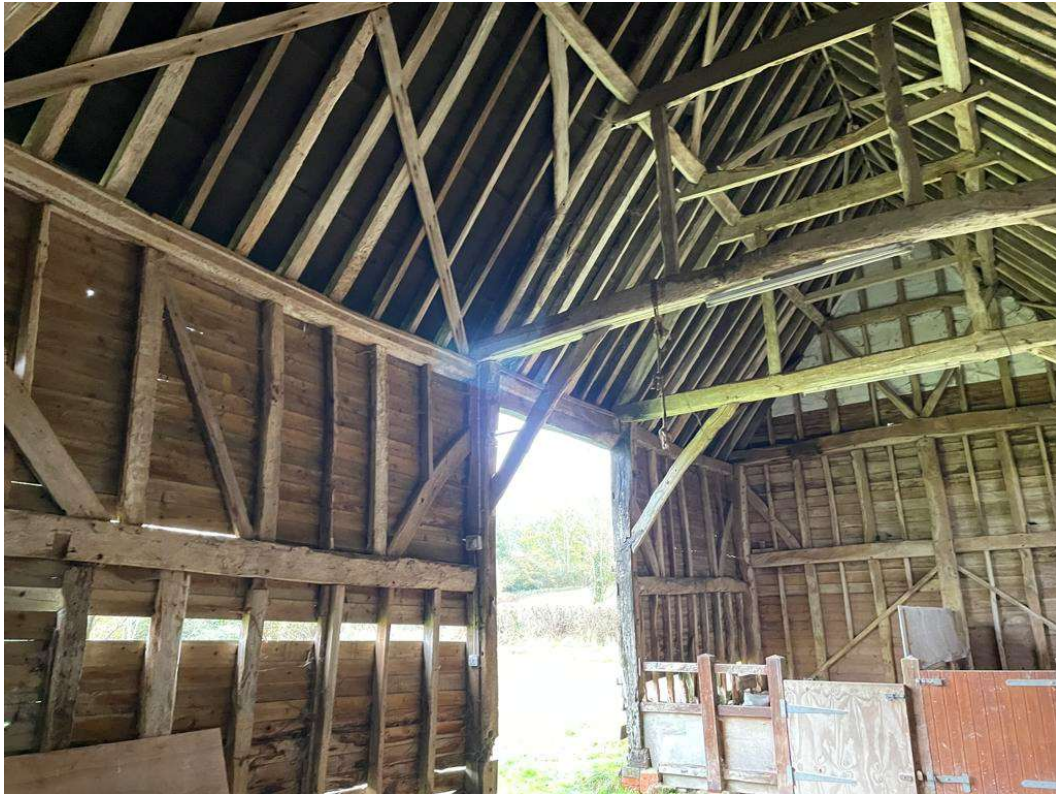
View on front wall of main barn showing posts, tie beams, queen posts and purlins

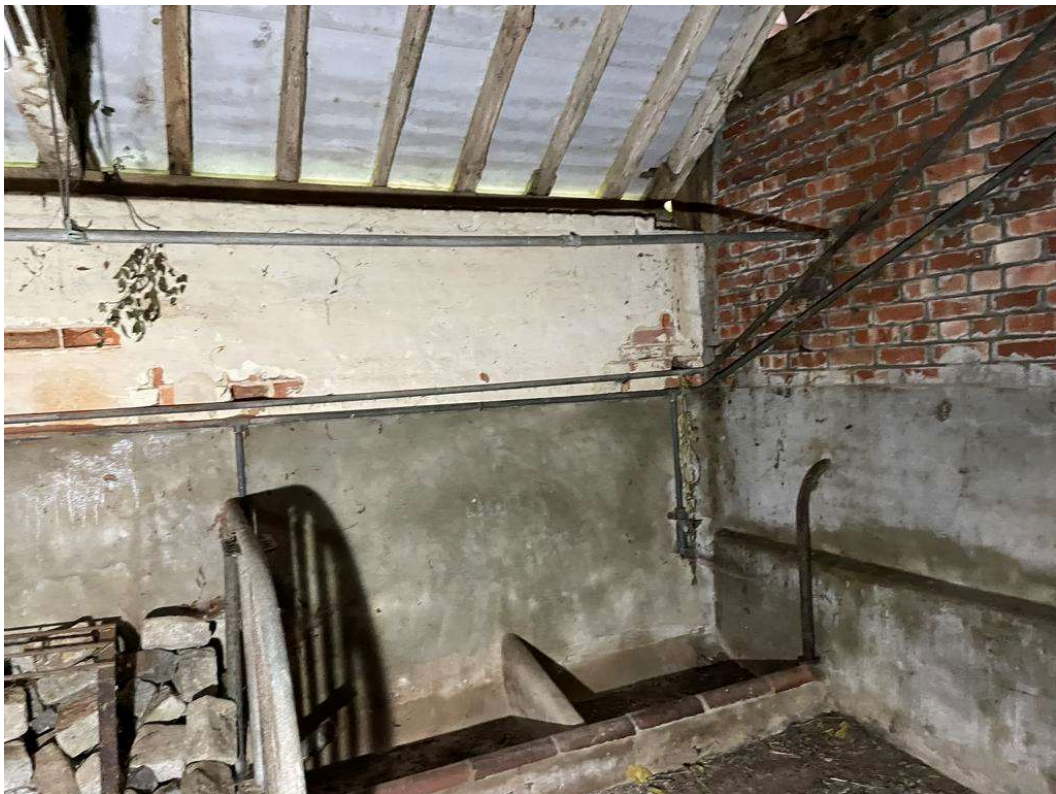
View on front wall of brick barn showing walls and local damage to brickwork

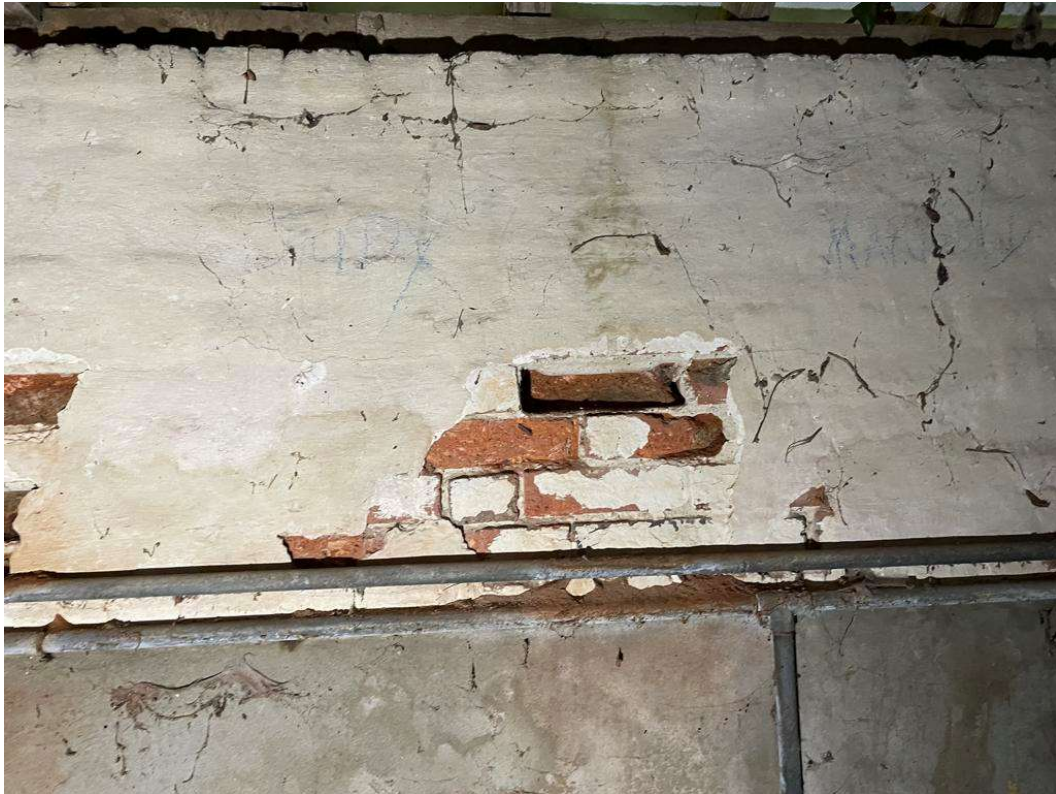
Detailed view on front wall showing eroded bricks

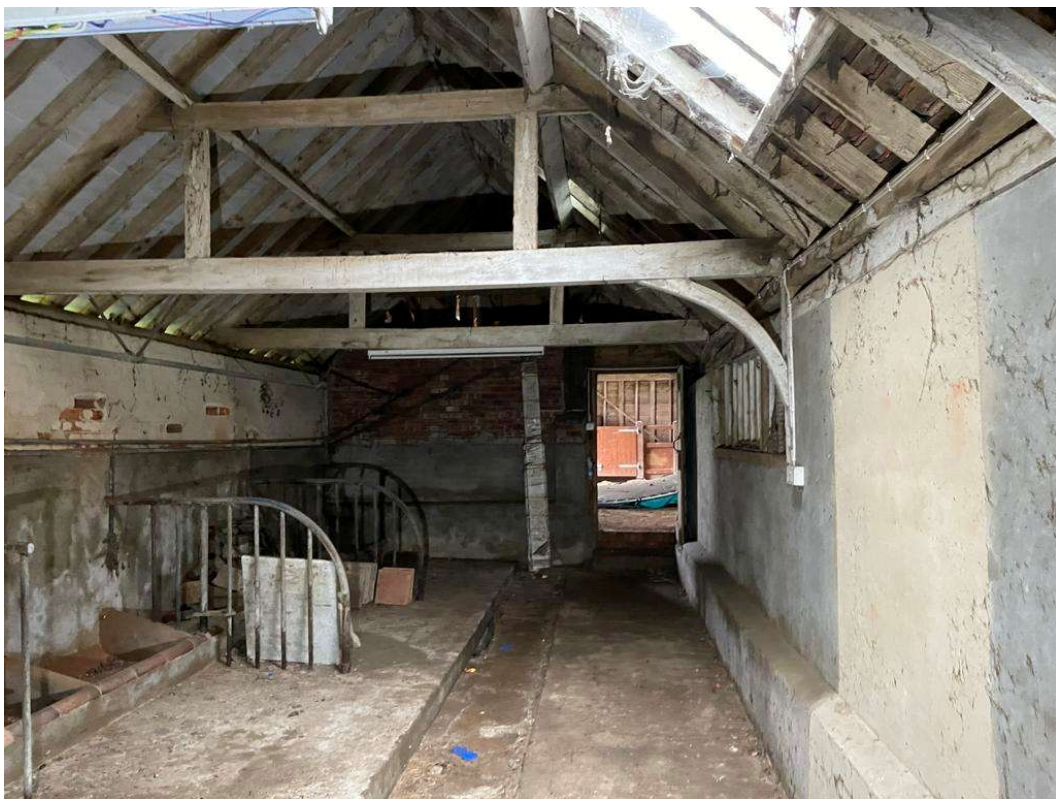
View on barns showing roof trusses, purlins and rafters

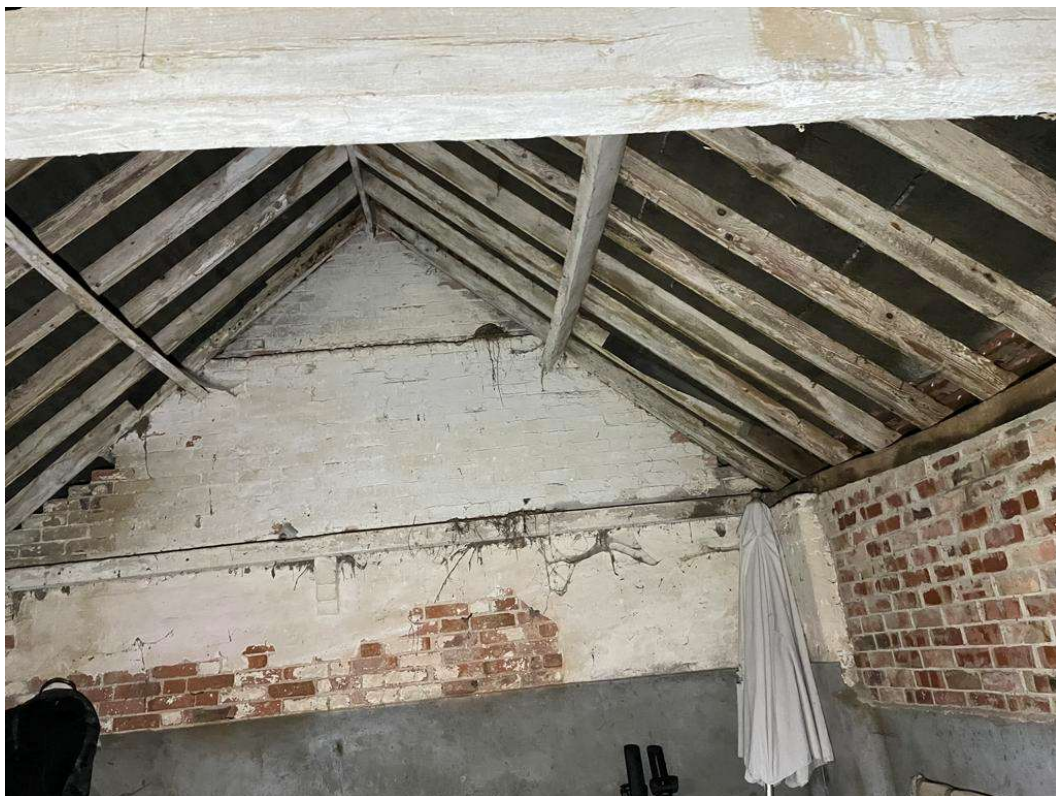
View on gable wall between brick barns

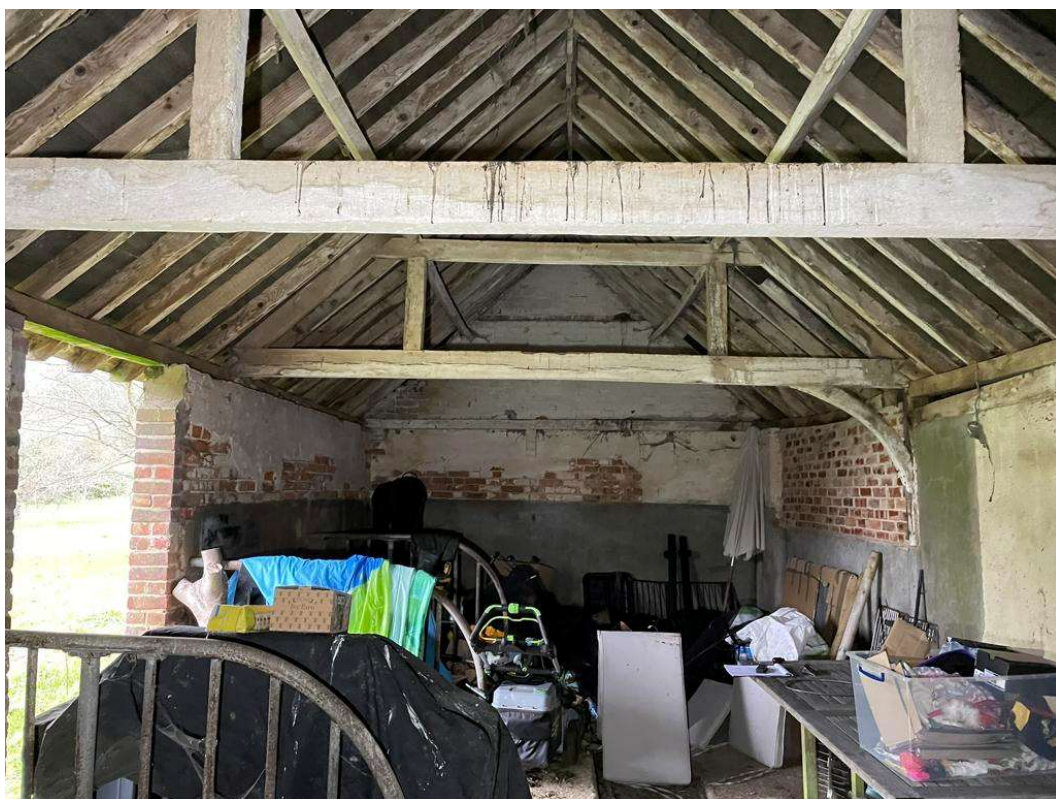
View on roof structure of southernmost barn showing structure as adjoining barn

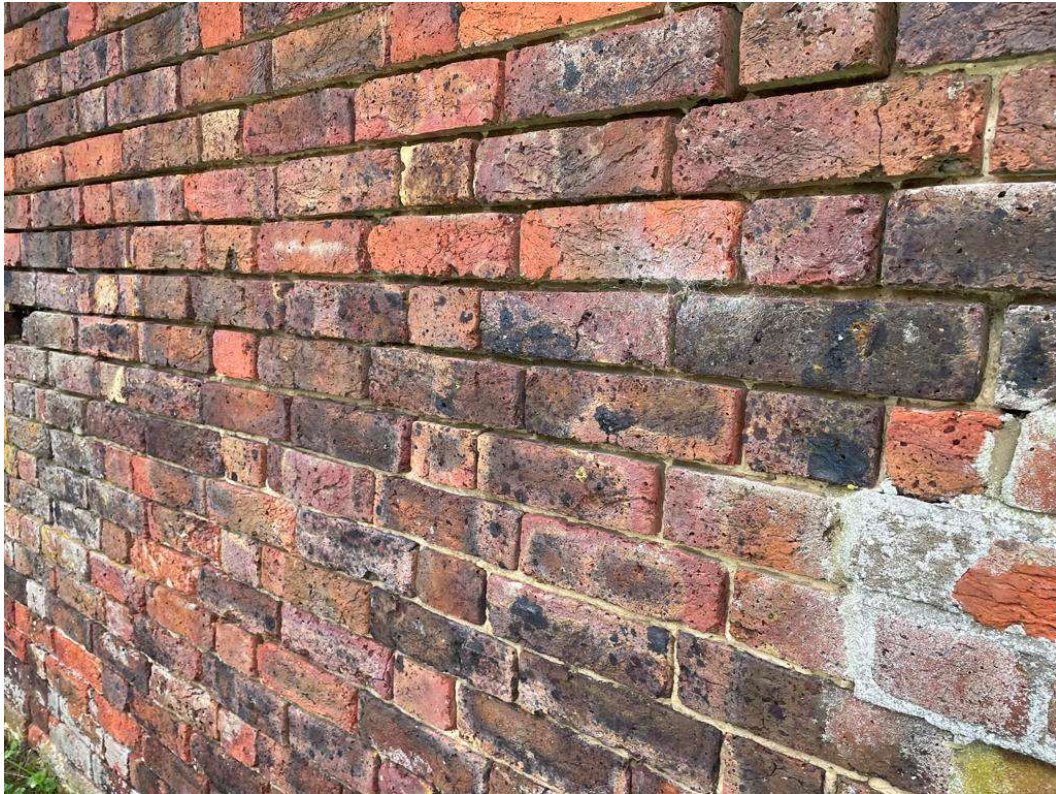
Detailed view on typical arear of front wall brickwork showing mortar recession

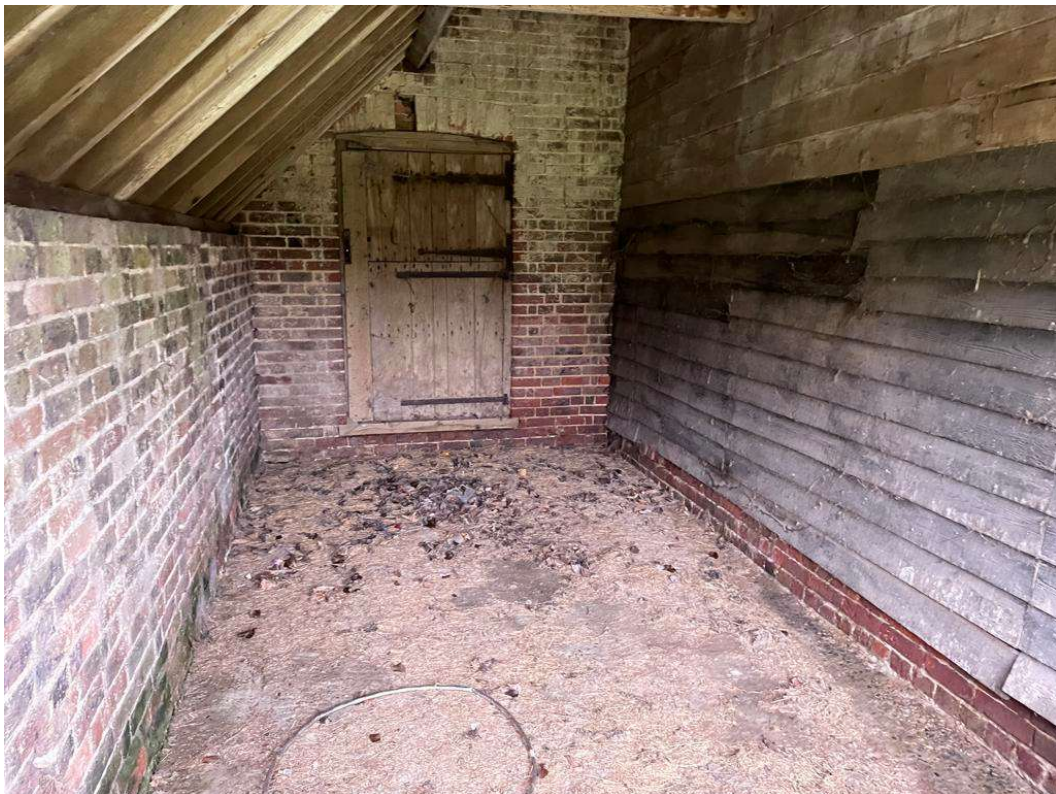
View inside of lean-to building to left of main barn
