**Report on a Structural Appraisal
14th September 2025**

**Three barns at the rear of
Pilgrims Farm, Stairbridge Lane,
Bolney, Haywards Heath. RH17 5PA**

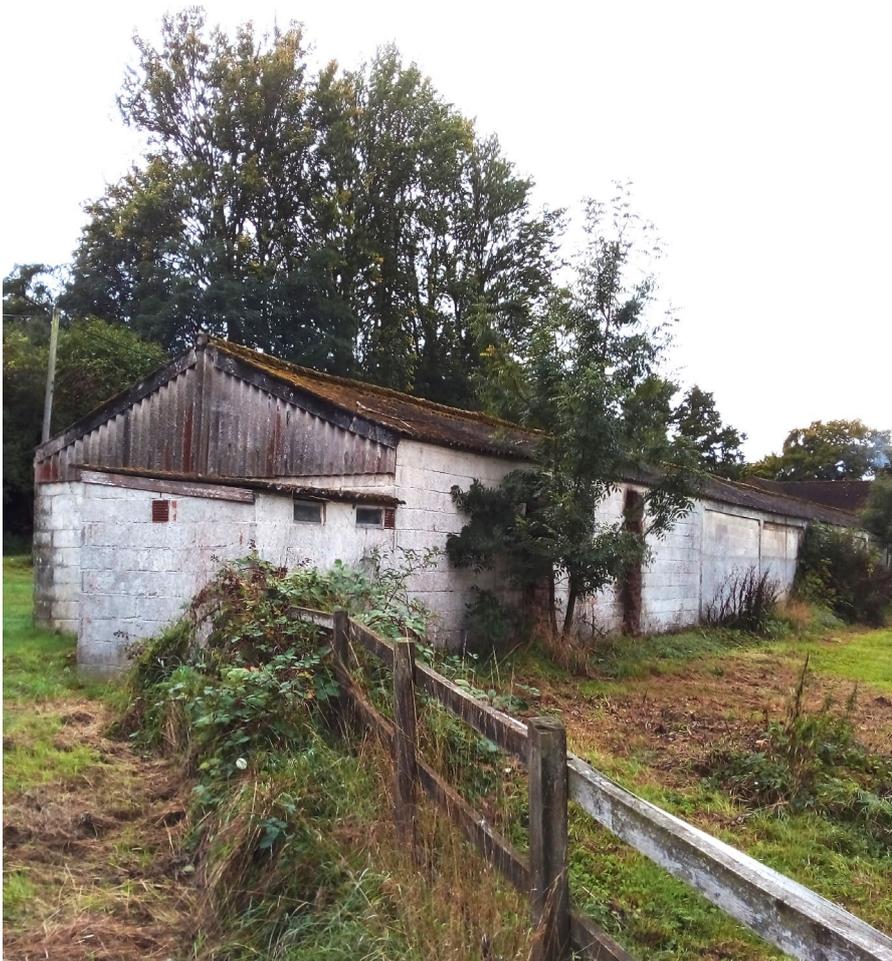
General view of the rear of the long barn – units 1,2 and 3

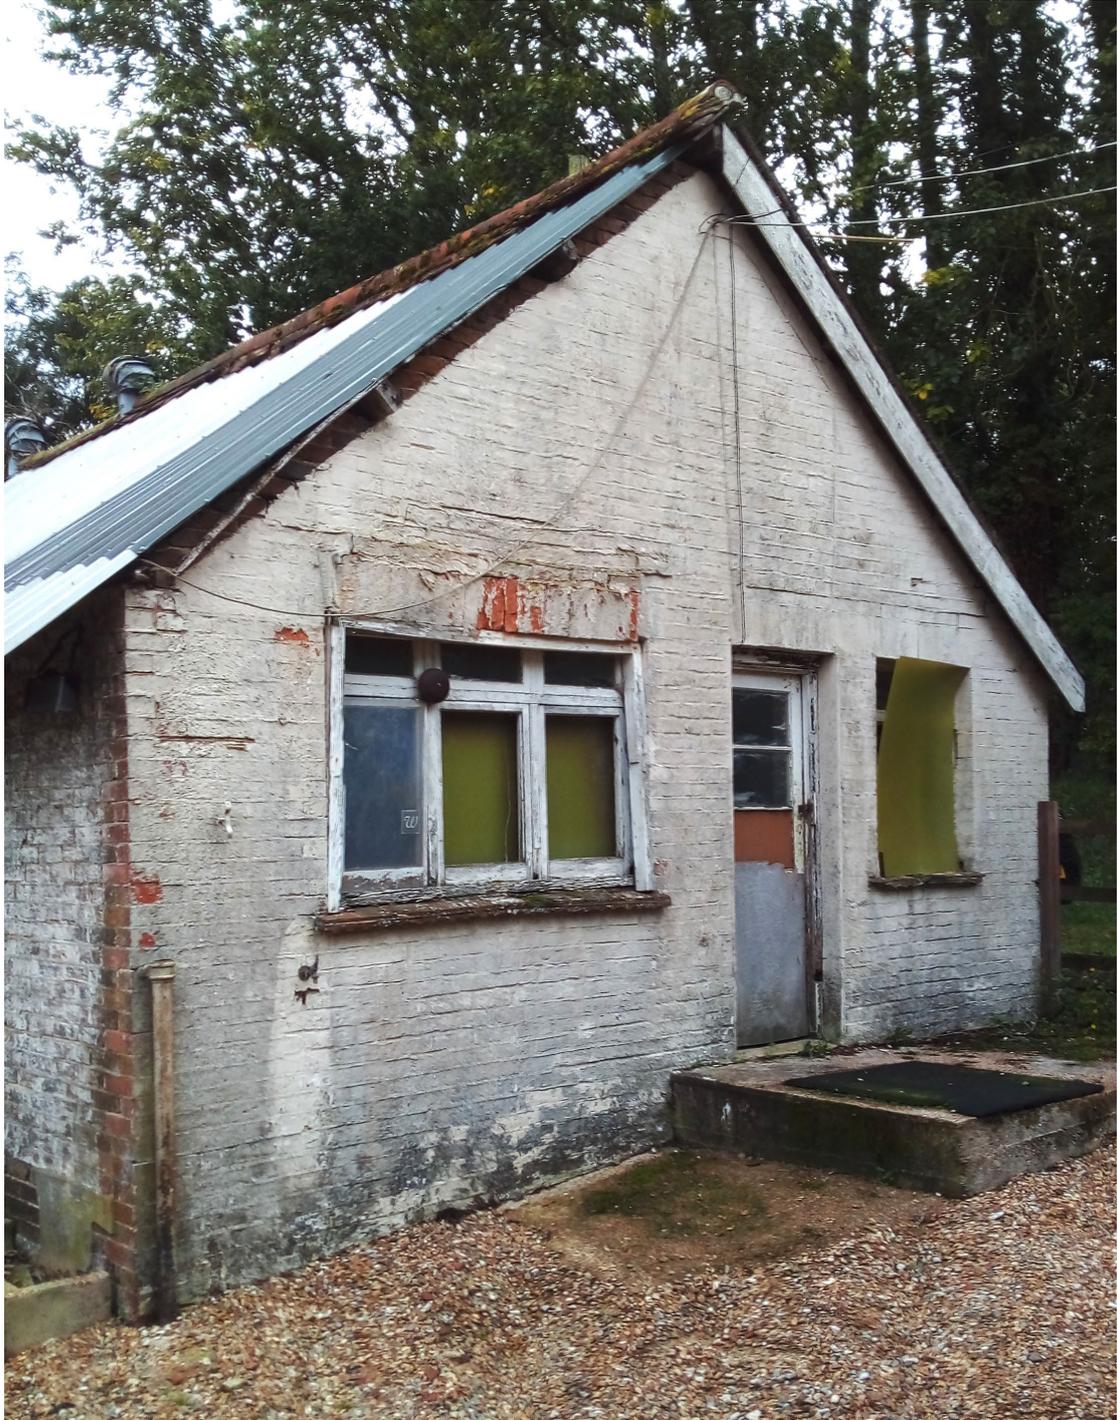
Gable end view of unit 5

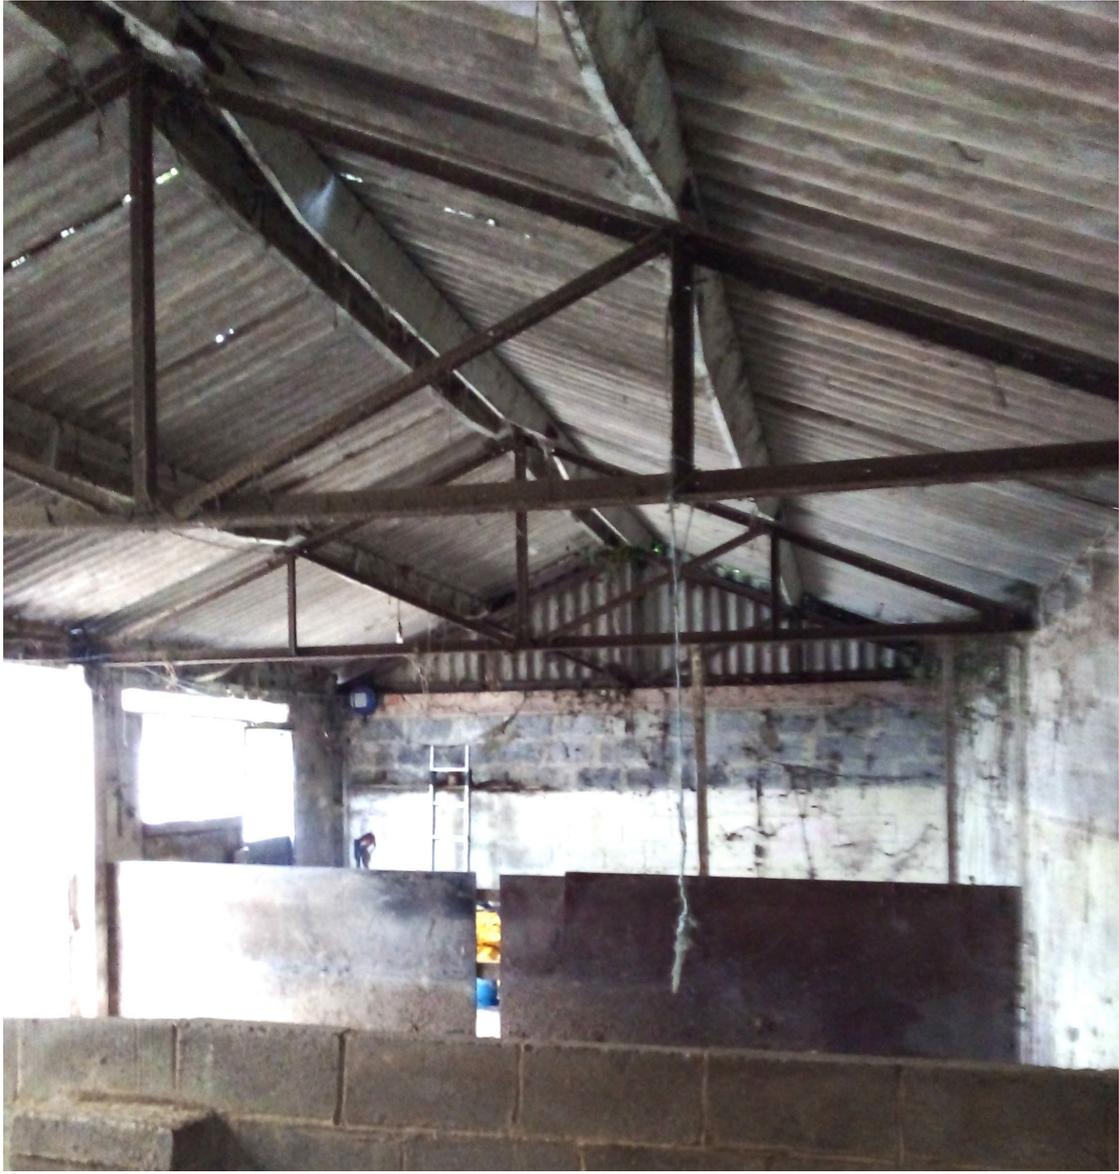
Internal view of unit 1 with dense concrete block walls and steel trusses over supporting roof

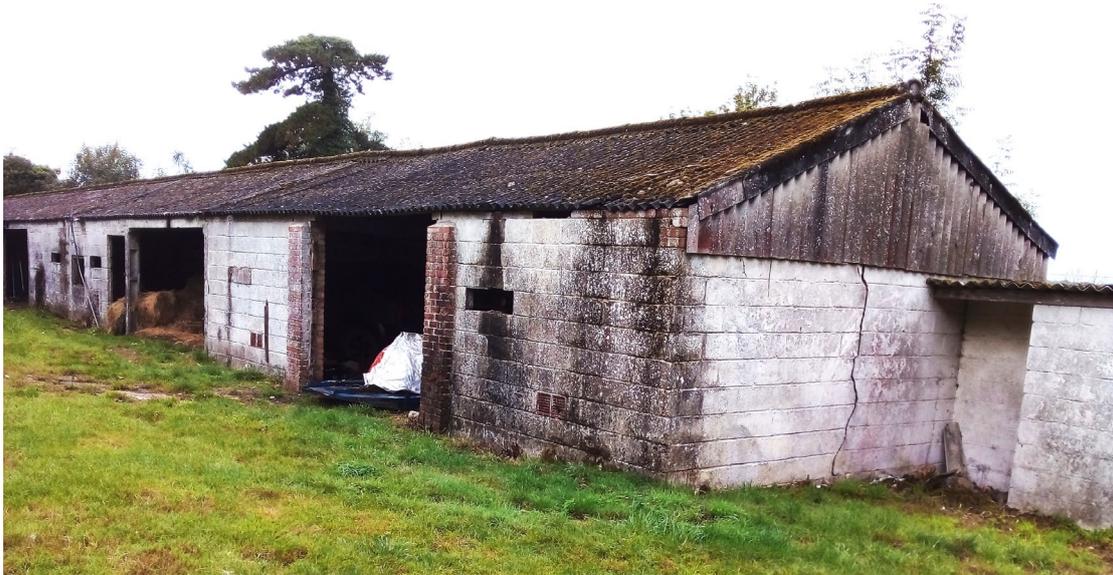
The corrugated roof sheeting is in variable condition.

External view of unit 3 showing corrugated asbestos roof on block walls

The sheeting will need replacing in all areas.

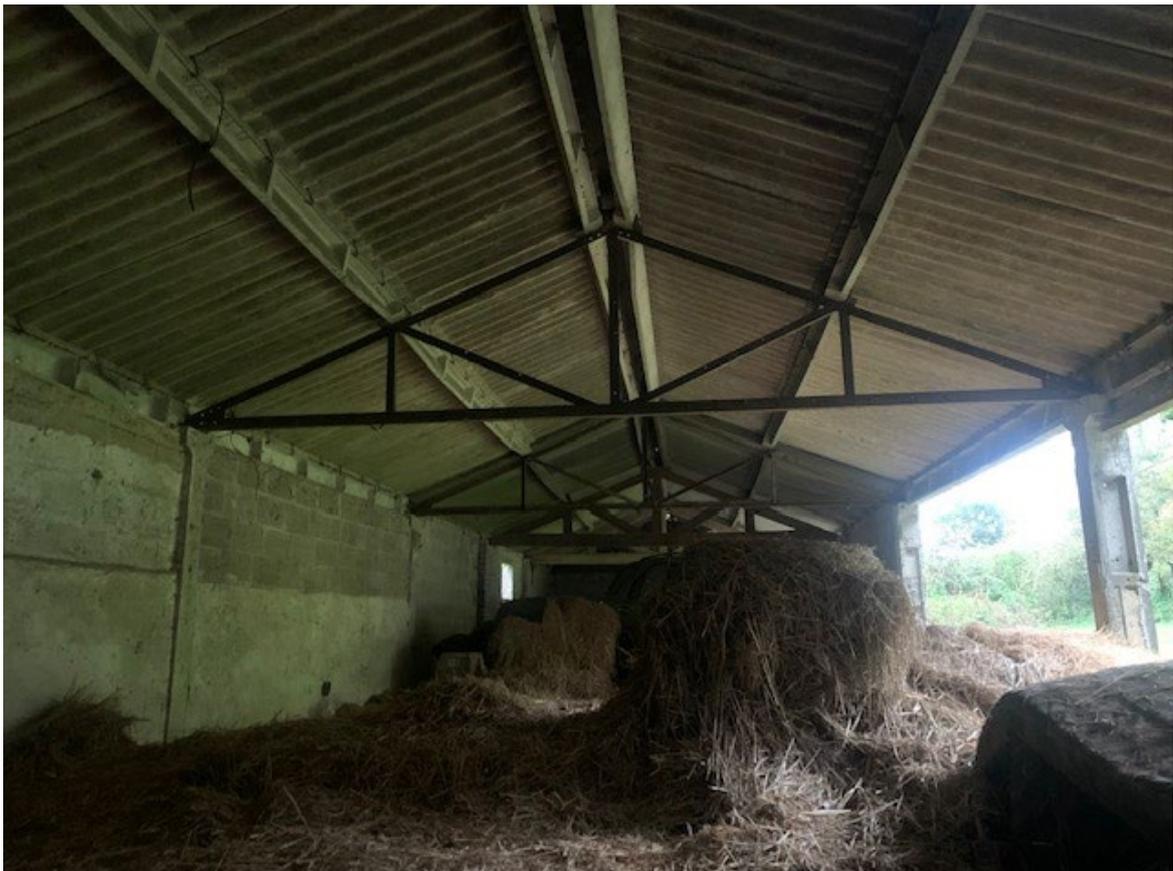
Roof structure of unit 3 showing timber trusses and purlins

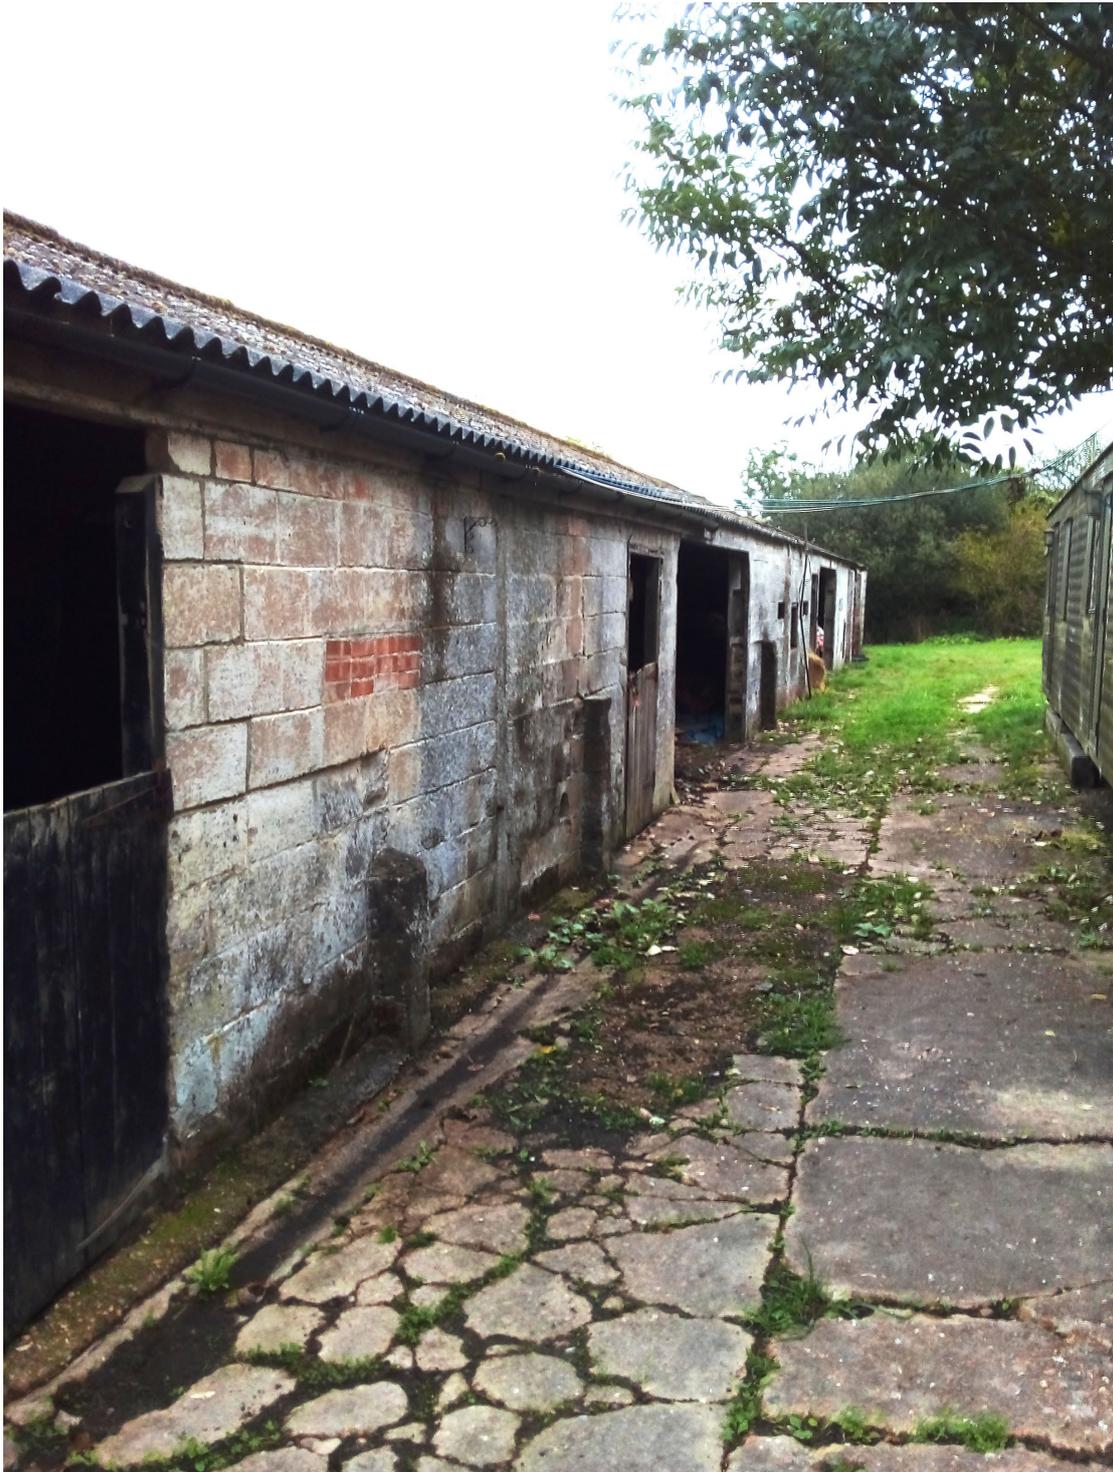
External view of units 1 , 2 and 3

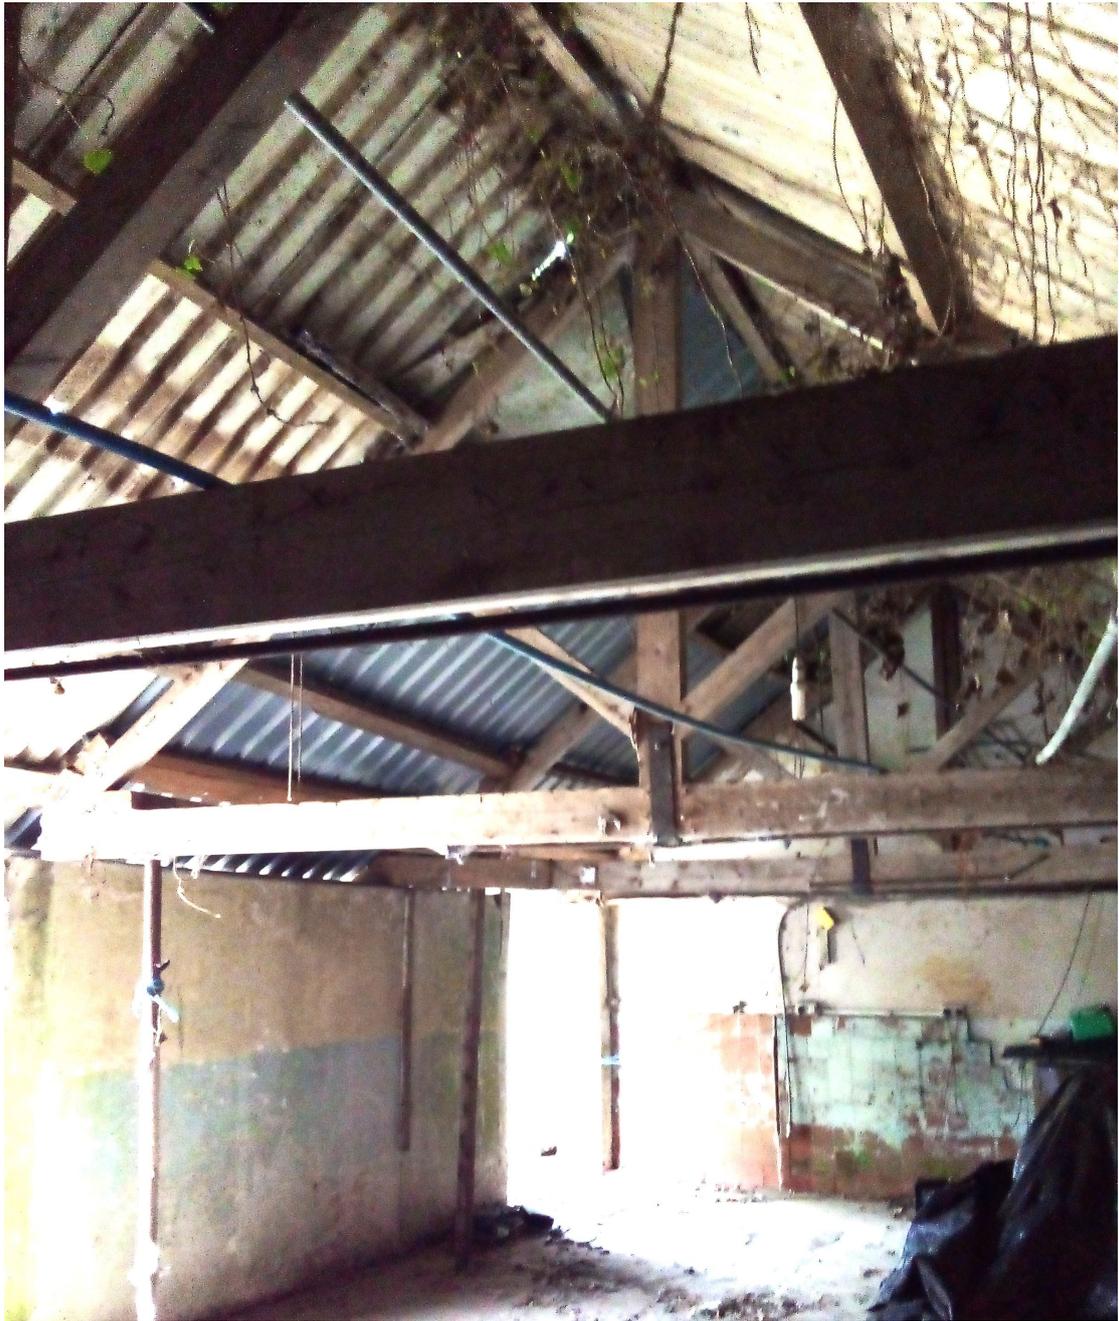
Internal view of unit 5 showing timber trusses, purlins and profiled metal sheeting
