## Tree condition Survey

**Client details:** Hunters Property Management

**Site:** Luscastes Court, 6 Paddockhall Rd, Haywards Heath, RH16 1HH

**Date of inspections:** 03.08.25

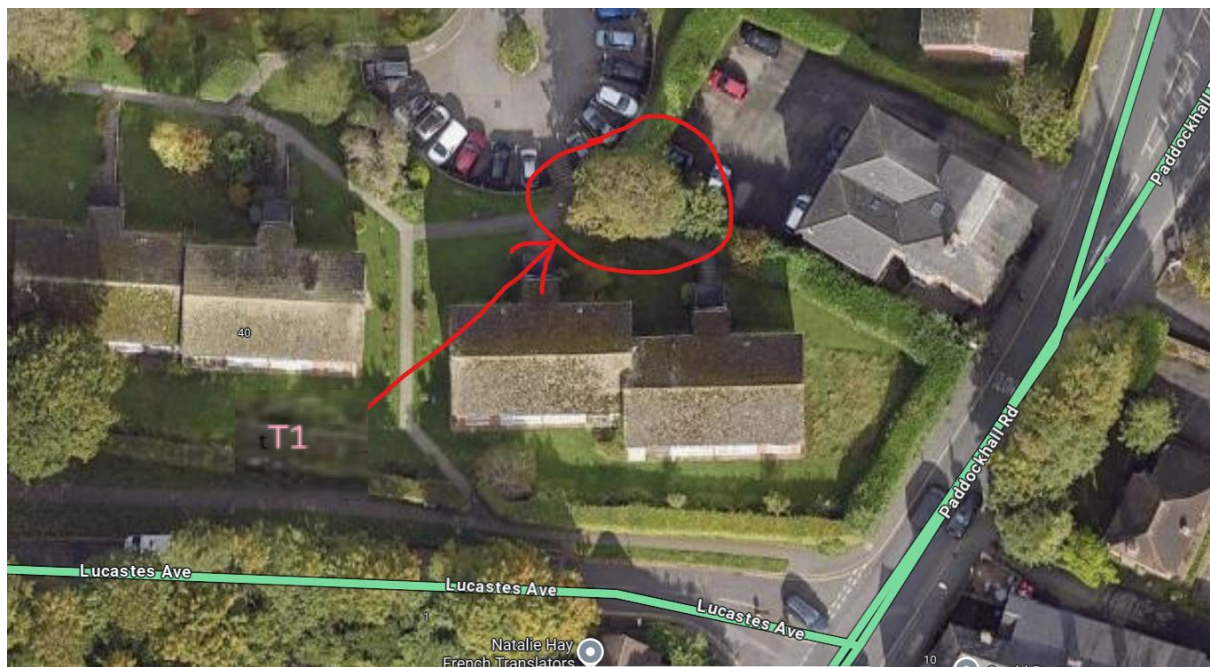
Pic 1: Tree location

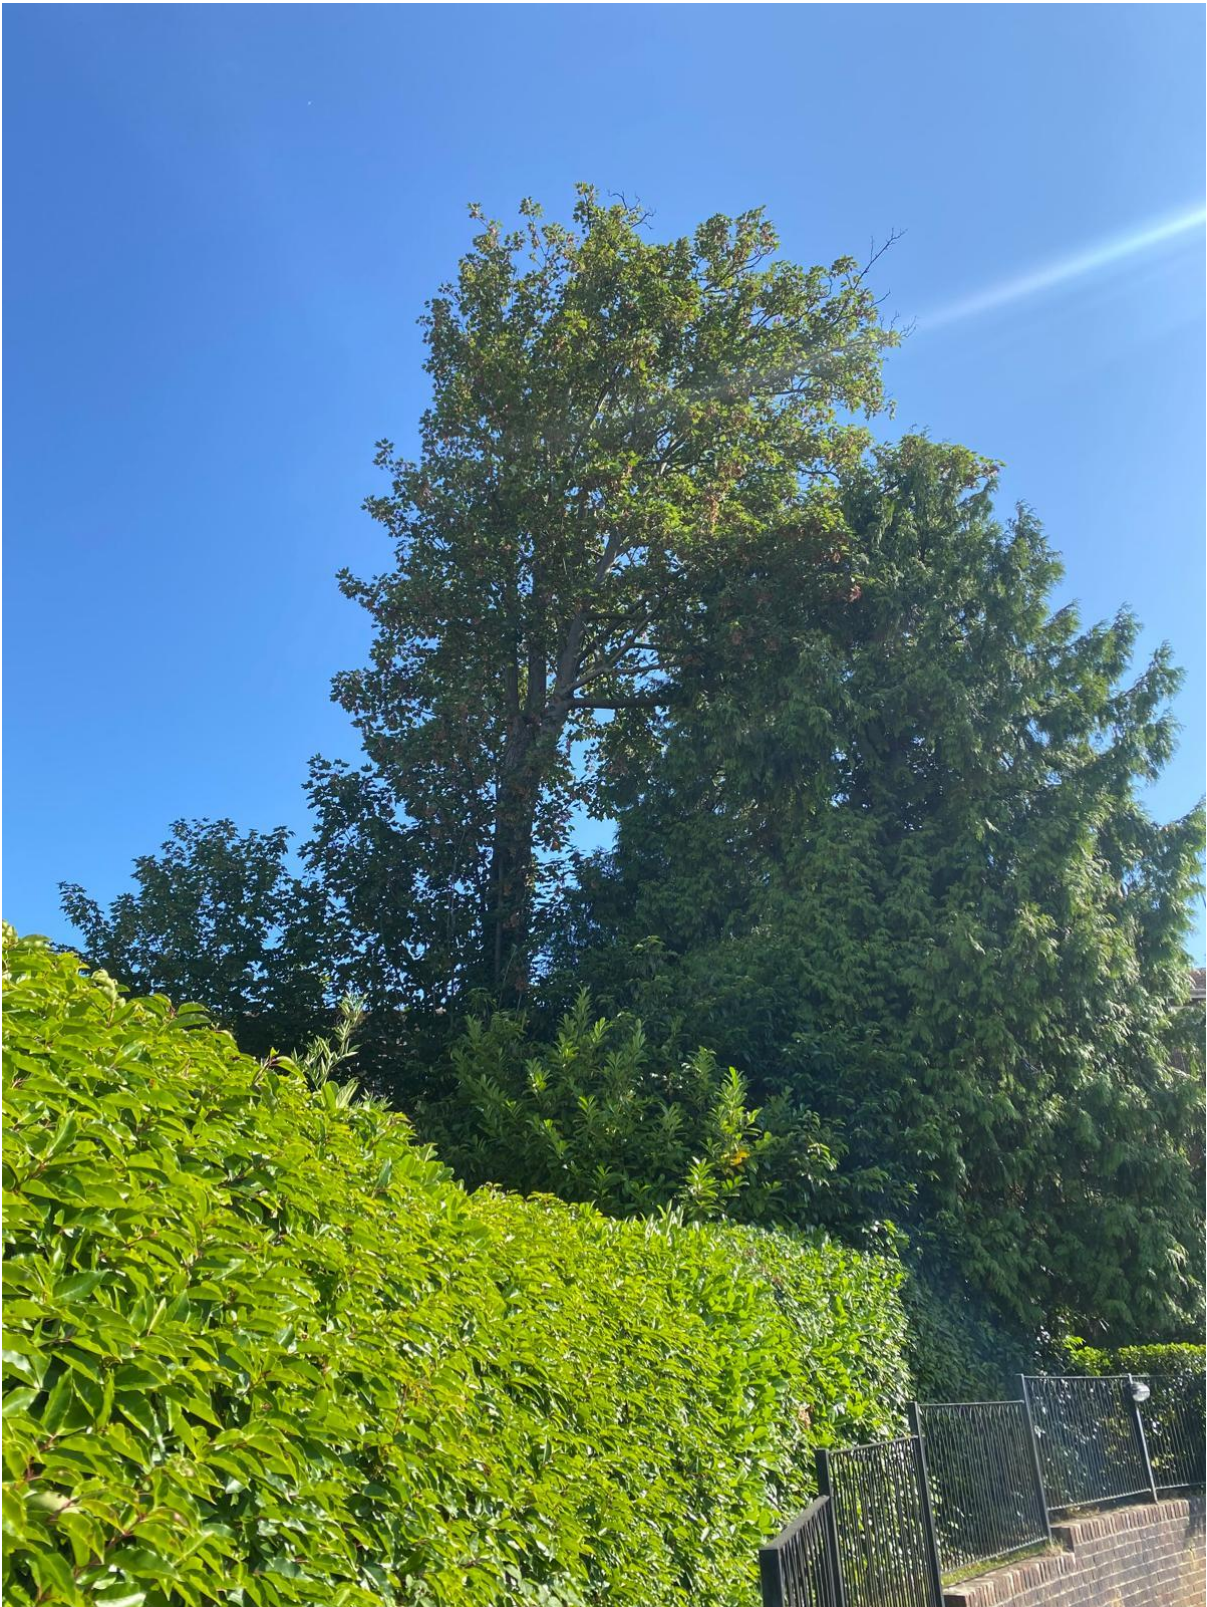
Pic 2: Tree viewed from North, looking south, from Winnals Park.

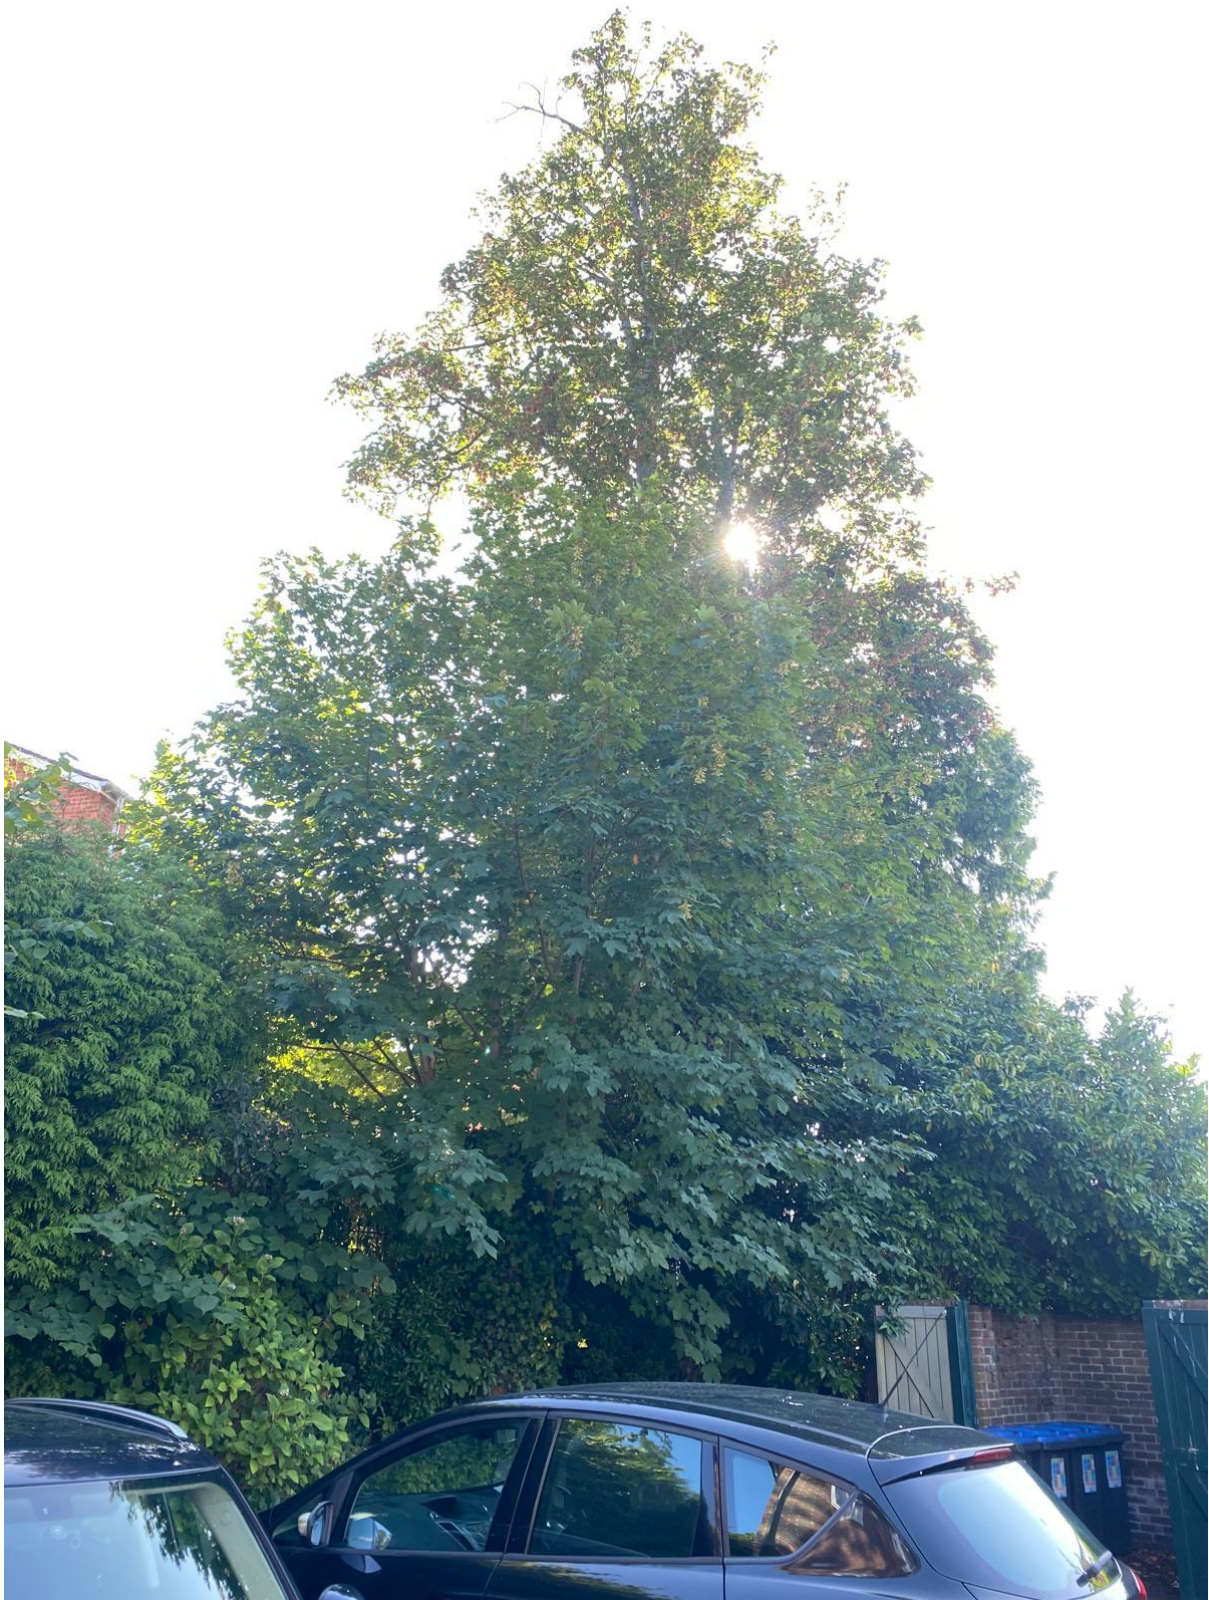
Pic 3. Tree viewed from east looking west, from Luscatess Court.

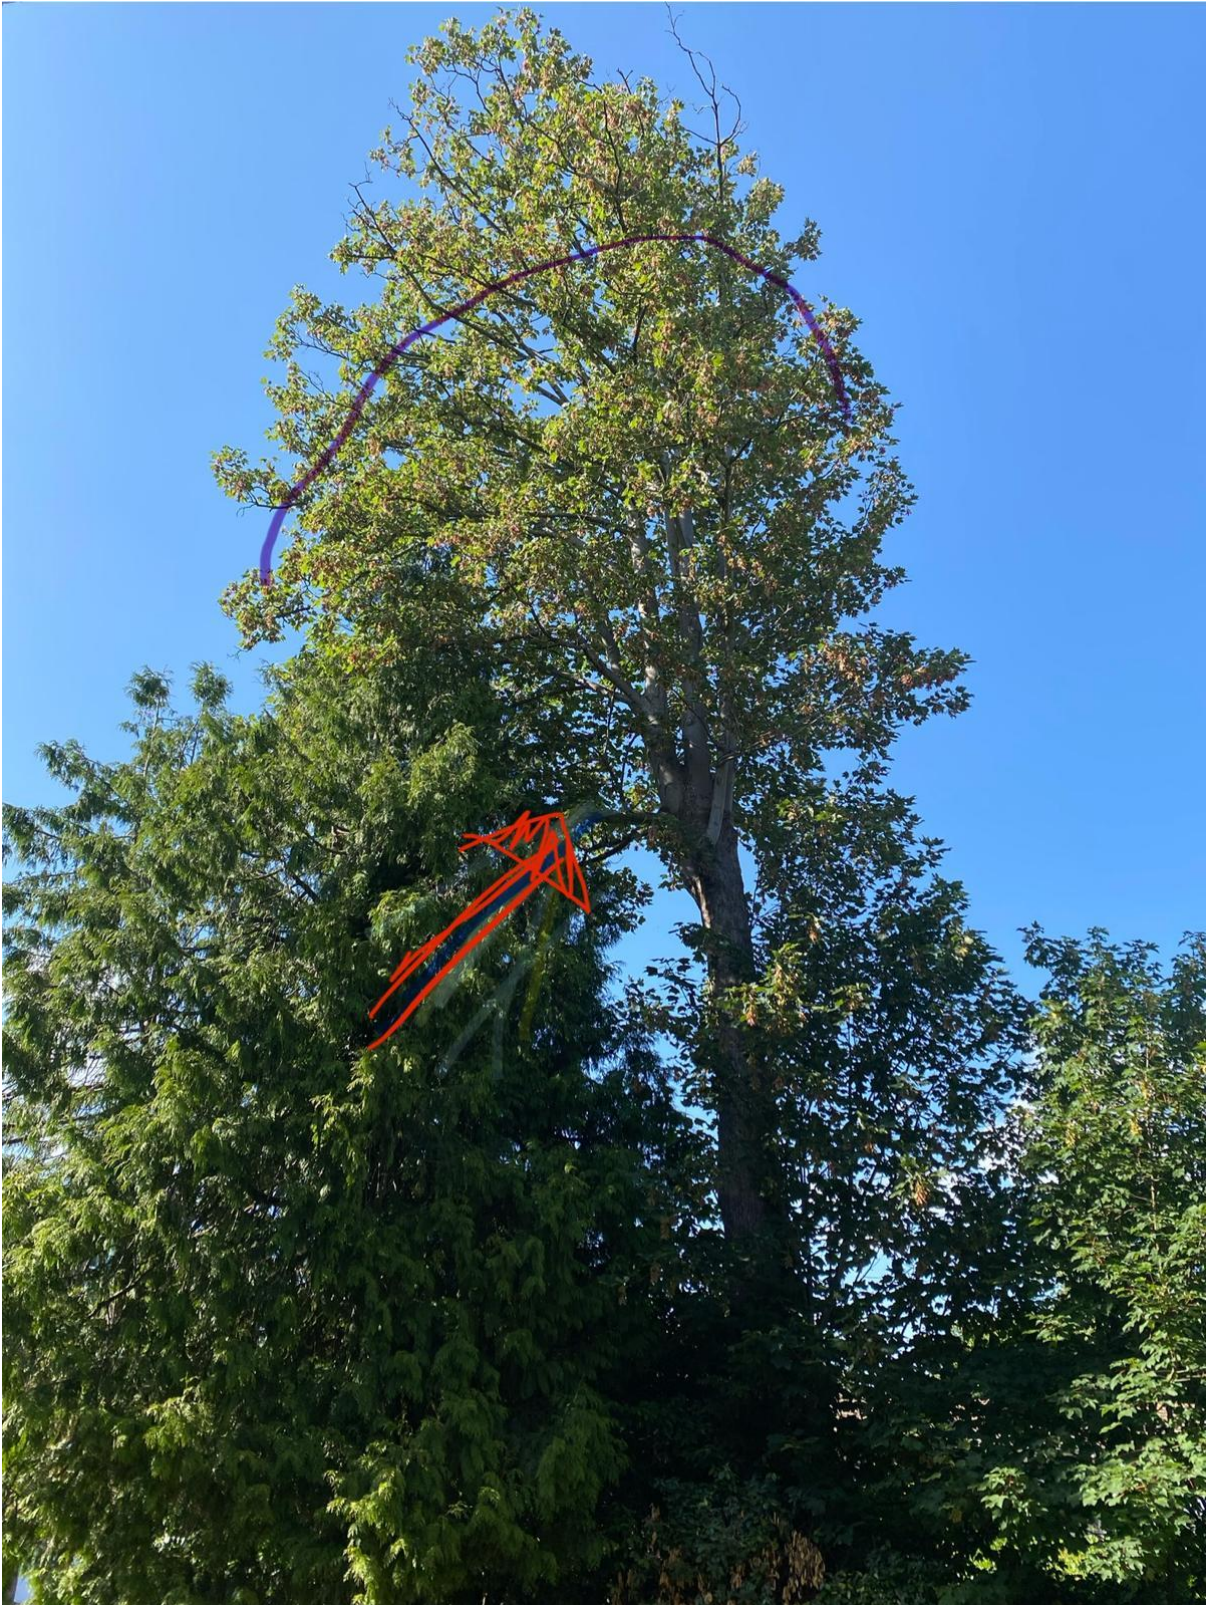
Horizontal limb to at approx. 10m crossing through adjacent Cypress tree. Could be causing some isolation of movement of the tree, with consequential reduction in strengthening of anchoring in roots.

Pic 4. Tree viewed from south looking north, from Winnals Park. Arrow indicates position of horizontal limb crossing through adjacent Cypress tree. Arc marked on picture indicated relative location of proposed extent of reduction.

Reduce tree height to approx. 15/16m – as indicated in Appendix 1, pic 4.

Remove/ reduce crossing horizontal limb to west, to release from adjacent Cypress tree.

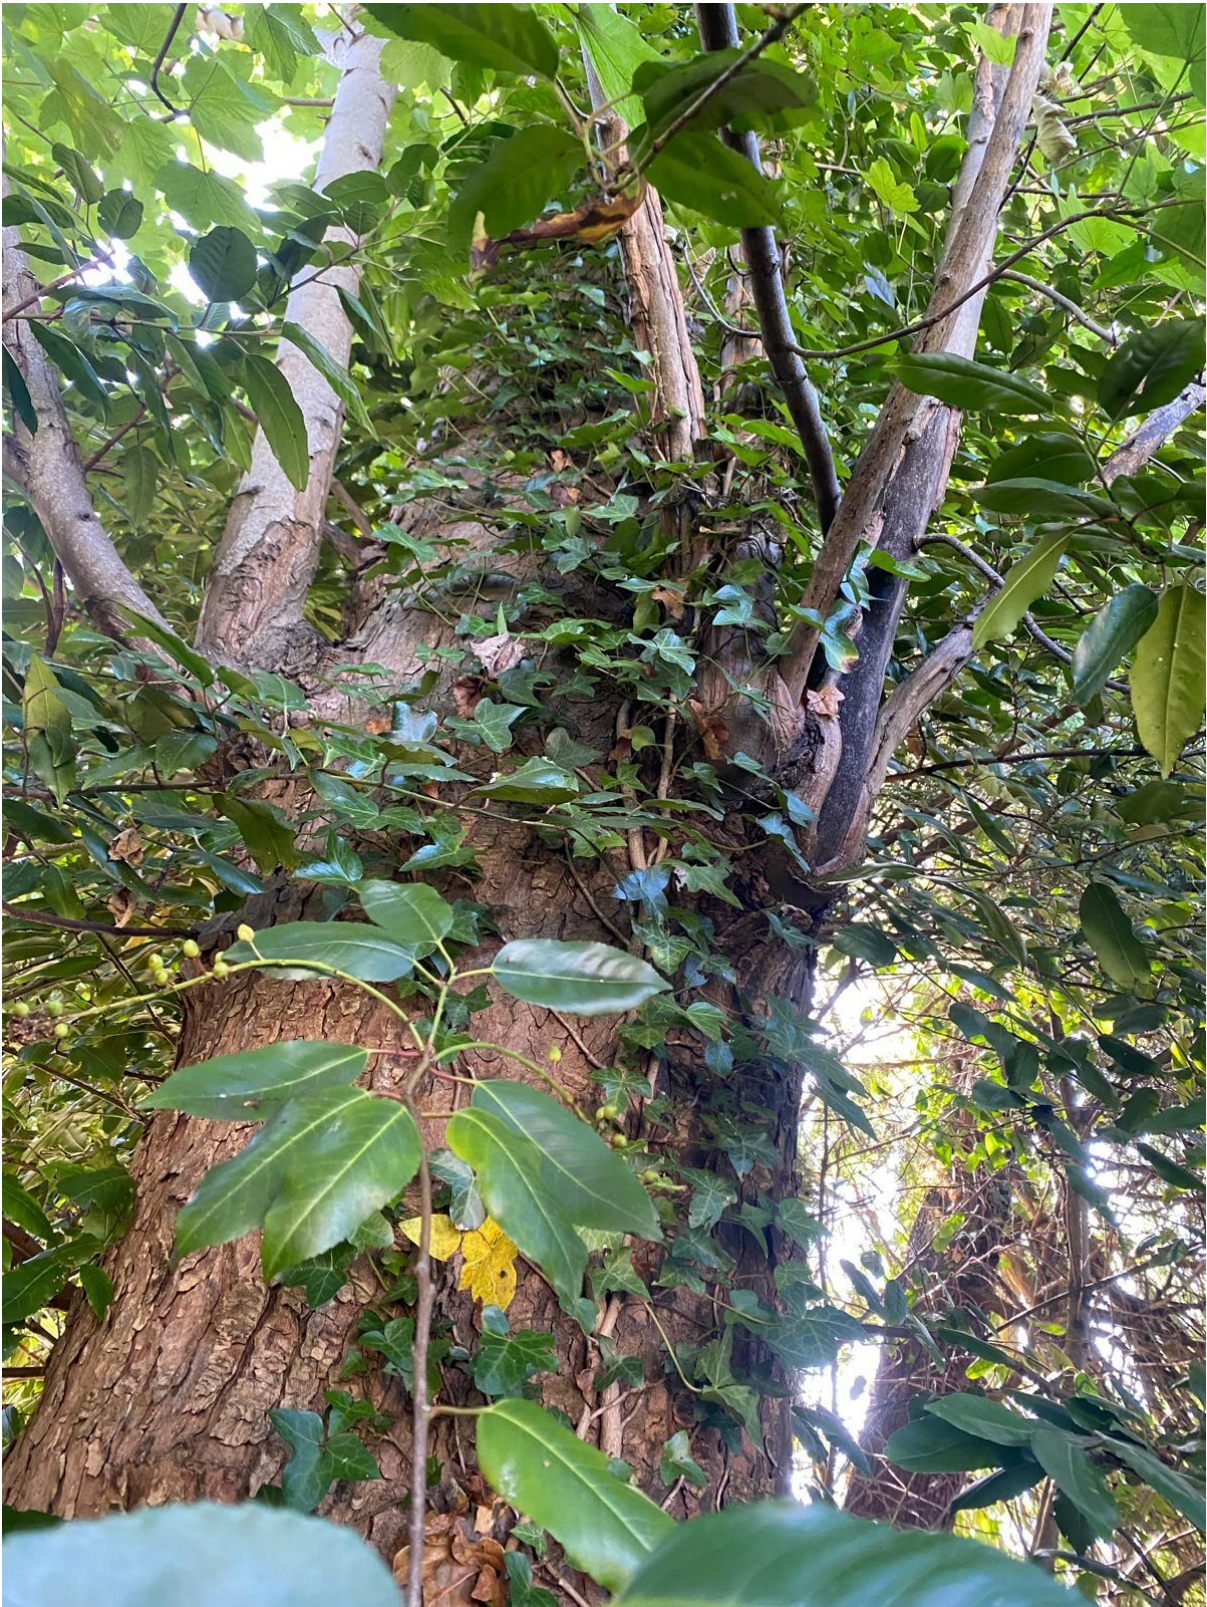
Low secondary epicormic growth at approx. 3m shows evidence of squirrel damage – further squirrel damage may be present in upper crown.

Pic 5. Lower stem at approx 3m. Indicating location and extent of squirrel damage.

Safety: Deadwood. Aerially inspect for squirrel damage. Reduce/remove any limbs where attachment is compromised by squirrel damage.

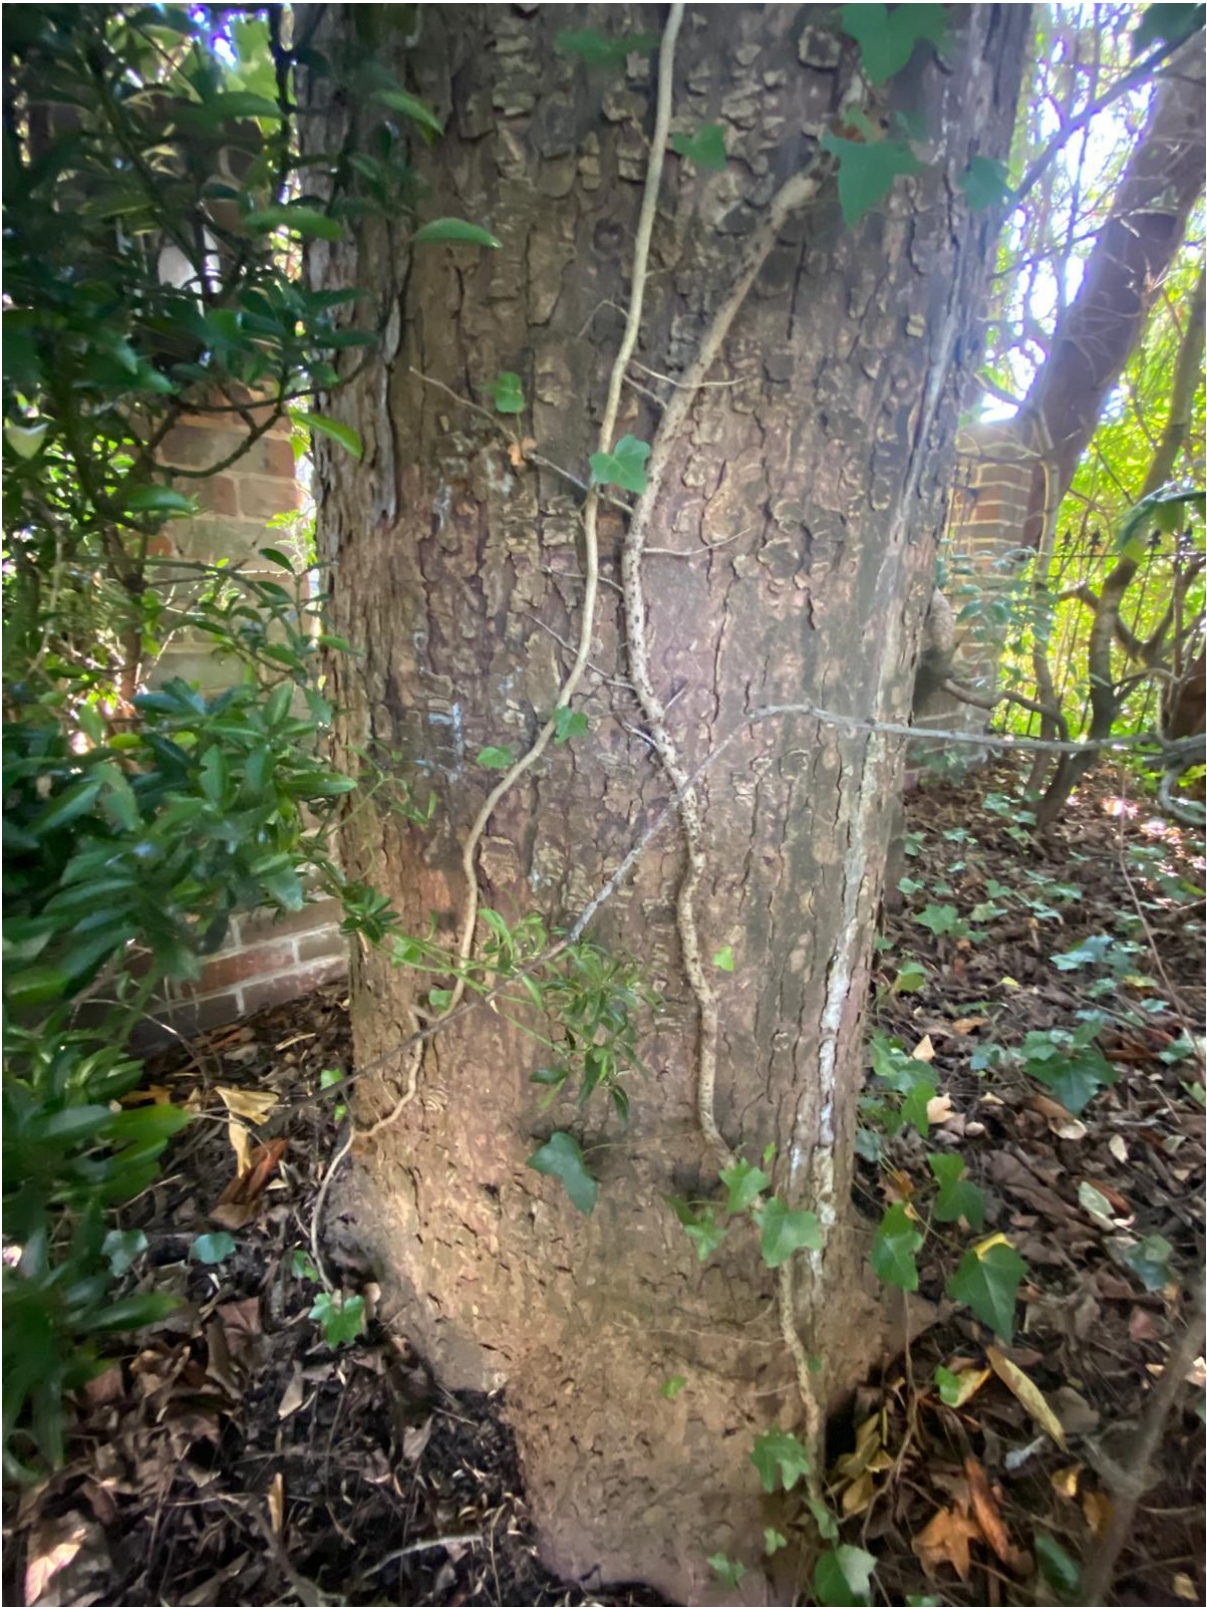
Pic 6. Lower stem approx. 0-2m. No visual defects.
