**19 Gander Hill**

**Haywards Heath**

**Bat and Breeding  
Bird Survey**

**JG Ecological Surveys Ltd**  
**33 Cranford Avenue**  
**Exmouth**  
**EX8 2QA**

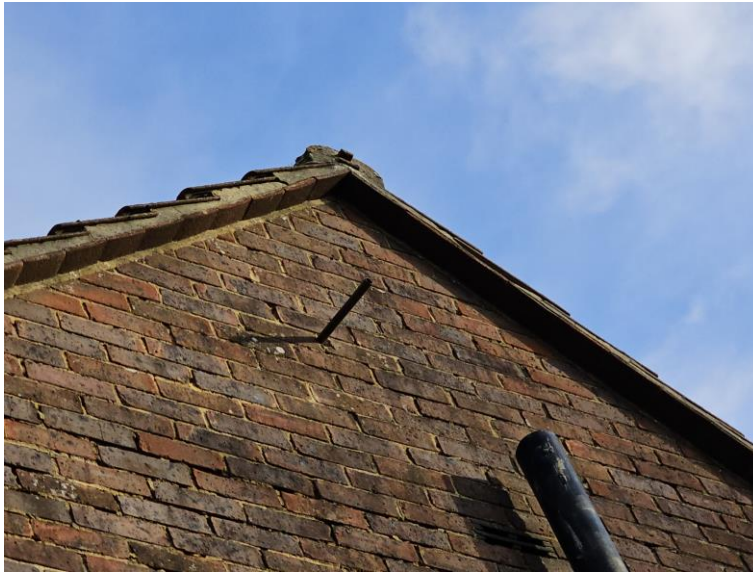
**Photograph 2: Example of the gable wall showing fully mortared tile runs and mortar sealed wall top to tile junction**

The building and roof coverings were in excellent condition with all tiles lying flat and interlocking with each other with no potentially exploitable gaps. All lead work to the chimneys and beneath the hanging tiles was in excellent condition with no lifting present. The wall tops were sealed to the roof structure via render at the gables and via a mastic sealant to the soffit boxes along the eaves offering no opportunities for bats to find access into the property. The mortar fillets along the end of the tile runs and along the ridge line were complete with no potential access points present.

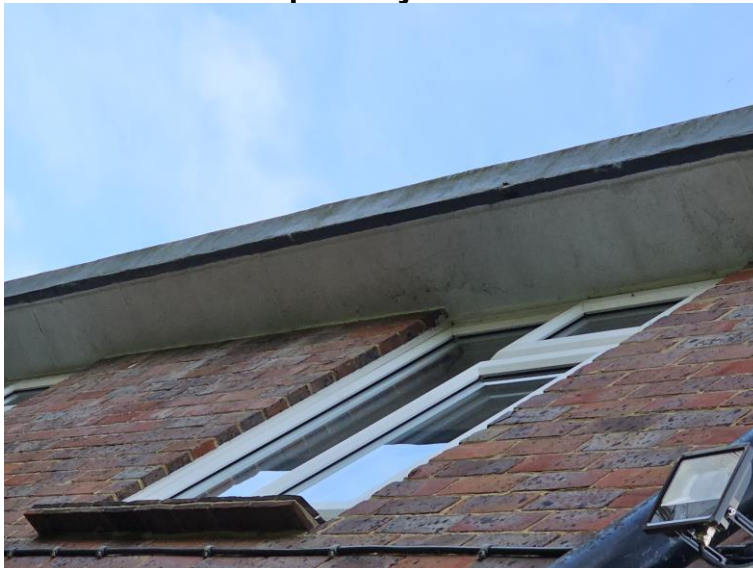
**Photograph 3: Mastic sealed wall to soffit box junction**

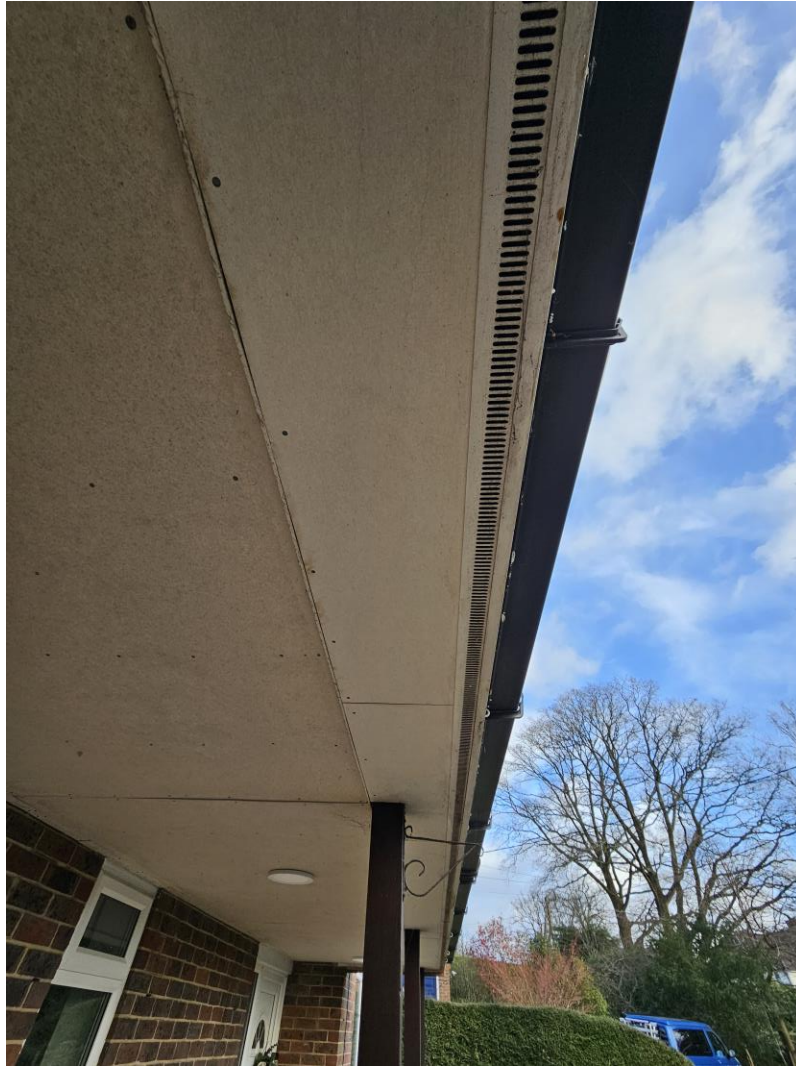
**Photograph 4: Meshed vent to lower level and garage**

The garage roof and lower level tiled section was sealed and had a fully meshed vent line preventing any bat access.

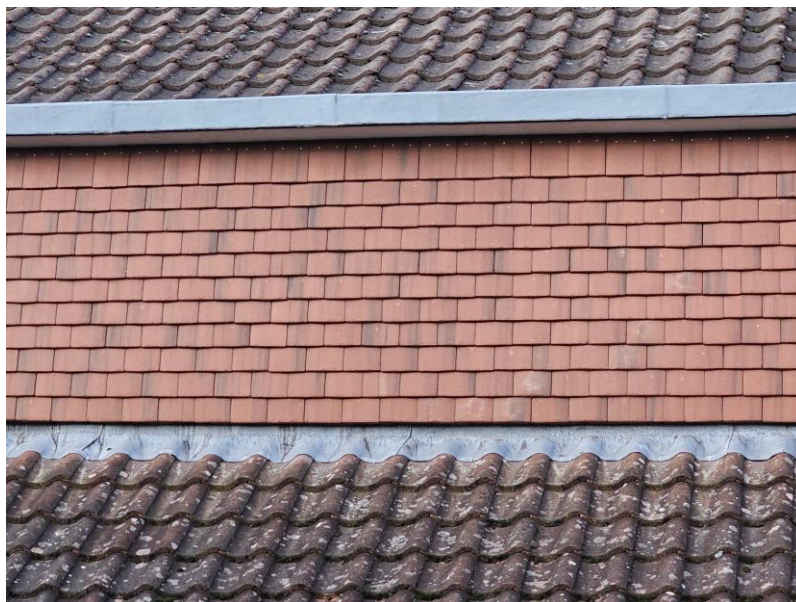
**Photograph 5: Condition of the hanging tiles and associated lead flashings**

The hanging tiles were in excellent condition with no missing, damaged or slipped tiles present. The tiles around the window were fully sealed.
