## **Damp and Timber Survey Report**

### **Marshalls Manor**

High Street  
Cuckfield  
Haywards Heath  
West Sussex  
RH17 5EL

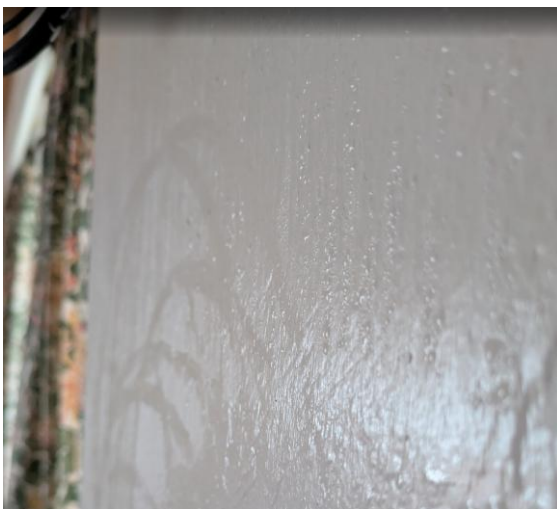
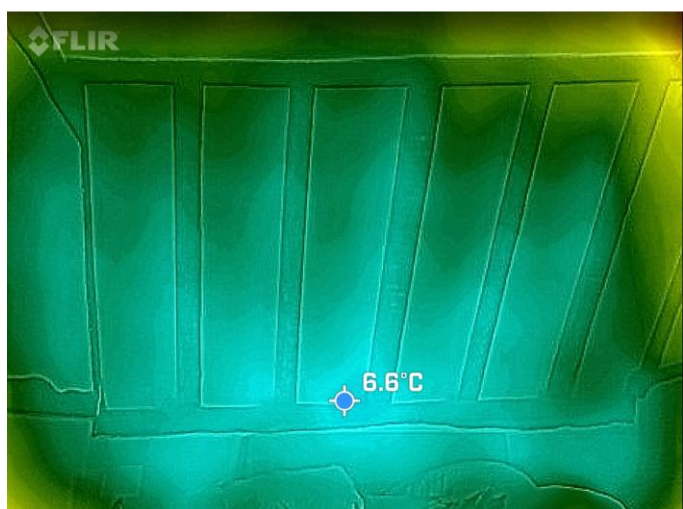
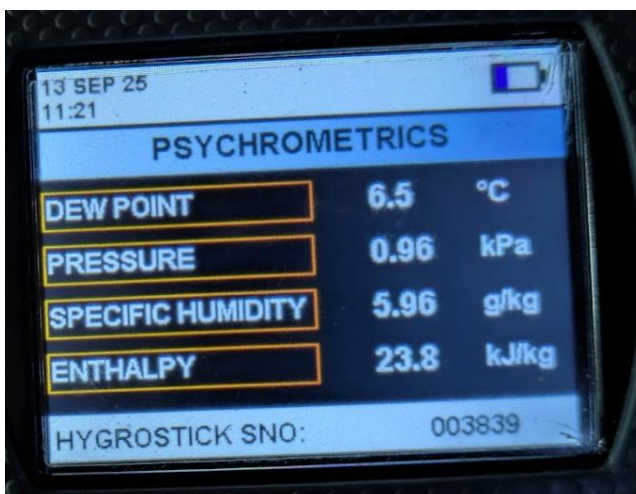
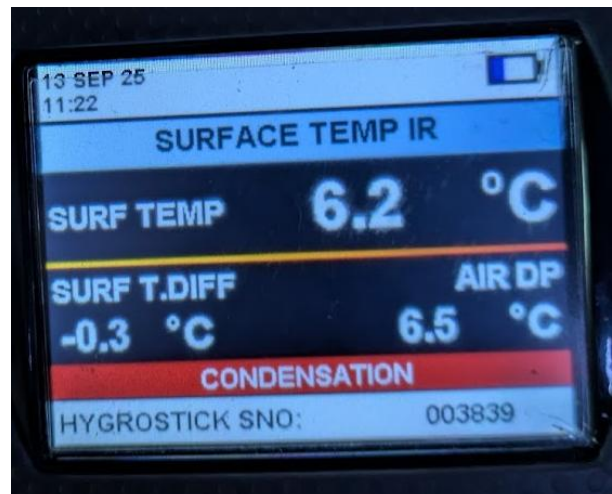
The majority of the surrounding brickwork in the annexe is a mix of cavity and 9" solid brickwork. The brick mortar has been removed and replaced with cement, and there are no provisions for cavity airflow or crossflow ventilation, which means the water inside the cavity stays trapped. The annex main roof void was also noted to have no insulation, which will cause significant temperature swings. This should be dealt with asap

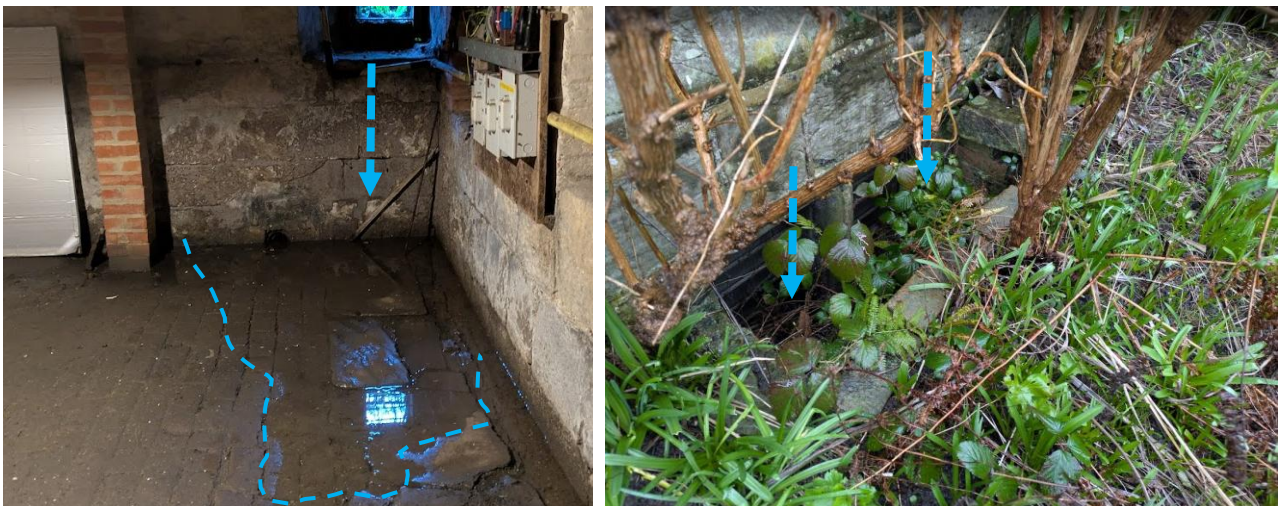
Standing water was observed in a corner of the basement floor, at a location corresponding to a historic drain outlet. The drain appears obstructed or partially collapsed, resulting in water accumulation during rainfall events. The water present is not under hydrostatic pressure through the wall face.

The mechanism is accumulation and evaporation rather than penetration. The image below shows the worst pooling area and the open coal shoot directly above it. This is allowing water to enter, while the blocked gully is preventing it from escaping.

The priority is to remove the standing water and restore drainage. Once liquid water is removed, mechanical ventilation must be introduced to keep the basement humidity below 65%. Until that source of airborne humidity is controlled, the upper floors will continue to feel its effects.

The basement drainage system requires formal investigation. A CCTV survey is recommended to determine whether the historic drain is obstructed, collapsed or disconnected. Clearance alone may be insufficient if structural failure is present. The objective is the complete elimination of standing water and reinstatement of reliable discharge.

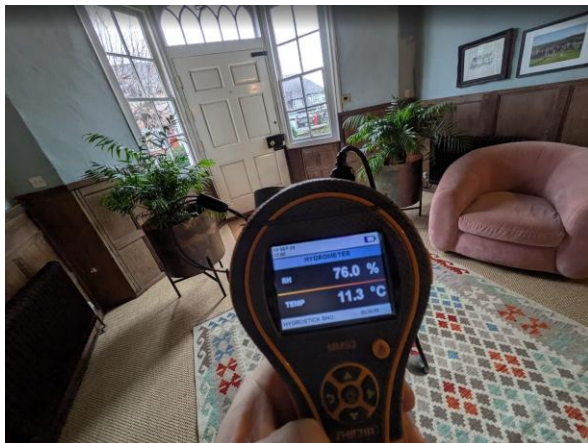
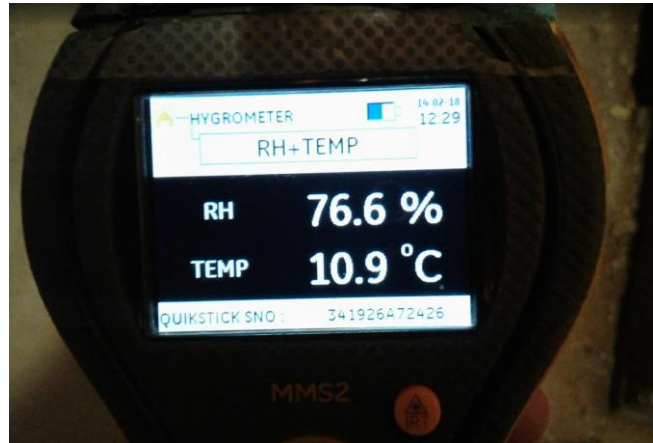
Readings taken in the hallway above the basement showed 76 % relative humidity at 11 °C. Under those conditions, surfaces that cool to around 7 °C will begin to form condensation, even if rain is not getting in. This means the wet basement is influencing conditions elsewhere.

The images below show the hallway and basement humidity levels; they are nearly identical.

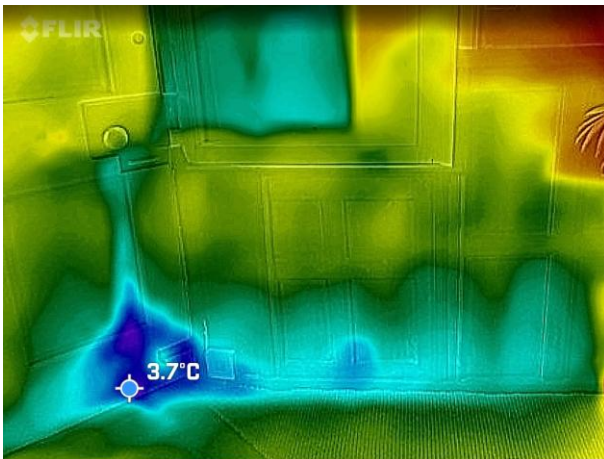
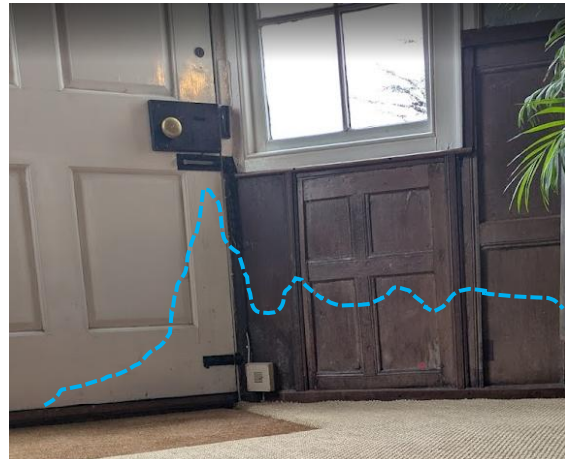
The trapped humidity from below is also causing the damp symptoms around the front door. The thermal images highlight this cause-and-effect. This is escaping humidity from below.

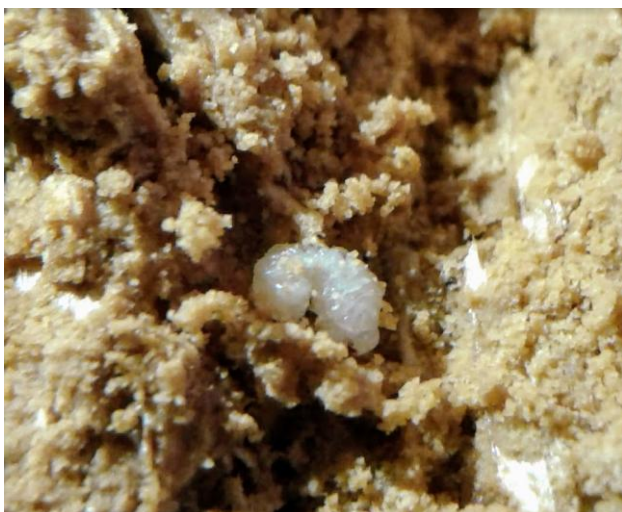
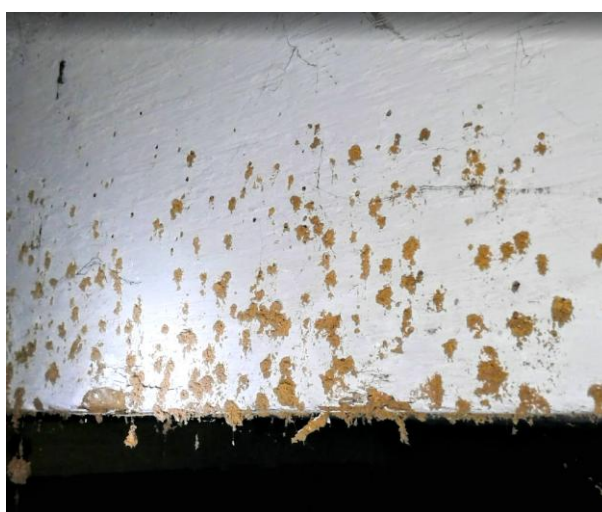
The basement timbers are already demonstrating signs consistent with a very damp environment. The environment is not seasonally dry. It is persistently moisture-laden. Timber exposed to such conditions will not stabilise below safe equilibrium levels unless the vapour source is removed.

Importantly, wood-boring insect activity was noted within this zone. Woodworm does not create damp timber. It selects damp timber. Active woodworm is an environmental indicator. It is evidence that the timber has been in a moisture condition suitable for insect viability over an extended period.

Wood-boring beetles require elevated timber moisture to complete their lifecycle. While exact species identification would require further sampling, the presence of activity confirms that the basement environment has supported elevated timber moisture for long enough to sustain insect habitation.

This is not a cosmetic issue. It is a signal of prolonged environmental dampness.
