**Report on a Structural Inspection  
29<sup>th</sup> February 2024**

**Proposed barn conversion at  
Pellings Barn, New House Farm  
Cuckfield Rd , Hurstpierpoint BN6 9LL**

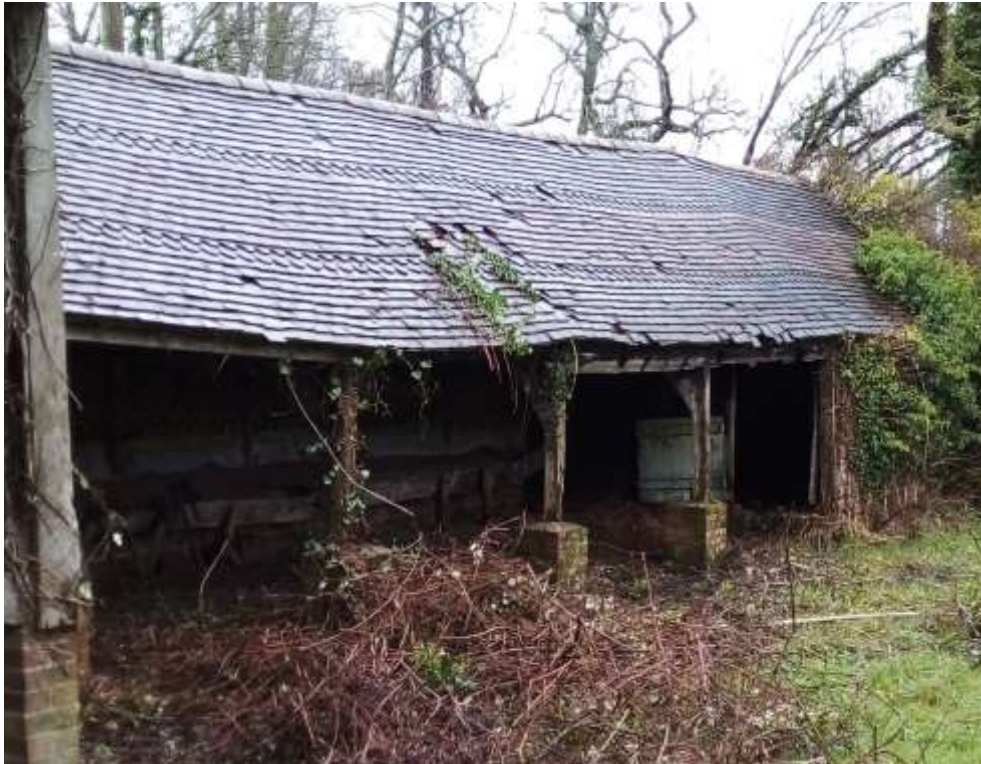
The roof of the low barn has moved but could be realigned.

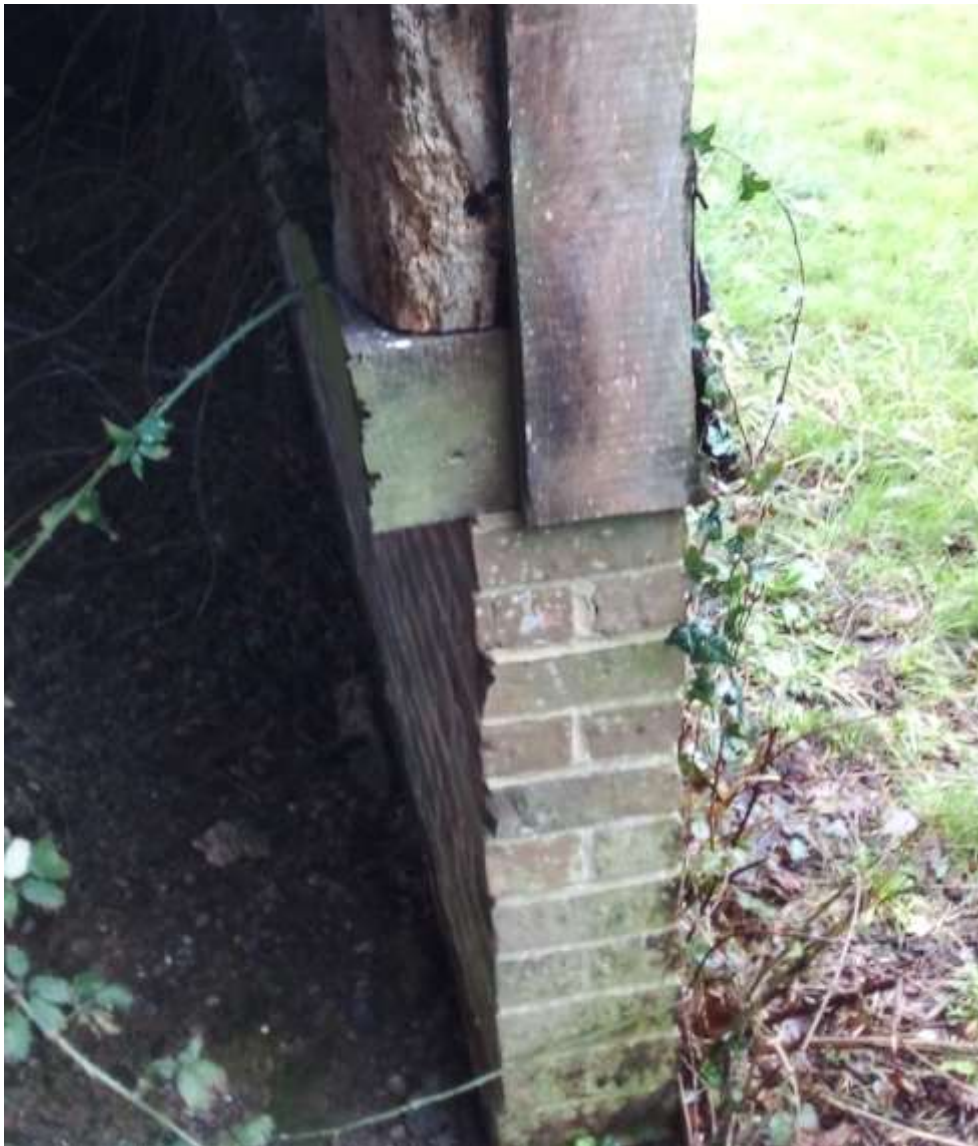
**Condition of the walls.** The timber framed walls were carefully inspected. No major problems were found, the sole plates and posts were in good condition. A detail is shown below

The dwarf walls, sole plates and oak posts are all in good condition

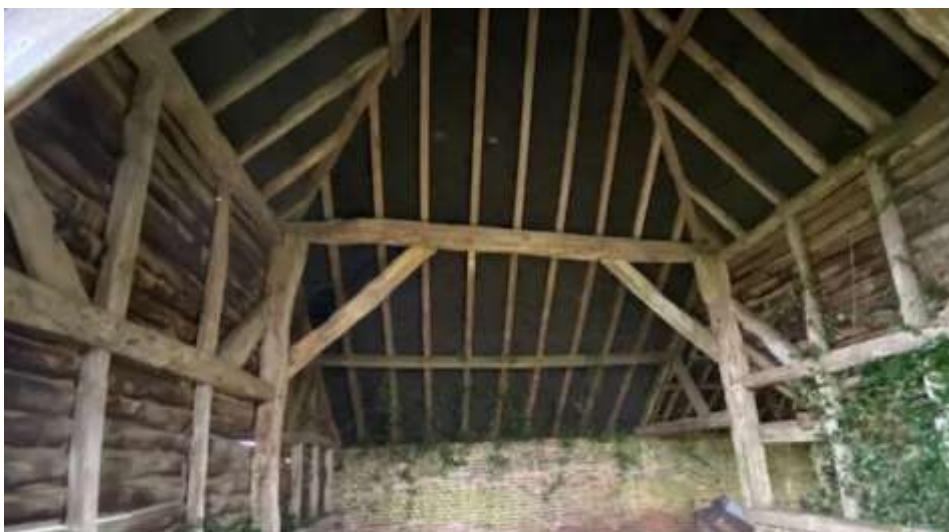
**Internal view of the tall barn showing the roof structure**

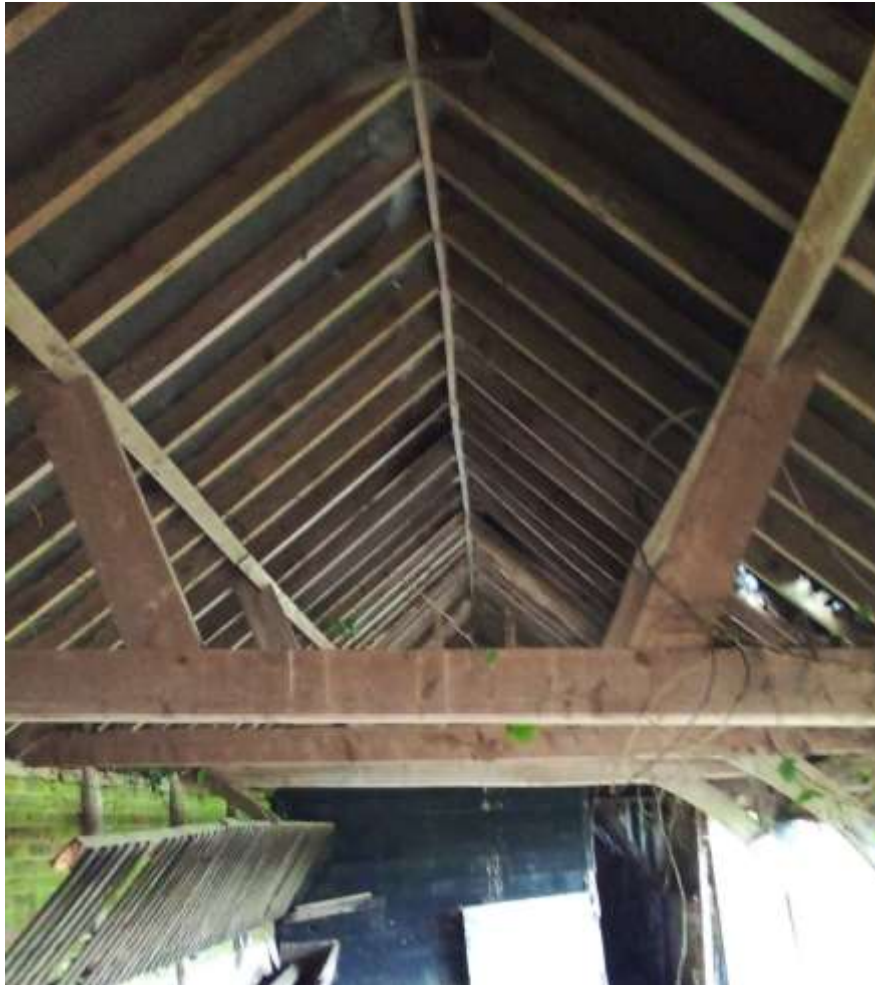
Low barn roof members – all in good condition
