## **Resistograph Tree Report**

**Lindfield Primary Academy,  
Primary Academy, School Lane,  
Lindfield,  
Haywards Heath,  
RH16 2DX**

**Prepared by  
Richard Daubeney Our Ref 0825-RD  
12th August 2025**

# Resistograph Report for trees at Lindfield Primary Academy, School Lane, Lindfield, RH16 2DX

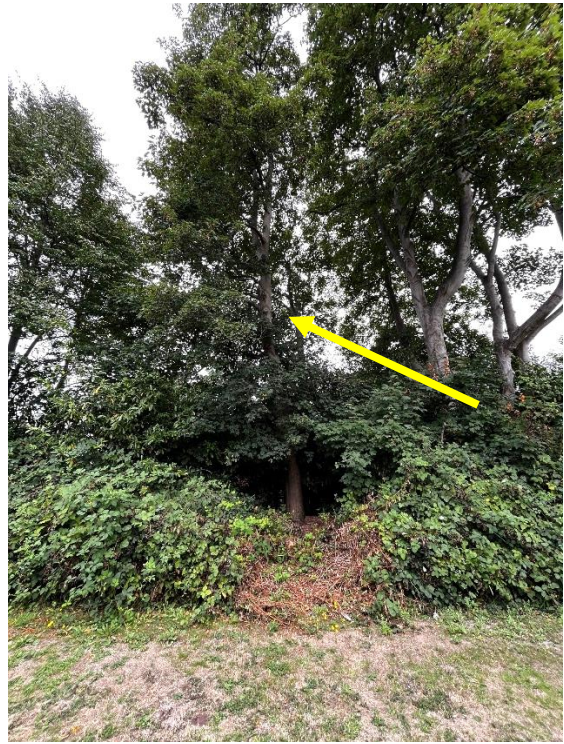
- 5.5 Following the resistograph testing of T131 Sycamore tree, the results revealed major decay and cavity formation within the stem, based on readings no. 1, 3 and 4 to the North, East, and South sides. The remaining sound and residual wood within the stem surrounding the decay is at unacceptable levels to retain this tree within this setting. The basal cavity to the South side is linked to internal decay within the stem.

- 6.4 The results gathered from the testing of T131 Sycamore tree, have shown there is major decay within the stem based upon the readings given, this creates an unacceptable level of sound and residual wood surrounding the decay. The tree is located within an area of high risk, with school grounds, general public and third-party properties all within striking distance of tree. We therefore based on the above evidence on recommend felling the Sycamore T131 to ground level. A replacement similar tree should be replanted within Winter 2025/2026.

**T131 Sycamore measurement looking Northeast towards drill location 1 and basal cavity location.**

**T131 Sycamore looking North**

| Tree No.<br>Tree<br>Tag. | Tree<br>Species | Hgt<br>(m) | Past<br>Management | Age Class | Risk Target | TPO Status | Defects | Works | Work Priority |
|---|---|---|---|---|---|---|---|---|---|
| T131<br>Tree<br>tag: N/A | Sycamore | 15-<br>19m | Subject to<br>previous<br>pruning. | Mature | High/<br>reinspect<br>July 2027 | No TPO in place<br>and Conservation<br>Area restrictions for<br>Mid Sussex District<br>Council . (CA)<br><br>Botanical Name:<br>( <i>Acer<br/>pseudoplatanus</i> ) | Gross Defect Noted. Major cavity to<br>Southwest side at ground level. Ivy on<br>stem previously severed. Multiple<br>pruning wounds on stem. Asymmetric<br>canopy. | Fell to ground level. | Urgent within<br>3 month. |

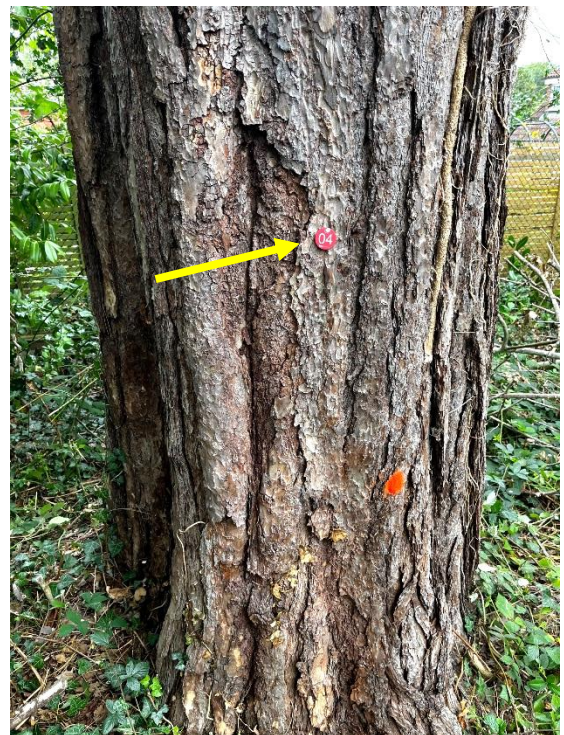
- 5.6 Following the resistograph testing of T138 Corsican pine, the testing indicated minor area of decay within the readings No. 2 And 3 to the West and Southwest side of the stem, but not significant at this time. The remaining readings taken for the tree highlighted good areas of sound and live residual sound wood. However, there is noted cavity on stem which require further investigation. Crown deadwood throughout canopy.

- 6.5 The results gathered from the testing of T138 Corsican pine tree, highlighted good areas of sound wood present, despite the minor area of decay within the stem, this is not significant at this time. The cavity located on the stem is a cause of concern and requires further investigation. The tree is located within area of high risk, with general public, third party properties, and school grounds all within striking distance of tree. We therefore based on the above evidence, to carry out a climbing inspection for the cavity to T138 Corsican pine and report back on the outcome of this inspection. The deadwood over 100mm throughout the canopy should also be removed. The work is to be completed within 3 months on urgent basis.

**T138 Corsican pine looking West.**

**T138 Corsican pine looking North towards Drill location No.4**

| Tree No.<br>Tree<br>Tag. | Tree<br>Species | Hgt<br>(m) | Past<br>Management | Age Class | Risk Target | TPO Status | Defects | Works | Work Priority |
|---|---|---|---|---|---|---|---|---|---|
| T138<br>Tree<br>tag: N/A | Corsican<br>pine | 20-<br>25m | Subject to<br>past<br>management | Mature | High/<br>reinspect<br>July 2027 | No TPO in place<br>and Conservation<br>Area restrictions for<br>Mid Sussex District<br>Council (CA)<br><br>Botanical Name:<br>( <i>Pinus nigra</i> ) | Hazardous Defect Noted, Fluting of<br>lower stem, Multiple pruning wounds<br>on stem. Cavity on stem at 6m above<br>ground level to Southeast side. Crown<br>dieback to 10-20%. Crown deadwood<br>present. | Removal of deadwood over<br>100mm throughout canopy.<br><br>Carry out climbing inspection for<br>cavity. Report back on outcome<br>of inspection. | Urgent within<br>3 months |
