# Report on a Structural Inspection of Barn Buildings

Hammonds Mill  
Hassocks  
West Sussex  
BN5 9NB

**Reinspected, reviewed and reissued 20 Feb 2025**

**Cassells Drummond** Building Structures Consultants

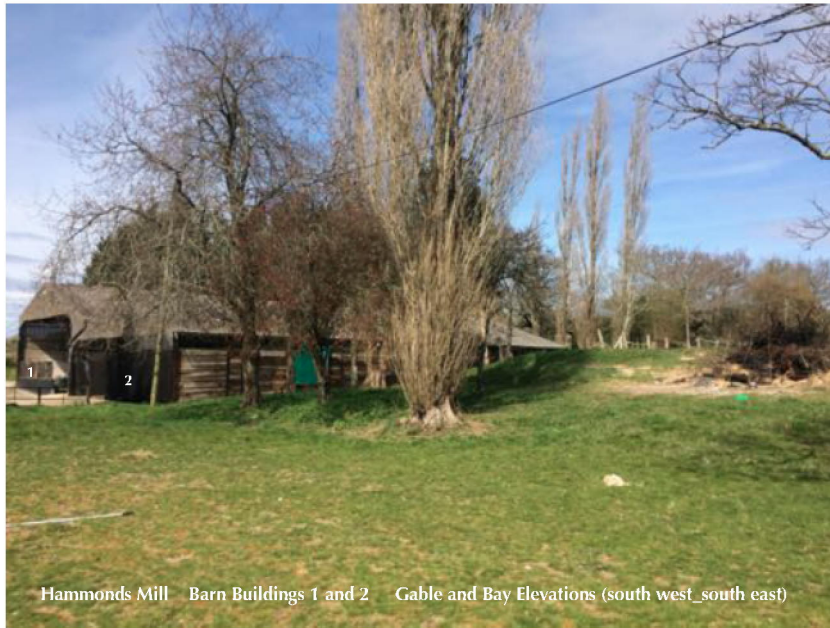
Hammonds Mill Barn Buildings 1 and 2 Gable and Bay Elevations (south west\_south east)

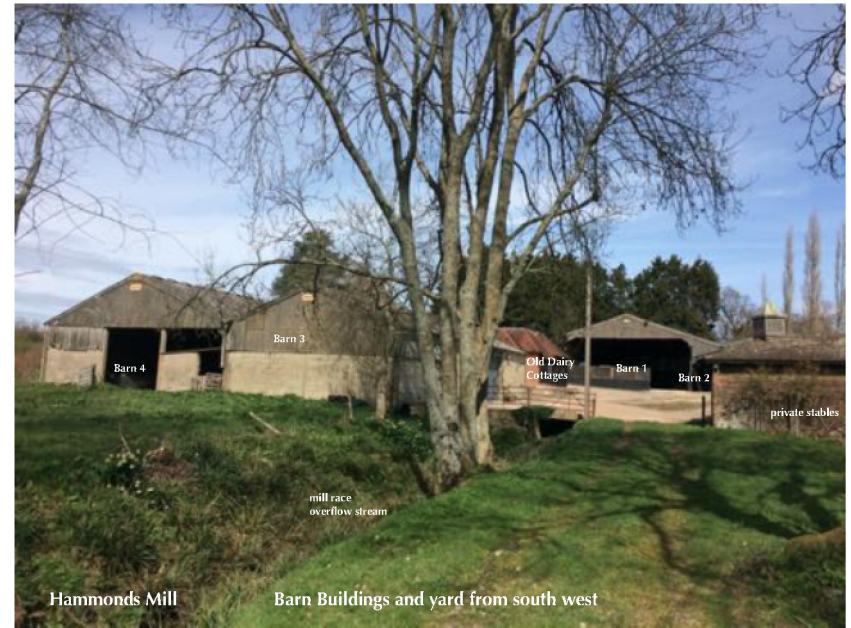
Hammonds Mill Barn Buildings and yard from south west
