**Paul Grinyer Associates Ltd**

**WICKENDEN MANOR, CHILLING STREET, SHARPTHORNE, EAST GRINSTEAD:**

Preliminary visual inspection report & structural appraisal of the existing stables buildings.

**Ref:** 20088  
**Date:** 28<sup>th</sup> July 2025

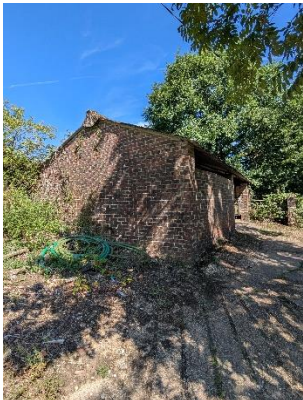
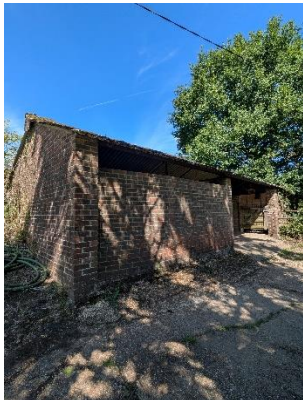
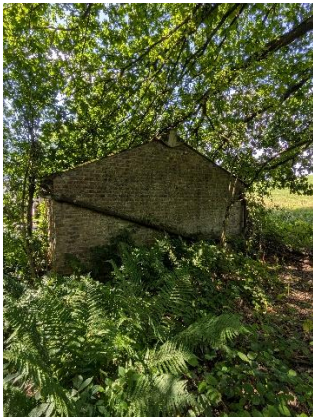
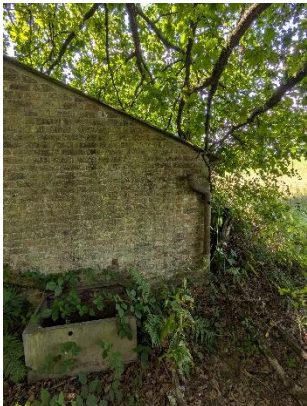
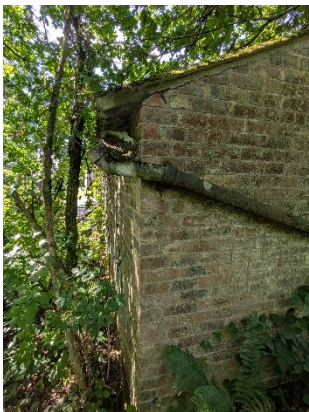
A load bearing masonry building, with a steel framed roof with steel purlins supporting corrugated cement sheet roof coverings. The ground floor was of concrete construction, sloping slightly to the east. The building was thought likely to be of mid / late 1950's construction. (Photo 1, 2, 3, 4 & 5)

| Photo 1 – Building A south elevation | Photo 2 - Building A east elevation |
| Photo 3 - Building A north elevation | Photo 4 - Building A west elevation obscured |
| Photo 5 Building A east elevation | Photo 6 - Building A Roof arrangement |

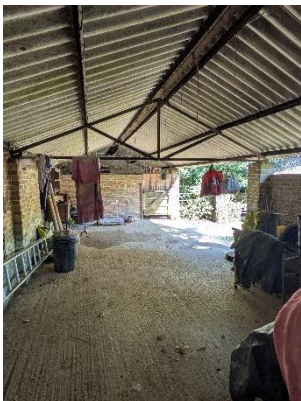
The steel roof trusses were formed using light gauge steel angle sections, welded to one another to form each truss. Steel purlins spanned between the trusses and supported the corrugated cement sheet roof. All elements of steel forming the trusses and purlins were corroded and had not been painted or otherwise maintained, likely since original construction of the building. (Photo 6).

There is no evidence of significant further deterioration of this building and the observations from September 2020 are reflective of the general current condition, perhaps with the exception of the steel trusses being slightly more corroded than previously evident.

The roof will need to be replaced.

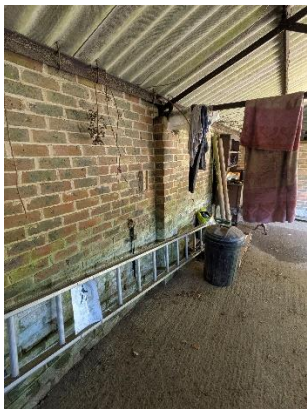
The west external wall was retaining around 800mm of ground to the west side of the building and the brickwork was noted, internally, to be wet and with damp and moisture staining. The brickwork appeared undamaged, other than the staining noted. (Photo 7).

| <p>Photo 7 – Building A internal west elevation showing moisture penetration.</p> | <p>Photo 8 - Building A south east corner horizontal tapered crack.</p> |

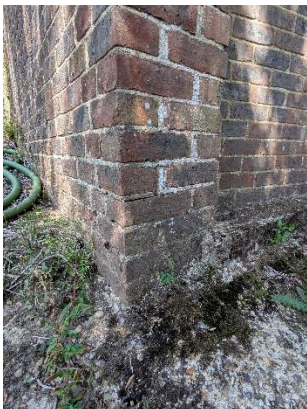
To the south east corner of the building, on the south elevation, a horizontal tapering crack was noted at around 150mm above the internal slab level and where it appeared localised downward movement of the foundation had occurred to the corner of the building. (Photo 8).

Localised downward movement of the foundations was noted to one corner of the building. This will likely require localised underpinning.

It should be possible to retain the existing external walls of the building, though it is likely, as is common with agricultural building being converted to domestic or similar use, there may be a need to underpin foundations to ensure they are of a sufficient depth to be below that of external ground levels and below the level of reduced dig for any replacement internal floor slab.

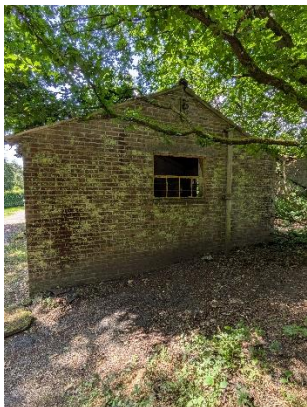
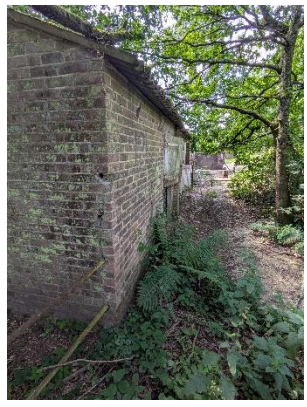
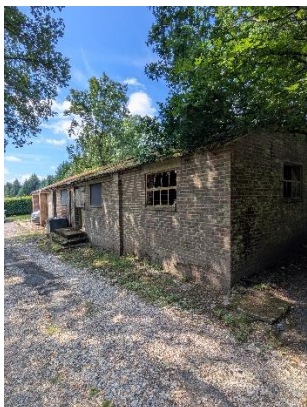
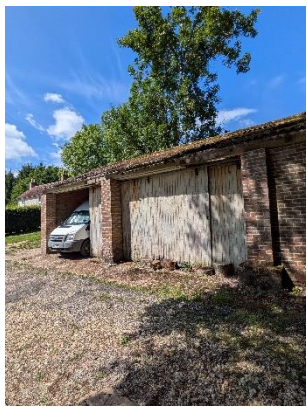
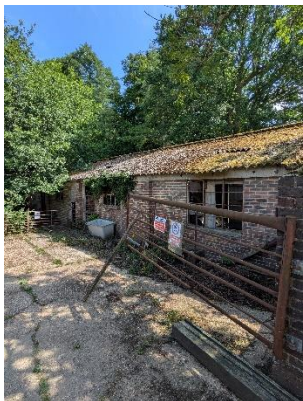
concrete eaves beams supported on precast concrete columns. It was thought likely the building had been constructed in the late 1950's or early 1960's. (Photos 9, 10, 11, 12 & 13).

| <p>Photo 9 - Building B north elevation</p> | <p>Photo 10 - Building B west elevation obscured</p> |
| <p>Photo 11 - Building B east elevation</p> | <p>Photo 12 - Building B east elevation</p> |

| Photo 13 – Building B west elevation. | Photo 14 - Building B roof arrangement. |

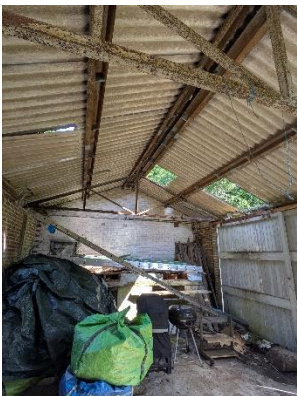
The steel roof trusses were formed using light gauge steel angle sections, welded to one another to form each truss. Steel purlins spanned between the trusses and supported the corrugated cement sheet roof. All elements of steel forming the trusses and purlins were corroded and had not been painted or otherwise maintained, likely since original construction of the building. (Photo 14)

This structure was in fair to poor general condition, as would be expected for an agricultural building of its age and form. The external walls appeared to be generally sound though were on 102mm thick for the most part in were generally not intended to originally support loads from the roof structure and thus may have limited or no foundations. The roof structure was of lightweight steel construction and in poor condition and it would not be capable of supporting load from a suitably

The roof will need to be replaced.

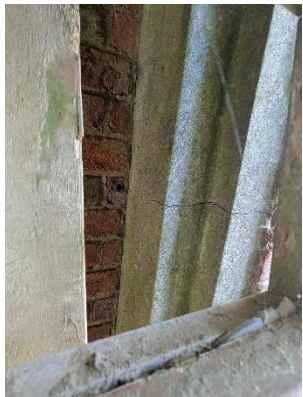
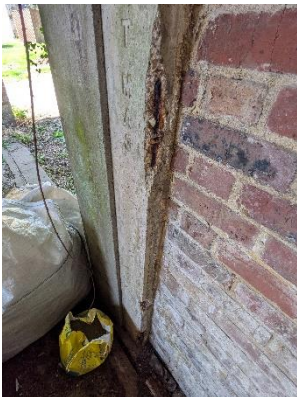
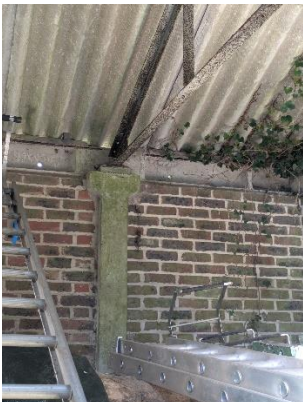
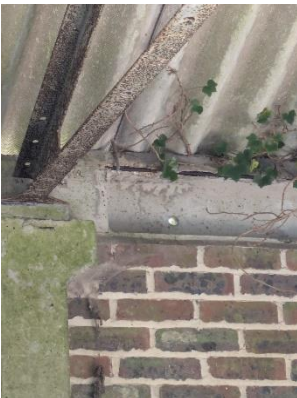
Precast concrete eaves beams spanned between precast concrete columns. Many of the precast concrete columns were noted to have been clad or encased in brickwork, though some were still exposed to the south end of the west elevation. Corrosion of reinforcement in the precast elements had resulted in spalling and damage to the concrete forming many of the elements, including the columns (where visible) and the eaves beams. (Photos 15, 16, 17 & 18).

insulated composite roof construction. The concrete eaves beams showed evidence of deterioration and corrosion of reinforcement and would not be considered to be economically repairable.

Similarly, the precast concrete columns supporting the same were also showing signs of corrosion, possibly significantly so where encased by brick piers to the south end of the building. These elements will need to be replaced.

| Photo 15 - Building B Cracked concrete precast column | Photo 16 - Building B cracked and corroded concrete column |
| Photo 17 - Building B Corroding reinforcement to eaves beam | Photo 18 - Building B Corroding reinforcement to eaves beam |

Building B can be retained but will require the roof structure to be replaced, internal ground floor to be replaced and possible underpinning of foundations to suit the floor slab replacement and proposal to alter internal levels. Parts of the structure such as precast concrete beams and columns will need to be removed and replaced with modern alternatives, such as steel beams and columns.

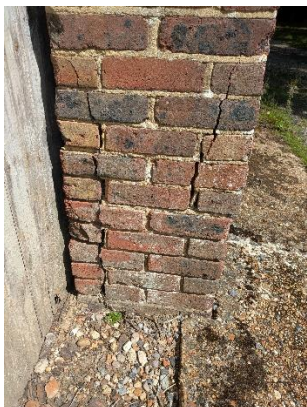
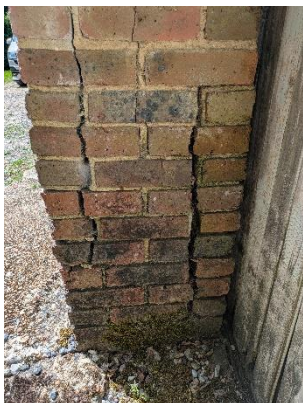
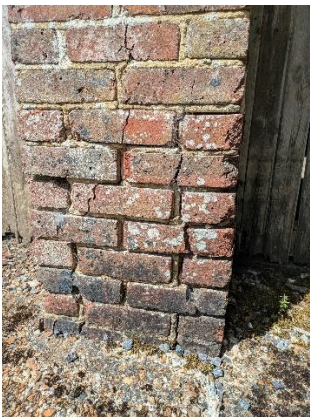
To the east elevation, at the south end of the building brick piers were present and vertical cracking was noted to the bottom sections of the piers on the two side faces and the front face of the pier. The piers appeared to be encasing precast concrete or steel columns, supporting the concrete eaves beams over the door openings to the east elevation. (Photo 19, 20 & 21).

| Photo 19 – Building B cracked brickwork around precast column. | Photo 20 - Building B cracked brickwork around precast column. |
| Photo 21 - Building B cracked brickwork around precast column. | Photo 22 - Building B cast concrete block to base of pier / column |

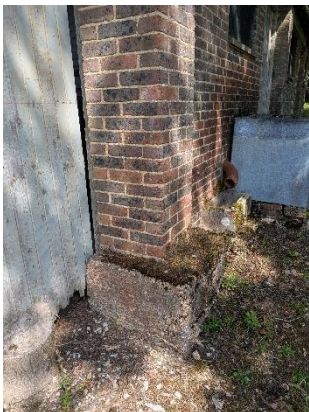
A cast concrete block or foundation was noted to the north end of the twin door openings in the east elevation of the building, possibly cast over or around the base of the original pier or precast concrete column. (Photo 22).

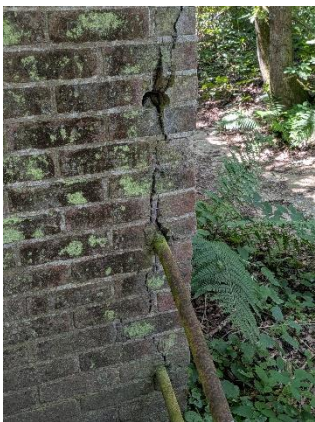
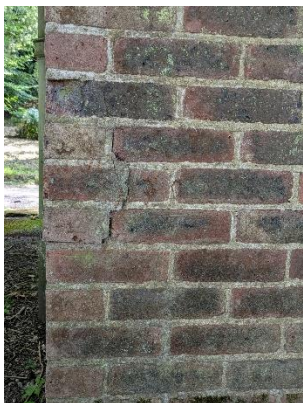
To the north west corner of the building cracking of up to 10mm wide was noted to the brickwork where embedded metal tubes were set into the brickwork and were corroding. Cracks were vertical to the north elevation and horizontal to the west elevation, running south around 0.6m. (Photo 23 & 24).

| Photo 23 - Building B Building B cracking to brickwork north west corner | Photo 24 - Building B Building B cracking to brickwork north west corner |

It is evident some damage to the masonry has occurred which will require limited remedial repair by brick stitching and possible introduction of a system of bed joint reinforcement in the damaged areas of structure, including the north east & north west corners, and possibly the north elevation under the window.

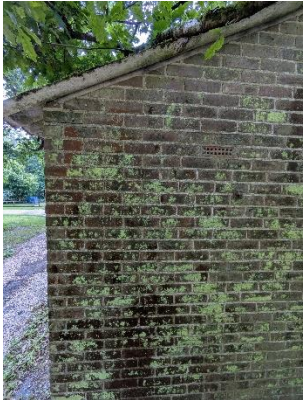
To the north east corner of the build, on the north elevation a tapered horizontal crack was present from the eaves of the east wall, extending back to the head of the window on the north elevation. (Photo 25). A tapered vertical crack was present to the sill of the north elevation window, of around 3mm wide and which extended and diminished into four brick courses below the sill. (Photo 26).

It appeared there had been some likely foundation movement to the north east corner of the building, which will likely require underpinning or some other form of foundation strengthening and stabilisation system.

| <p>Photo 25 – Building B north east corner horizontal cracking towards window head.</p> | <p>Photo 26 - Building B vertical tapered crack through north elevation sill &amp; bricks below.</p> |
