## Climbed Inspection Report

**Client:** Burgess Hill Girls School

**Site:** Burgess Hill Girls School, Keymer Road, Burgess Hill, RH15 0EG

**Scope:** Carry out climbed inspection to T296 Oak

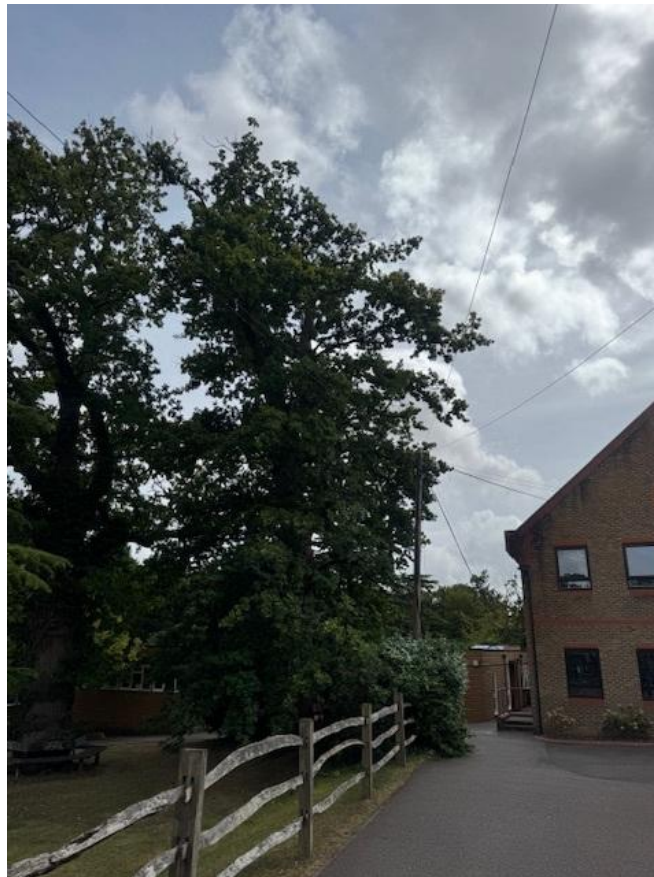
Dominant, mature and notable specimen in grassed courtyard area in centre of school grounds. Tree exhibiting veteran features. Immediately prior to the climbing inspection, the tree had extensive and more than average deadwood in its upper crown early stag-heading. All deadwood removed.

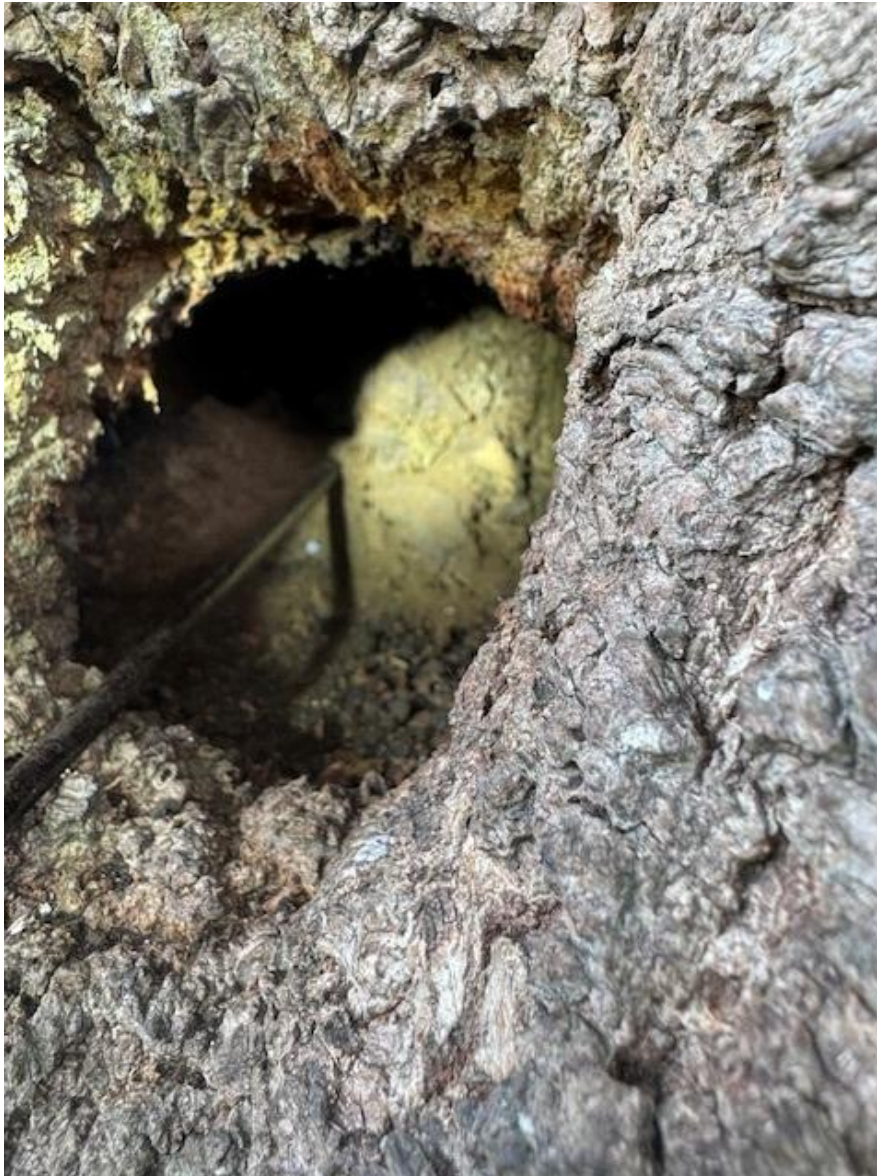
1. Knothole on S side on trunk at 5m AGL. External dimensions 100mm high x 80mm wide. Internally probed horizontally 150mm. The feature slightly extends above and to both sides forming a bowl line structure. Minor decay evident, but localised. Good wound-wood formation. Bat potential.
