## FORMAL INSPECTION OF 1 X COMMON BEECH (T284)

**AT:** Keymer Road,  
Burgess Hill,  
West Sussex,  
RH15 0EG

**CLIENT:** Burgess Hill Girls School

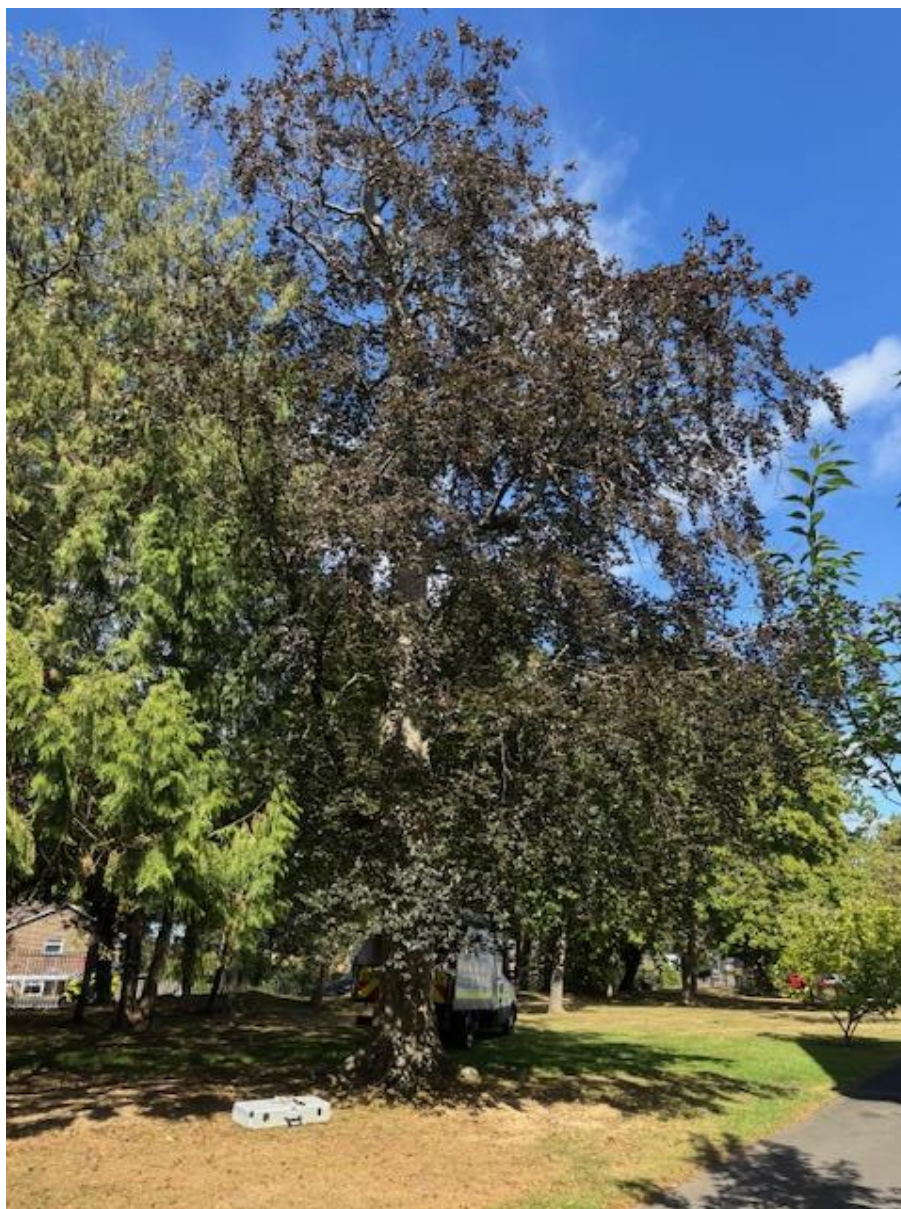
**Photograph 1**

6.1 The tree is a mature purple beech (*Fagus sylvatica 'Purpurea'*), a photograph of the tree is shown below. It is a significant component of the landscape and easily visible from the public highway.

9.6 During the survey it was noted that the tree's crown showed obvious signs of stress, with crown sparsity and smaller than usual leaf size throughout its crown.

10.2 **Recommendation:** Fell the tree and as close to ground level as possible and plant a replacement tree.

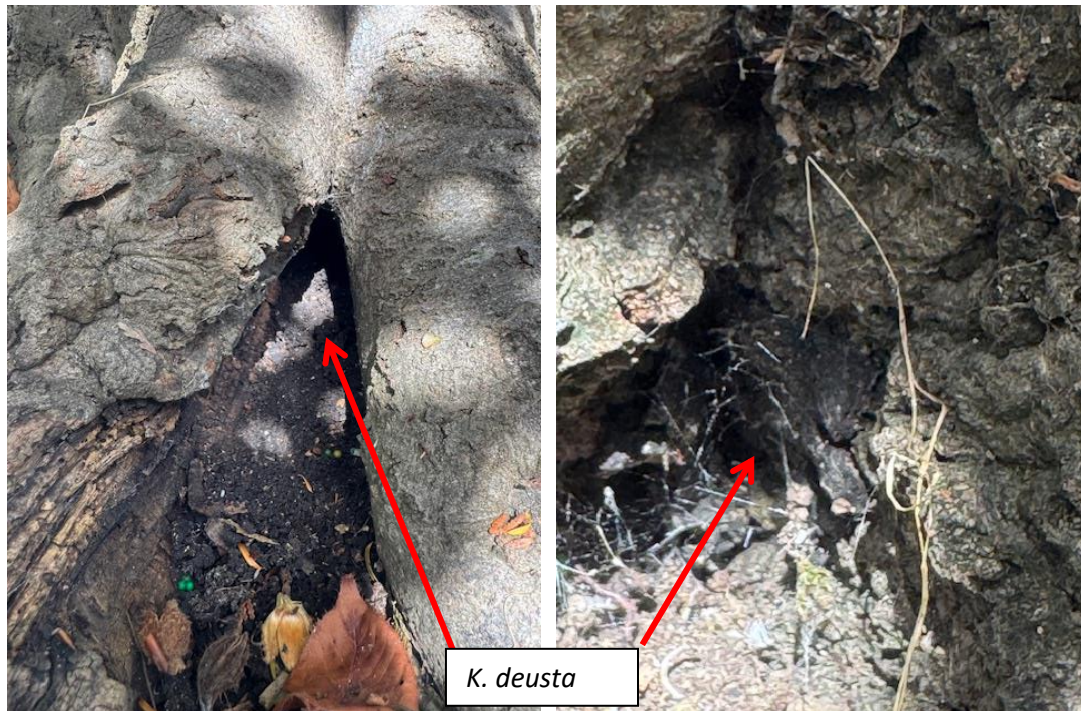
Photographs 2a – 2b.

6.3 A survey conducted by MJC Tree Services Ltd in 2025, which identified numerous fruiting bodies of pathogenic decay fungus *Kretzschmaria deusta*, at the tree's base. The full results from this survey can be found by contacting MJC Tree Services Ltd.

9.1 Pathogenic decay fungus *Kretzschmaria deusta* was visually identified at various locations at the base of the tree. This particular fungus is known to be a particularly dangerous decay fungus, due to the type of decay it causes. The decay starts as a soft rot of wood progressing in later-stages to a white rot, which reduces the strength of the tree. The decay can extend up the stem, as well as into the roots. Eventually the tree can succumb to windthrow.

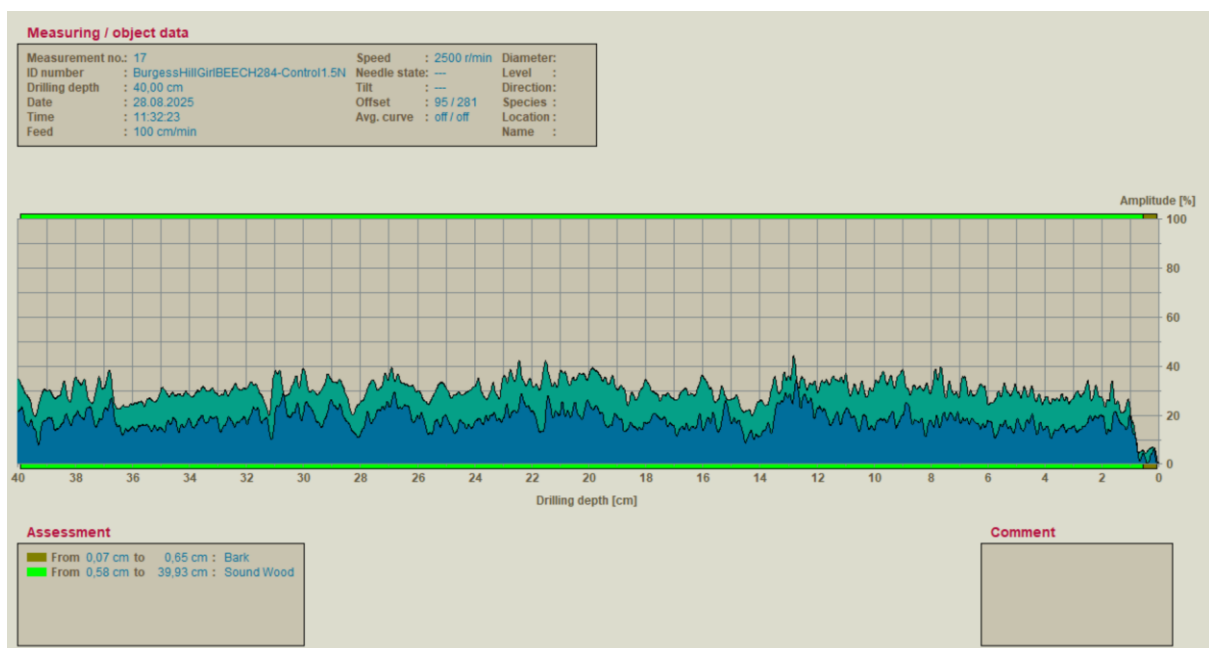
Table 2 Showing the control assessment carried out at 1.5m on north side of trunk..

9.2 The control showed consistent drill and feed resistance (see Table 2, in the results above), suggesting a uniform wood density throughout and is considered a good comparative control against other investigations carried out at the tree's base.

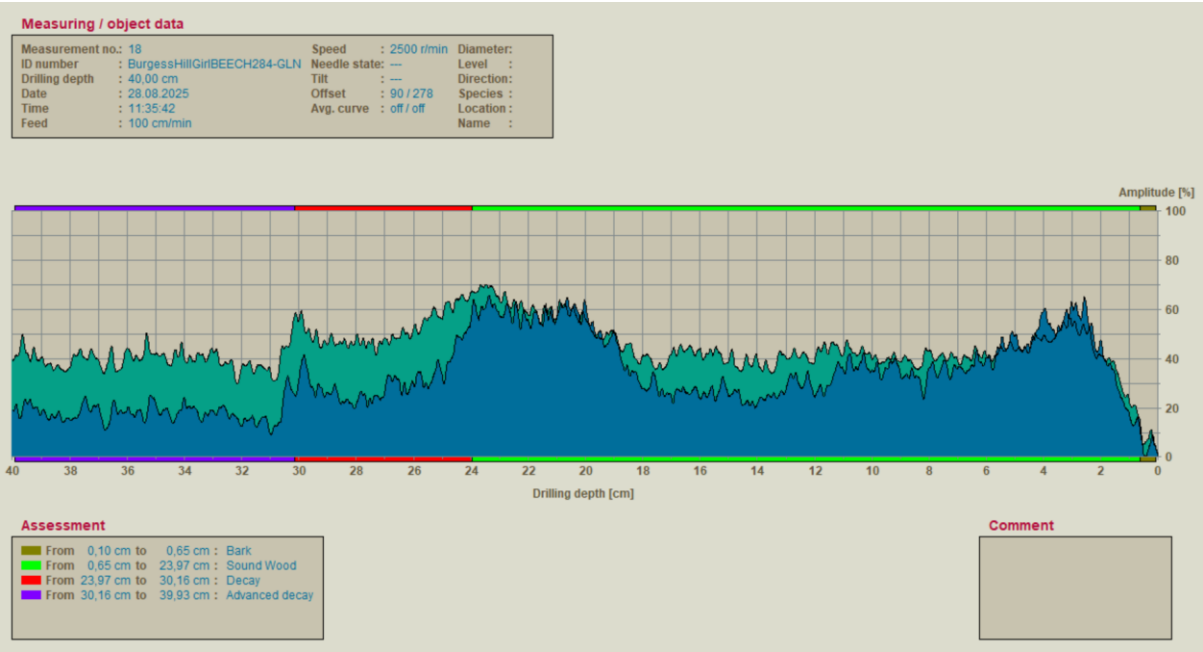
Table 3 - Showing the assessment carried out at ground level on the north side.

9.3 In most of the microdrill investigations (see tables 3, 6, 7 & 8, in the results above) there were areas where the wood integrity appeared evidently compromised, this is demonstrated by a clear reduction in both the microdrill's feed and drill resistance throughout each investigation. These samples were taken from various locations at the trees base, suggesting that most of the tree's base is affected by internal decay.

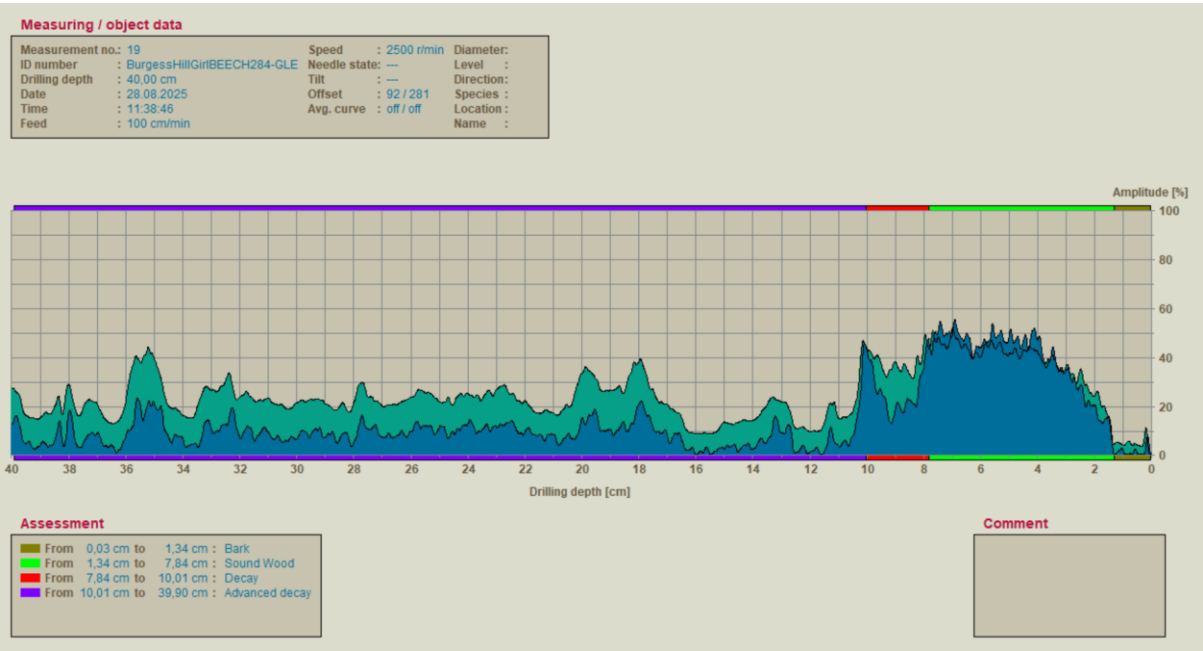
Table 4 - Showing the assessment carried out at ground level on the east side.

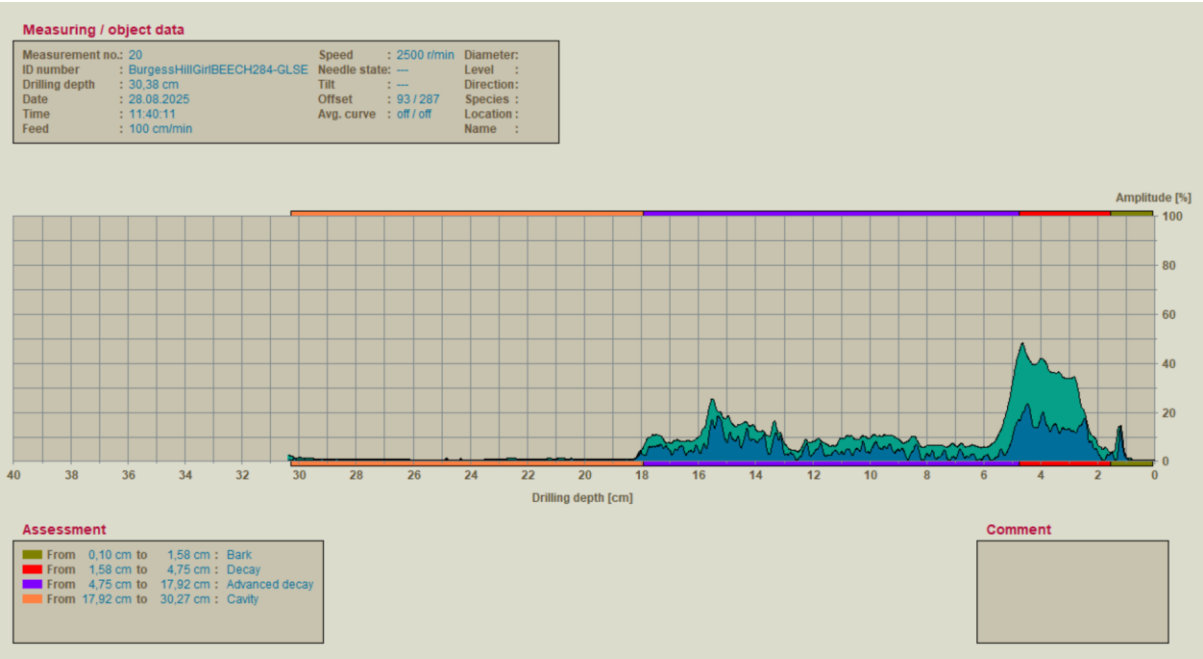
Table 5 - Showing the assessment carried out at ground level on the south-east side. NB needle auto retracted at 30cm.

9.4 Most significantly, investigations carried out at the base on south-east side and another at 1.5 metres from ground level on the south side of the trunk clearly shows an internal decay cavity (see tables 5 & 9, in the results above). Note that the microdrill automatically retracted, as a safety precaution to prevent damage to the equipment.

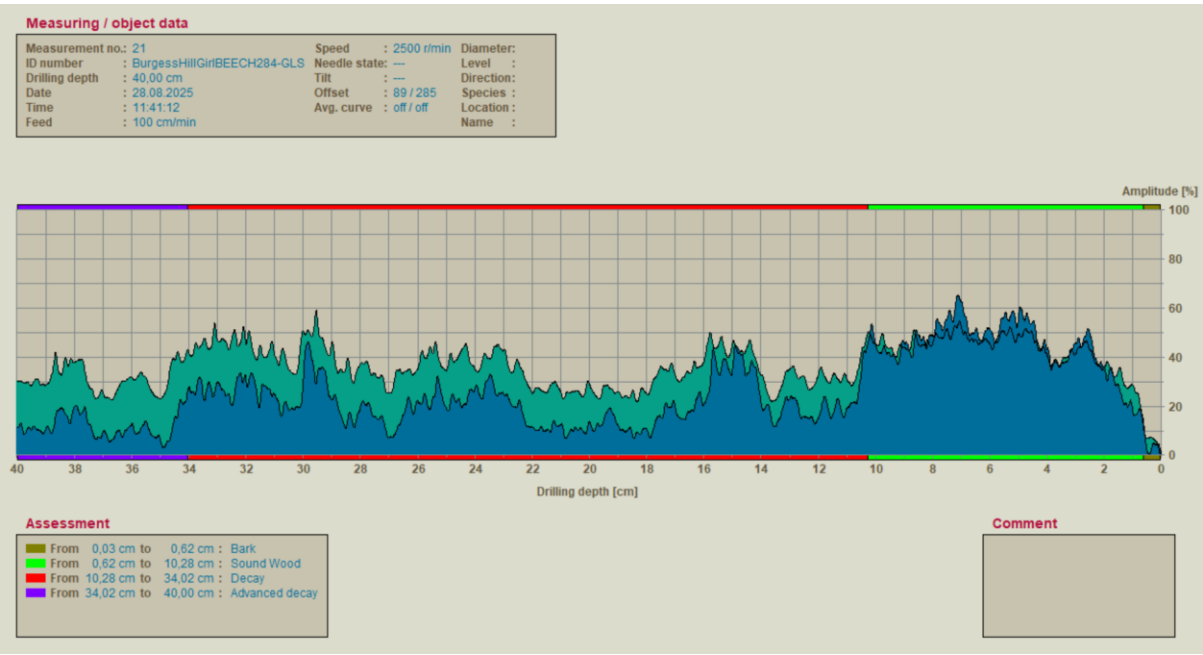
Table 6 - Showing the assessment carried out at ground level on the south side.

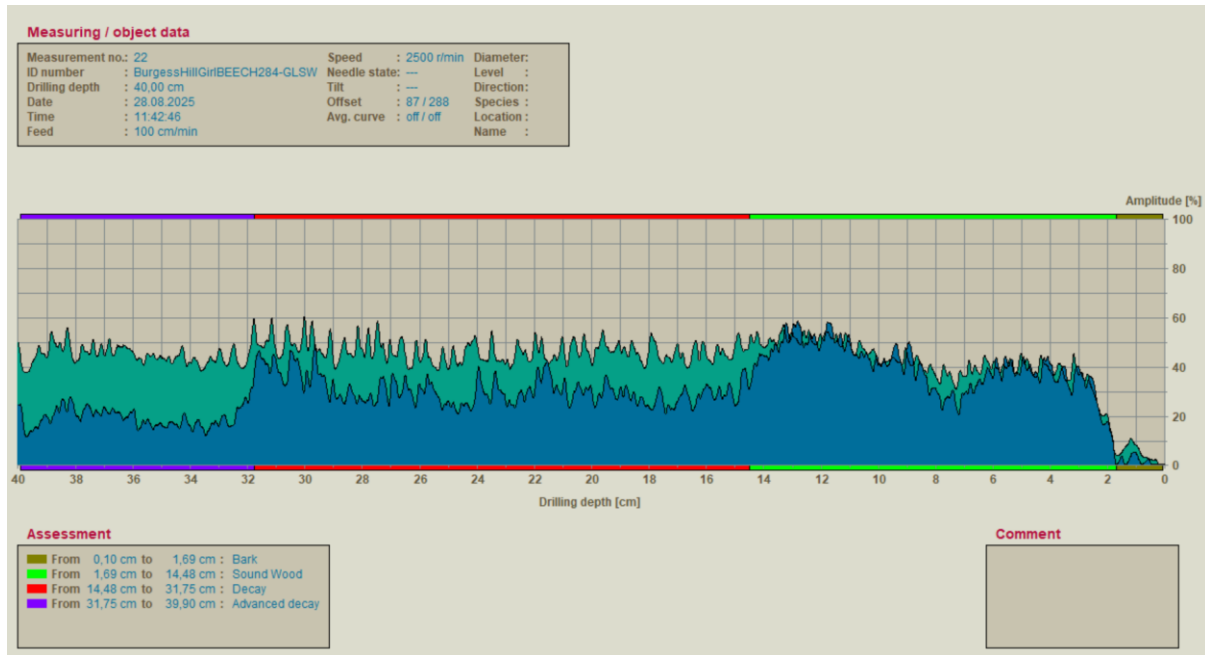
Table 7 - Showing the assessment carried out at ground level on the south-west side.

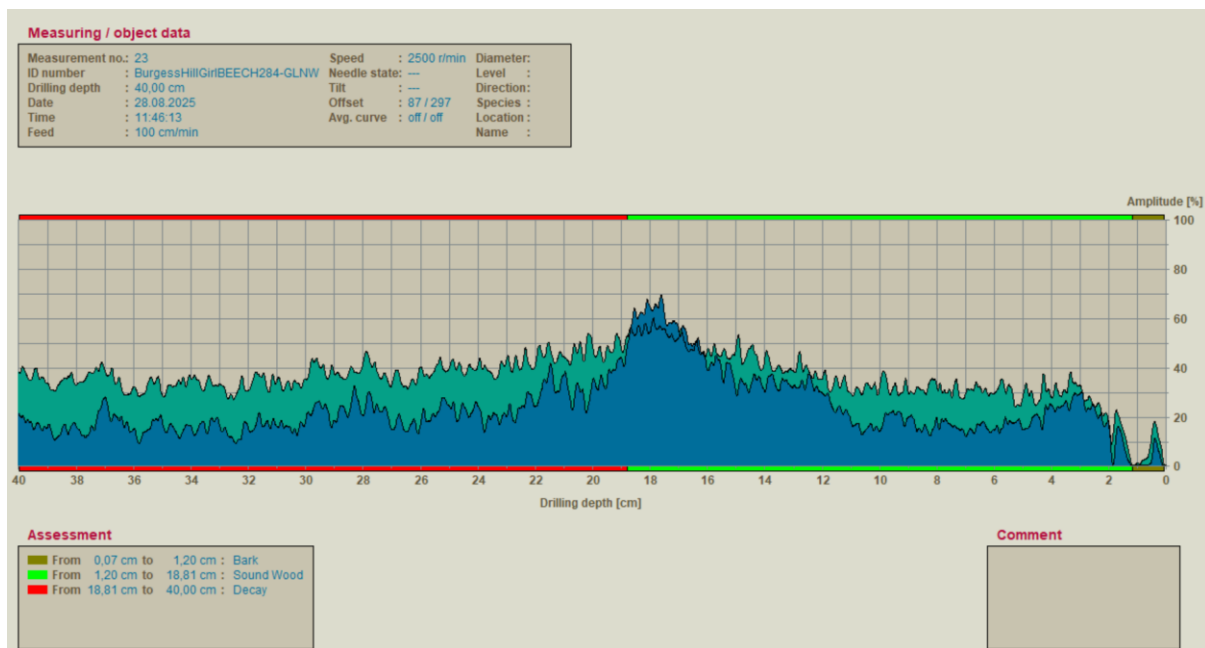
Table 8 - Showing the assessment carried out at ground level on the north-west side.

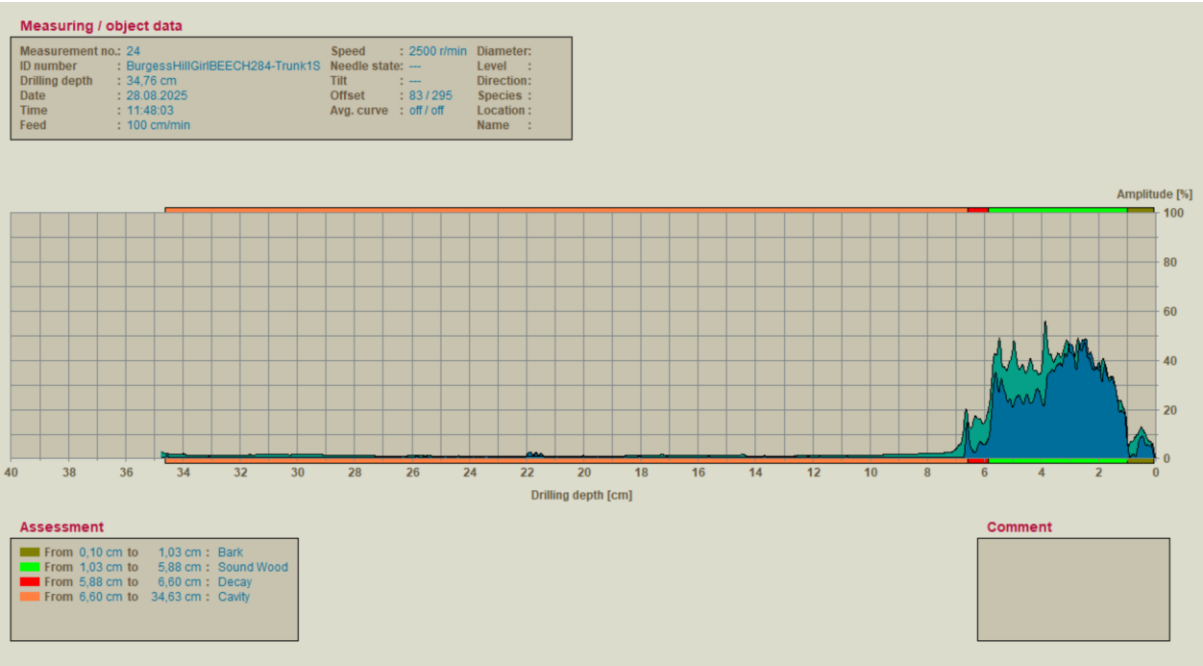
Table 9 - Showing the assessment carried out at 1.5m on south side of trunk. NB drill auto. retracted at 35cm.
