## FORMAL INSPECTION OF 1 X OAK (T278)

**AT:** Keymer Road,  
Burgess Hill,  
West Sussex,  
RH15 0EG

**CLIENT:** Burgess Hill Girls School

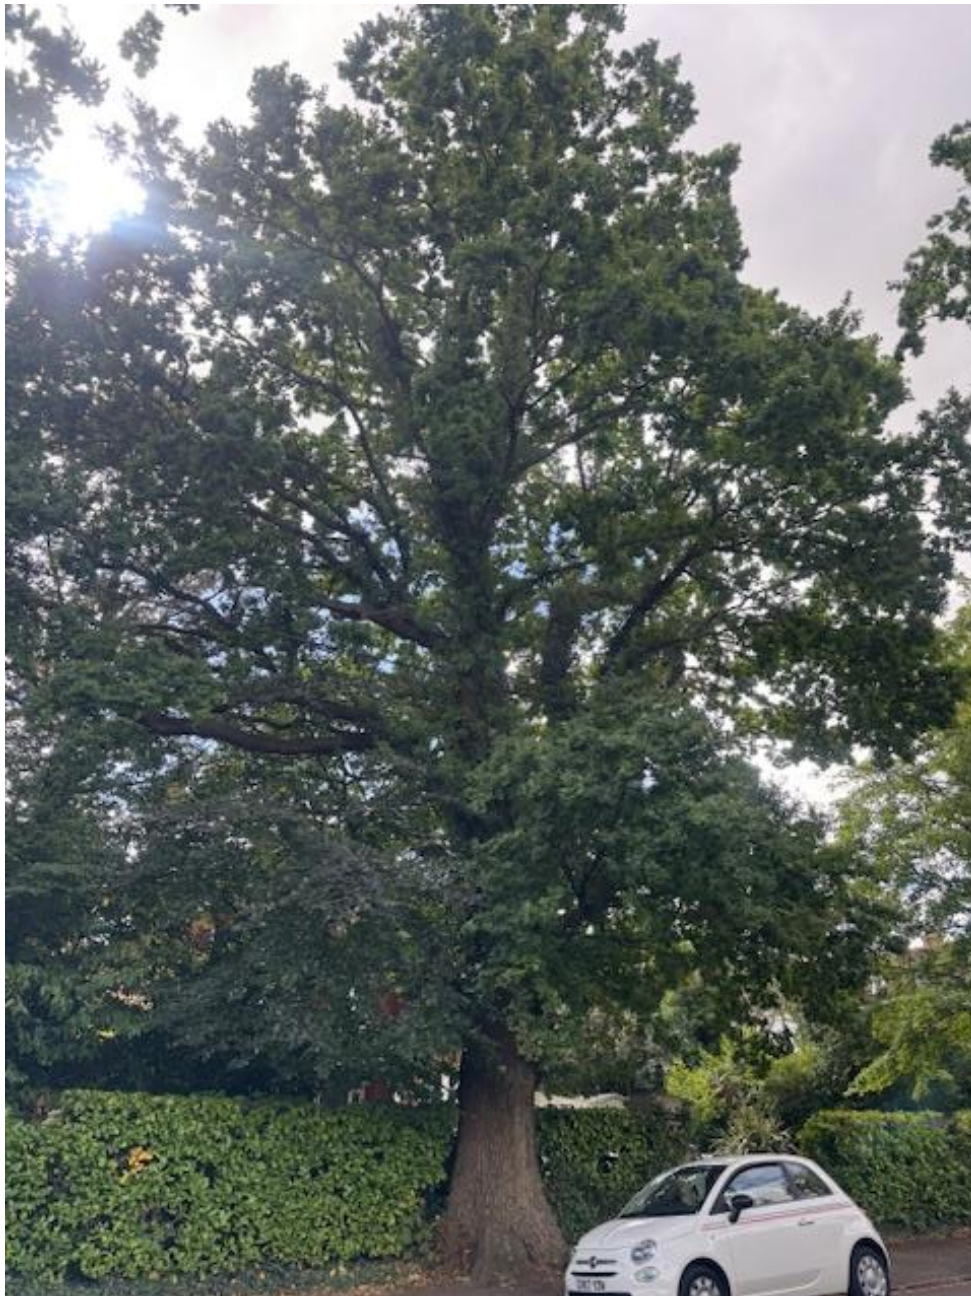
Photograph 1

6.1 The tree is a mature Pedunculate oak (*Quercus robur*), a photograph of the tree is shown below. It is an essential component of the landscape and easily visible from the public highway.

6.2 The tree is 19 metres tall, with a trunk diameter of 1200mm measured above the root flare at approximately 300mm above ground level.

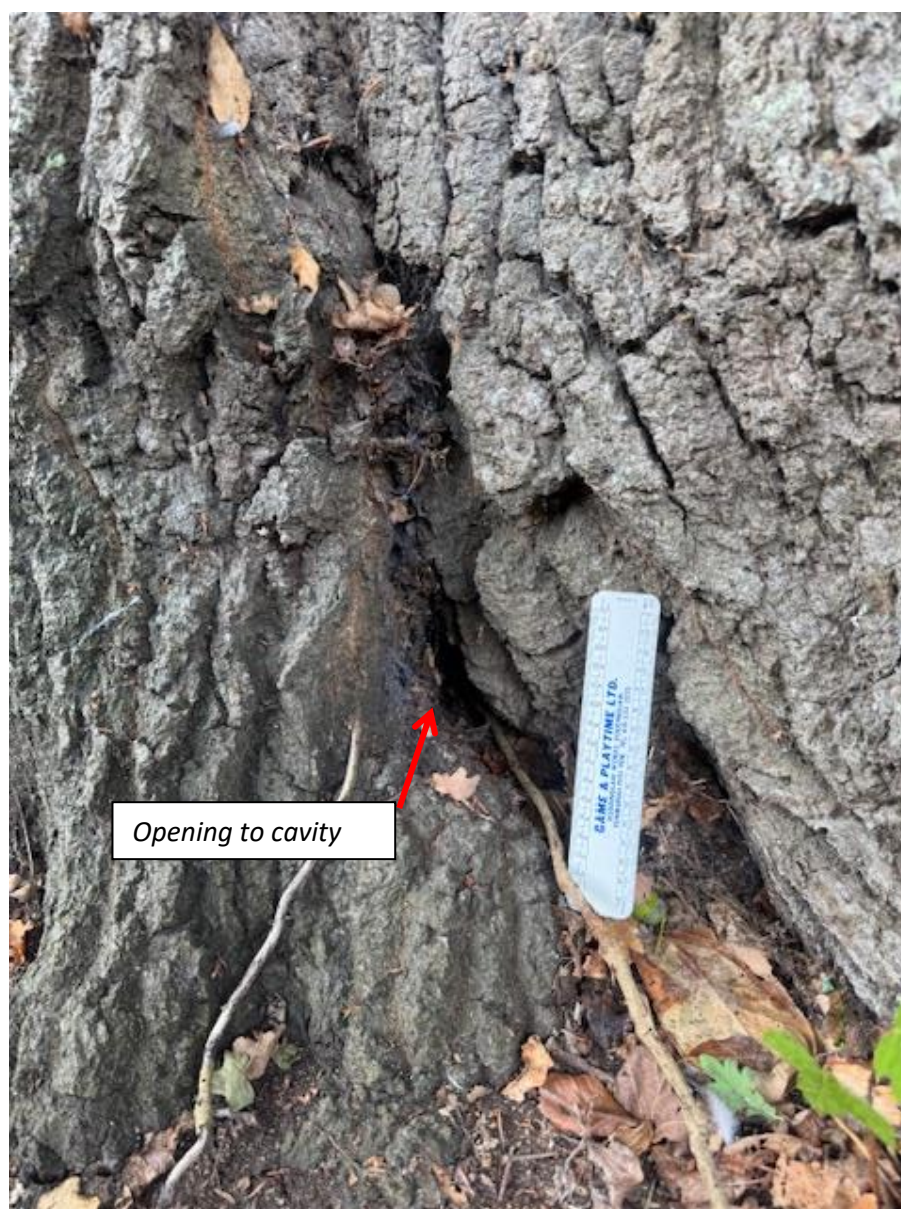
Photographs 2

6.3 A survey conducted by MJC Tree Services Ltd in 2025, which identified a basal cavity between the two roadside buttress roots (see photograph 2 m below). The survey also recorded large quantities of large diameter deadwood throughout the trees crown. The full results from this survey can be found by contacting MJC Tree Services Ltd.

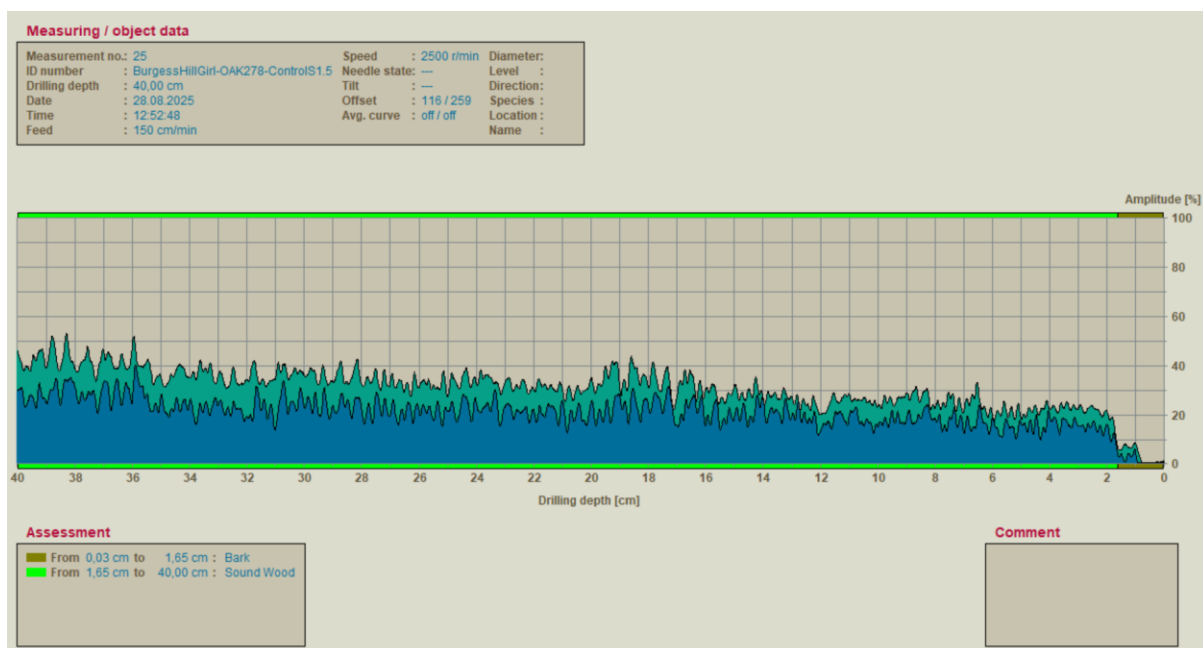
*Table 2 Showing the control assessment carried out at 1.5m on south side of trunk.*

9.4 The control showed consistent drill and feed resistance (see Table 2, in the results above), suggesting a uniform wood density throughout and is considered a good comparative control against other investigations carried out at the tree's base.

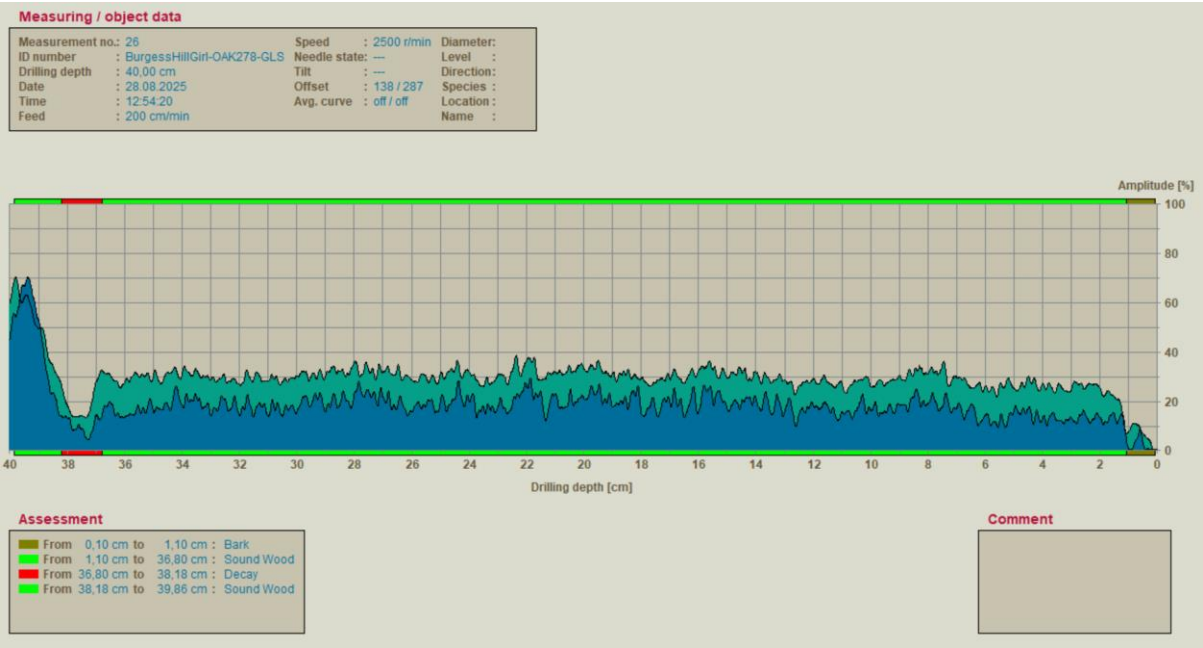
Table 3 - Showing the assessment carried out at ground level on the south side.

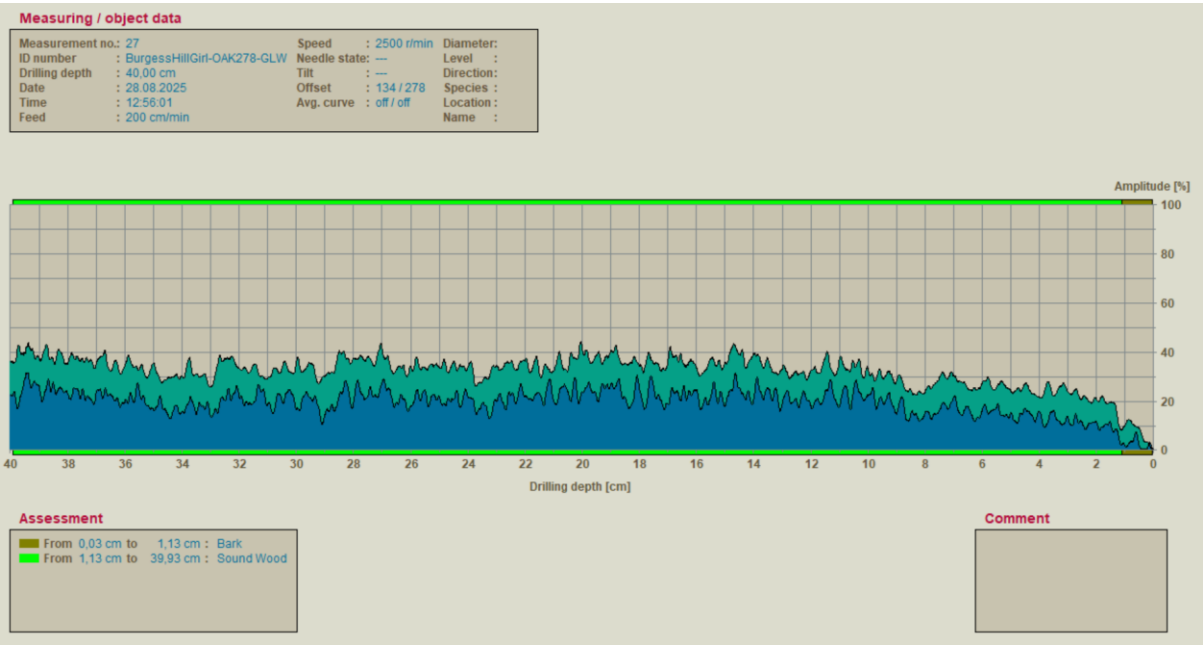
Table 4 - Showing the assessment carried out at ground level on the west side.

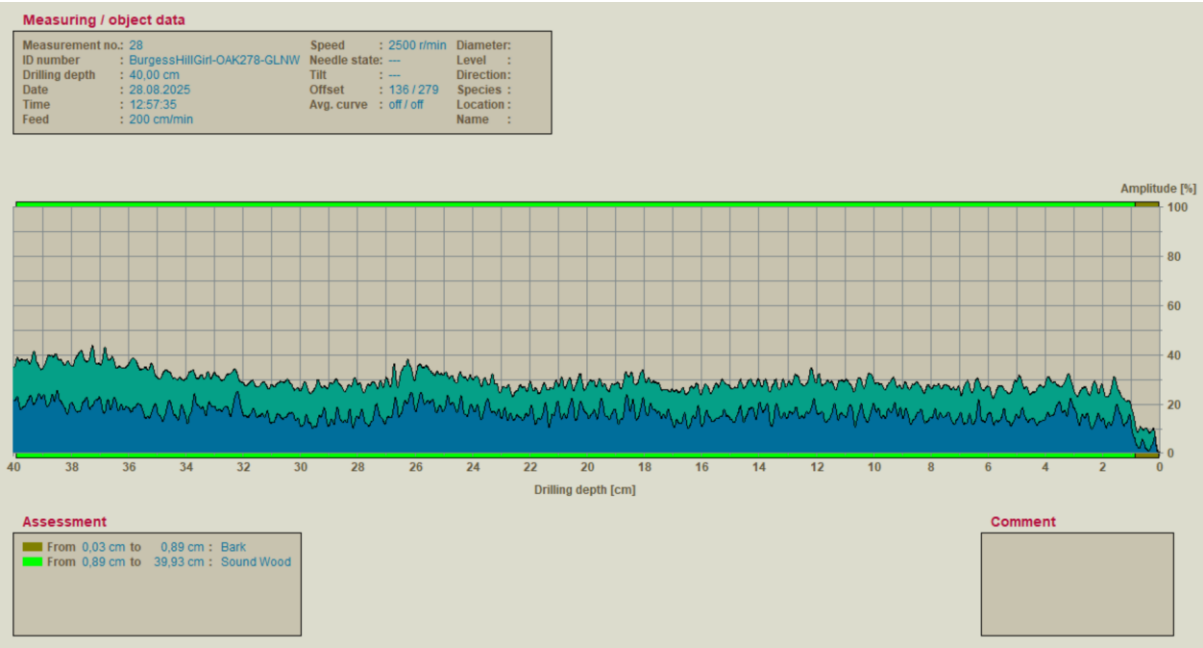
Table 5 - Showing the assessment carried out at ground level on the north-west side.

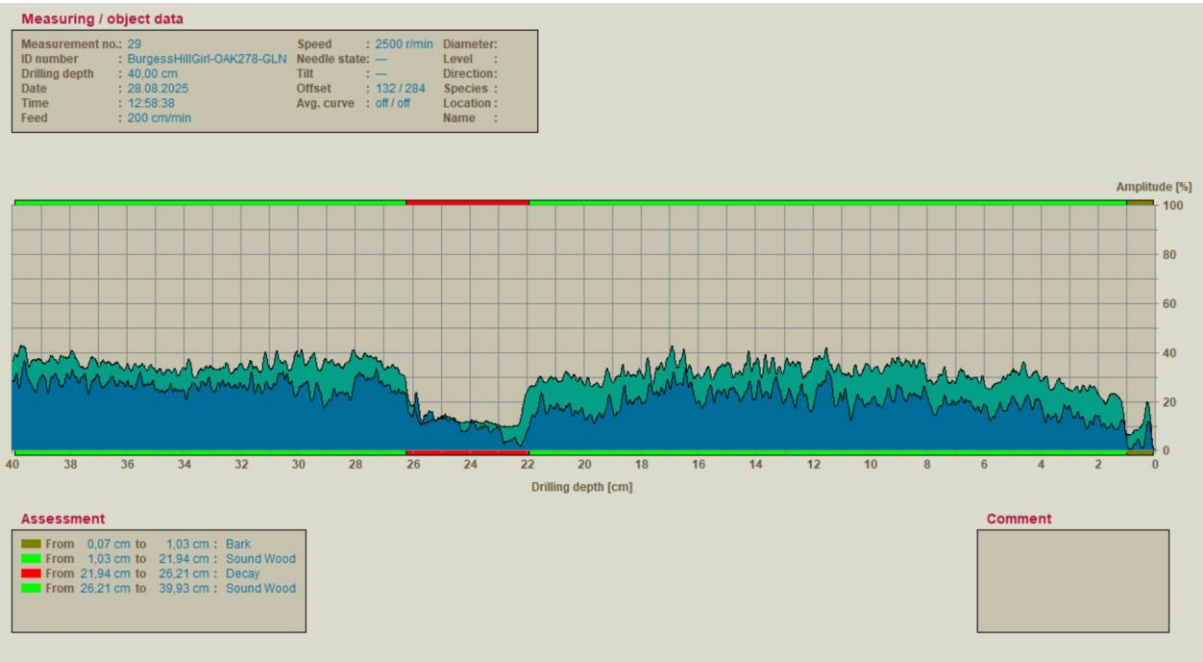
Table 6 - Showing the assessment carried out at ground level on the north side.

9.6 As mentioned above in microdrill investigations there were areas where the wood integrity appeared compromised, this is demonstrated by a clear reduction in both the microdrill's feed and drill resistance throughout each investigation. These ranged from only 2 centimetres column (see Table 6), during a ground level investigation on the north side.

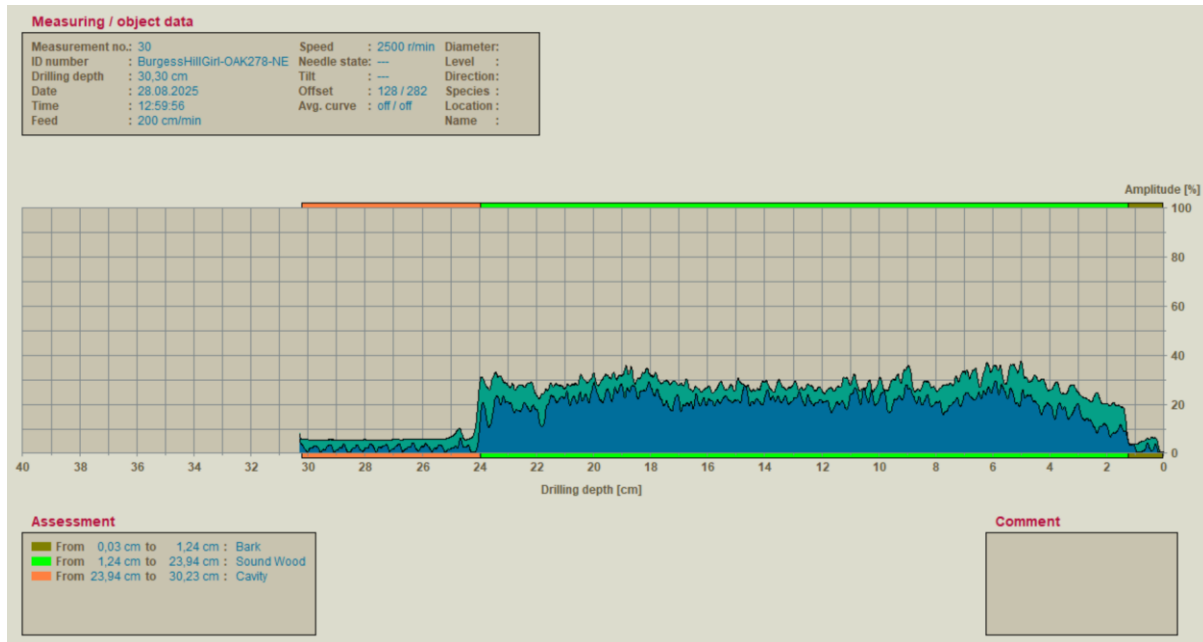
Table 7 - Showing the assessment carried out at ground level on the north-east side. NB drill auto. retracted at 30cm.

9.7 In the ground level microdrill investigation of the north-east side of the tree, there was a clear drop in both the microdrill's feed and drill resistance, with the drill auto retracted at 240 millimetres (as a safety precaution to prevent damage to the equipment), suggesting a cavity. Due to the drill auto retracting, it could not be determined whether the cavity extended beyond this point (see Table 7, in the results above).

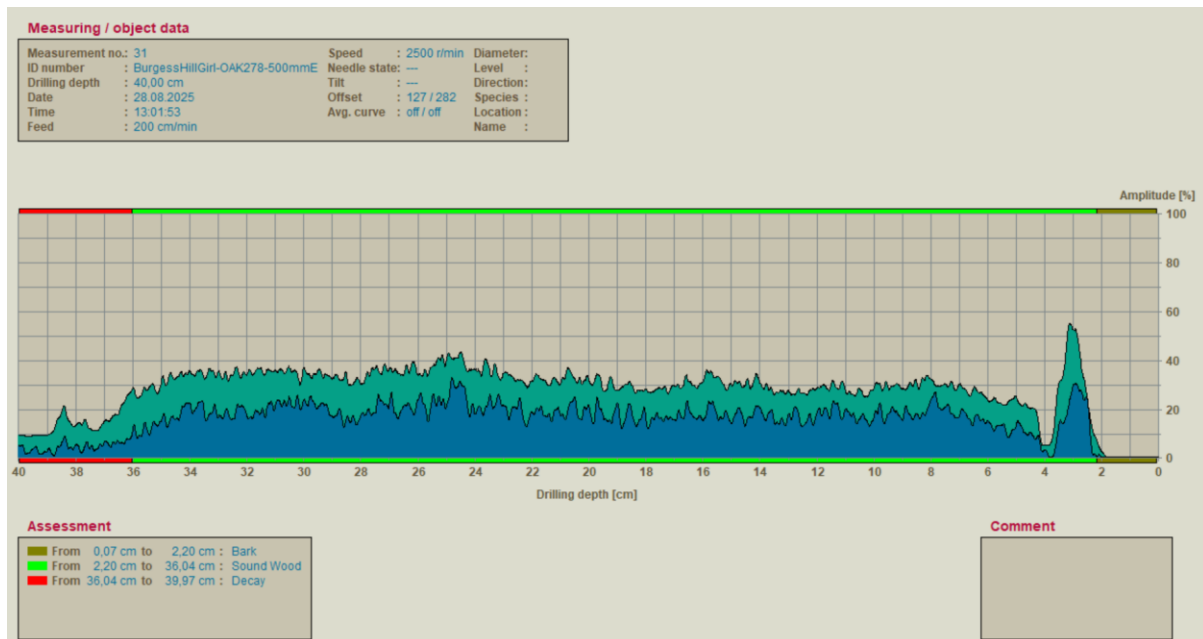
Table 8 - Showing the assessment carried out at 500mm above ground level on the east side.

9.8 Similarly in the microdrill investigation of the east side, both the microdrill's feed and drill resistance reduced at 360 millimetres, suggesting decay, but it is unknown how far this extended beyond this point (see Table 8, in the results above). This investigation could only be carried out at 500 millimetres above ground level, due to obstructions mentioned in paragraph 9.3, it is unknown whether the cavity extended below this point.

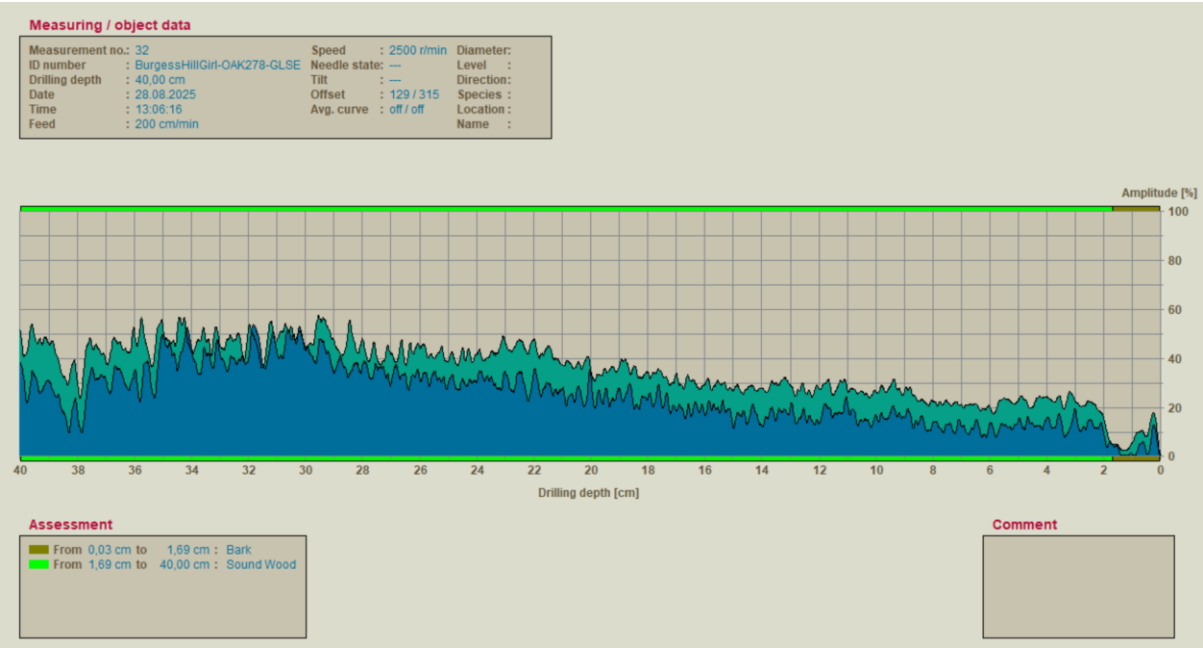
Table 9 - Showing the assessment carried out at ground level on south-east side.

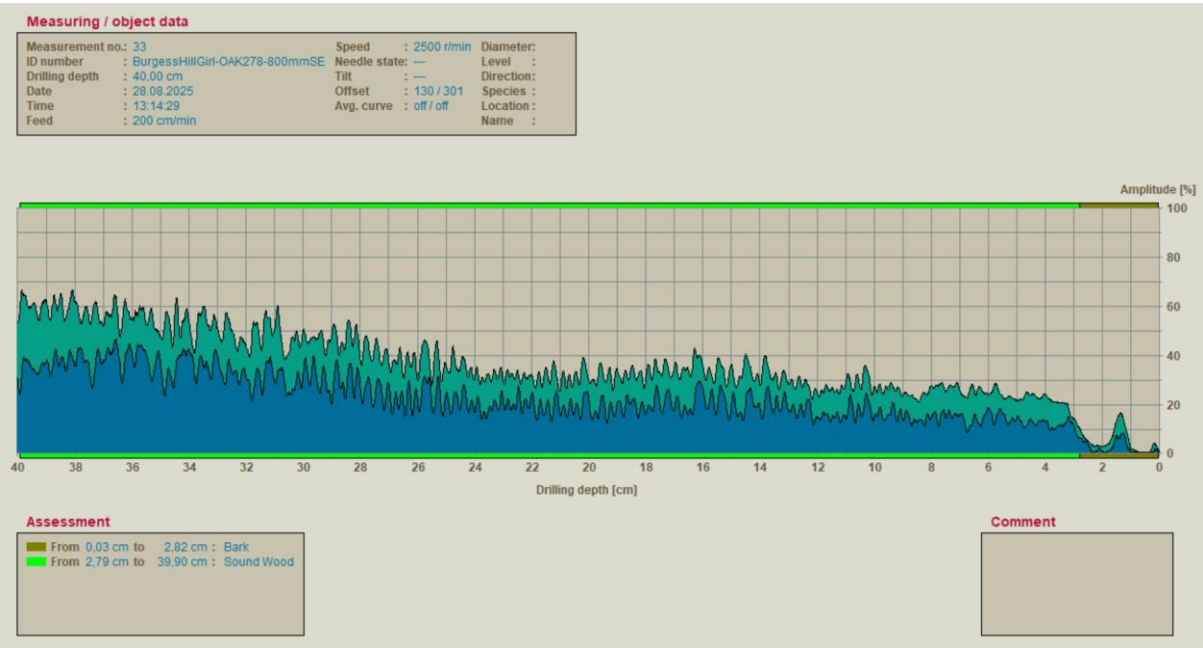
Table 10 - Showing the assessment carried out at ground level on south-east side.

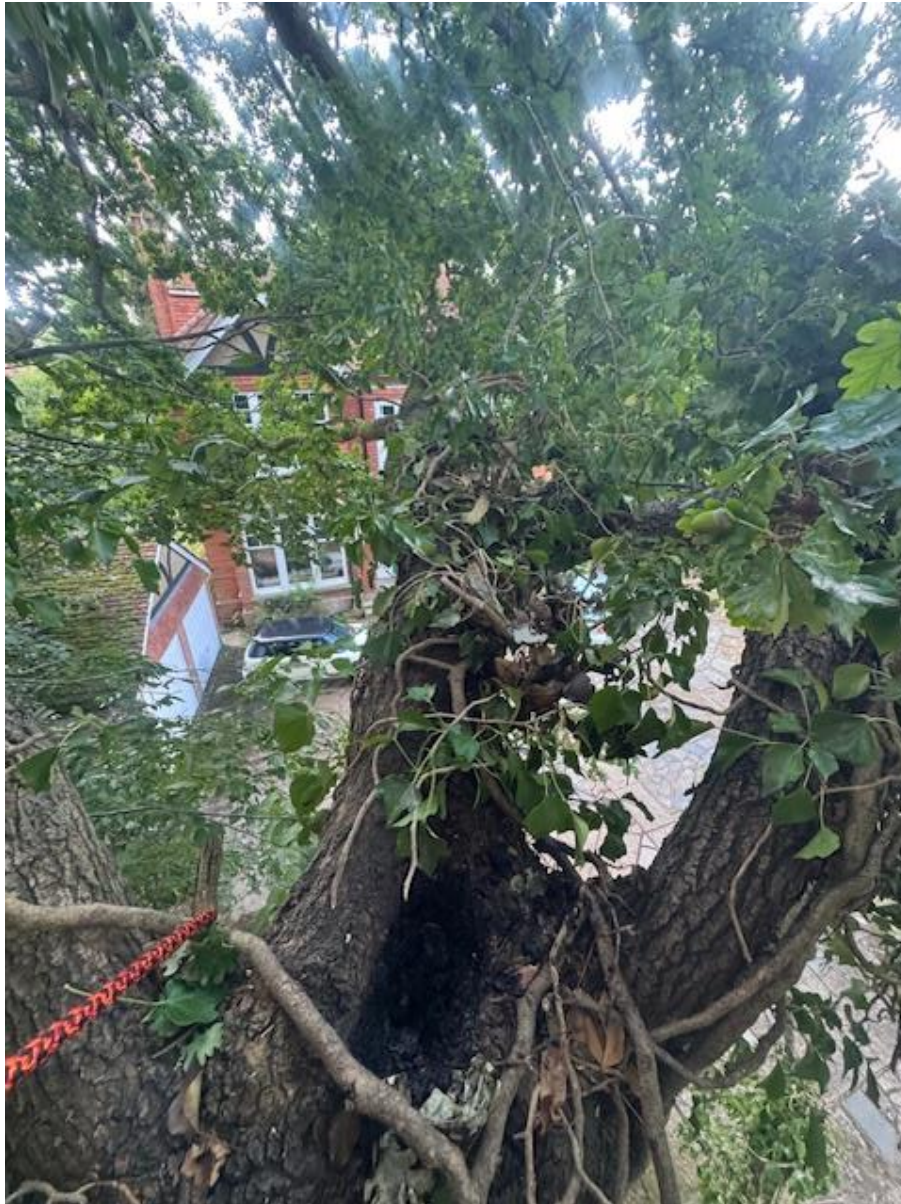
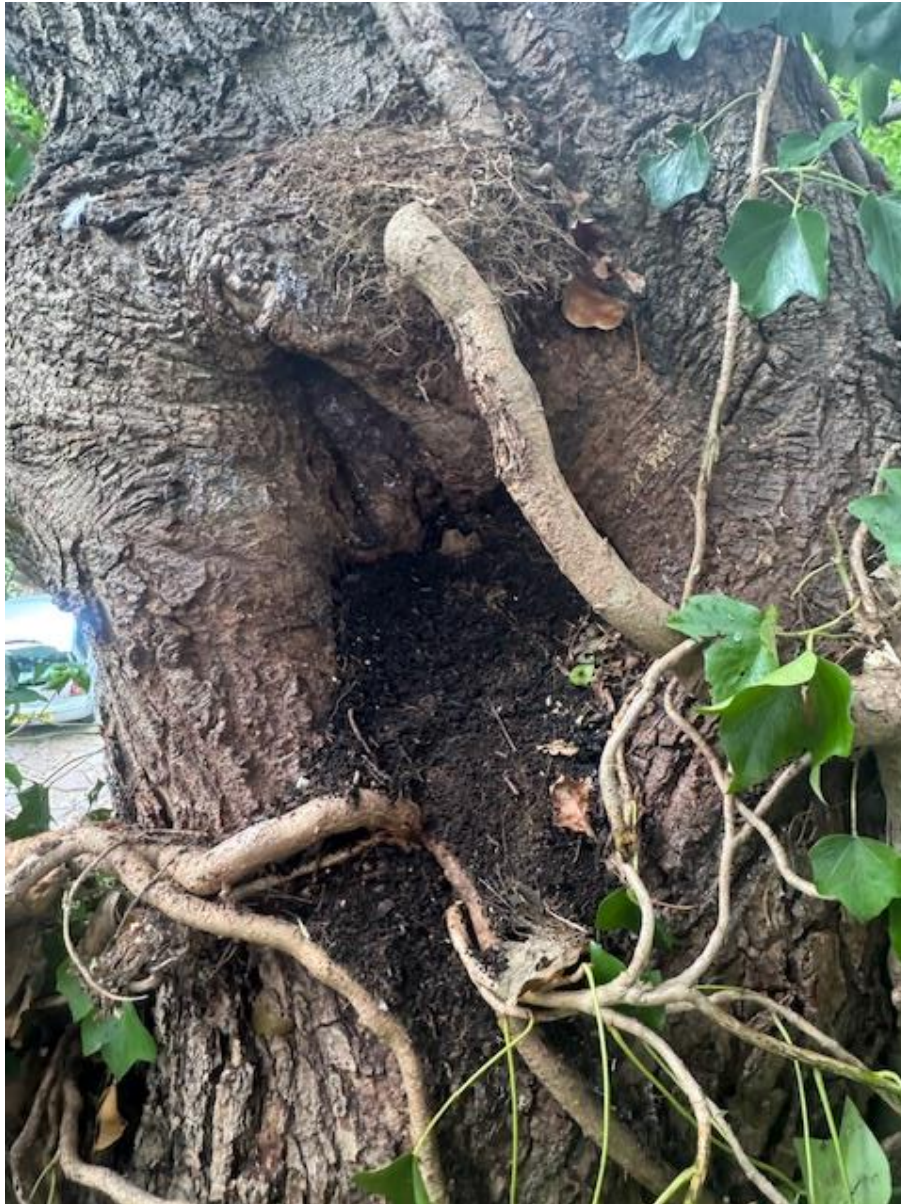
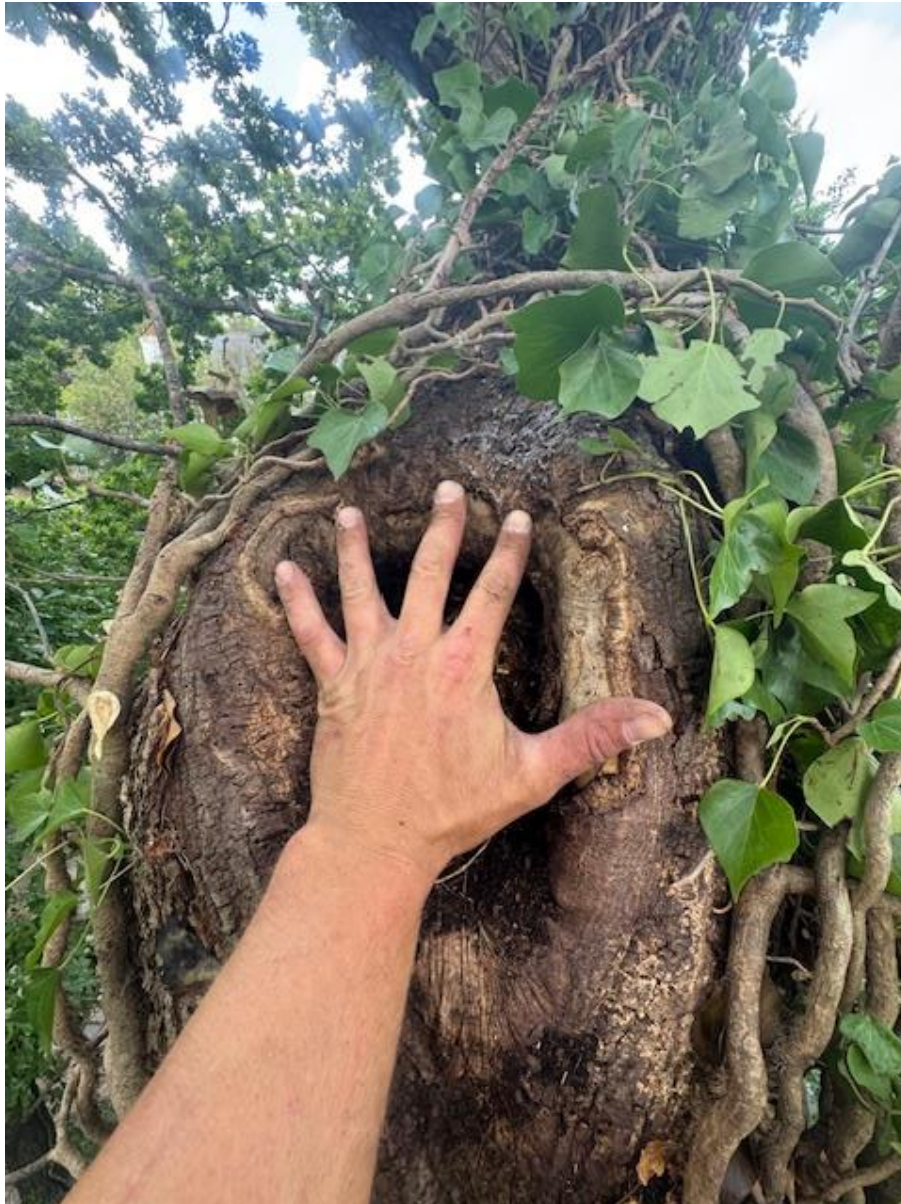
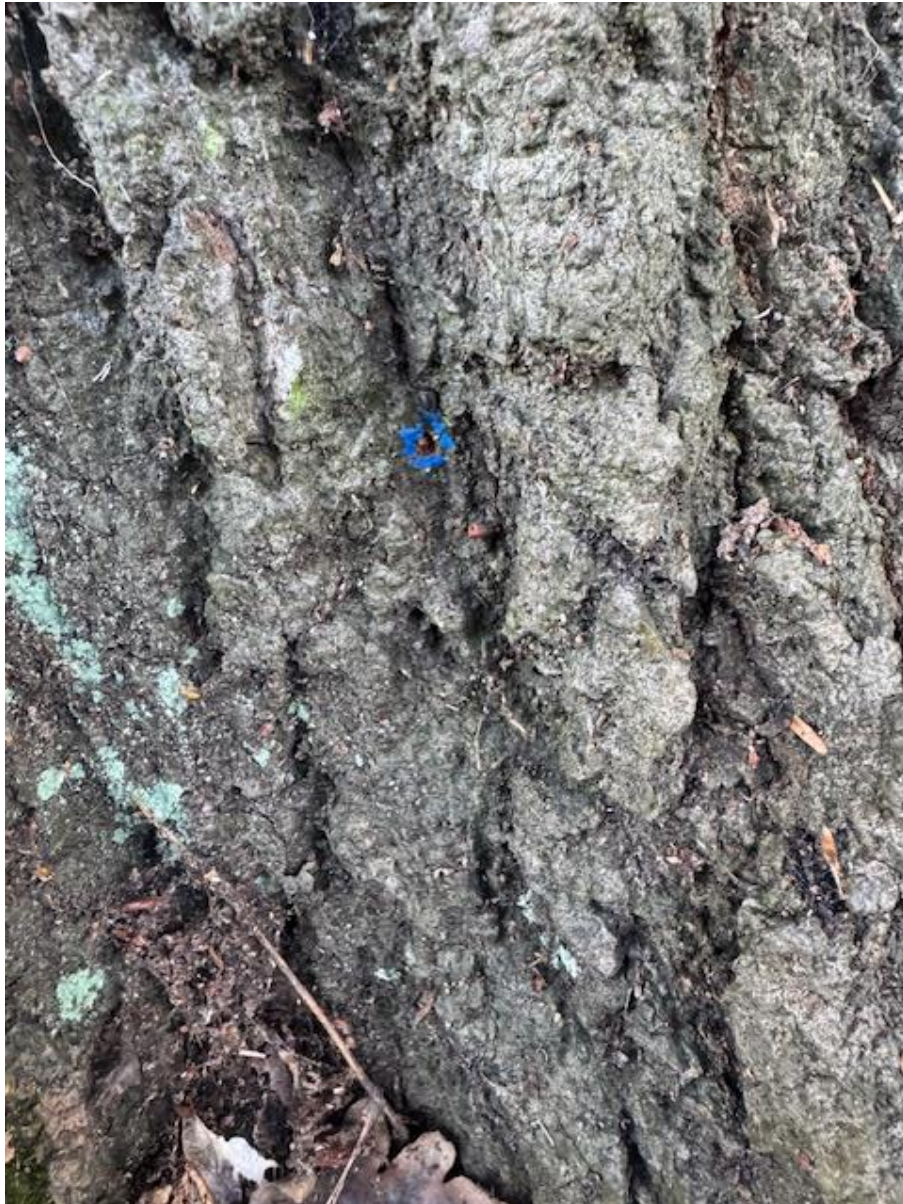
## APPENDIX 2: SITE PHOTOGRAPHS

9.9 After the microdrill investigation, the tree was subsequently climbed during removal of its deadwood, which exposed various defects not visible from the ground. Firstly, a large knothole on the south at 5m above ground level measuring 400 mm x 250 mm wide x 250 mm deep. Secondly another knothole on the west side at 8m above ground level, measuring 270 mm long x 180 mm wide x 300 mm deep. Both were filled with detritus. Various other smaller defects were also recorded (see photographs in Appendix 2 – Site Photographs below).

10.2 **Recommendation:** Reduce the entire crown by up to 2m in all dimensions, reducing back to a substantial lateral branch to leave as natural a shape as possible. Reduce to form a more compact crown with a finish tree height of approximately 17m and lateral finish branch length of approximately 9m.
