## Foul and Surface Water Drainage Report

**C- Store, Prince Albert, Copthorne**

**Westcoast Developments Ltd**

**Project Name:** Prince Albert Pub RH10 3QX  
**Project Description:** General CCTV - Condition Check  
**Project Number:** JSD7518  
**Project Status:** Complete  
**Project Date:** 25/07/2024  
**Inspection Standard:** MSCC4 Sewers & Drainage GB (SRM4 Scoring)

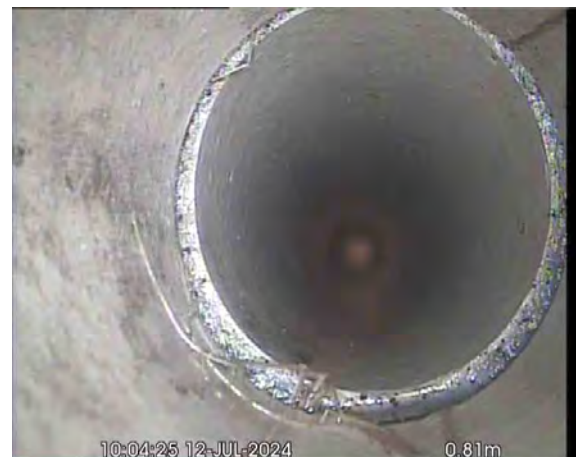
GULLYX\_b10122b8-1f1f-4b61-85ad-1d1dd839dd63\_20240725\_090208\_797.jpg, 00:01:01, 0.81 m  
Crack, circumferential at joint from 6 o'clock to 9 o'clock

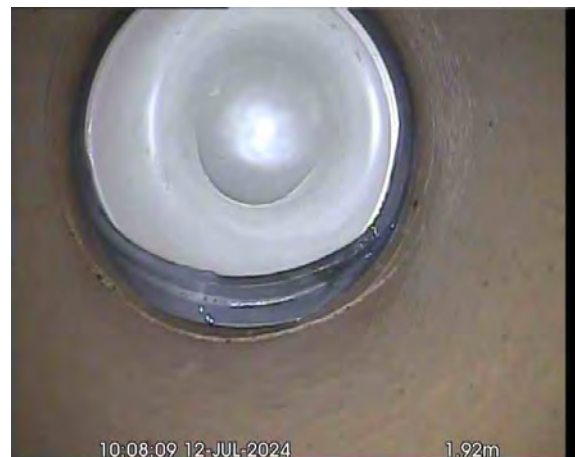
W\_CX\_140950e0-f4b9-4fa9-b1b6-8f3dc2314eb6\_20240725\_090748\_590.jpg, 00:01:01, 1.92 m  
Crack, circumferential at joint from 12 o'clock to 12 o'clock

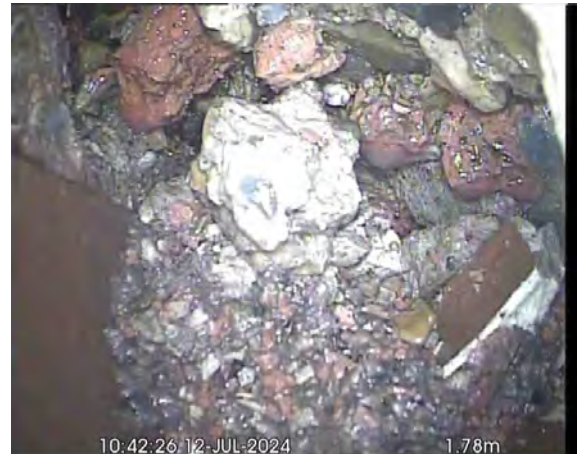
REDUNDANTX\_716789ca-25ee-4cc2-8135-a7bc7aff19d4\_20  
240725\_091212\_524.jpg, 00:00:56, 1.78 m  
Settled deposits, hard or compacted, 100% cross-sectional  
area loss

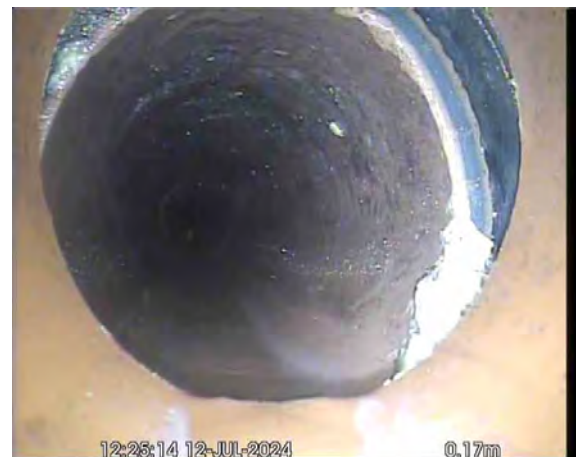
MH5X\_a67b5490-9c73-459b-9229-8a05c12ea946\_20240725\_094558\_658.jpg, 00:00:41, 0.15 m  
 Joint displaced, large

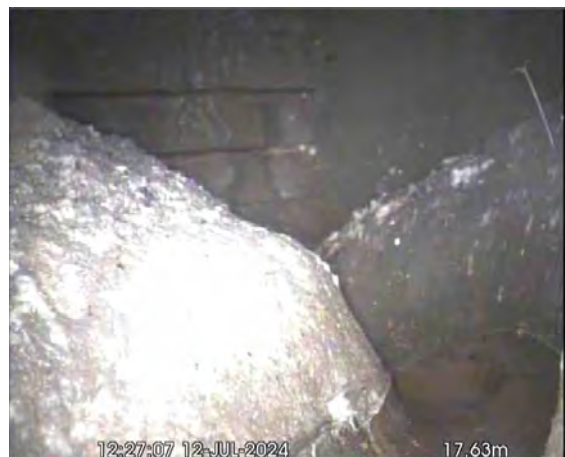
MH5X\_245e56e0-af60-4cc5-9251-72fe8d11e2b2\_20240725\_094946\_179.jpg, 00:02:23, 17.33 m  
Fracture, multiple from 12 o'clock to 12 o'clock

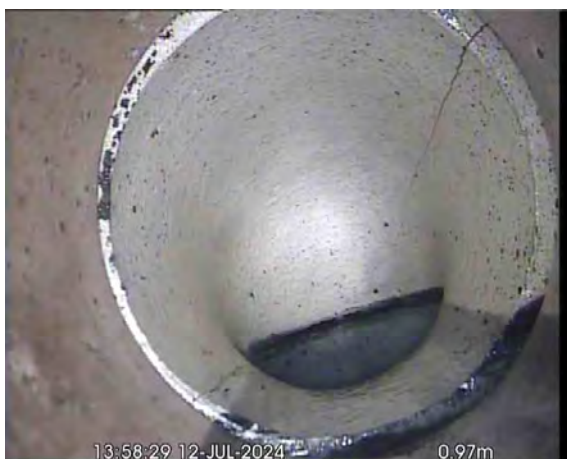
GULLYX\_36dc49d5-3dc1-4da4-862e-24eaa0b586df\_20240725\_100014\_047.jpg, 00:00:24, 0.97 m  
Crack, longitudinal at joint at 2 o'clock
