## BUILDING SURVEY REPORT

**BARN - WILLOWBROOK, DANWORTH LANE,  
HURSTPIERPOINT, HASOCKS BN6 9LW**

DATE OF INSPECTION: 4 APRIL 2023

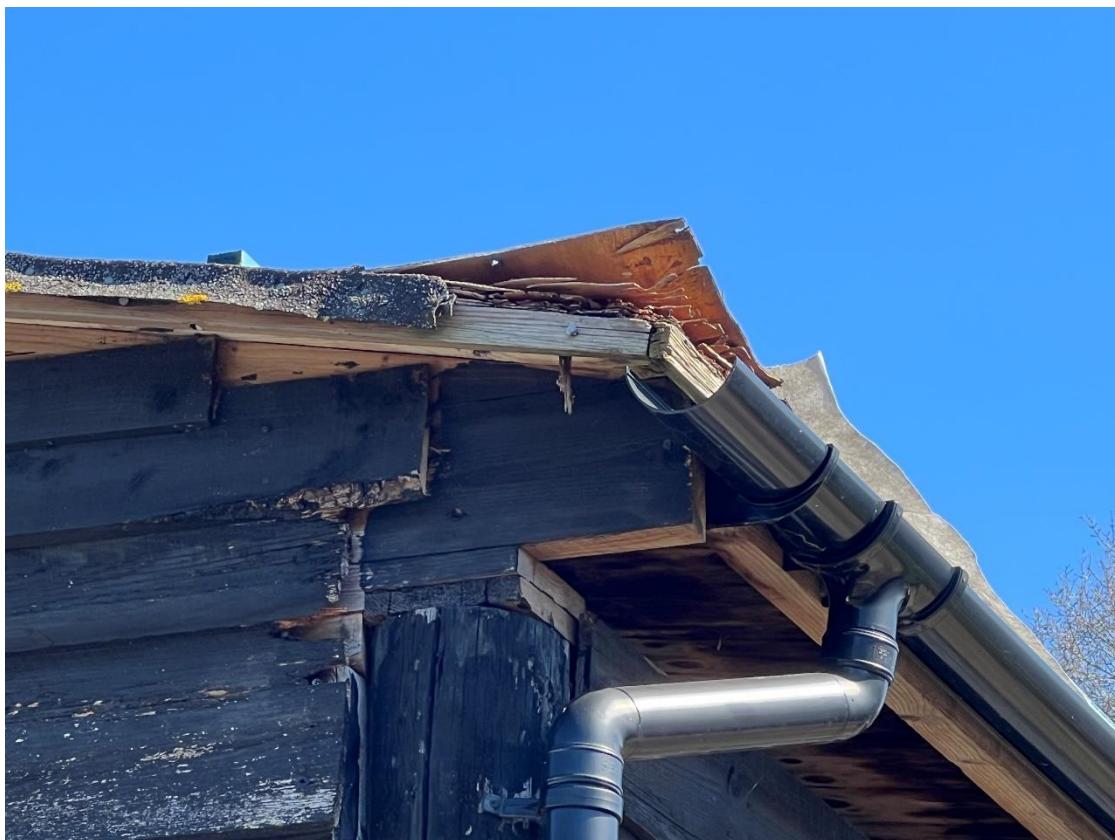
The felt covering has failed and in places from the inside daylight can be seen through the joints of the plywood. There is water damage to some of the plywood, most notably to the front left corner. The majority of the plywood, however, appears to be in a good condition and can be reused.

Whilst there is evidence of some mould growth on the underside of the plywood this is of no concern due to the property currently being well ventilated due to its current intended use.

I recommend that the existing covering is removed. Patch repairs should then be carried out to the plywood, removing rotten and damaged parts. New sections of external grade plywood should be installed where required before a suitable new weatherproof covering is installed.

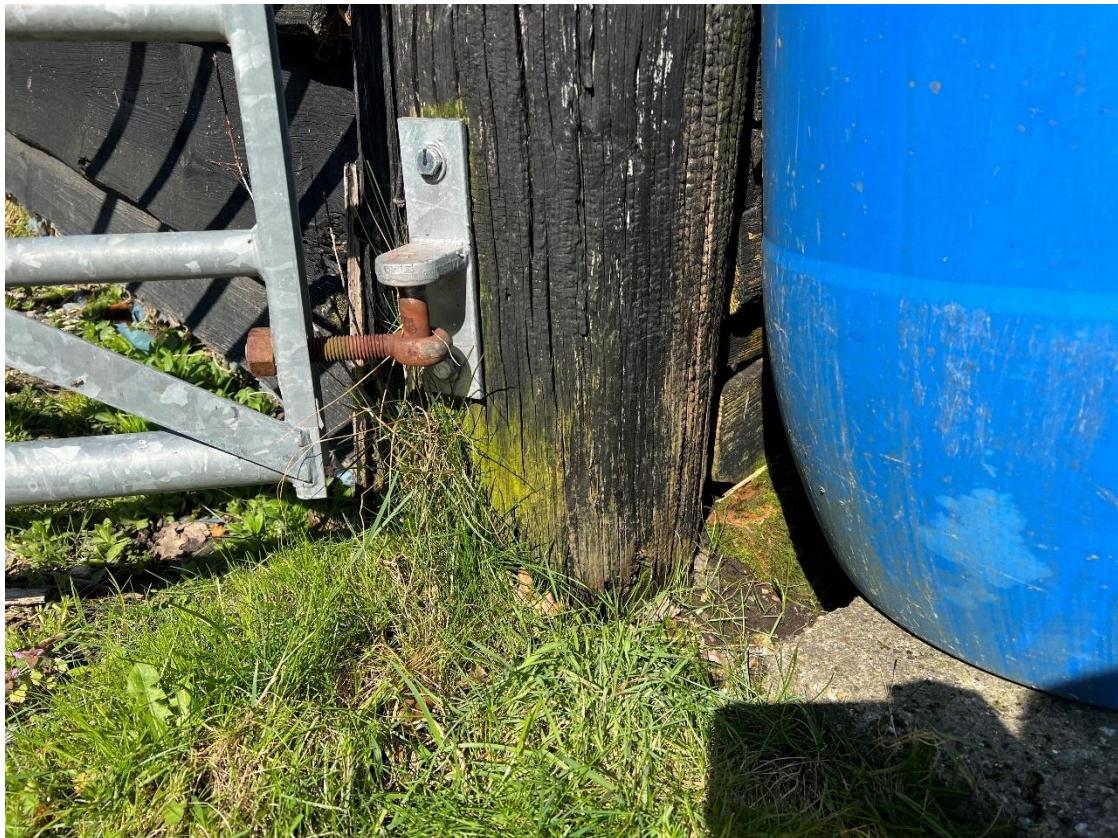
Where visible, most notably to the front right hand corner post, there is significant surface rot to the telephone poles where these bear into the ground, however, the underlying heartwood appears to be in a good and structurally sound condition and there does not appear to be any need to carry out significant repairs to the structural timber posts to ensure its ongoing condition.

The surfaces of the posts/poles are affected by weathering and there are large 'shakes'/cracks due to the standard drying out of timber but there is no need to carry out repairs to these but you may wish to have these filled with a suitable material to stop the penetration of rainwater. Generally these ten structural posts appear to be in a good structural condition.

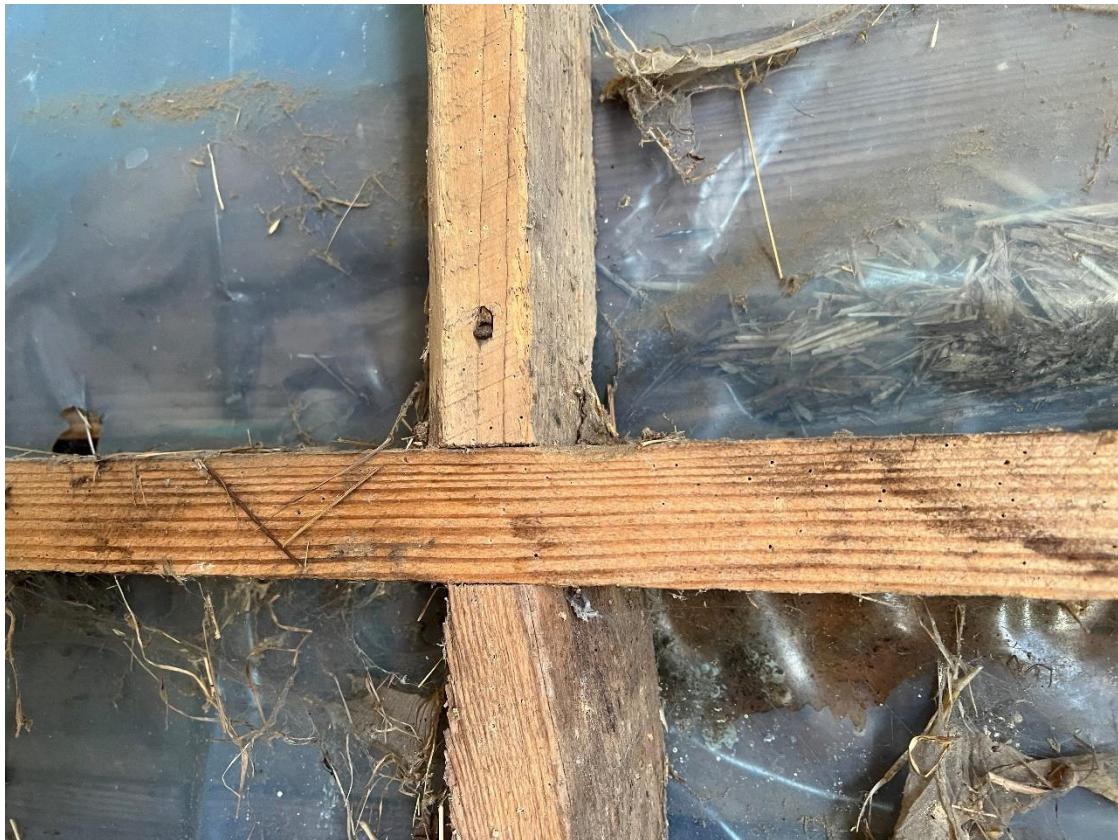
The timber studwork supporting the timber cladding varies in its condition. Most notable would be to the bases where numerous timber studs were found to be significantly rotten and in places entirely eaten away and are now supported in mid-air by other parts of the structure. It is unclear what these studs are supported onto but there is evidence in one location of a timber ground plate but the majority of the junction with the ground is concealed. These rotten posts/studs will require replacement or parts to be cut out and new timbers scarf jointed in.

However, the majority of the studwork forming the wall cladding structure is in a reasonable condition and structurally sound with parts above the immediate ground generally free from rot and significant damage. No obvious need for repair was seen to the majority of this supporting studwork, however, almost all parts are affected by wood boring insects but none was noted to such an extent that timbers require replacement. I recommend that all of the timbers are treated against woodworm.

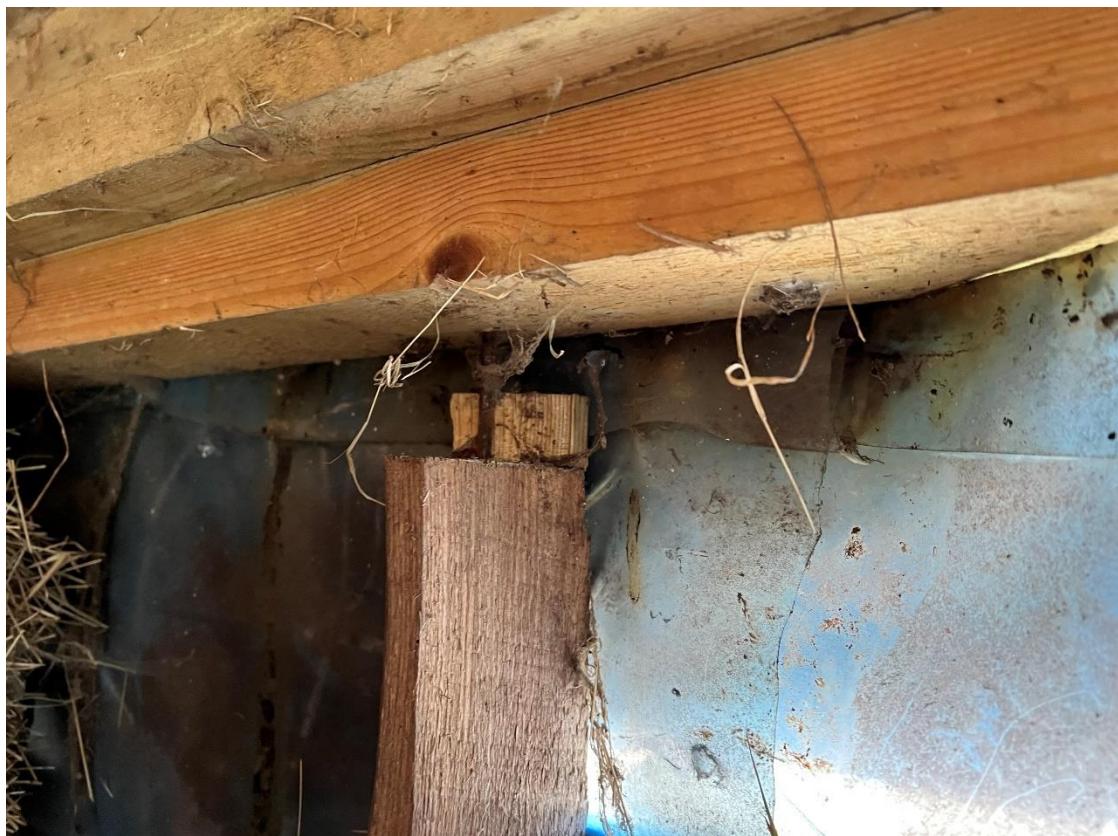
To the left hand side elevation at high level the timber wall plate is not fixed into the studwork as it appears to have moved. As such there is insufficient restraint to this part of the structure. Repairs should be carried out to reconnect the wall plate to the studwork.

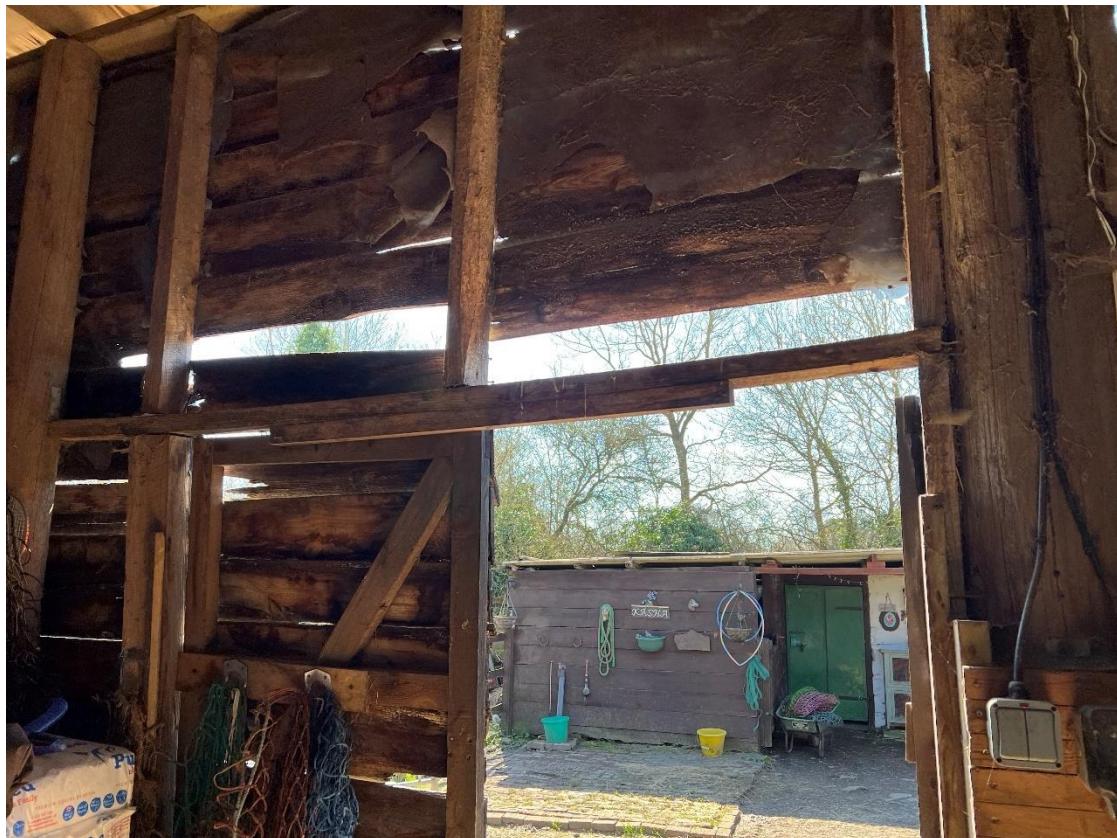
The vertical post to the right hand side of the front door frame is entirely rotten at the base and requires replacement.

The horizontal section of supporting frame above the front doors significantly bows and appears to be undersized. This part should be reinforced.
