## Tree Survey Report

### Proposed Emergency Generator, Worth School, Turners Hill RH10 4SD

Title:  
Tree Survey and Constraints Plan

Dwg No 2503/23/TCP Revision -

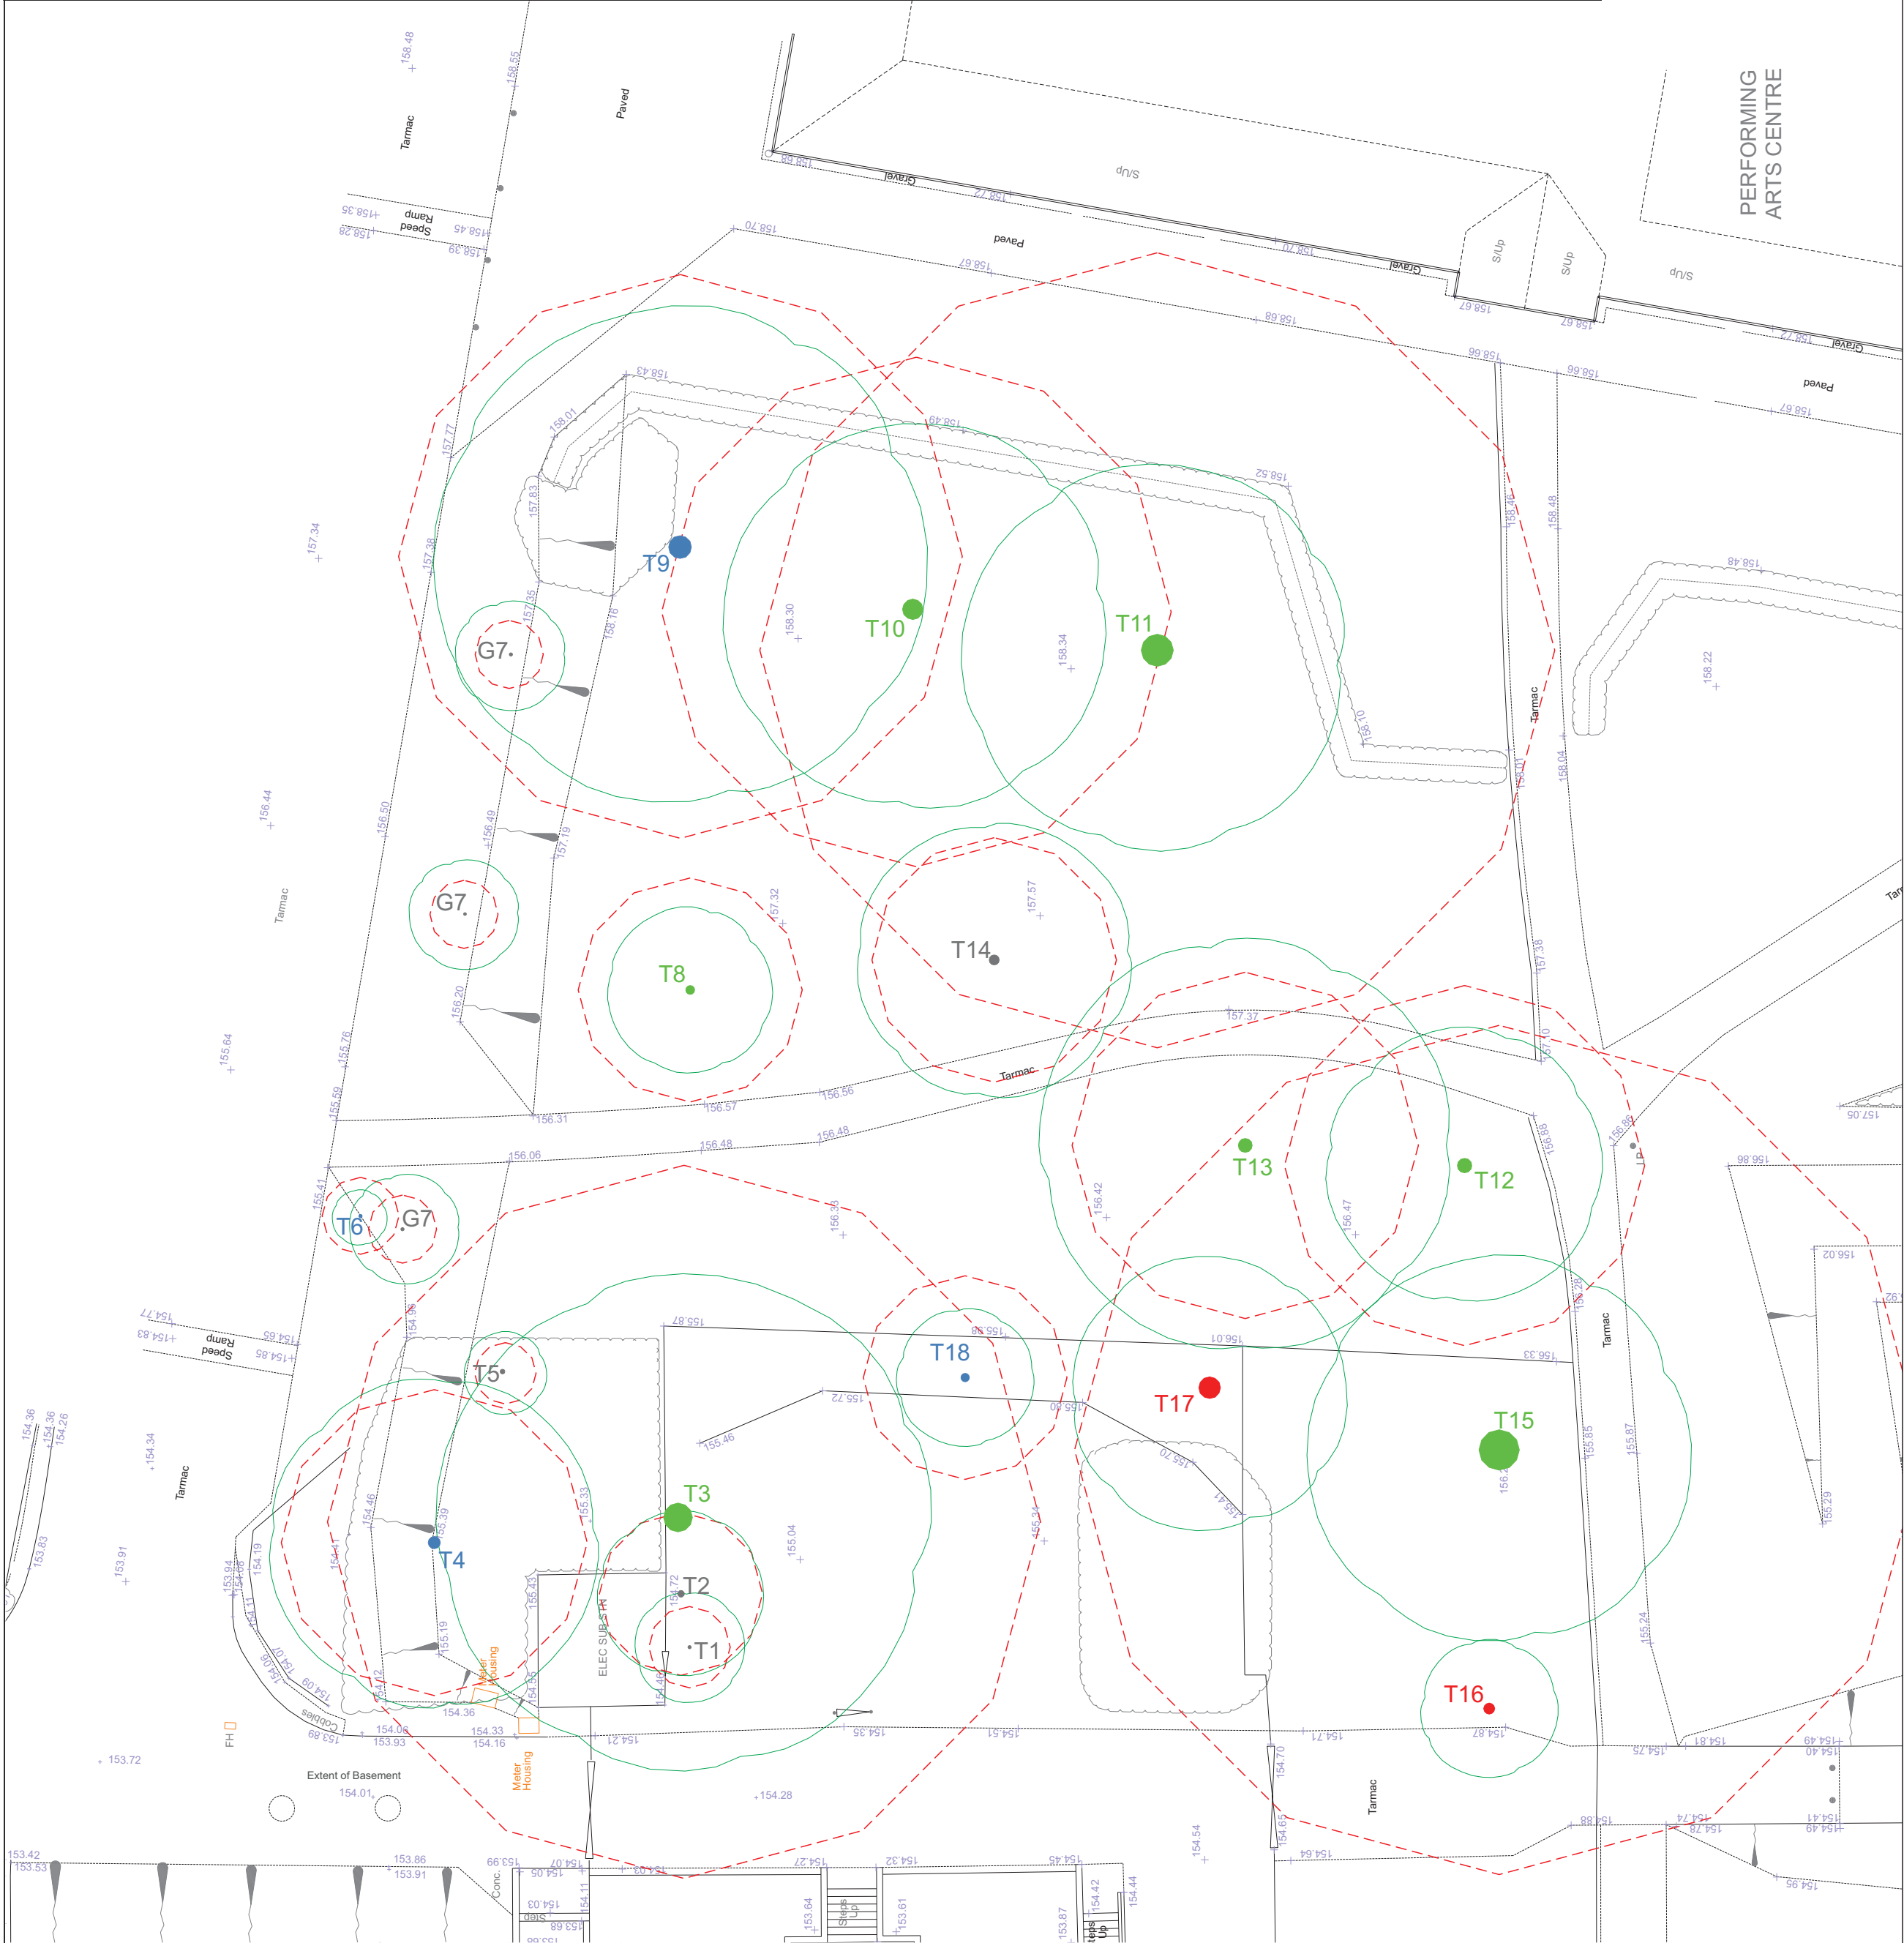
3.2 The tree schedule shown on the Tree Survey and Constraints Plan (ref 2503/23/TCP), provides the dimensions of those specimens included in the survey together with an assessment of their condition and life expectancy with specific comments regarding their condition where appropriate. In addition, each tree has been categorised according to its retention value following criteria provided in Table 1 of BS5837.

3.3 Two trees, a crab apple, T16, and a large western red cedar, T17 are in such condition that they are unlikely to survive 10 years. Accordingly, they are graded category U.

5.4 The RPA for each retained tree is detailed in the schedule of trees and shown on the tree survey plan as red dashed polygons. Where offsetting is considered appropriate it is specifically noted.

5.5 In this case, there are no obvious site features that would have any influence of significance on root growth. No off-setting of RPAs is therefore required.

4.2 In this case, it is recommended that the two category U trees, T16 and T17 are removed.

4.3 In addition, whilst it is currently in good condition, the small self-set ash tree, T2, should be removed. It is growing very close to the fence surrounding the nearby sub-station and is not suitable for this position.
