## Arboricultural Impact Assessment

### Proposed Emergency Generator, Worth School, Turners Hill RH10 4SD

Title:  
Arboricultural Impact Assessment

| Dwg No | 2503/23/A1A | Revision | - |

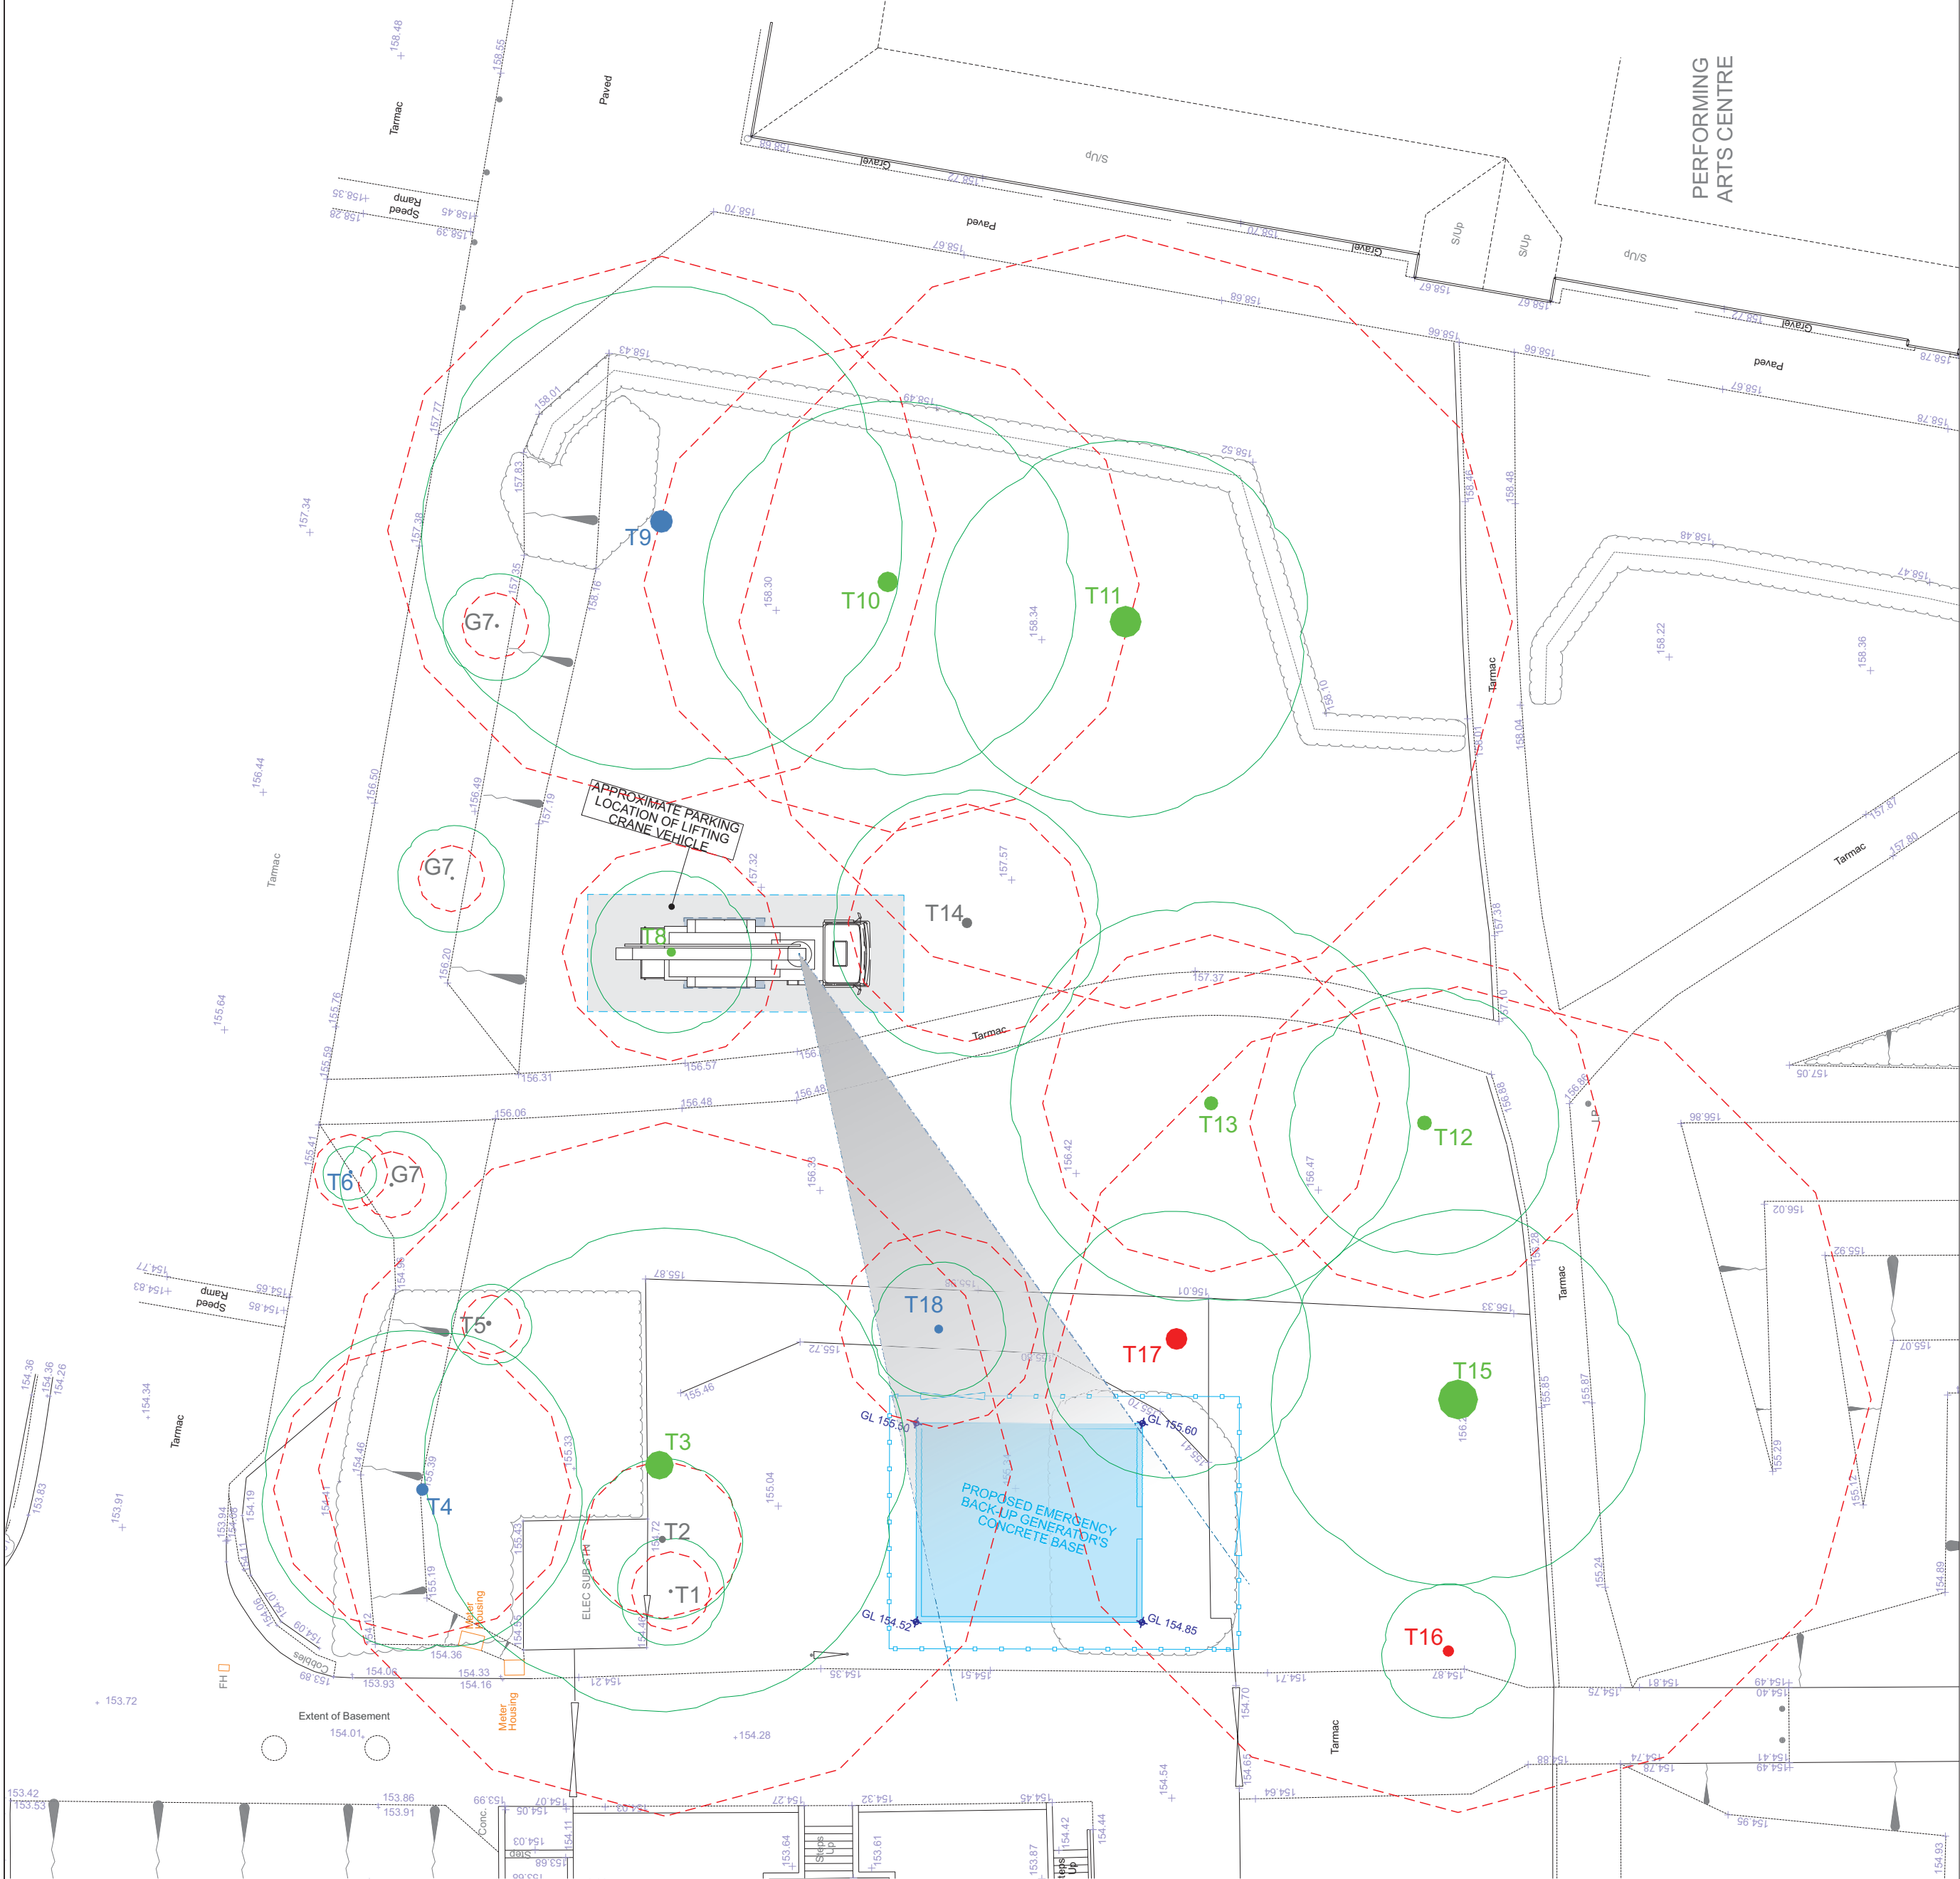
3.2 The tree survey report recommends the removal of trees T16 and T17 due to their poor condition. In addition, the removal of tree 2 is recommended due to its unsuitability to the position in which it is growing.

4.1 The construction of the base and surrounding enclosure for the proposed generator do not in themselves necessitate the removal of any trees. It will however be necessary to remove two trees, T8 and T14 to allow access for the mobile crane that will be used to lift the generator into place.

4.2 T8, a pin oak, is a relatively young tree of excellent form and significant potential, accordingly it was graded category A in the tree survey. Whilst it is regrettable to lose a tree of good form at just 11m high, its current contribution to the landscape is quite limited. Views of the oak are restricted to a small area within the School grounds, it is not visible from any position of wider public access.

4.3 Tree T14, is a 9m high horse chestnut. The chestnut has been categorised of low value due to significant areas of bleeding canker on its stem and main branches that have caused the leading stem to die out. Whilst it is possible that the tree may overcome these issues in time, its current condition does not warrant a higher grading.

4.5 The position of the concrete base for the generator will require an incursion into the root protection area of an oak, tree T3 of around 4% of the overall area. There will also be an incursion of around 2.7% into the RPA of the western red cedar T15. In both cases, the extent of incursion is quite minor and within tolerable levels. Low retaining wall around the north, east and west sides will allow adjacent ground levels within the enclosure to be maintained as existing.

4.6 Whilst no information regarding new underground services has been provided, it is assumed that a connection between the generator and the existing sub-station will be required. It is recommended that any new underground services be routed from the south side of the concrete slab, as far away from the oak T3 as possible. It will be necessary for excavations for any service trench within the RPA of T3 to be dug by hand so that any roots greater than 25mm in diameter can be retained, unharmed. Cables shall be routed below or between roots as necessary.

4.7 Provided that the tree protection measures specified in the accompanying arboricultural method statement (AMS) and tree protection plan (TPP) are implemented and strictly maintained throughout the construction period there is no reason why the retained trees should not be adequately safeguarded from the effects of construction.
