# APPENDIX 3 - FIVE YEAR ROLLING MAINTENANCE PROGRAMME

## ST STEPHENS CHURCH, HORSTED KEYNES

## **Appendix 2 - Schedule of Photographs**

### **St Stephens Church, Horsted Keynes RH17 7DX**

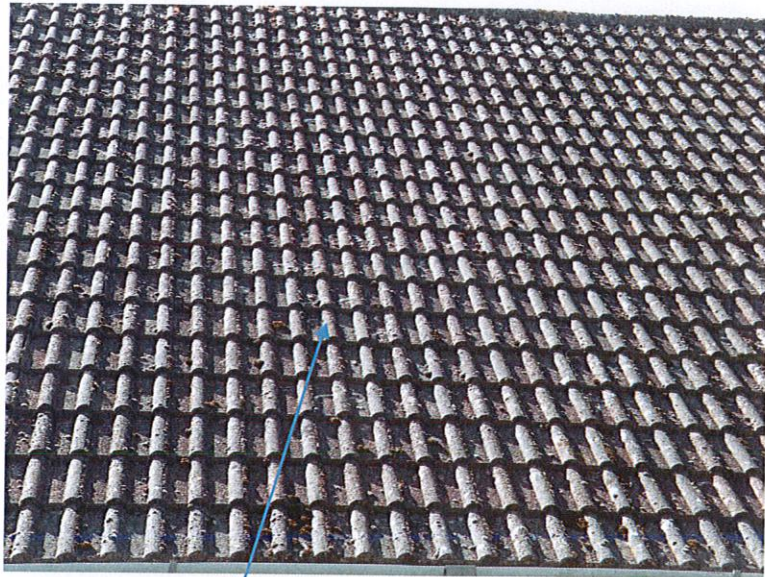
Roof profile true and even. Tiles generally well fixed,  
Photograph C3

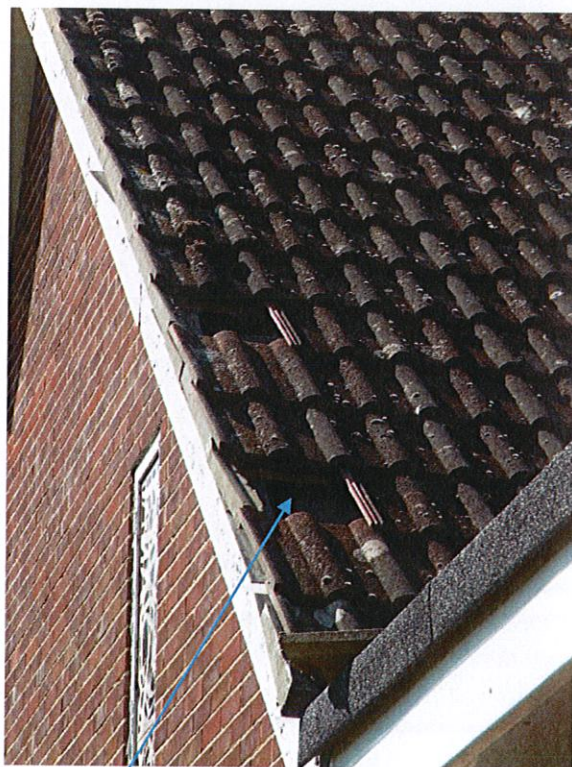
Missing tiles to southern gable  
Photograph C4

4. Isolated tiles to the southern gable have slipped or are missing and will need to be refixed as a priority item as this has led to internal water penetration (see photograph C4).

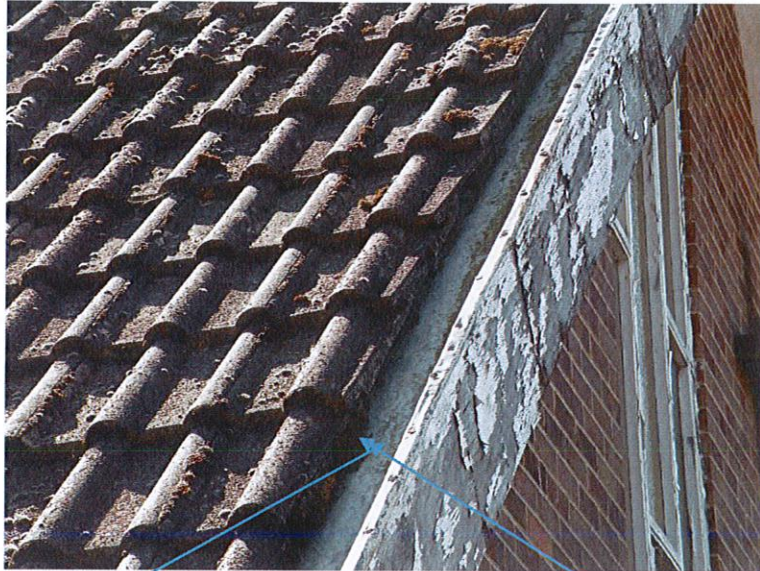
**Photograph C5**

**Lead lined channel to gable verge    Cracked and missing cement fillets**

7. The original lead lined channel to the north facing gable is aged and worn and although still considered serviceable, has in our opinion a limited lifespan and will need to be replaced in the short term (see photograph C5).

8. Cement fillets at the junction between the end coursing of tiling and leadwork are cracked and loose and will need to be re-formed.
  9. The ridge line undulates slightly but not seriously so.

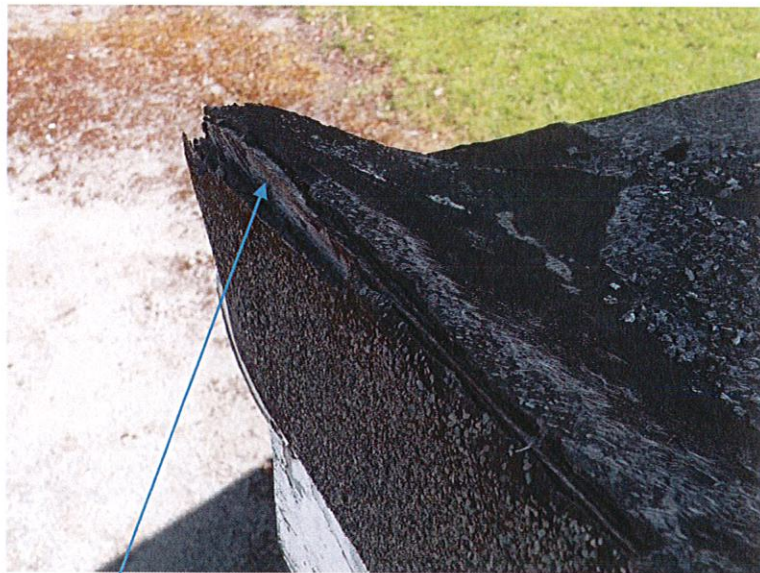
**Photograph C6**

**Split and blistered bituminous felt covering to verges**

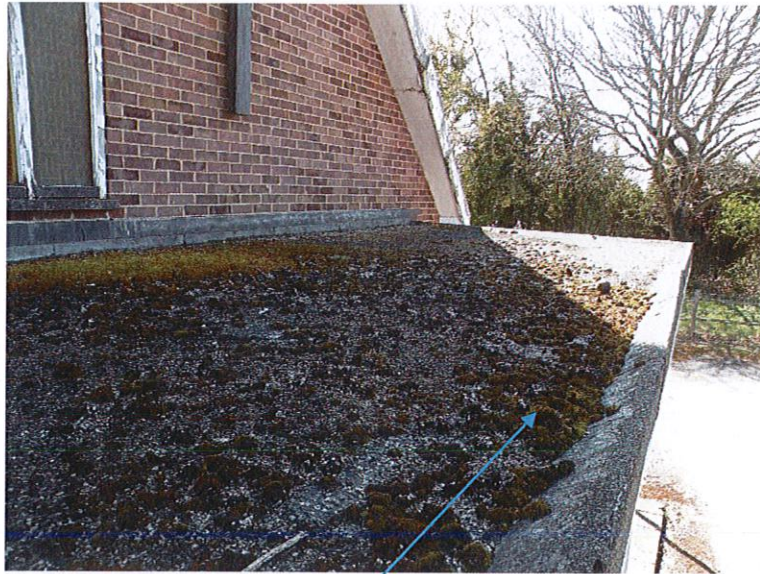
**Moss build up**  
**Photograph C7**

- 1.18 This roof is of timber framed flat construction surfaced with bituminous felt.
- 1.19 Bituminous felt upstands are provided at the junction with the north elevation wall together with lead cover flashings, which have been fixed into the brickwork and dressed down over the felt upstand.
- 1.20 We would make the following observations:
1. The roof covering is in a poor state of repair.
  2. There is evidence of splits and blistering of the felt most notably along the line of the verge (see photograph C6).
  3. There is moss and lichen growth which is an indication that water is tending to pond on the roof. Ideally, this should be removed (see photograph C7).

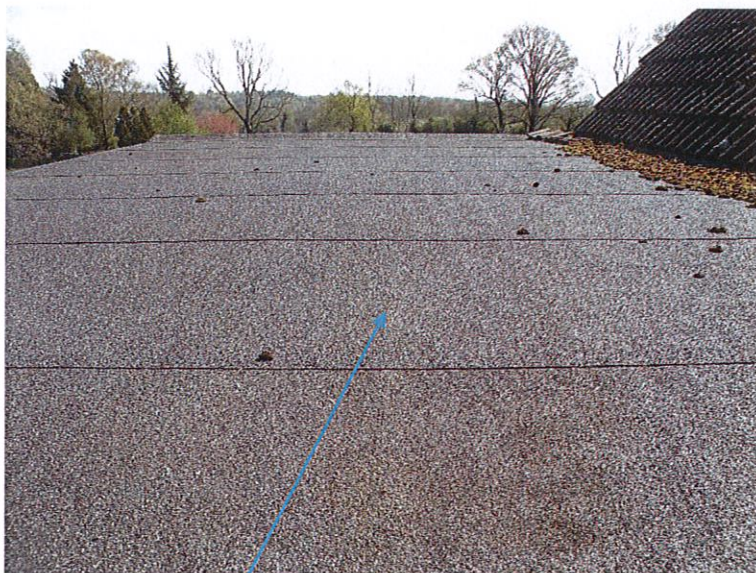
**Elastomeric felt is in good order**  
**Photograph C8**

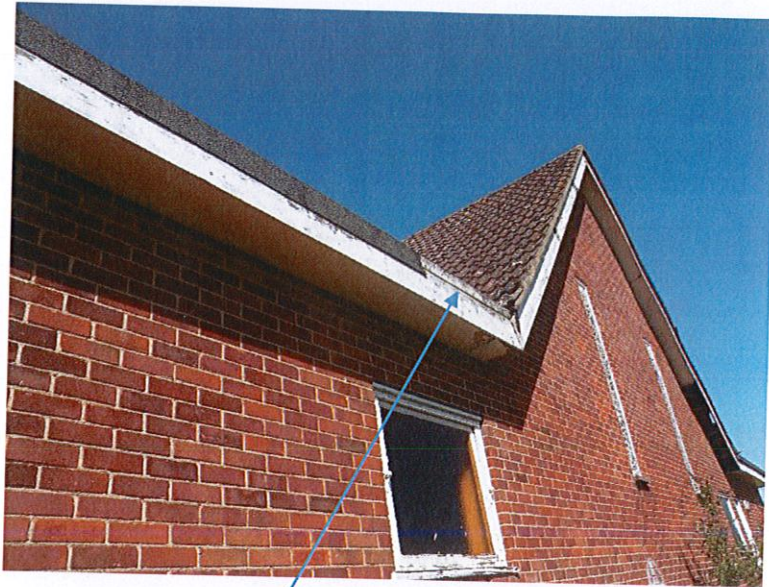
Missing section of felt covering to verge  
Photograph C9

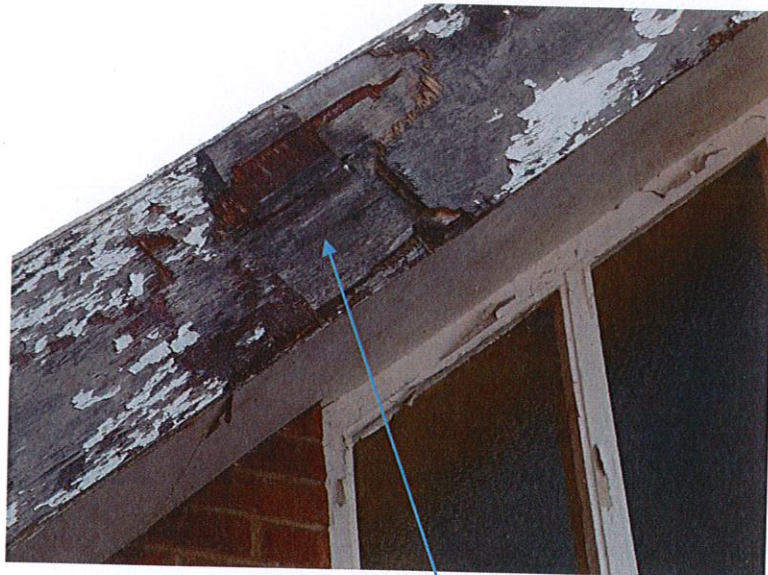
Wet rot to plywood barge board  
Photograph C10

1. There was extensive evidence of wet rot and softening to fascia, soffit and bargeboards (see photograph C10) including those sections serving the flat roofs.

2. The soffit boards to the south gable are missing in places (see photograph C11).
3. In our opinion the timber fascia, soffit and bargeboards have now come to the end of their useful lifespan and will need to be replaced with uPVC modern equivalents. This should reduce future maintenance costs.

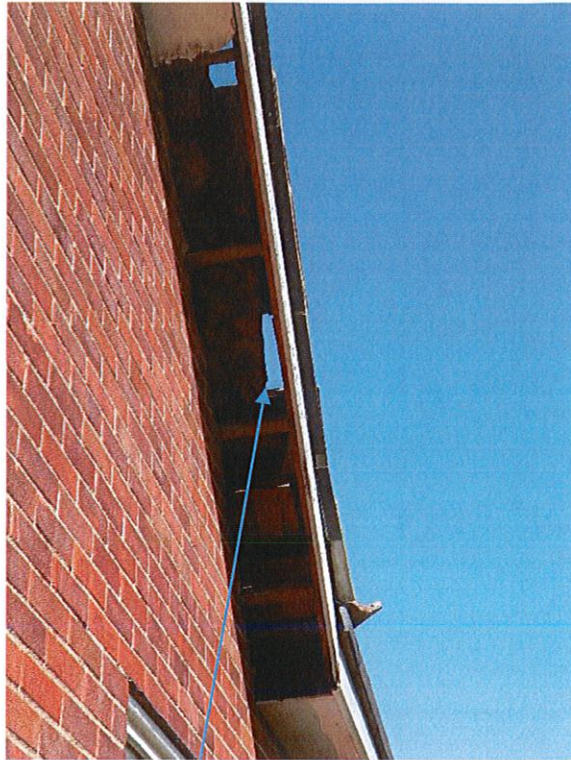
**Photograph C11**

**Missing soffit and tiles**

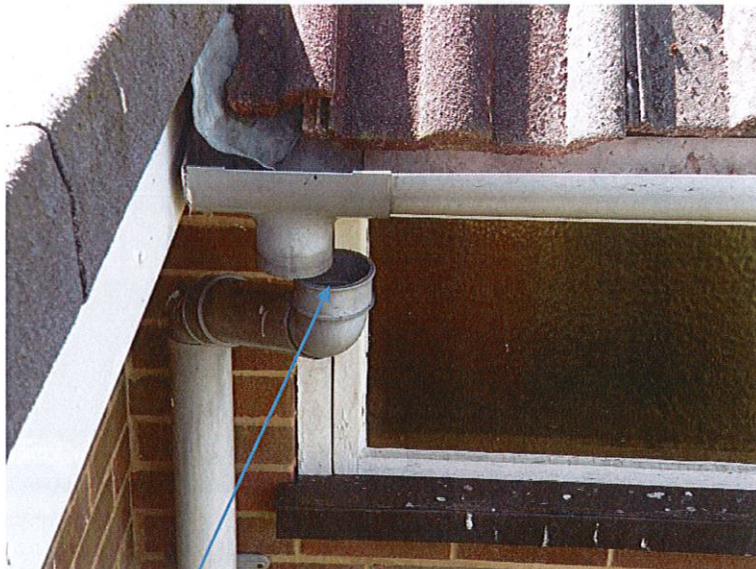
**Photograph C12**

**Swan neck connection needs refixing**

6. There was however, evidence of open joints and connections between gutters and rainwater pipes (see photographs C12 and C13). This has led to damp staining of brickwork. Moreover, some of the stop ends to the gutters are missing and junctions with fascia boards poorly detailed (see photograph C14).

7. An extensive overhaul of the external gutters will need to be carried out in the short term to prevent further damp penetration of external brickwork and the possibility of internal dampness. We suspect several sections of guttering will need to be replaced.

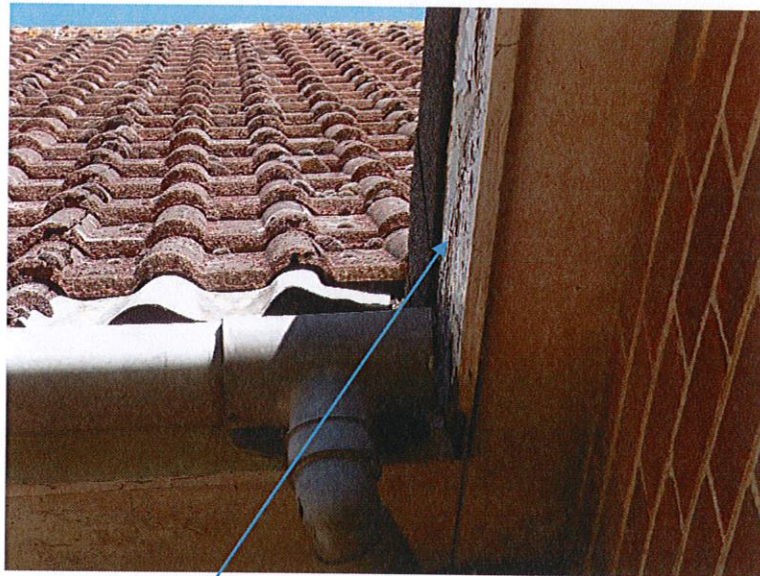
**Photograph C14**

**Poor detailing to external gutter at junction with fascia board**

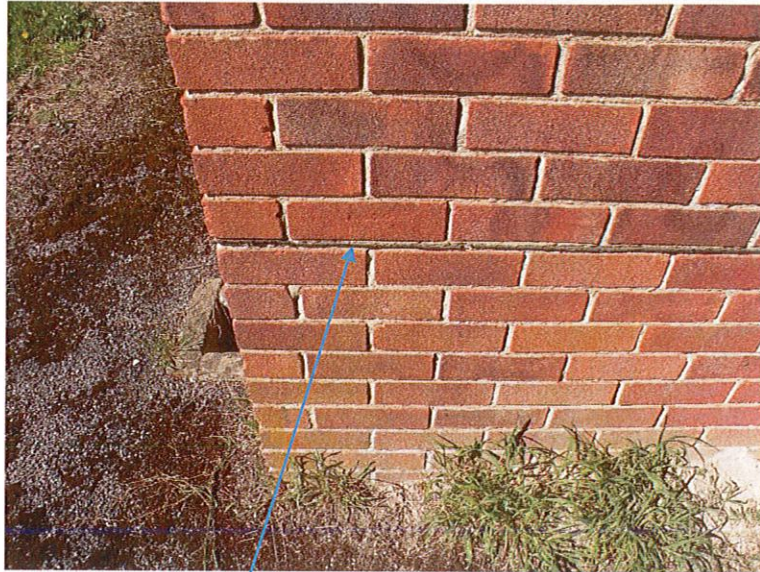
**Bituminous based damp proof course**  
**Photograph C15**

- 1.40 A bitumastic based damp proof course is provided within the external walls embedded within mortar joints (see photograph C15).
- 1.41 We presume that similar damp proof courses have been incorporated within internal walls and partitions.
- 1.42 The external damp proof course maintains an adequate height in relation to external ground levels negating the possibility of bridging across the cavity and creating internal rising dampness.
- 1.43 Random moisture meter tests were undertaken to the inner faces of external walls, internal walls and partitions. No significant levels of rising dampness were detected.

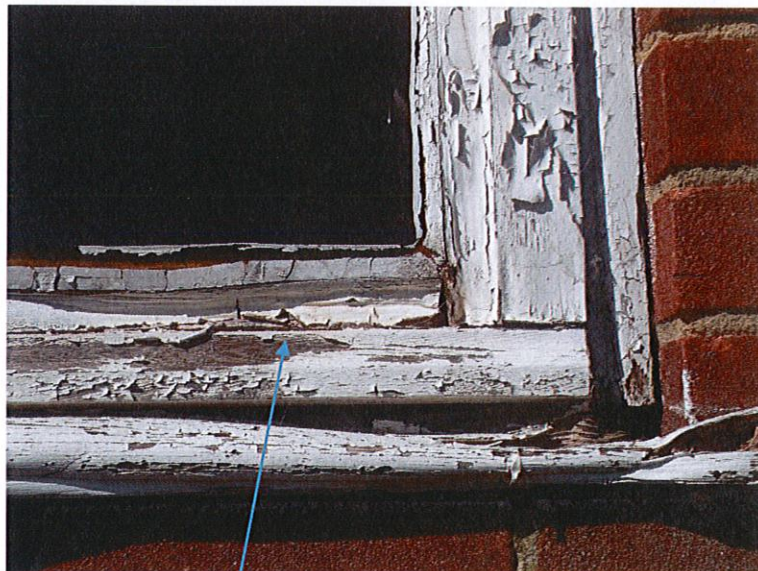
**Wet rot to frame and cill**  
**Photograph C16**

1. All of the windows are in a very poor state of repair.
2. Extensive wet rot was noted to the timber frames and window cills (see photographs C16 and C17).
3. Similar comments can be made with respect to the frames and cills of the external doors particularly the fire doors (see photograph C18).
4. In our opinion the wet rot is such that it would not be possible to carry out economical repairs and we are of the opinion that the most cost effective solution would be to completely replace the windows and doors with modern uPVC double glazed equivalents.

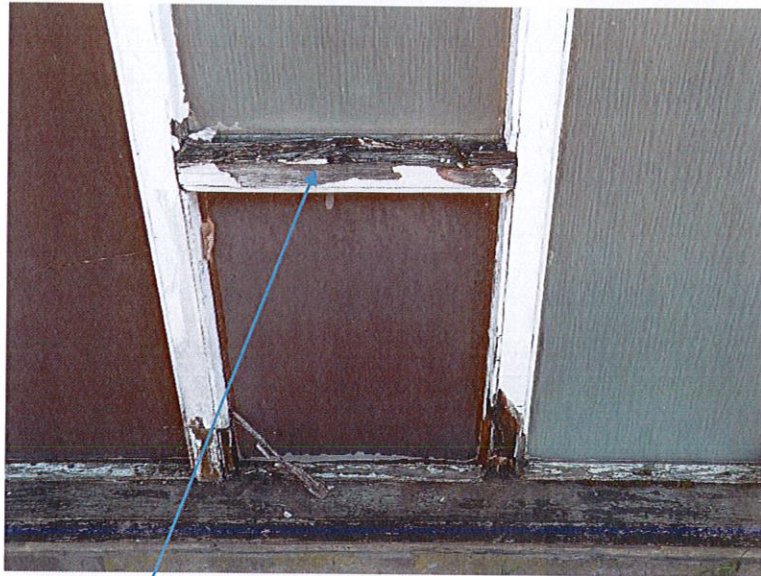
**Photograph C17**

**Extensive wet rot to window frame and cill**

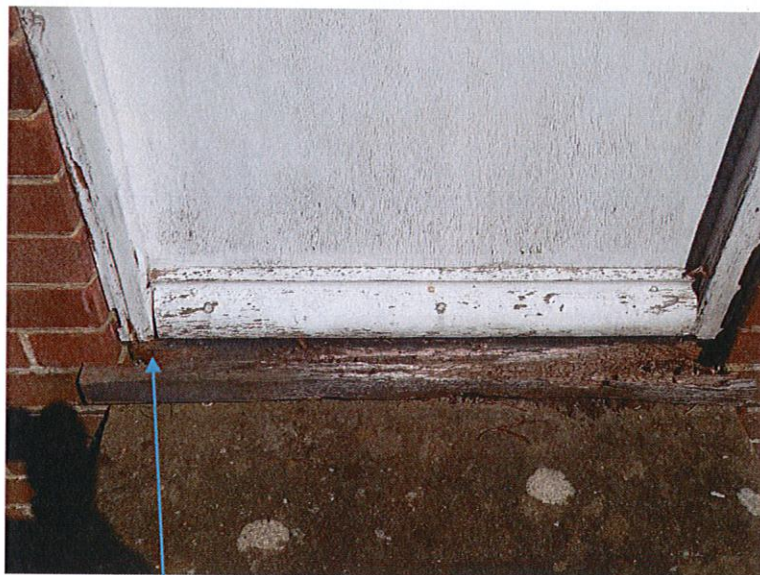
**Photograph C18**

**Wet rot to frame and threshold**

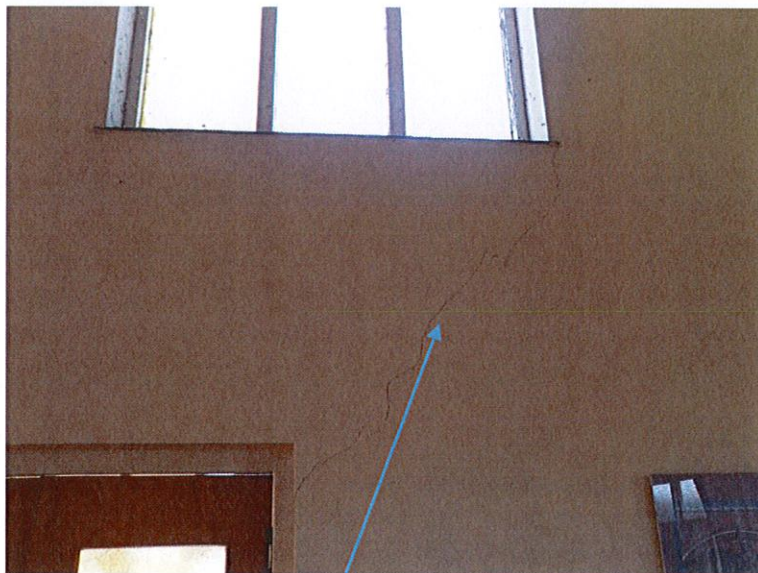
**Diagonal cracking**  
**Photograph C22**

- 1.65 To the main Church hall and various extensions diagonal cracking (width not exceeding 1mm-3mm) was observed above and beneath window apertures on the west and east facing elevation walls (see photograph C22).

- 1.66 On present evidence the cracking does not appear to have increased in size since the last Quinquennial inspection. Such cracks in our opinion relate to slight deflection of window lintels over the years. We would recommend that the cracking be filled during the next phase of internal redecoration works.

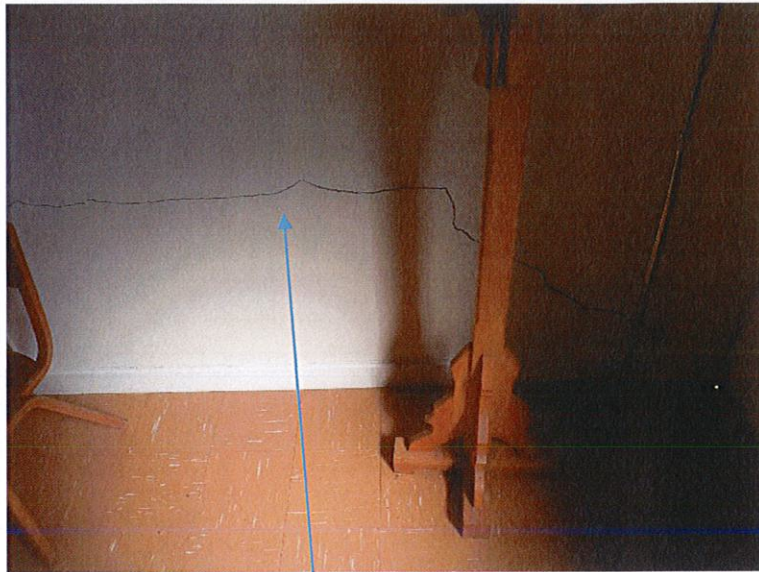
**Horizontal cracking**  
**Photograph C23**

- 1.67 To the west projection severe horizontal cracking (width not exceeding 8mm-10mm) together with lateral displacement in the order of approximately 8mm was observed to lower sections of projecting pier on the south external walls (see photograph C23). The cracking would not appear to have opened up significantly since our last inspection.

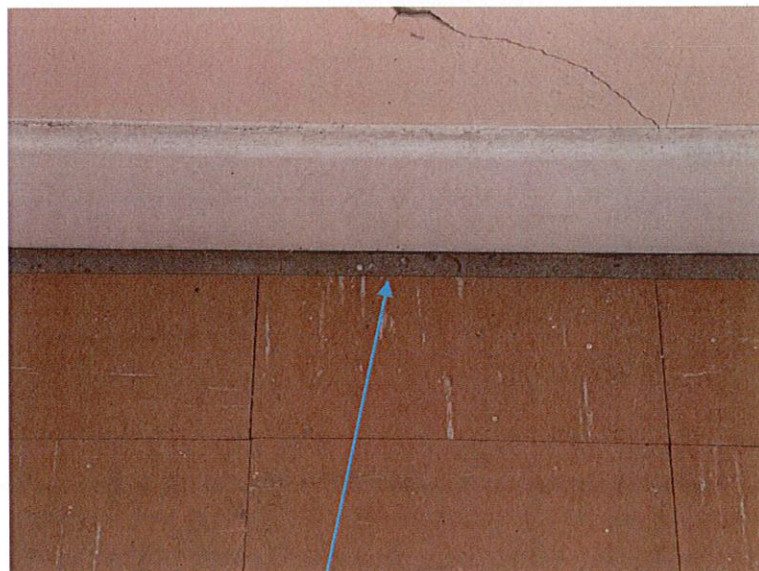
**Gap between floor and skirting**  
**Photograph C24**

- 1.68 As pointed out in our previous Quinquennial inspection the floor slab to the west projection has been affected by settlement with gaps of upto 20mm observed between the floor surface and underside of the timber skirting (see photograph C24).

- 1.75 Some internal doors require easing and adjusting.
- 1.76 Settlement of ground floor bearing concrete slabs is often caused by poorly compacted hardcore beneath the concrete slab at the time of construction. The floor slab can settle over the first 10 years of its construction after which the slab will tend to find a new position of equilibrium. Sometimes pockets can remain beneath the floor slab resulting in some sections of the slab being unsupported underneath.

- 1.77 Particle erosion as a result of defective rainwater goods can cause collapse of the surrounding air pockets which leads to further settlement of the slab and opening up of the cracks. If such movement continues then expensive remedial underpinning works may be required to the slab.

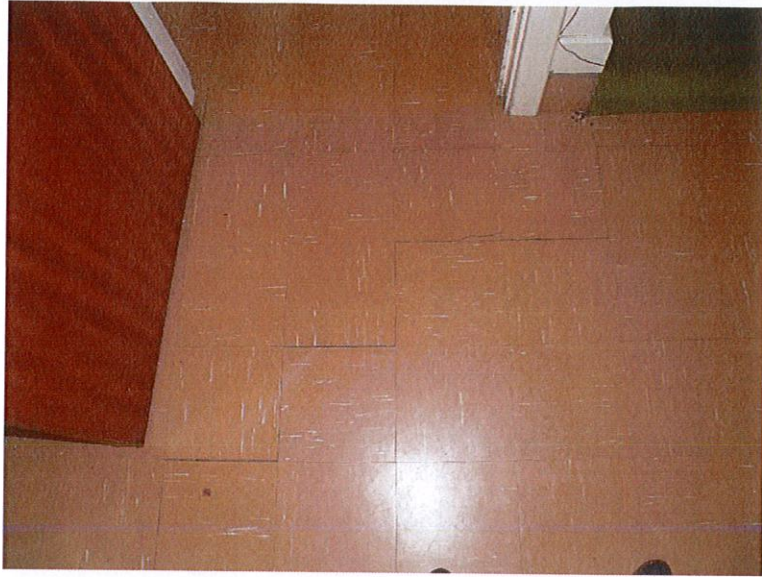
**Photograph C25**

**Thermoplastic floor tiles**

- 1.78 Where floor slab settlement is less pronounced ie. within the north projection it may be possible to utilise a self-levelling latex screed to minimise surface undulations.
- 1.79 The floor slab has been covered with thermoplastic tiles which generally remain well fixed (see photograph C25).
- 1.80 Within the Church hall horizontal cracking was observed to thermoplastic floor tiles at the junction of floors to the east and west projections and the main floor to the Church.
- 1.81 From the Asbestos Register these are noted to contain chrysotile/asbestos.
