**Current roof condition - January 2026.**

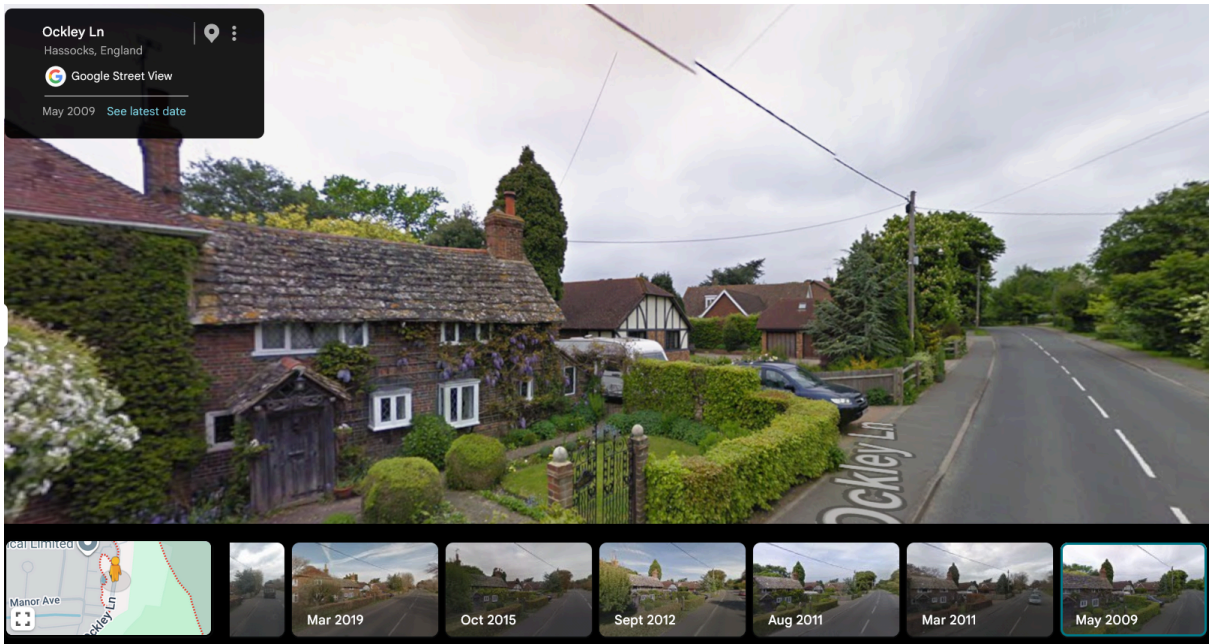
Roof condition 2009

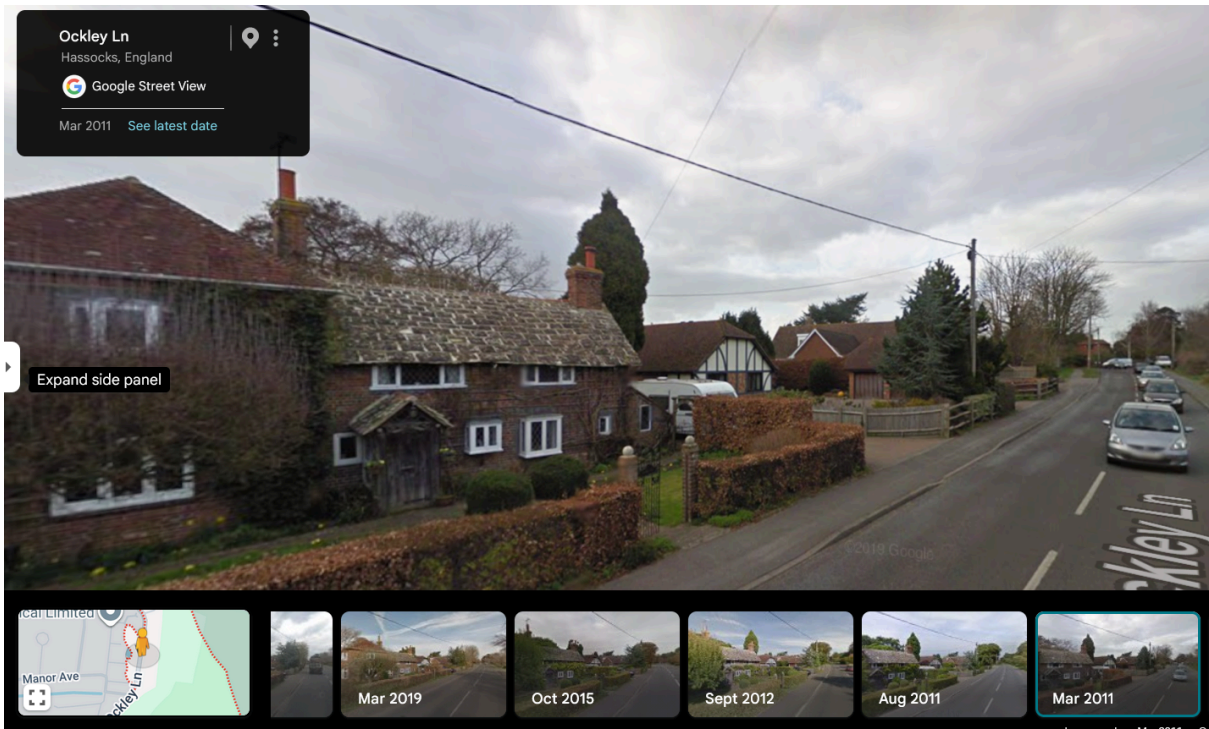
Roof maintenance carried out in 2011

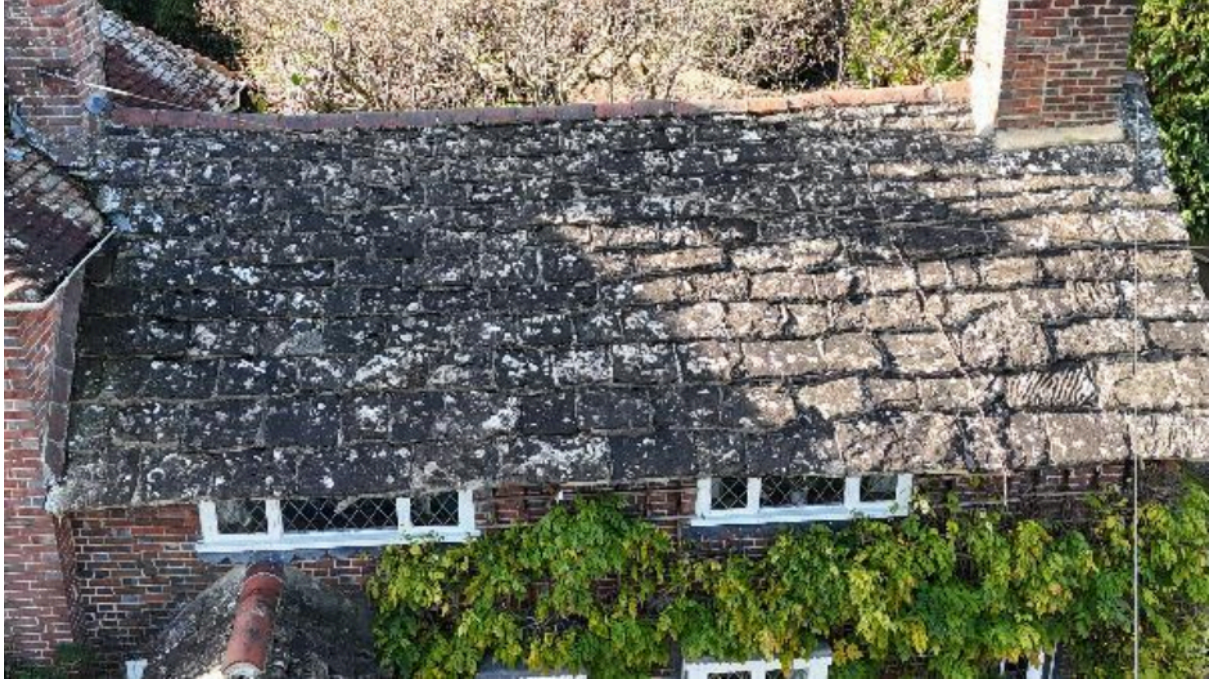
The stones are weathered but overall appear to be in generally satisfactory condition given their age. The original stones will be reused and relaid in a like for like manner. However, the mortar bedding the slates are cracked and damaged and require repair.

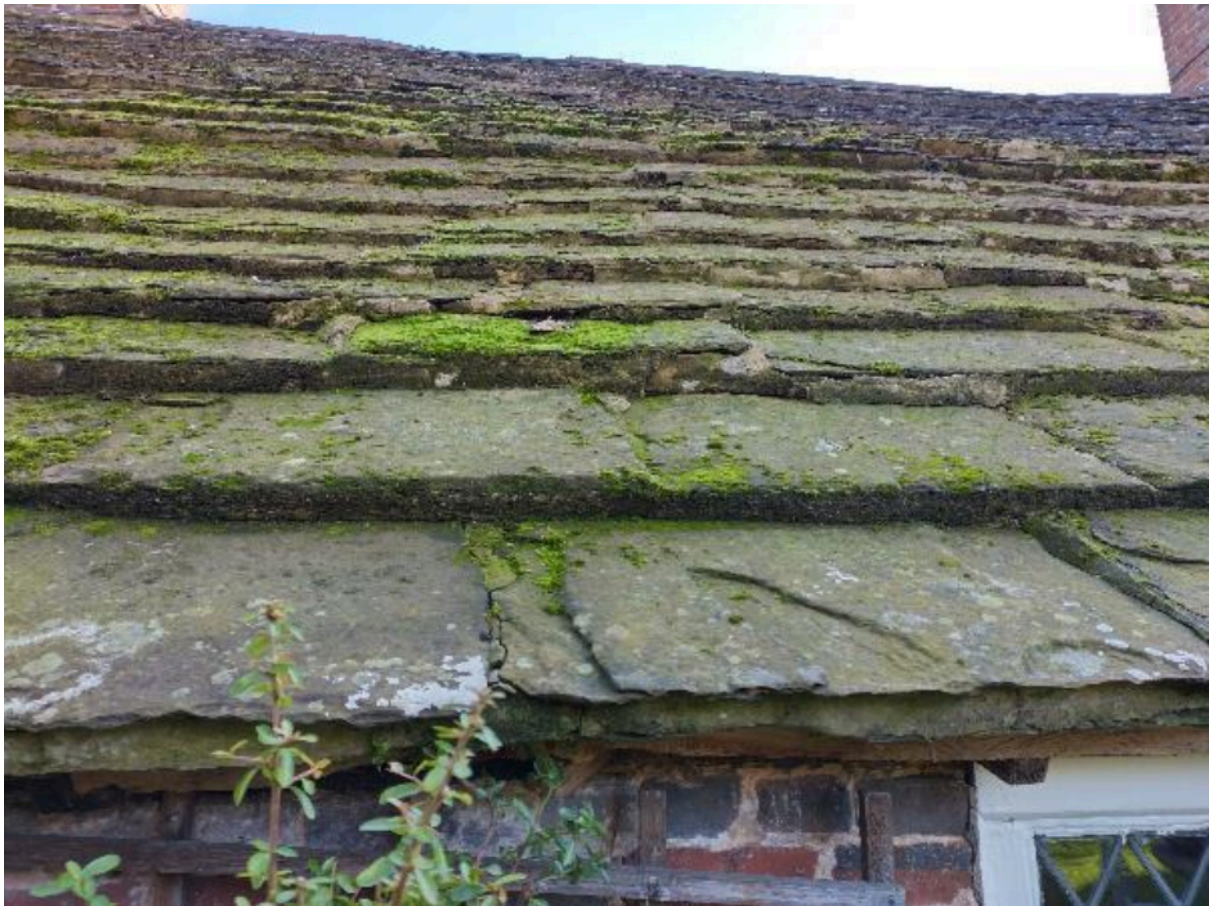
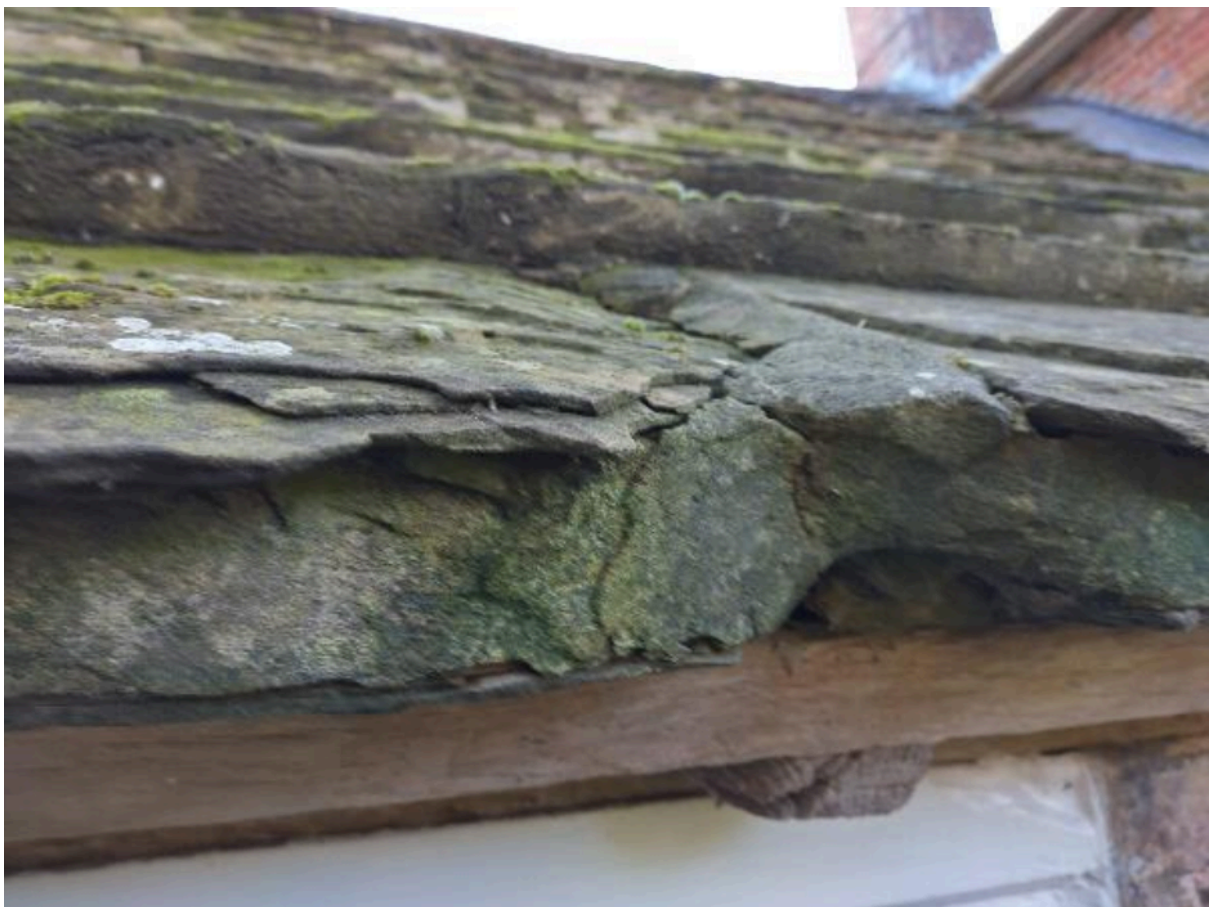
Rear elevation. Here also stones are in good condition, cracked mortar requires maintenance

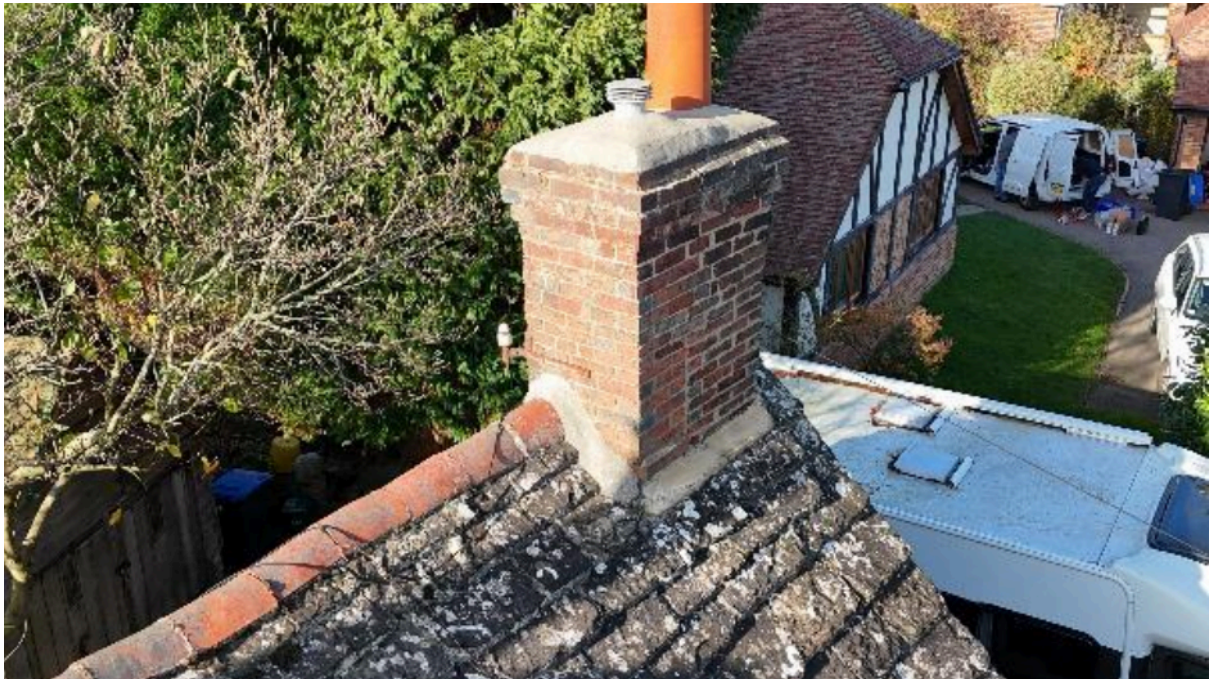
The mortar fillets at the junction with the stack and the roof are cracked in places, and are allowing dampness to penetrate

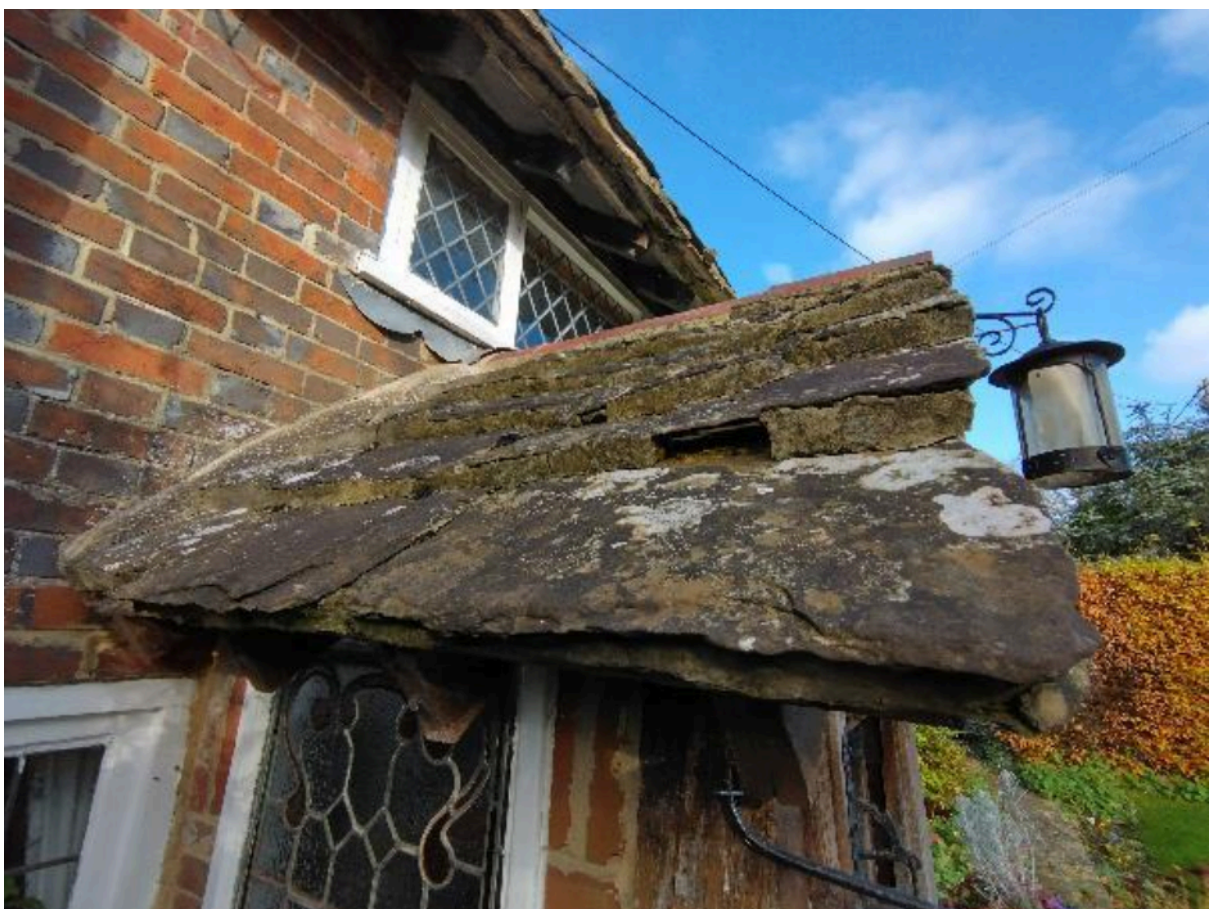
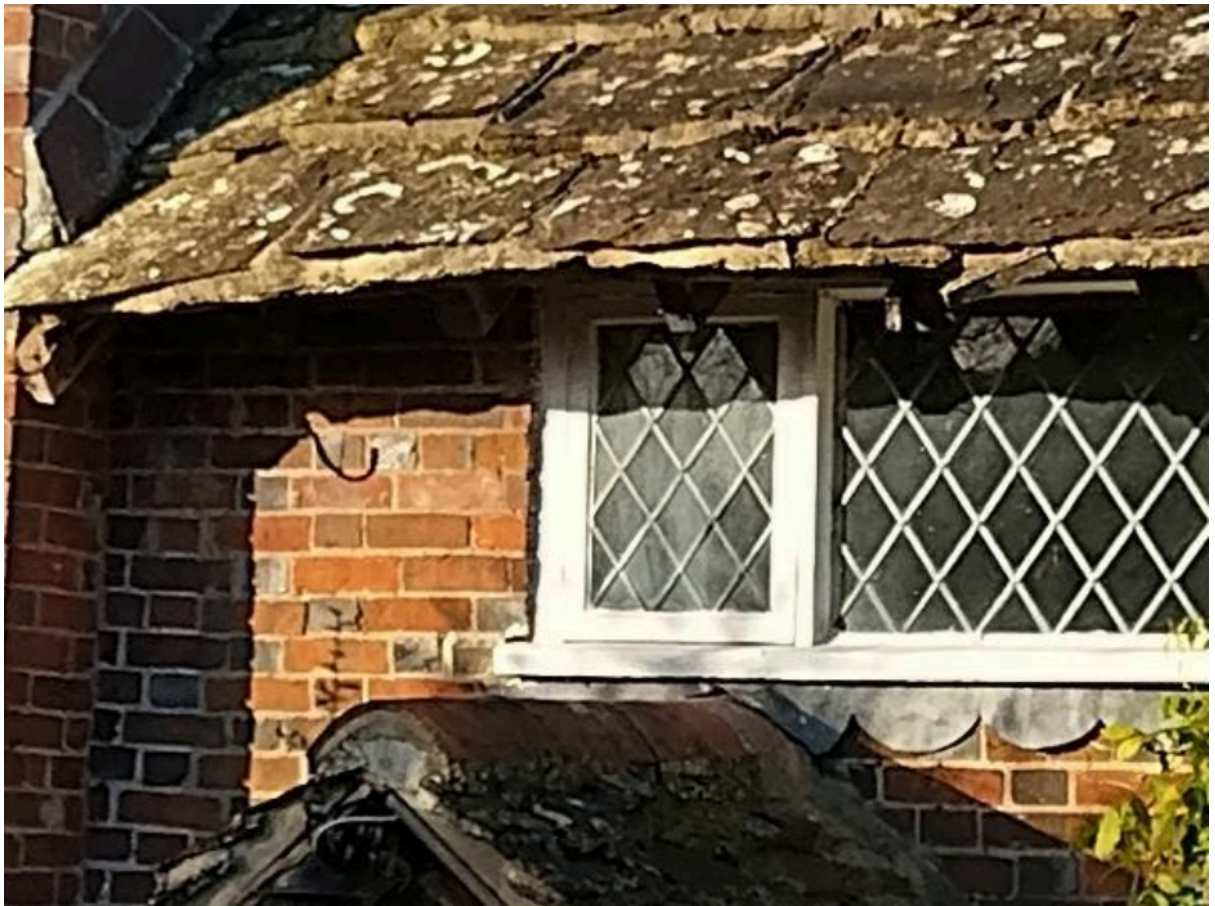
Examples of cracked mortar that needs maintenance
