## 2.9 GEORGIAN STYLE HOUSE - AS CURRENTLY

## 2.10 BUILDING CONDITION

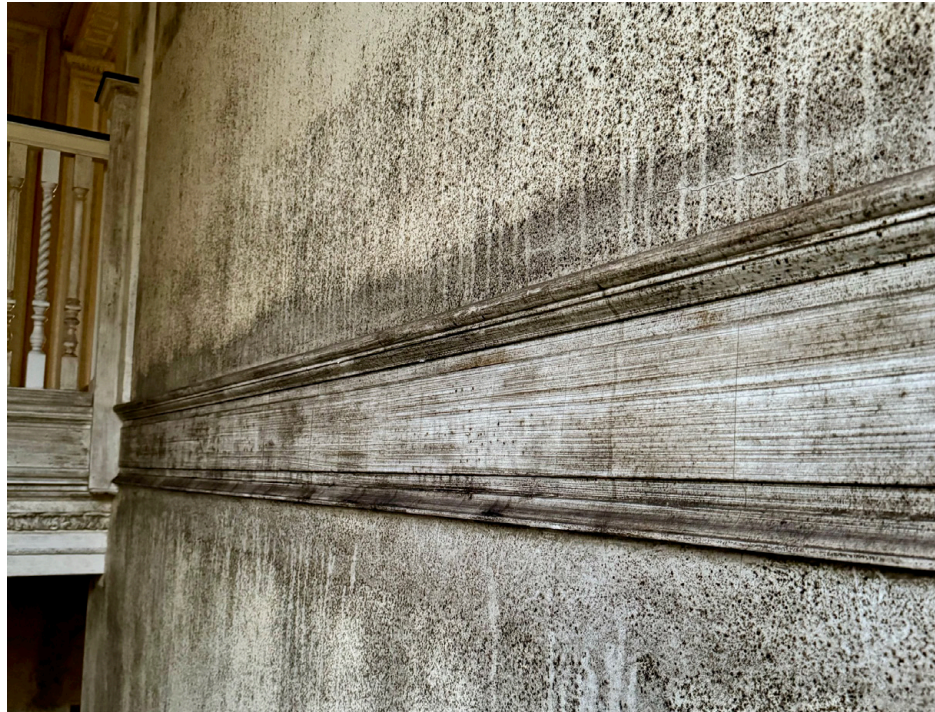
Top Left: Significant moisture degradation is evident to all surface

- Complete tanking and installation of ventilation within the basement
- Insulate basement walls and floor to avoid cold zone within dwelling.
- Removal and replacement of all internal finishes.
- Remove any parts of the timber structure that are defective with rot.
- Removal and replacement of all single glazed windows and replacement with double or preferably triple glazed windows.
- Installation of energy efficient heating system
- Assessment of heat loss through walls and provision of 'breathable' woodfibre internal insulation.
- Provide insulation at ground floor level
- Provide insulation at roof level
- Install whole house ventilation system to ensure constant adequate ventilation

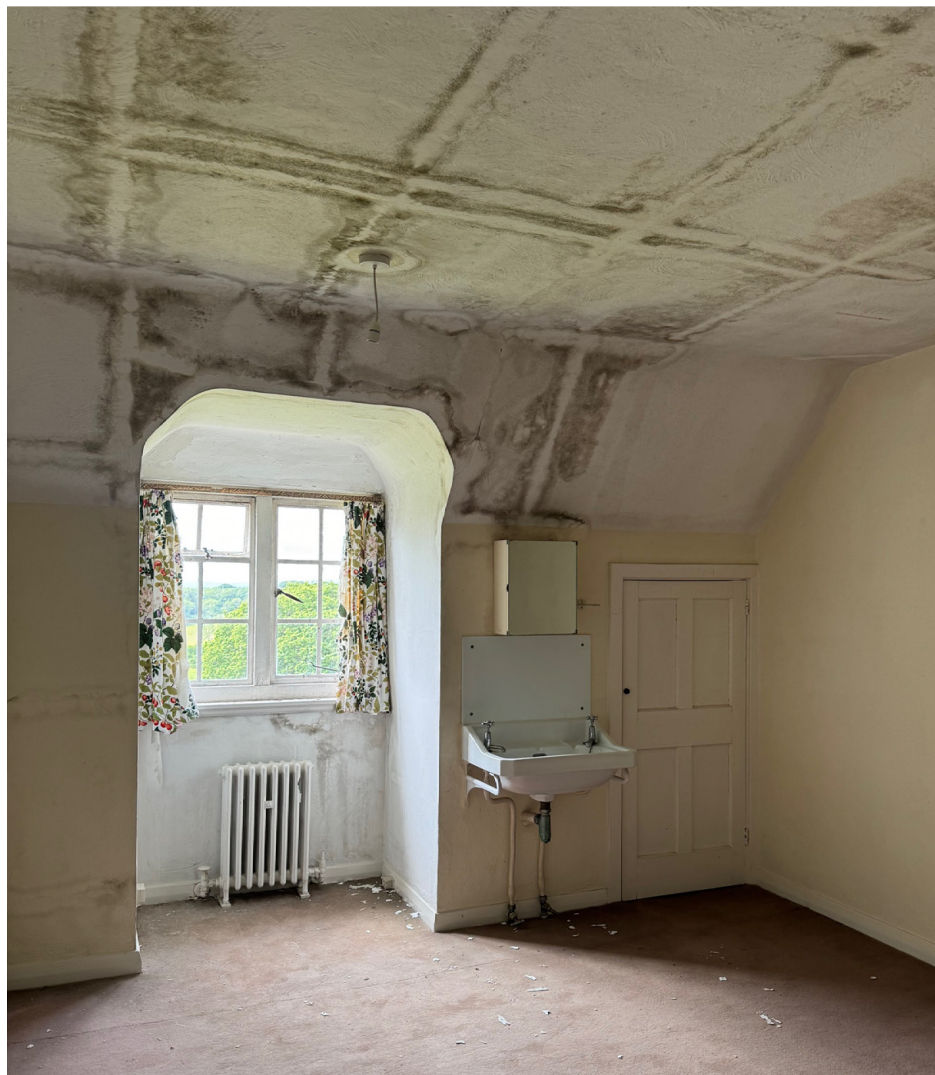
Bottom Left: At roof level the moisture damage at roof level is evident

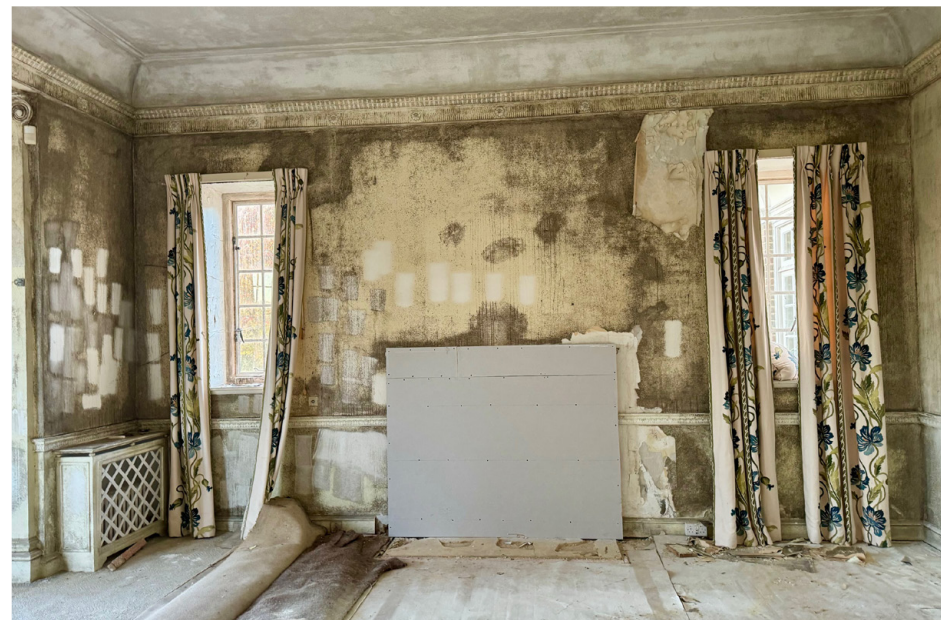
Bottom Right: A view of the one of the bedrooms showing the external walls as currently exist.

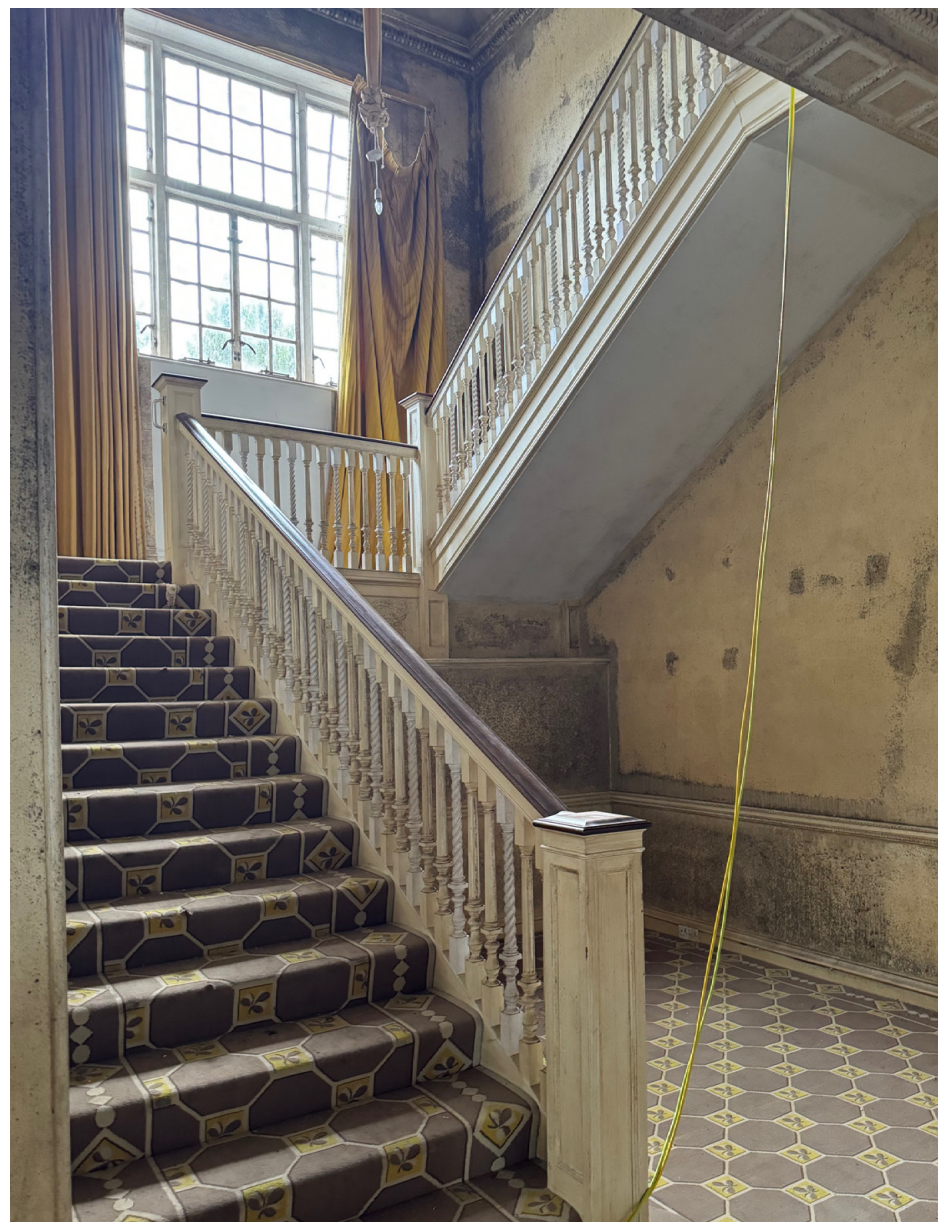
Above: The main staircase. Moisture damage is evident to all walls

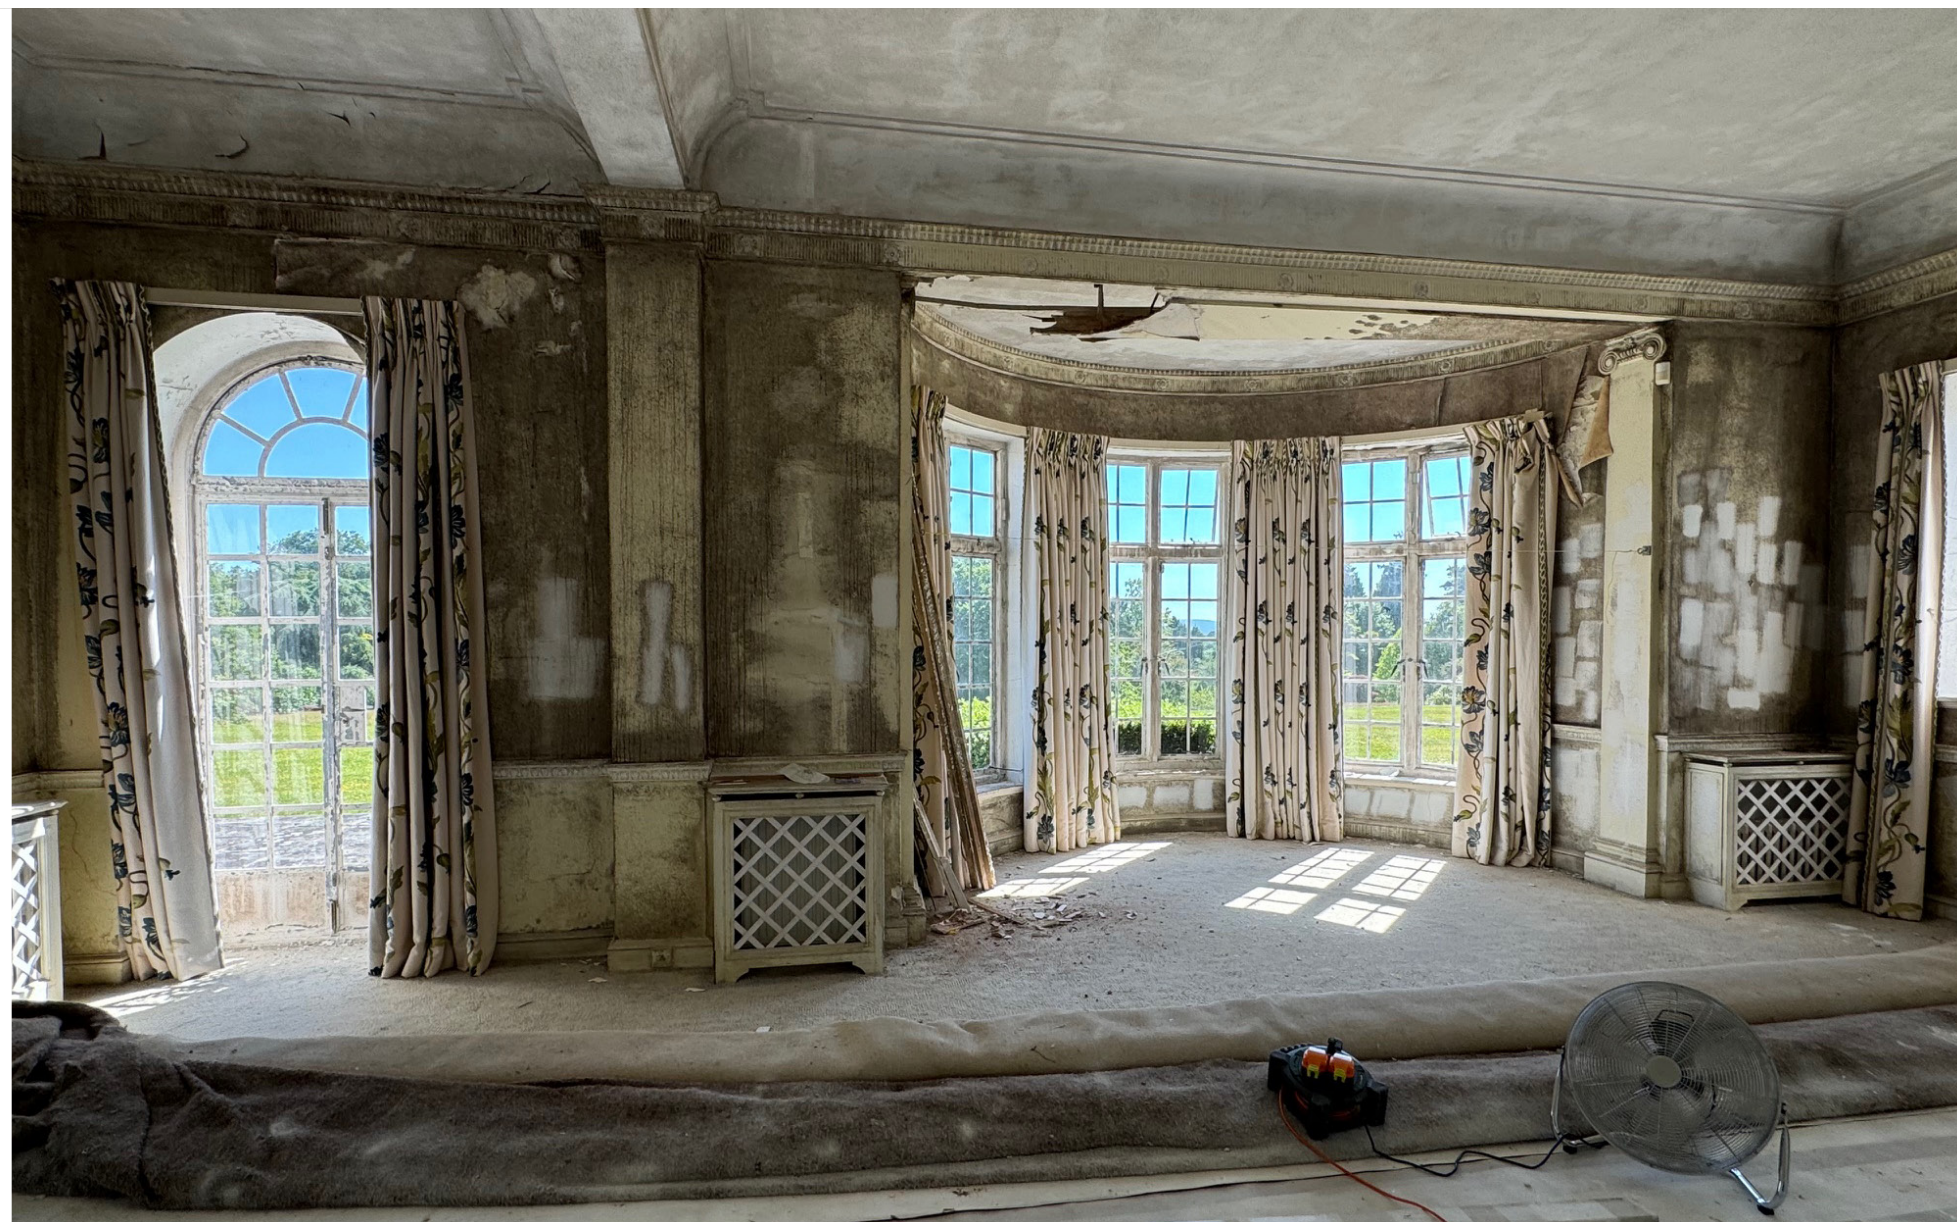
Right: Ground floor living room showing damage to the external walls and structural failure to the bay ceiling. It can be seen in the photograph that the use of fans have been used in an attempt to aid air flow. This has not prevented the rapid decline of the structure.

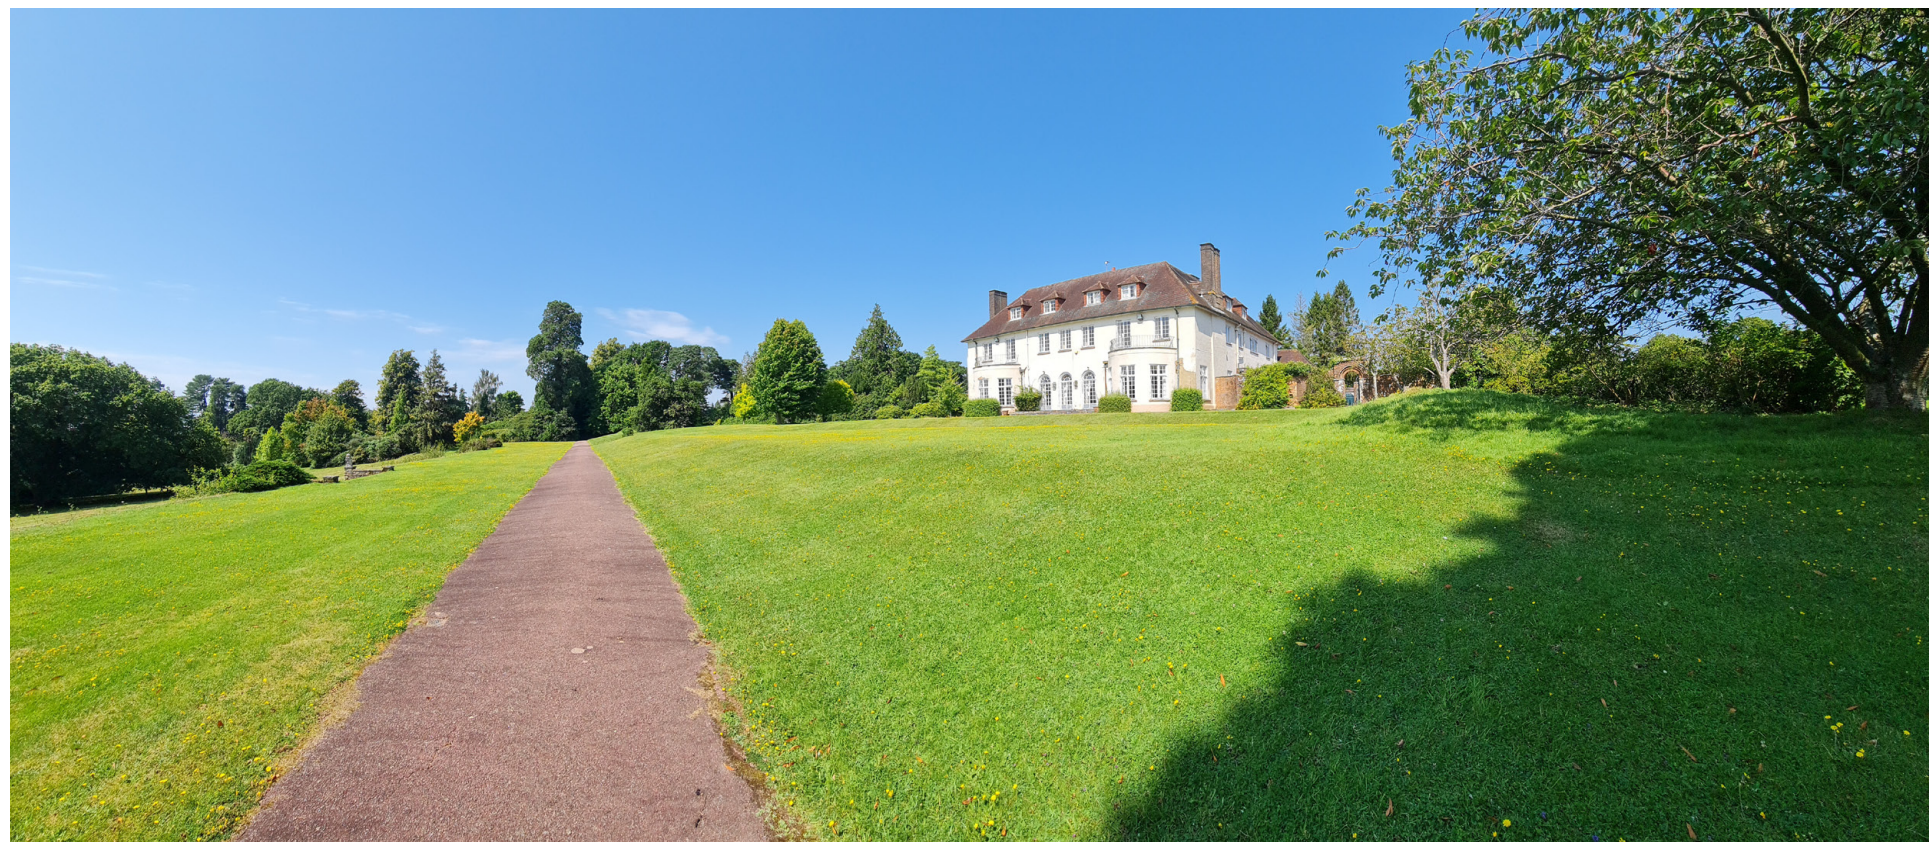
View of the house from the south west with the parkland gardens beyond. Hardstanding, non-permeable paths are a more modern feature of the landscape as can be seen in the photograph here.
