- 1.01 In accordance with your instructions, subsequently confirmed by our letter of the 4<sup>th</sup> November 2025 we attended the above property on 12<sup>th</sup> November 2025 in order to carry out a detailed inspection of the property, identify any defects, causes of such defects, and advise in relation to possible remedies.
- 1.02 We have listed our findings with respect to the Garage/Annexe in Appendix 4, Leisure Complex in Appendix 5 and The Cottage in Appendix 6.
- 1.03 We have not been instructed to provide or arrange for any other associated services.

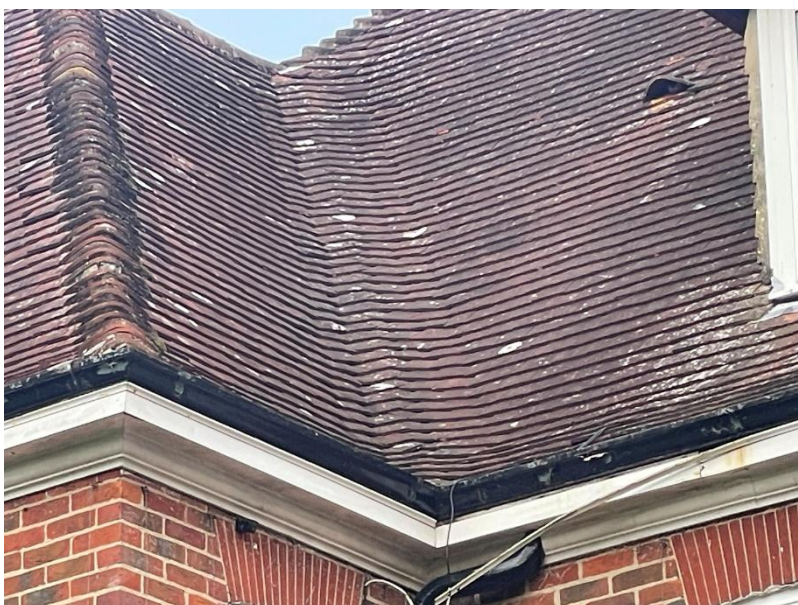
4. The alignment and gauge of the tiles, although slightly uneven in places, is considered satisfactory.
5. As is to be expected given the age of the roof covering, a number of tiles are chipped, cracked, spalled or have slipped and will need to be replaced as part of ongoing maintenance.
6. The ridge and hip lines undulate slightly but significantly so.
7. The majority of the ridge and hip tiles remain well pointed and bedded.
8. Isolated tiles however have open and weathered bedding joints and will need to be repointed/rebedded when access is next available.
9. The swept tiled valley gutters are generally well detailed and remain in reasonable condition.

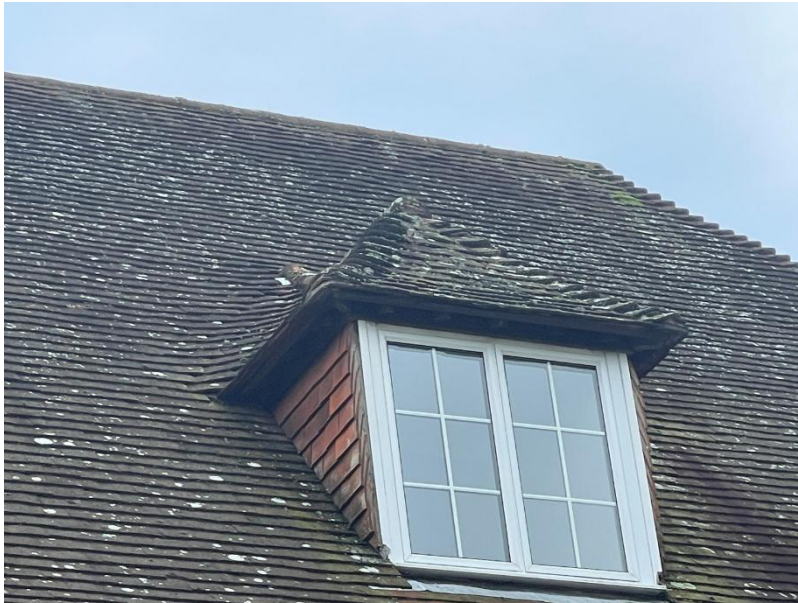
10. It was noted that some repairs and re-forming of the valleys have been undertaken in recent years.
11. The tiled roofs and vertically hung tiling to the hipped dormers are considered serviceable. Some replacement of cracked and chipped tiles, and rebedding of ridge and hip tiles, should be anticipated in the short term.

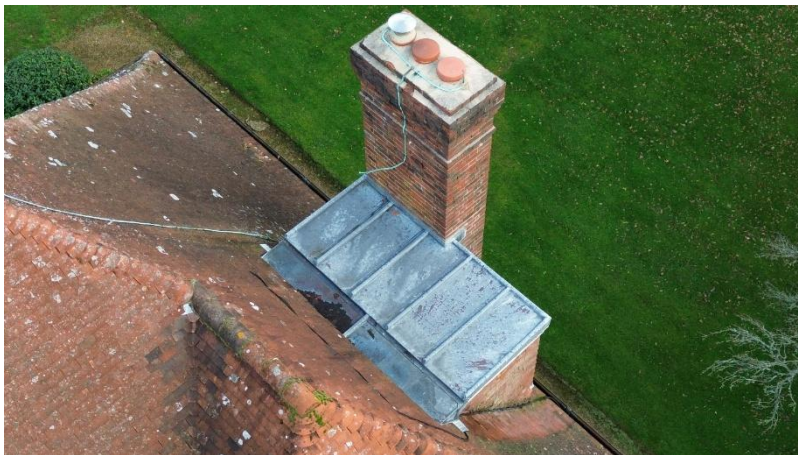
12. The lead lined flat roofs to the dormers on the east roof slopes appear to have been replaced in recent years. The leadwork is well detailed and laid. No significant defects were noted.

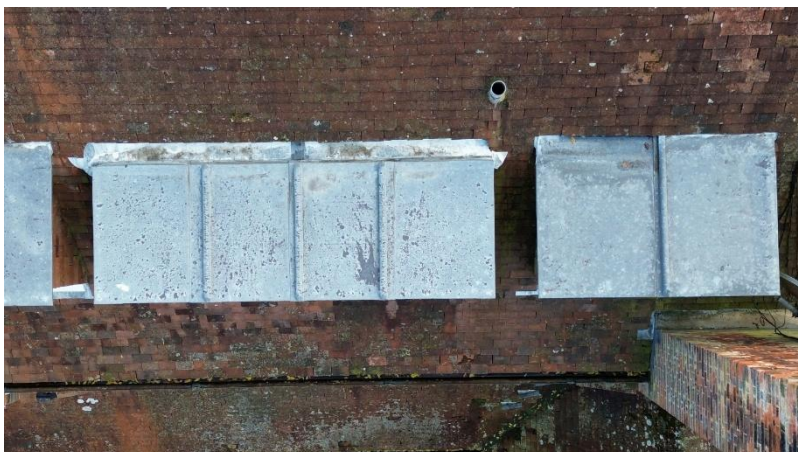
13. The lead work serving the flat roofs to the dormer windows to the west facing roof slope is original and generally aged and worn. Moreover, there was evidence of patch repairs having been carried out to the lead in recent years.

14. Whilst there was no evidence of internal damp penetration through the covering we are of the opinion that the lead has a limited lifespan, and allowances will need to replace it in the short term.
15. The front gable over the entrance lobby is terminated with a projecting brick parapet wall.
16. The wall is terminated with a brick on edge coping with tiled creasing and cement fillets.
17. The inner face of the parapet wall is detailed with stepped lead flashings and cement fillets.
18. In general terms, the leadwork, although aged and worn, appears to be well fixed and dressed over the adjoining tiles. No significant defects were noted.

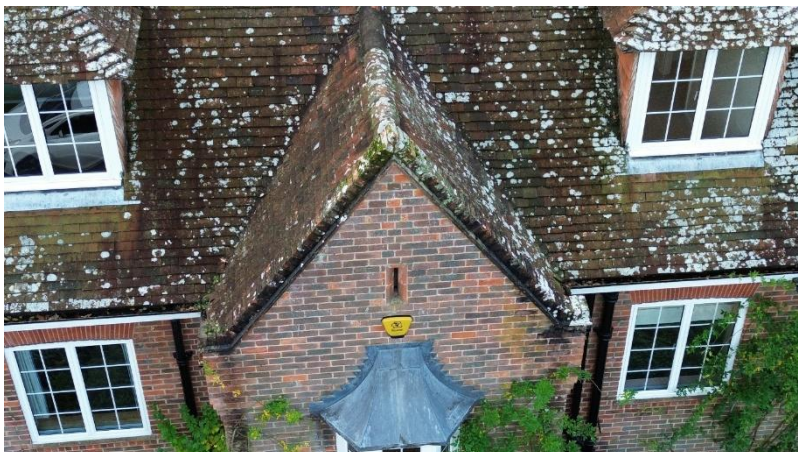
19. Sections of the cracked cement fillets will need to be repointed, and some isolated spalled bricks replaced as part of ongoing maintenance.
20. The upper brickwork is damp stained which has led to the early stages of the surface spalling.

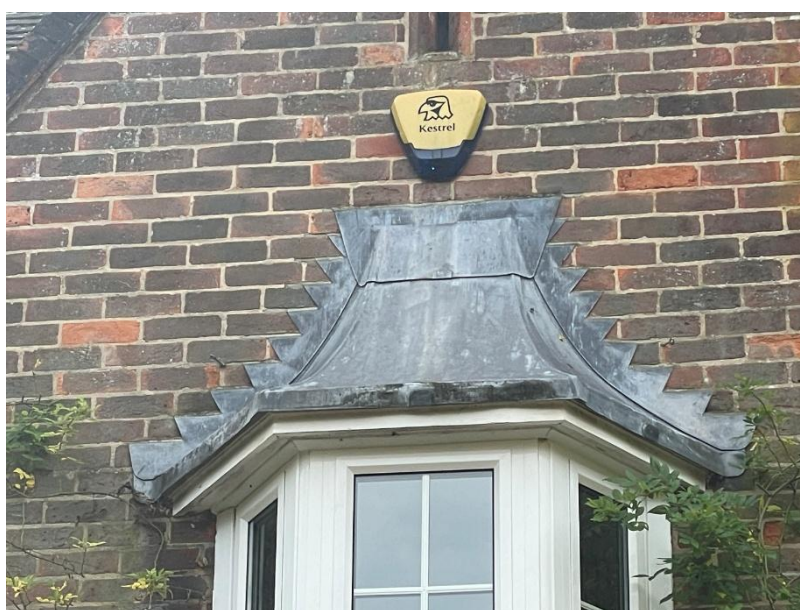
8.16 It would appear that the lead covering has been replaced in recent years.

8.17 The leadwork is in good condition and is well fixed into the brickwork.

8.18 No significant defects were noted.

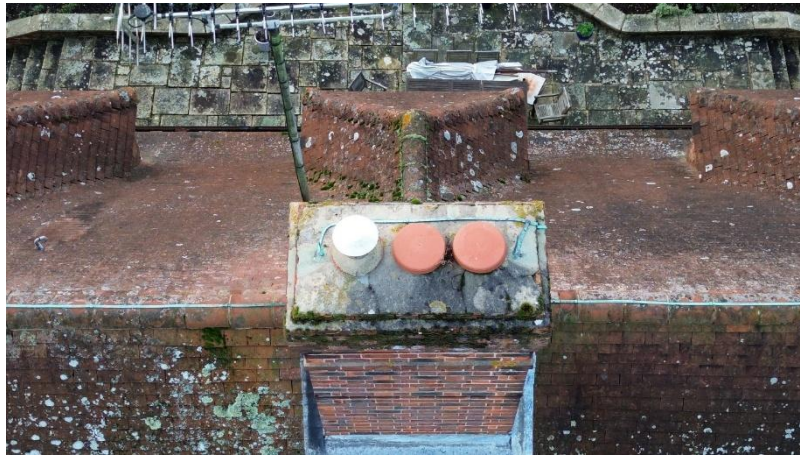
5. The cement flaunching into which the chimney pots are seated is cracked in places and will need to be repaired/reformed when access is next available.

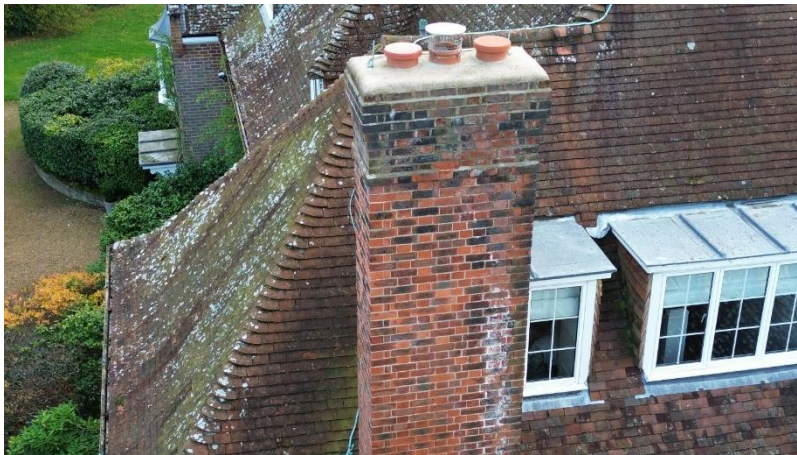
### Chimney Stack 3

- 8.32 This stack projects through the west facing roof slope (north section).

- 8.33 The stack is surmounted with three terracotta chimney pots and serves the fireplace in the family room, bedroom 4 and bedroom 5.
- 8.34 In general terms, our comments in relation to chimney stack 2 apply equally to this stack, and similar repairs are required.
- 8.35 Isolated bricks are showing the early stages of surface spalling.
- 8.36 The upper oversailing courses are blackened with soot deposits and some of the mortar joints are open and weathered. Areas of brickwork in this area will require to be carefully raked out and repointed.

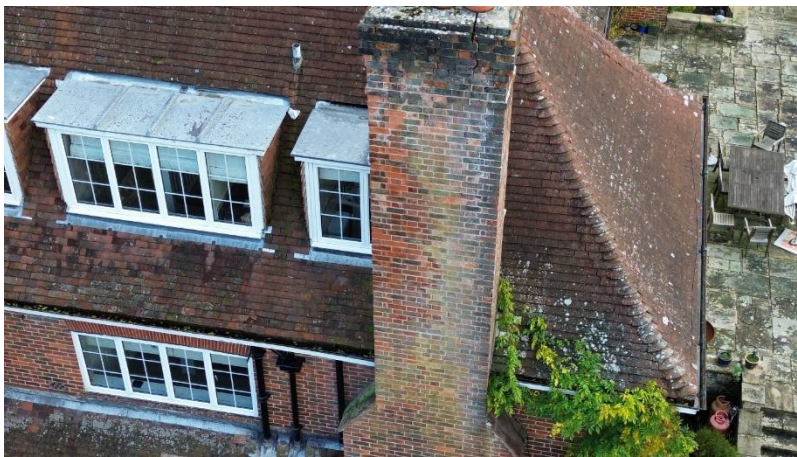
- 8.37 This stack projects through the west facing roof slope (southern section).
- 8.38 In general terms the stack is in similar order to chimney stacks 2 and 3 with spalled brickwork and aged and worn leadwork.
- 8.39 A vertical crack was noted extending from the cement flashing through seven courses of brickwork. A further examination is advised when access is next available. Some Hilti steel bars may need to be fitted within the joints to prevent any further thermal cracking together with repointing.

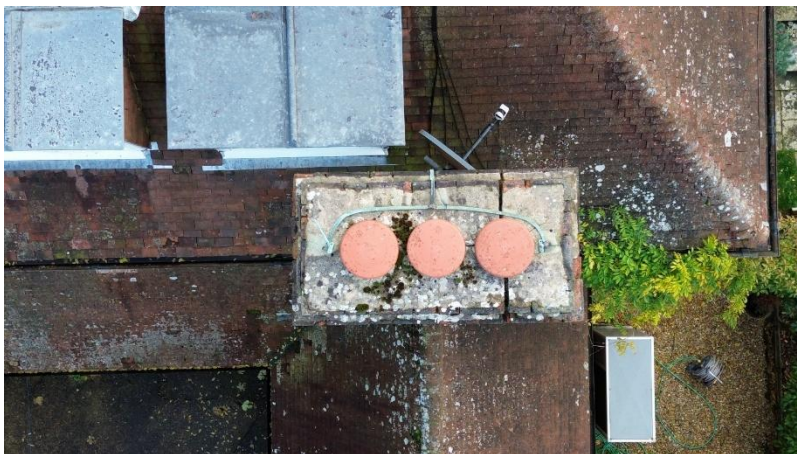
- 8.40 Some mortar joints, particularly to the south facing section, are weathered and open and will need to be repointed. Some spalled individual bricks were noted and will need to be replaced
- 8.41 Repairs to the cracked cement flashing will also be required.

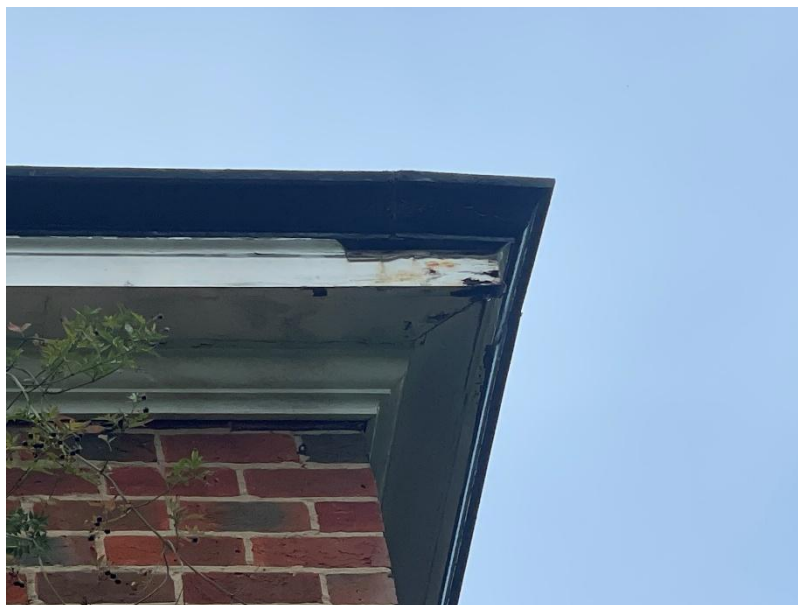
1. There is as one would expect given the age of the property, evidence of softening of sections of fascia and soffit boarding, particularly where joints have opened up and are defective and leaking.

2. Allowances will need to be made for the defective sections to be cut out and replaced as part of the next phase of external redecoration works.
3. For the most part, the external gutters and rainwater pipes appear to be well fixed and in reasonable condition.

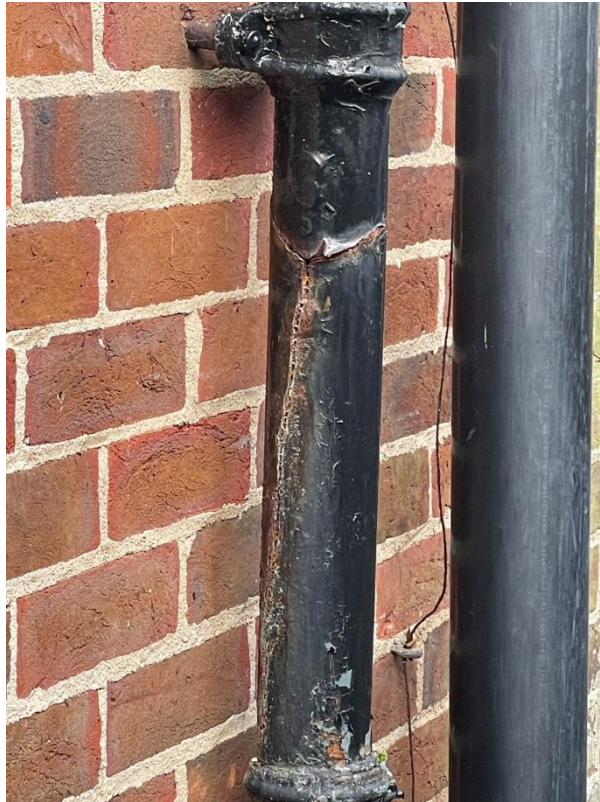
4. There was however evidence of corrosion around some original cast iron sections. Moreover, some rainwater pipes are cracked and leaking. This has led to some isolated damp staining to areas of brickwork.

6. In our opinion, the external gutters and rainwater pipes require an overhaul. Such work will include resealing open collar joints to the gutters and swan neck connects to rainwater pipes, together with the replacement of corroded and cracked sections of pipework. Some gutters require stop ends being fitted.

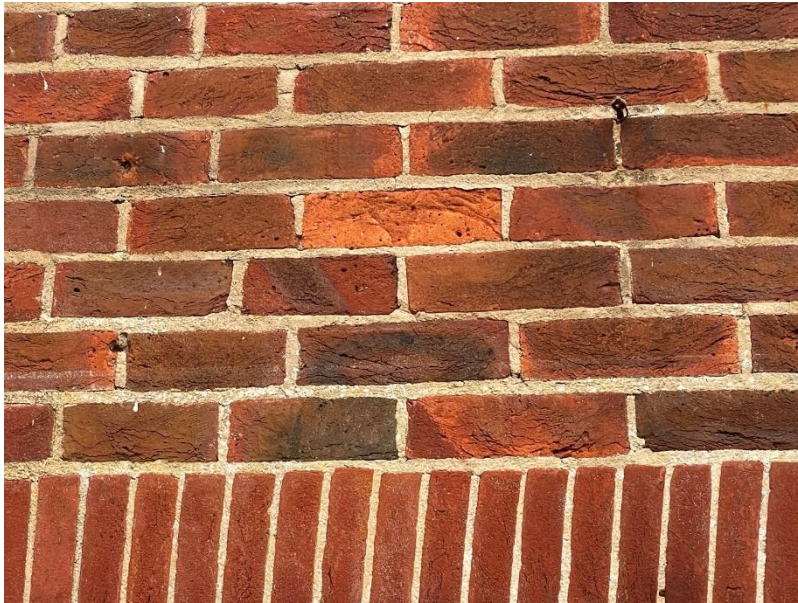
1. The walls throughout generally remain upright and plumb with no evidence of significant structural cracking extending either through the brickwork or mortar joints.
2. The bricks are of good quality and generally remain in reasonable condition.
3. Isolated bricks, as with the chimney stacks, are showing the early stages of surface spalling. In time the individual bricks will need to be cut out and replaced with matching brickwork or covered with a tinted mortar.

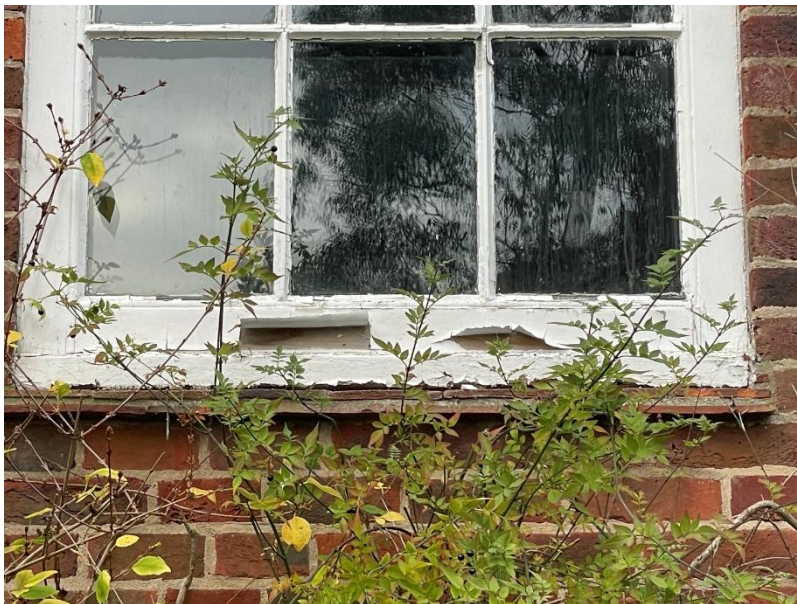
- 8.77 Flaking of paintwork was noted to areas of the fascia, soffit and cornices, together with cast iron sections of external gutters and rainwater pipes.
- 8.78 In addition, the timber frame to the original Venetian window and cill are also showing signs of extensive flaking, with cracked or missing putties. Some softening to the window frame was also noted.

- 8.79 We have identified repairs being required to areas of the external joinery and gutters and rainwater pipes. Once these repairs have been attended to we would strongly advise external redecorations are carried out.

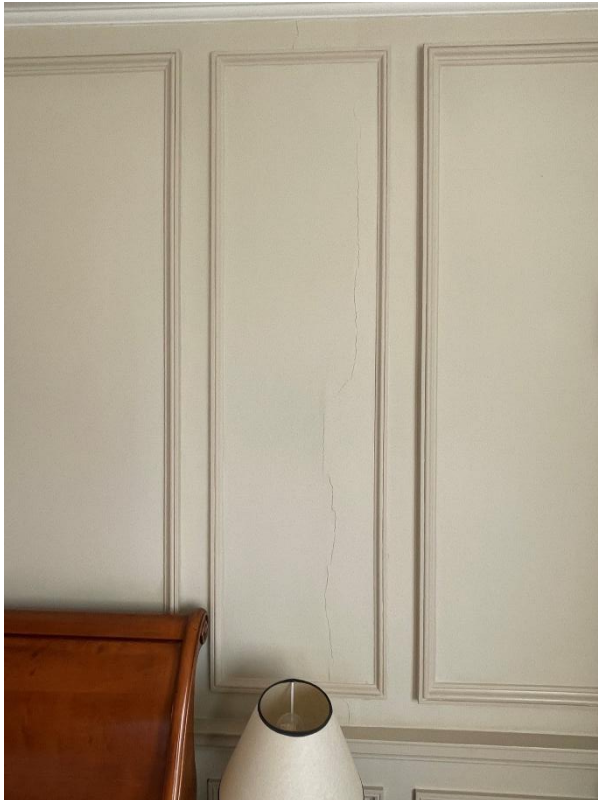
3. The cracks are not considered to be of major structural significance and can be filled prior to the next phase of internal redecoration.
4. It is likely that some shrinkage cracking wills reopen.
5. The plastered surfaces, particularly to the inner faces of external walls, where tested appear to retain a good degree of adhesion to the underlying brickwork.
6. The ceramic tiles generally remain well fixed and grouted.
7. Wall surfaces in the main en suite bathroom have been lined with marble which is well fixed and remains in reasonable condition.
8. Some flaking of paintwork and black pin mould growth was noted to some shower cubicles. This has occurred primarily due to a lack of mechanical ventilation leading to high levels of condensation.
