**APPENDIX 6**  
**BUILDING SURVEY REPORT**  
**On**  
**THE COTTAGE**

**Client**

**Patricia Estridge**

**GH1080**

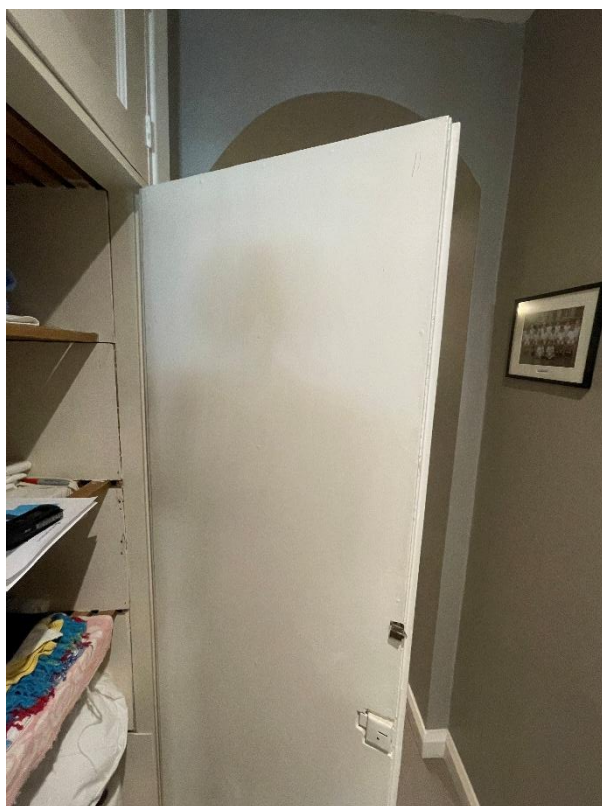
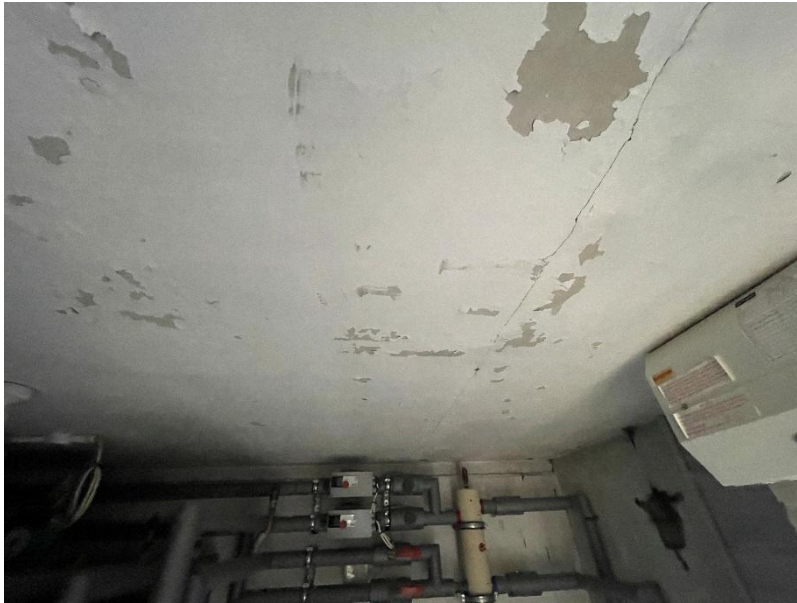
- 12.08 We did not carry out a full survey for asbestos at the time of our inspection as this would be beyond the terms of our engagement.
- 12.09 Given the age of the property, it is likely that asbestos based products would have been used in its original construction. Such products will include asbestos lagging to original pipework serving the central heating installation and fire retardant boarding around radiators, and linings of ceilings in the plant room and to internal doors that we noted. Where visible, the boarding remains in reasonable condition.

- 12.11 The same comments can be made with respect to pipe lagging in concealed places within the roof void and old boiler room.
- 12.12 As a precautionary measure it would be prudent to arrange for a specialist contractor to make a more detailed examination of lagging identified in the roof void and provide comment in relation to the boarding surrounding the plant room ceilings.

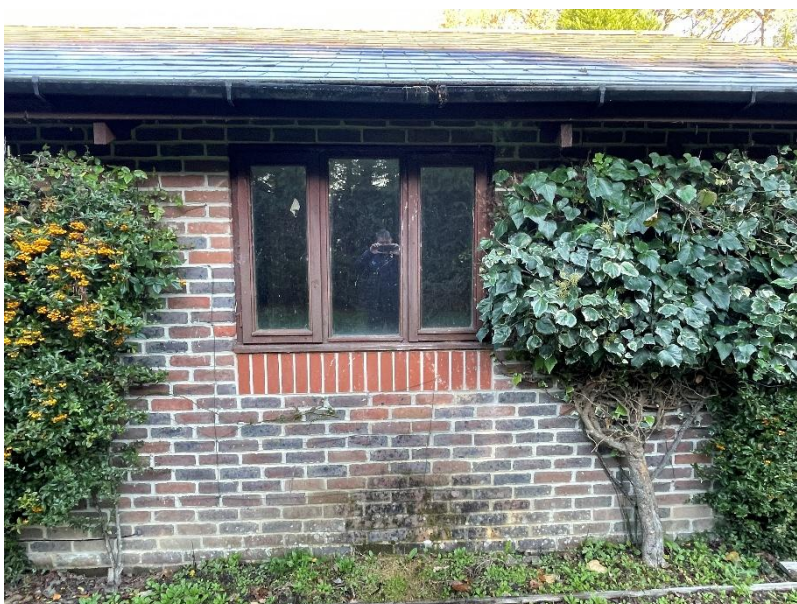
- 2.10 The gutters are well secured to the fascia boards by means of PVC clips.
- 2.11 It was noted that the number of the collar joints to the guttering are leaking, which has led to damp staining to the underlying brickwork.

2.12 Junctions between the rainwater pipes in sealed and external gullies need resealing.

2.13 In our opinion, the gutters are in need of an overhaul, and all leakages should be attended to.

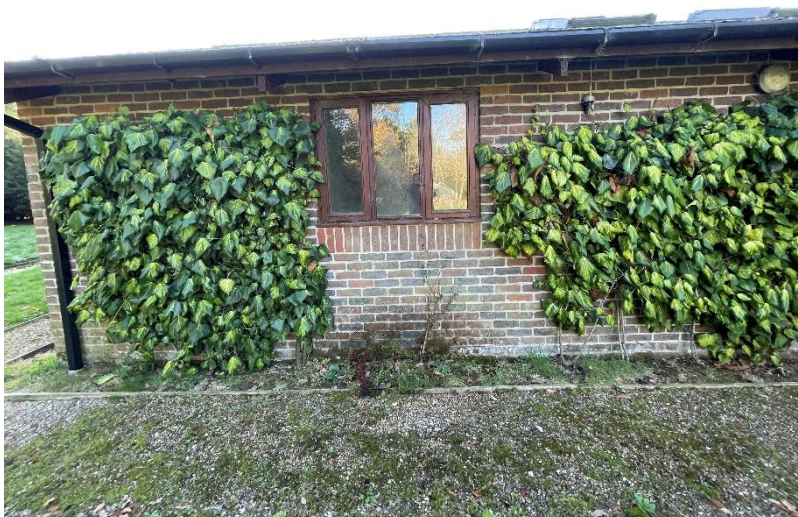
1. The external wall remains upright and plumb with no evidence of any abnormal stress cracking either through the brickwork or mortar joints.
2. The brickwork and mortar joints are in good condition.
3. Steel Catnic lintels have been provided above window apertures with no signs of any rotational cracking around their bearing ends.
4. Climbing vegetation was noted, particularly to the west elevation wall. We would recommend that this be pruned back or removed as over a period of time it can affect external mortar joints.

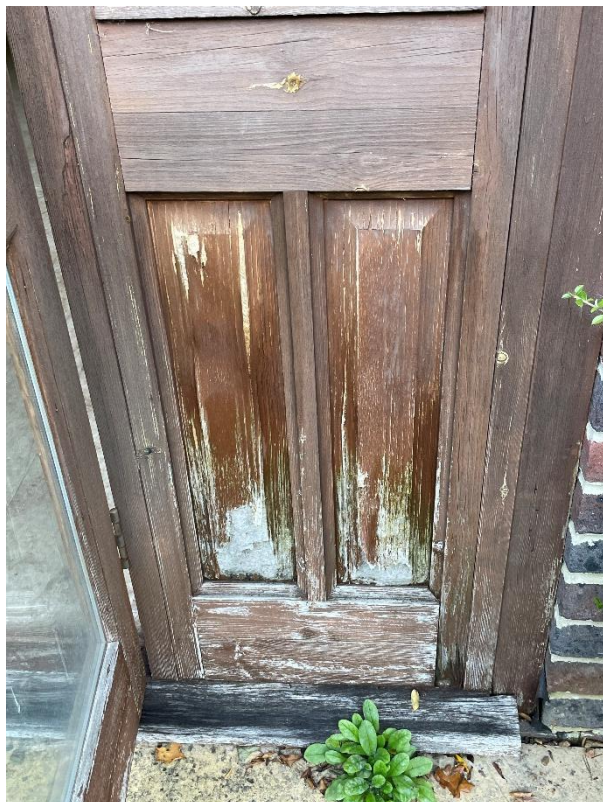
2.29 Not all of the windows were tested but those that were, appeared to be serviceable. Some minor softening was noted to frames and cills.

2.30 The exterior paint to the window and doors are showing signs of flaking and will need to be redecorated in the short term. Some repairs should be anticipated to the panelled sidelights.

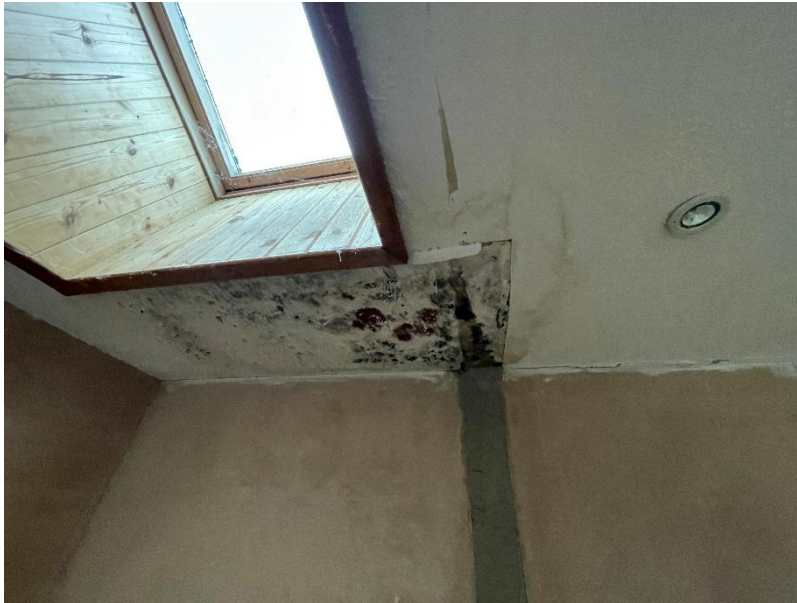
- 3.05 The ceilings throughout are formed in plasterboard with an artex finish.
- 3.06 No coving has been provided at junctions with internal walls and partitions.
- 3.07 Ceilings generally remain true and even with no signs of any significant structural cracking.
- 3.08 Damp staining and black pin mould growth was noted underneath one of the rooflights which has been referred to in this report. Repairs should be undertaken to the rooflights.
