**Sunte House – Window Schedule** (photographic record and brief description based on visual check from the interior)

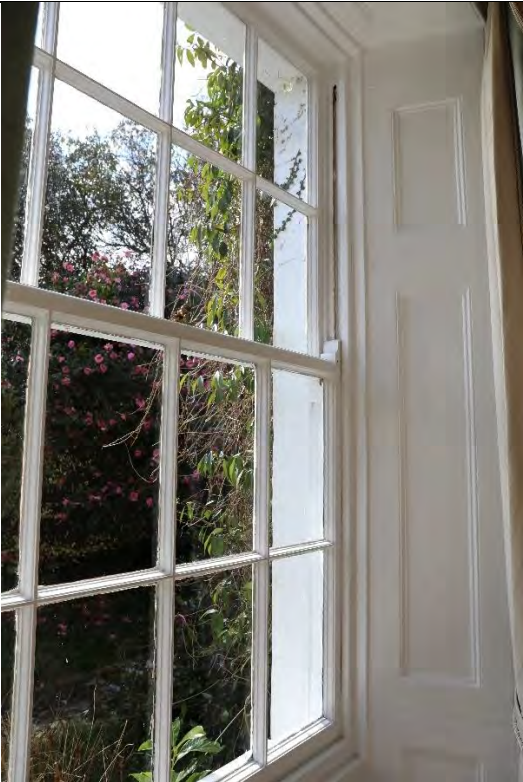
| Ground Floor (GF) | |
|---|---|
| | GF – SW1 (1) (Dining Room) |
| | <ul style="list-style-type: none"><li>- Timber-framed sash with simple curved horns (Twentieth Century based on physical and documentary evidence (see Windows narrative in paras 3.50 – 3.56 in the Heritage Statement))</li><li>- Single-glazed (8 over 8)</li><li>- Modern Brass Brighton fastener</li></ul> <p>Some peeling of paint. Timber does not look soft or rotten. Overall appears to be in fair condition including the sash cord.</p> |

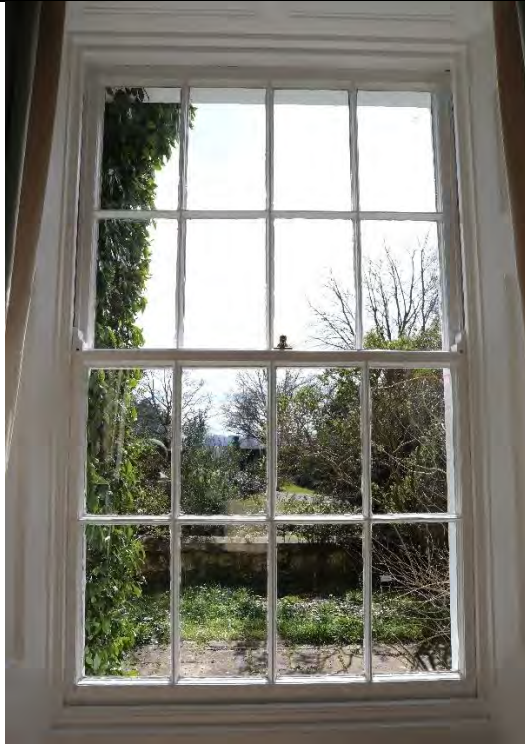
GF – SW2 (1) (Dining Room)

- Timber-framed sash with simple curved horns (Twentieth Century based on physical and documentary evidence (see Windows narrative in paras 3.50 – 3.56 in the Heritage Statement))
- Single-glazed (8 over 8)
- Modern Brass Brighton fastener

Some peeling of paint. Timber does not look soft or rotten. Overall appears to be in fair condition including the sash cord.

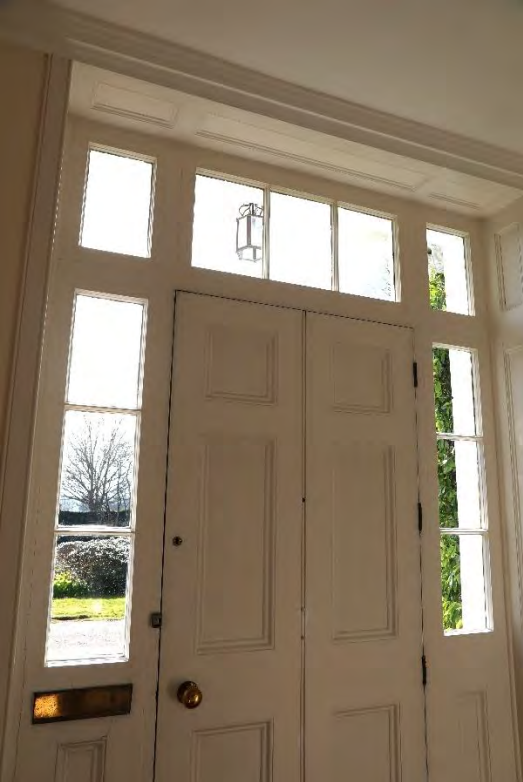
| South Elevation (S) | Middle (M) |
|---|---|
| | <p>GF – SM1 (1) Porch</p> <ul style="list-style-type: none"> <li>- Timber-framed sidelights and fanlight (Twentieth Century based on physical and documentary evidence. Glazing bars have the same molding profile as the windows in the dining room (see Windows narrative in paras 3.50 – 3.56 in the Heritage Statement))</li> <li>- Single-glazed (sidelights to each side of the central door comprised four panes; fanlight above comprises three panes)</li> <li>- Modern Brass Brighton fastener</li> </ul> <p>Timber does not look soft or rotten. Overall appears to be in fair condition.</p> |

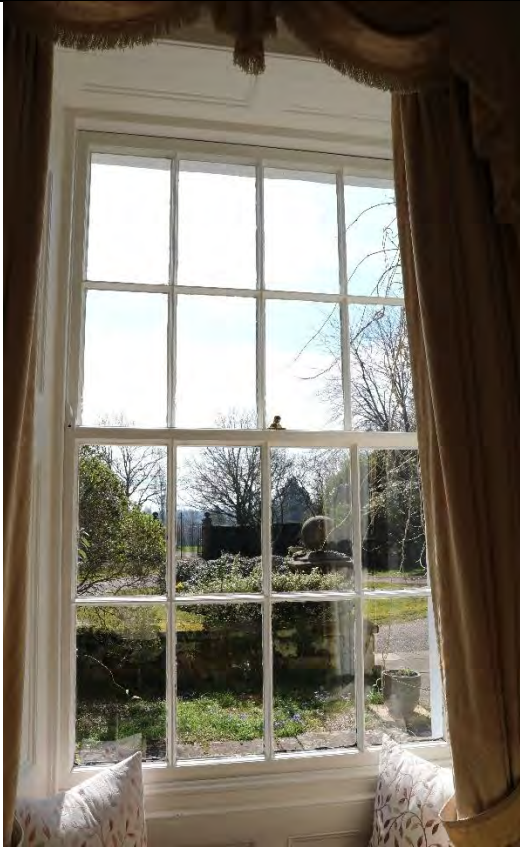
| South Elevation (S) | East (E) |
|---|---|
| | <p>GF – SE1 (1) (Main Sitting Room)</p> <ul style="list-style-type: none"> <li>- Timber-framed sash with simple curved horns (Likely Twentieth Century based on physical and documentary evidence. Glazing bars have the same molding profile as the windows to the east elevation and in the dining room (see Windows narrative in paras 3.50 – 3.56 in the Heritage Statement))</li> <li>- Single-glazed (8 over 8)</li> <li>- Modern Brass Brighton fastener</li> </ul> <p>Some peeling of paint. Timber does not look soft or rotten. Overall appears to be in fair condition including the sash cord.</p> |

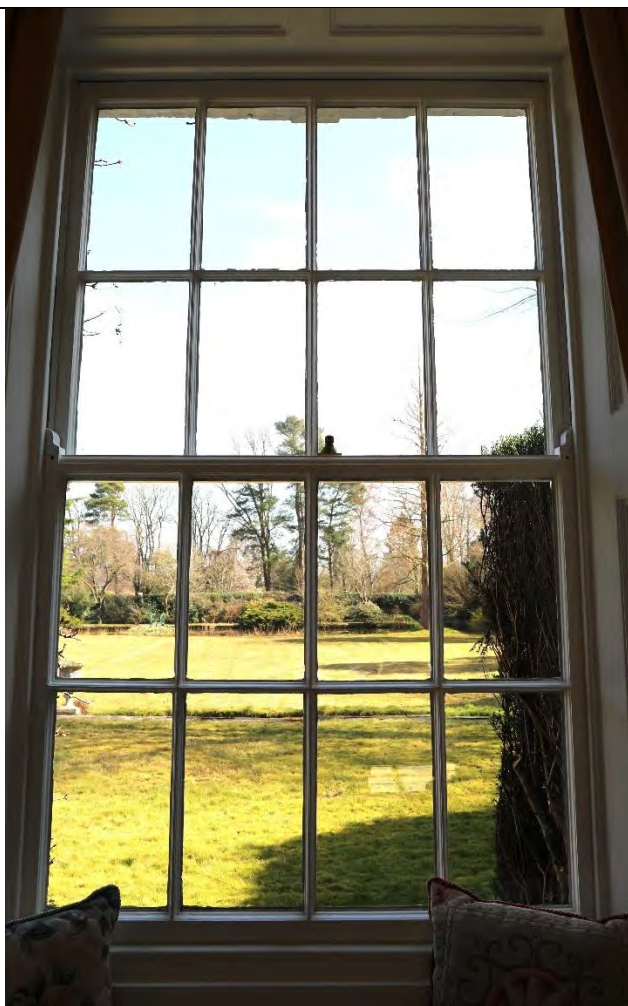
GF – ES1 (1) (Main Sitting Room)

- Timber-framed sash with simple curved horns (Twentieth Century based on physical and documentary evidence. Glazing bars have the same molding profile as the windows to the south elevation and in the dining room (see Windows narrative in paras 3.50 – 3.56 in the Heritage Statement))
- Single-glazed (8 over 8)
- Modern Brass Brighton fastener

Some peeling of paint. Timber does not look soft or rotten. Overall appears to be in fair condition including the sash cord.

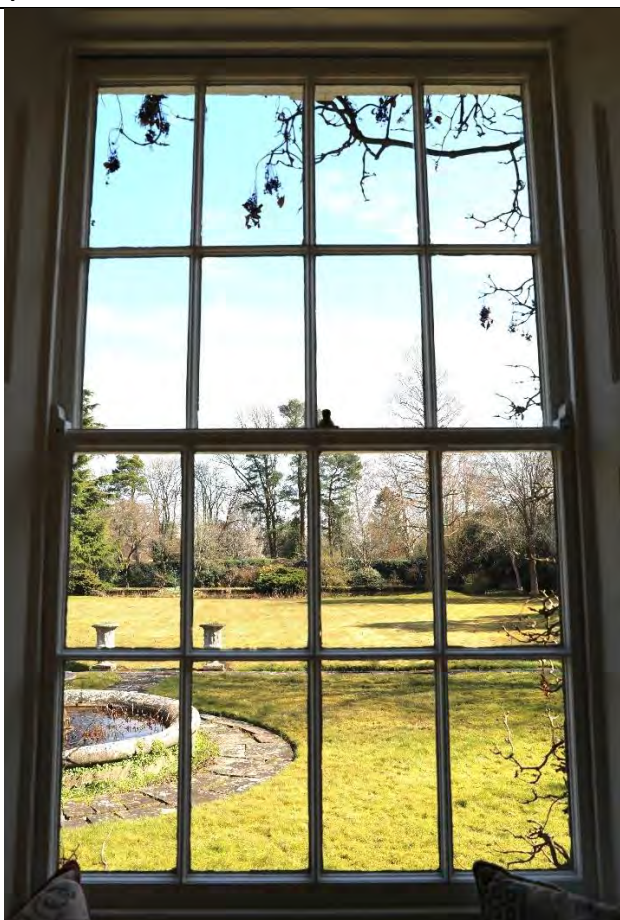
GF – ES2 (1) (Main Sitting Room)

- Timber-framed sash with simple curved horns (Twentieth Century based on physical and documentary evidence. Glazing bars have the same molding profile as the windows to the south elevation and in the dining room (see Windows narrative in paras 3.50 – 3.56 in the Heritage Statement))
- Single-glazed (8 over 8)
- Modern Brass Brighton fastener

Some peeling of paint. Timber does not look soft or rotten. Overall appears to be in fair condition including the sash cord.

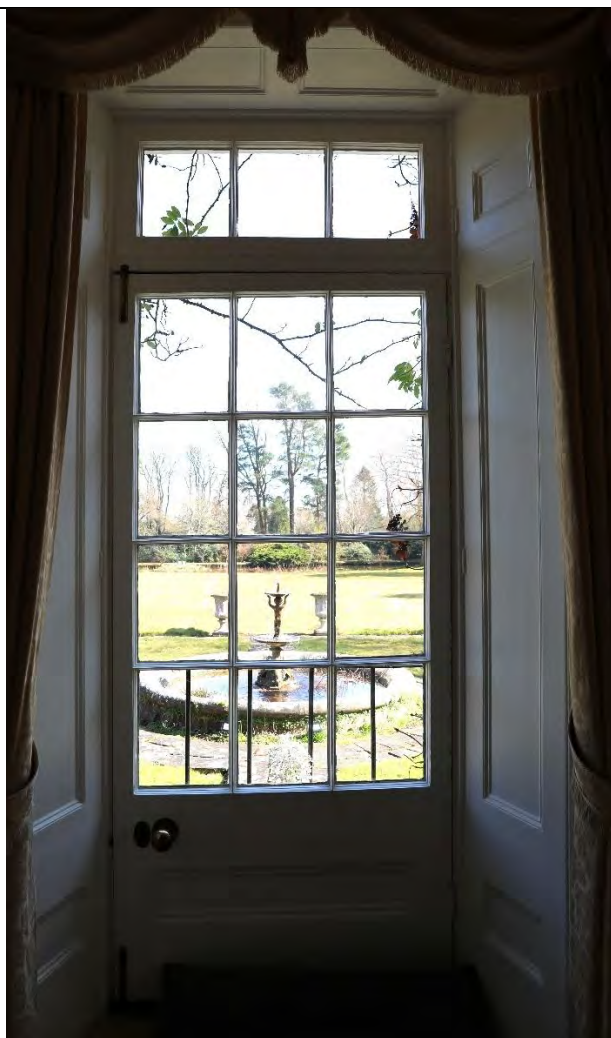
GF – ES2 (1) (Main Sitting Room)

- Part-glazed timber door with 3-light fanlight (Twentieth Century based on physical and documentary evidence. (see Windows narrative in paras 3.50 – 3.56 in the Heritage Statement))
- Single-glazed (12 panes)
- Modern brass door knob
- Painted shutter hinges indicate in situ timber shutters

Some peeling of paint. Timber does not look soft or rotten. Overall appears to be in fair condition.

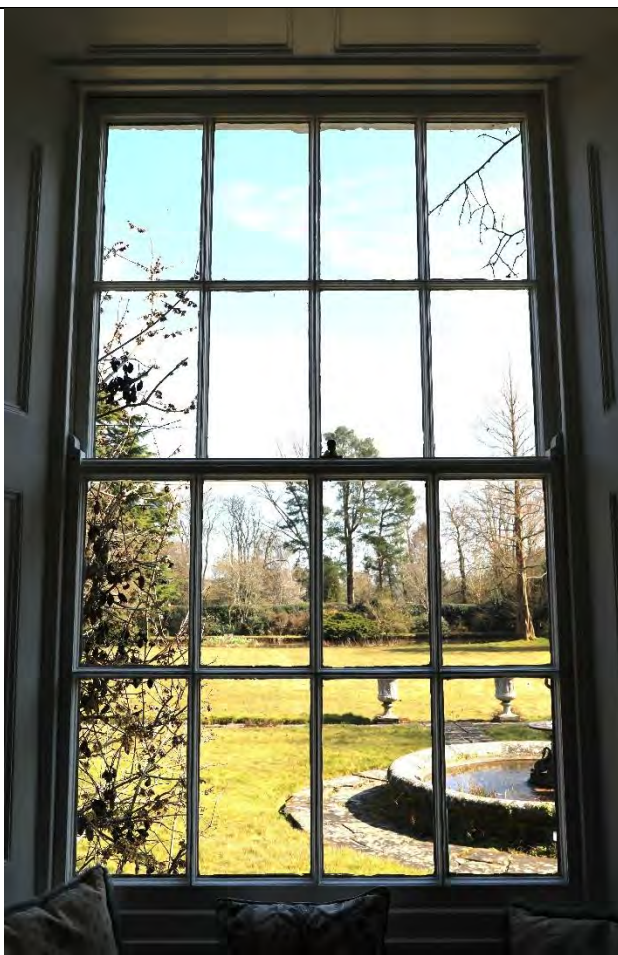
GF – EN1 (1) (Sitting Room)

- Timber-framed sash with simple curved horns (Twentieth Century based on physical and documentary evidence. Glazing bars have the same molding profile as the windows to the south elevation and in the dining room (see Windows narrative in paras 3.50 – 3.56 in the Heritage Statement))
- Single-glazed (8 over 8)
- Modern Brass Brighton fastener

Some peeling of paint. Timber does not look soft or rotten. Overall appears to be in fair condition including the sash cord.

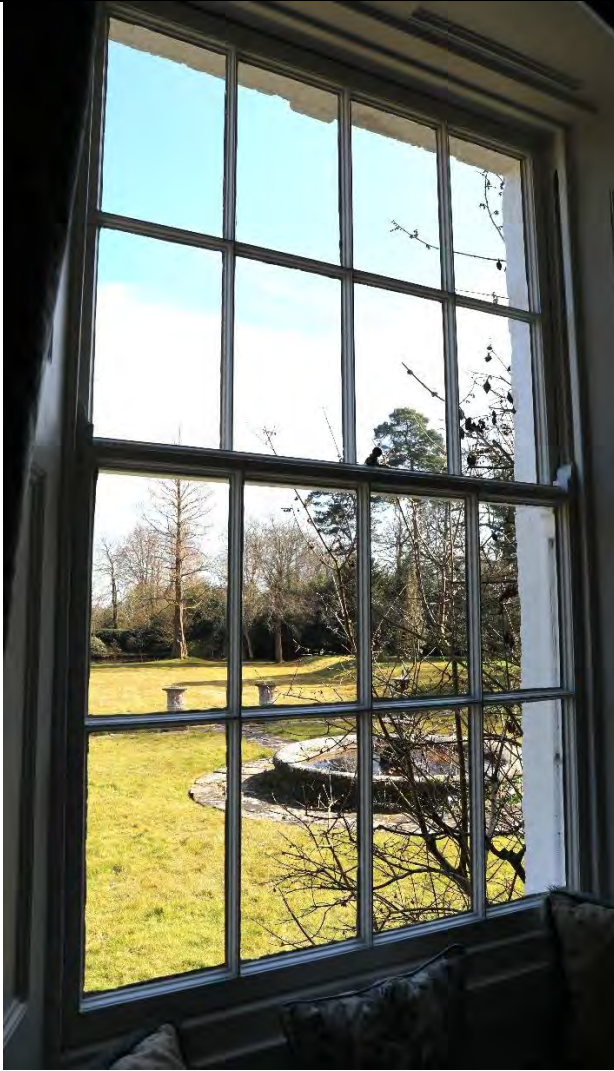
GF – EN2 (Sitting Room)

- Timber-framed sash with simple curved horns (Twentieth Century based on physical and documentary evidence. Glazing bars have the same molding profile as the windows to the south elevation and in the dining room (see Windows narrative in paras 3.50 – 3.56 in the Heritage Statement))
- Single-glazed (8 over 8)
- Modern Brass Brighton fastener

Some peeling of paint. Timber does not look soft or rotten. Overall appears to be in fair condition including the sash cord.

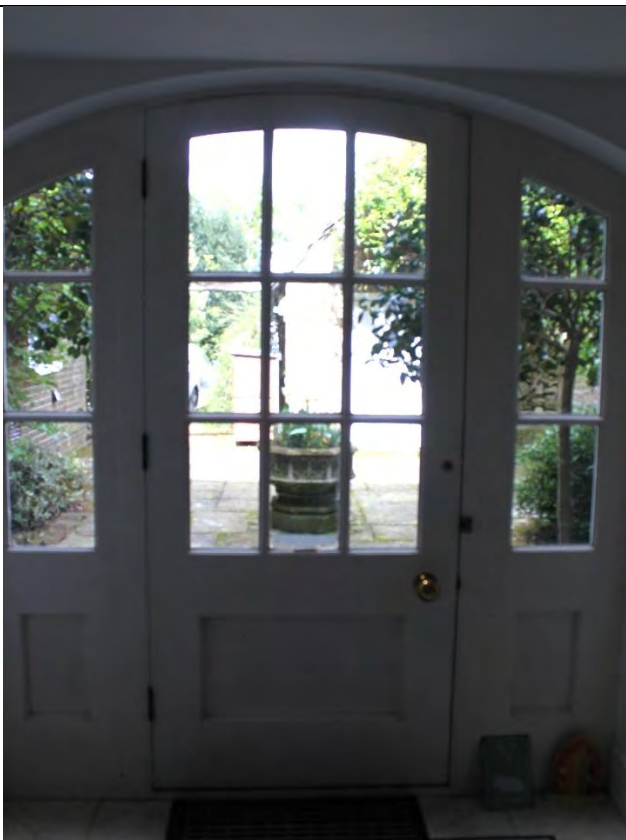
GF – NM1 (Rear Hallway)

- Part-glazed timber door with 3-light sidelights (Twentieth Century based on physical and documentary evidence)
- Single-glazed (door – 9 panes)
- Modern brass door knob

Timber does not look soft or rotten. Overall appears to be in fair condition.

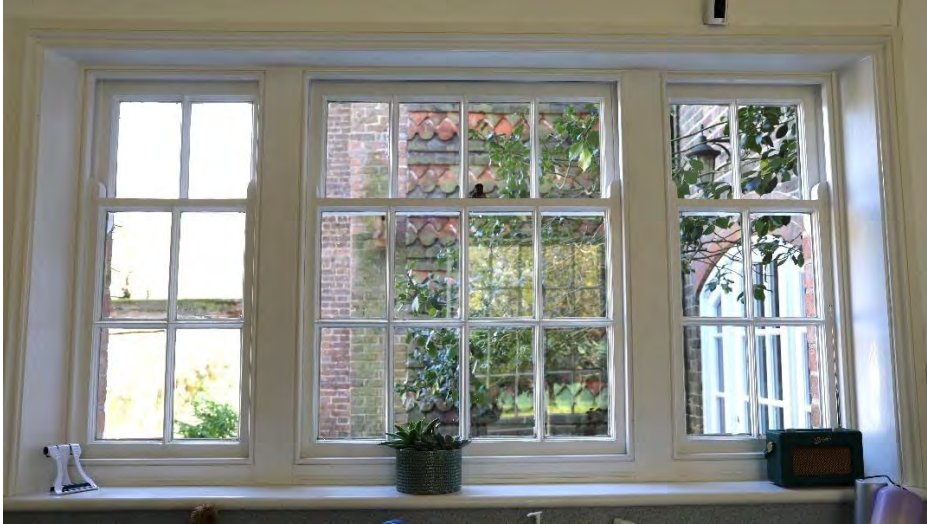
| Northeast Elevation (NE) | |
|---|---|
| | <p>GF – NE1 (Kitchen)</p> <ul style="list-style-type: none"> <li>- Coupled style 3 timber sash with simple curved horns (Twentieth Century based on physical and documentary evidence)</li> <li>- Centre window – 4 over 8; side windows – 2 over 4</li> <li>- Modern Brass Brighton fastener</li> </ul> <p>Timber does not look soft or rotten. Overall appears to be in fair condition.</p> |

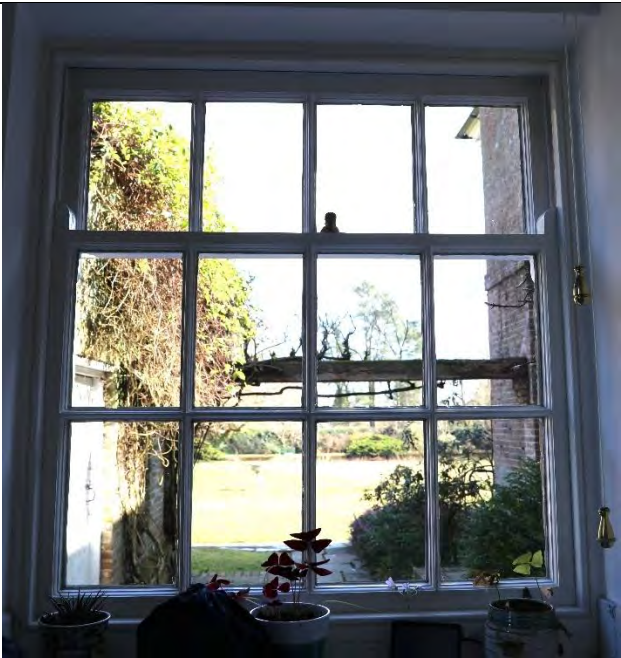
| Northeast Elevation (NE) | |
|---|---|
| | <p>GF – NE2 (Utility Room)</p> <ul style="list-style-type: none"> <li>- Timber sash with simple curved horns (Twentieth Century based on physical and documentary evidence)</li> <li>- Single-glazed (4 over 8)</li> <li>- Modern Brass Brighton fastener</li> </ul> <p>Timber does not look soft or rotten. Overall appears to be in fair condition.</p> |

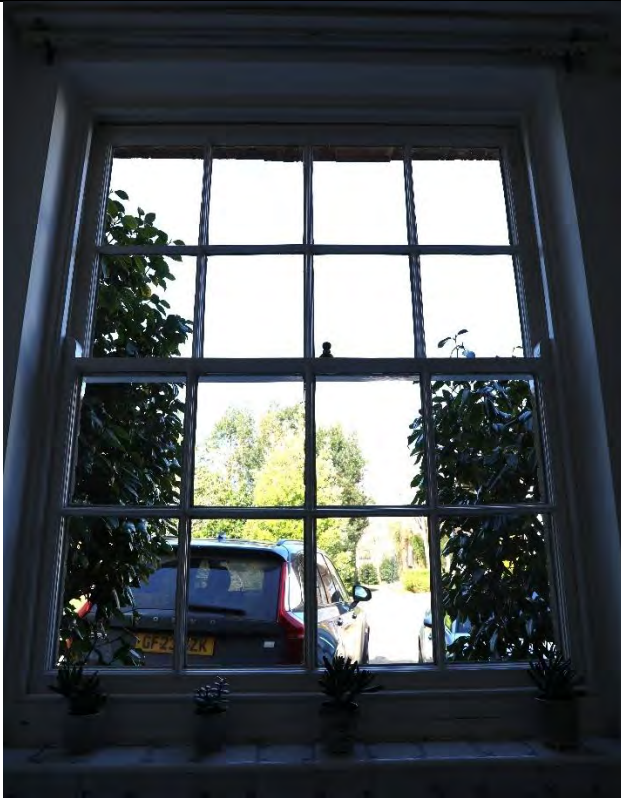
GF – N1 (Utility Room)

- Timber sash with simple curved horns (Twentieth Century based on physical and documentary evidence)
- Single-glazed (8 over 8)
- Modern Brass Brighton fastener

Timber does not look soft or rotten. Overall appears to be in fair condition.

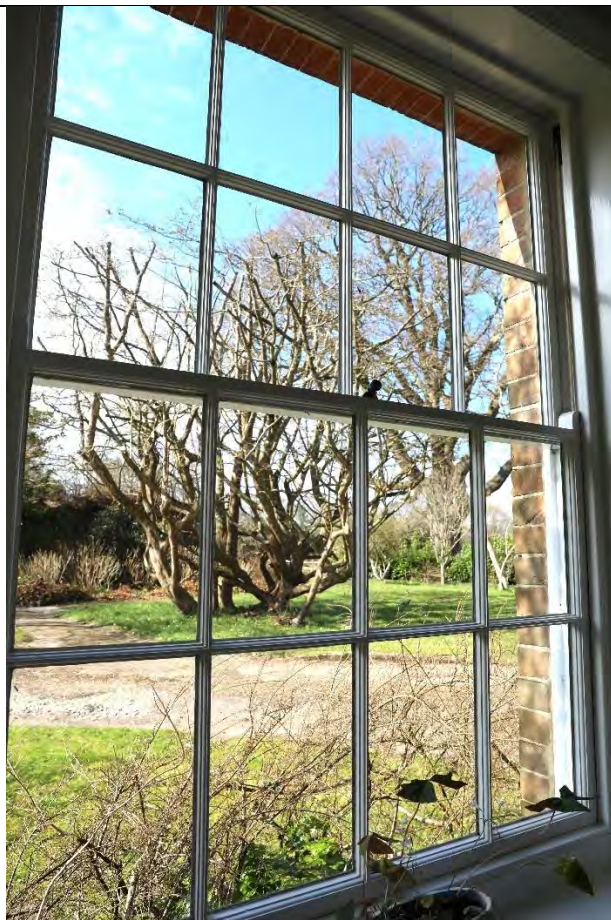
GF – WN1 (Hallway)

- Timber-framed sash with simple curved horns (Twentieth Century based on physical and documentary evidence)
- Single-glazed (8 over 8)
- Modern Brass Brighton fastener

Timber does not look soft or rotten. Overall appears to be in fair condition including the sash cord.

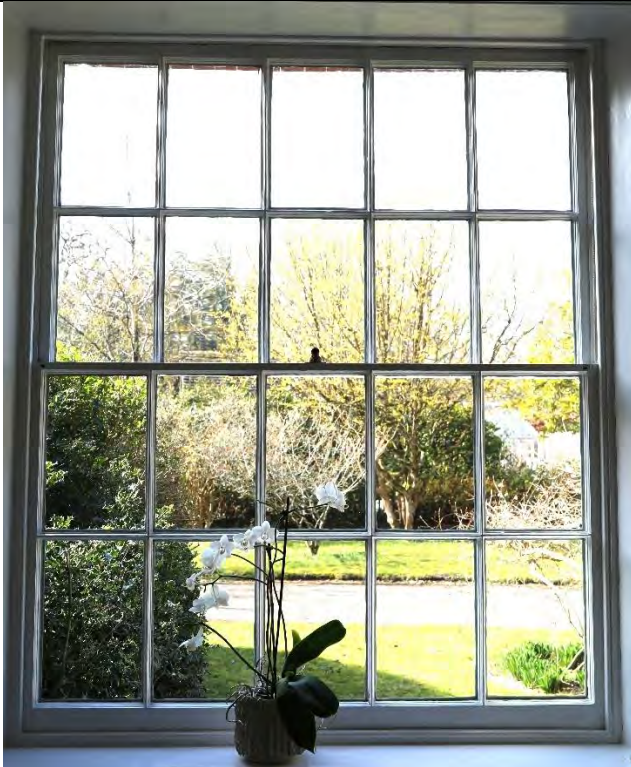
GF – WN1 (Kitchen)

- Timber-framed sash (Likely Twentieth Century (in the Georgian style))
- Single-glazed (10 over 10)
- Modern Brass Brighton fastener

Some peeling of paint. Timber does not look soft or rotten. Overall appears to be in fair condition including the sash cord.

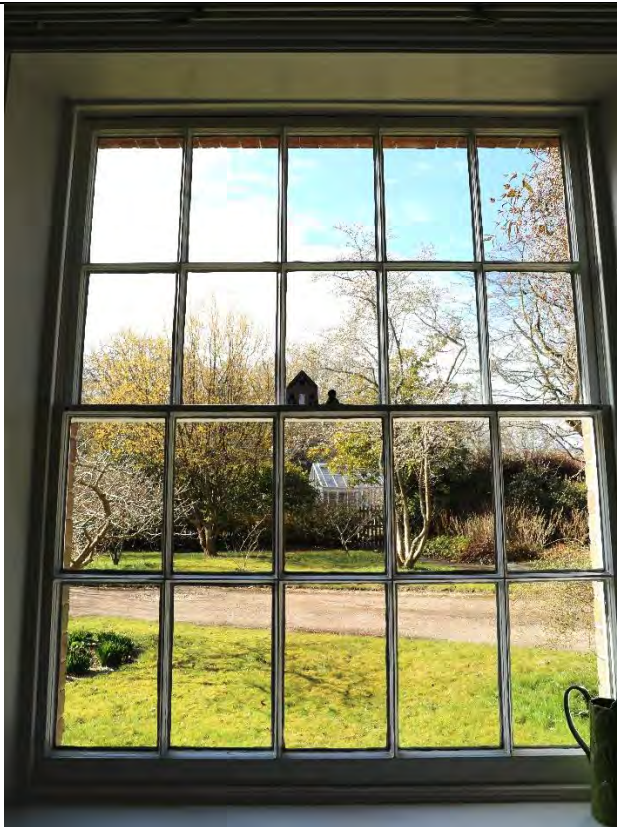
GF – WN2 (Kitchen)

- Timber-framed sash (Likely Twentieth Century (in the Georgian style))
- Single-glazed (10 over 10)
- Modern Brass Brighton fastener

Some peeling of paint. Timber does not look soft or rotten. Overall appears to be in fair condition including the sash cord.

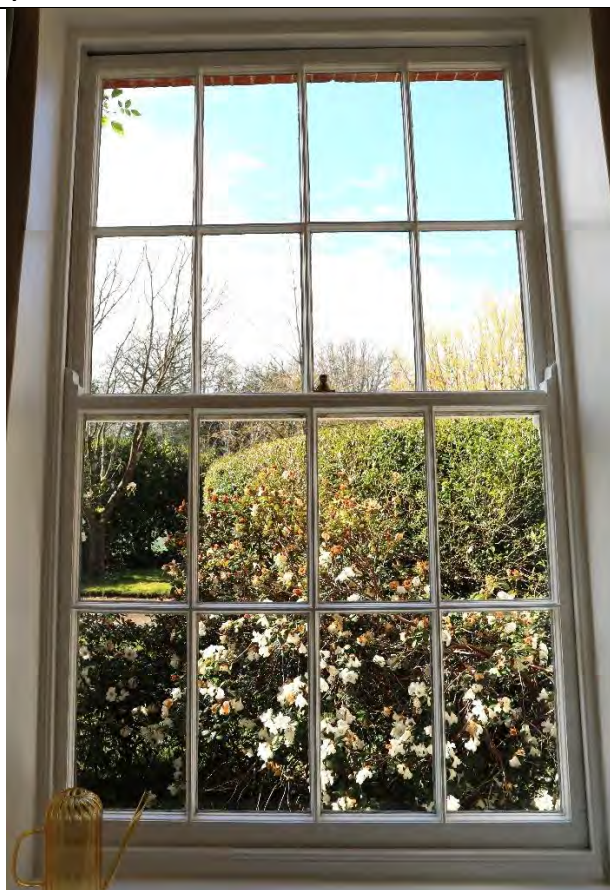
GF – WS1 (Dining Room)

- Timber-framed sash with simple curved horns (Likely Twentieth Century based on physical evidence. Glazing bars have the same molding profile as the windows to the south and east elevations (see Windows narrative in paras 3.50 – 3.56 in the Heritage Statement))
- Single-glazed (8 over 8)
- Modern Brass Brighton fastener

Some peeling of paint. Timber does not look soft or rotten. Overall appears to be in fair condition including the sash cord.
