Chownes Mead  
Haywards Heath

Outline Schedule of Condition and Repair  
July 2026

Outline Schedule of Condition and Repair

PN4268 OSCR1

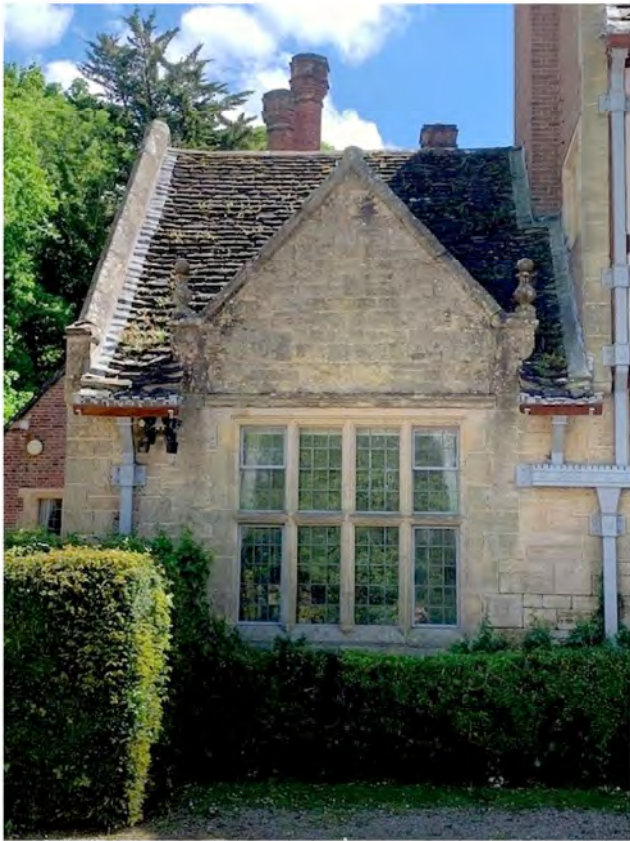
Plate 4: Ground Floor elevation to northeast of main house

- c) Inspection of flashings to all areas will be required. Although there are few indications that there is considerable deterioration, some may require refixing. This is particularly at chimneys and junctions between pitches and walls (Plate 4)

- d) Gables appear to be suitably elevated over the barge-board to shed water to the main roof rather than over the gable boards to cause damage, but opportunity ought to be taken for the stability of the tilting fillets, which it is assumed result in the increased height, are stable. Similarly, where the pitched roof meets parapet walls (Plate 4), the condition of the flashings requires checking.

- e) Rainwater goods appear to be generally in reasonable condition (Plate 4). They will all be tested for watertightness and stability. Any repairs will be carried out on a like-for-like basis. Birds, leaf and insect guards ought to be checked where they exist and fitted if they do not.

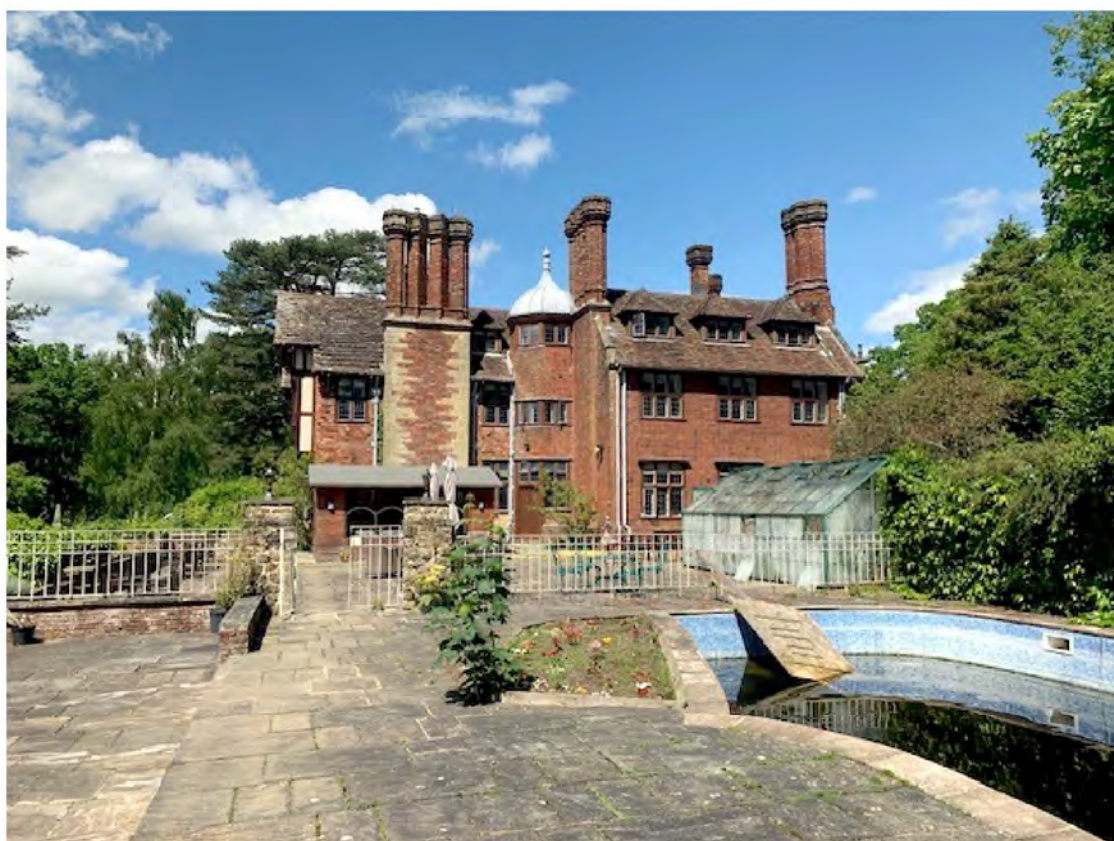
Plate 12: Southeast elevation beyond swimming pool

- 1.21** Some more recent additions have been allowed to deteriorate as they are not planned to be reused, including the pool and associated structures (Plate 12), but this is not impacting the historic fabric.

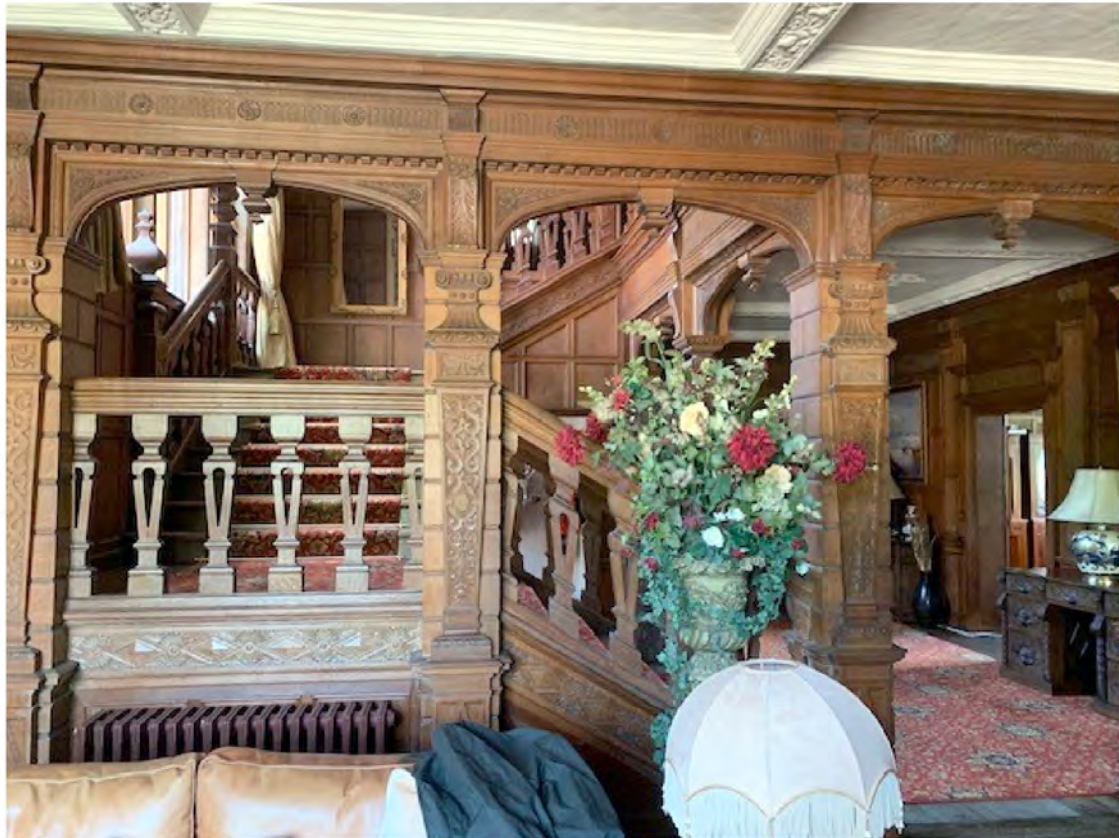
Plate 15: Entrance Hall looking southeast towards staircase

- 3.4 *Timber panelling*** is used extensively throughout the entrance hall (Plate 15), ground floor main rooms (Plate 16), first-floor landing (Plate 30 and main bedrooms (Plate 31). It is of high quality and largely in its original condition. No damage or deterioration was noted other than light aging. It requires only a gentle clean and it will be protected temporarily, when works which might cause damage are taking place.

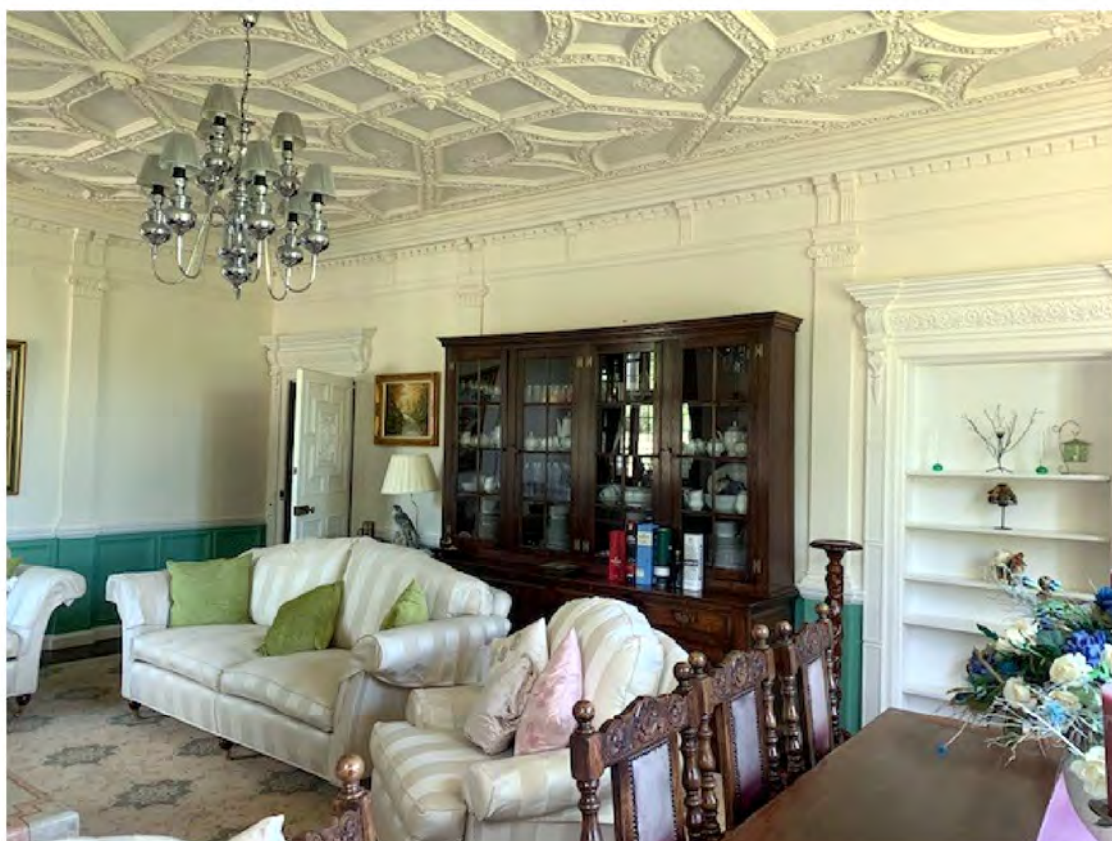
Plate 18: Office looking south towards door and chimneypiece

- 3.6** Some minor making good may be required in the Drawing Room where a doorway which has been infilled with a bookcase (Plate 18) is being returned to a doorway. It is anticipated that reinstatement of detail to match the adjacent doorway will be carried out, using it as a template for repair and replacement of detail.

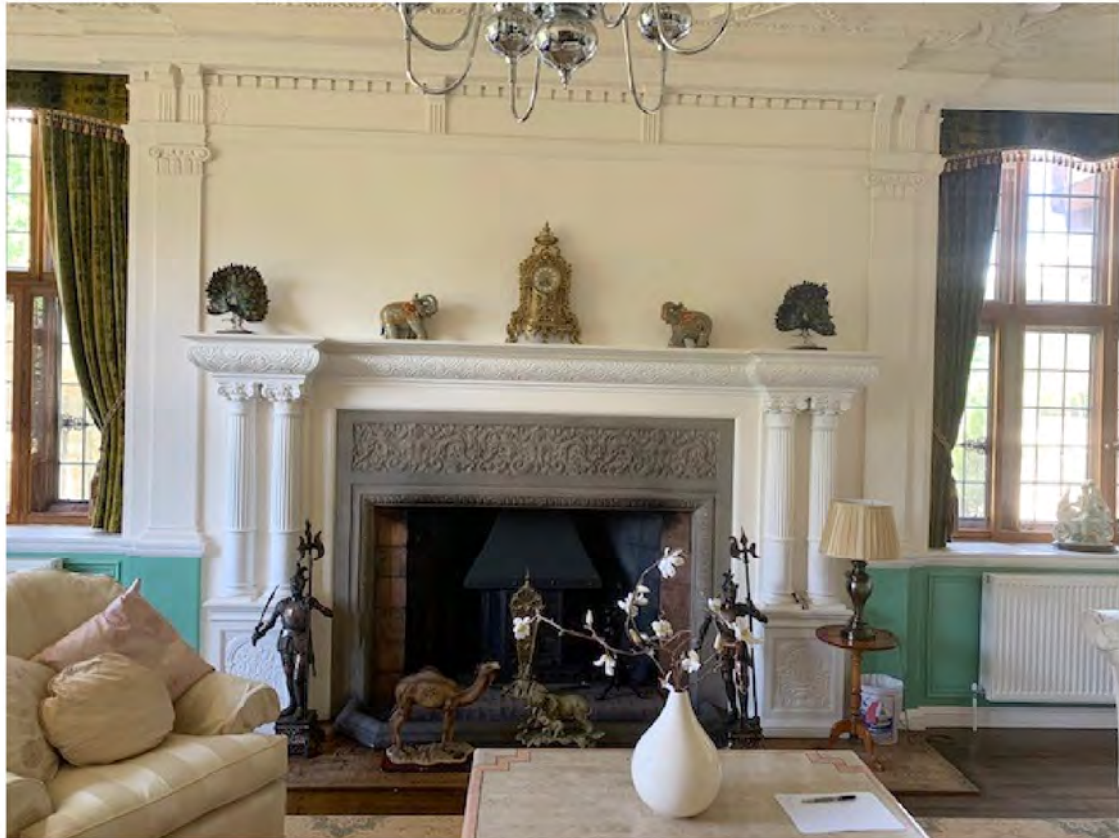
Plate 19: Drawing Room chimney piece in northwest wall

- 3.8 Some rooms, such as the drawing room, have ***plaster walls with associated decorative detailing*** (Plate 19). The condition of the plasterwork, including dentilled and columned detail is very good and requires little if anything in the form of repair.

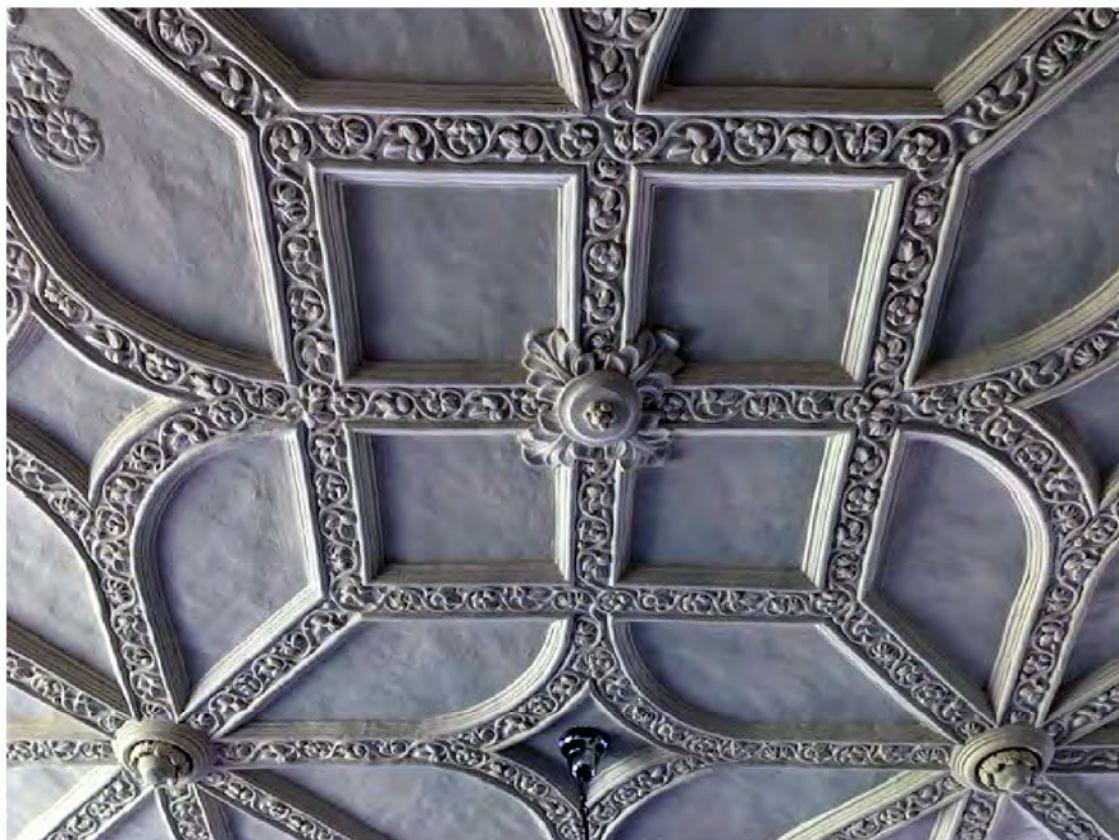
Plate 20: Drawing Room ceiling detail

- 3.2** Whilst the flat sections to the plaster are often undulating which reflects the patina of age (Plate 20), not a construction fault, the fabric does appear stable with no cracking or unsound areas. Care will be taken during the works not to disturb this plasterwork, particularly when working within the above floor spaces to avoid loosening plaster keys around the battens. Propping, protective barriers and other means of preventing damage to the ceilings, will be used where potential disruption might be anticipated.

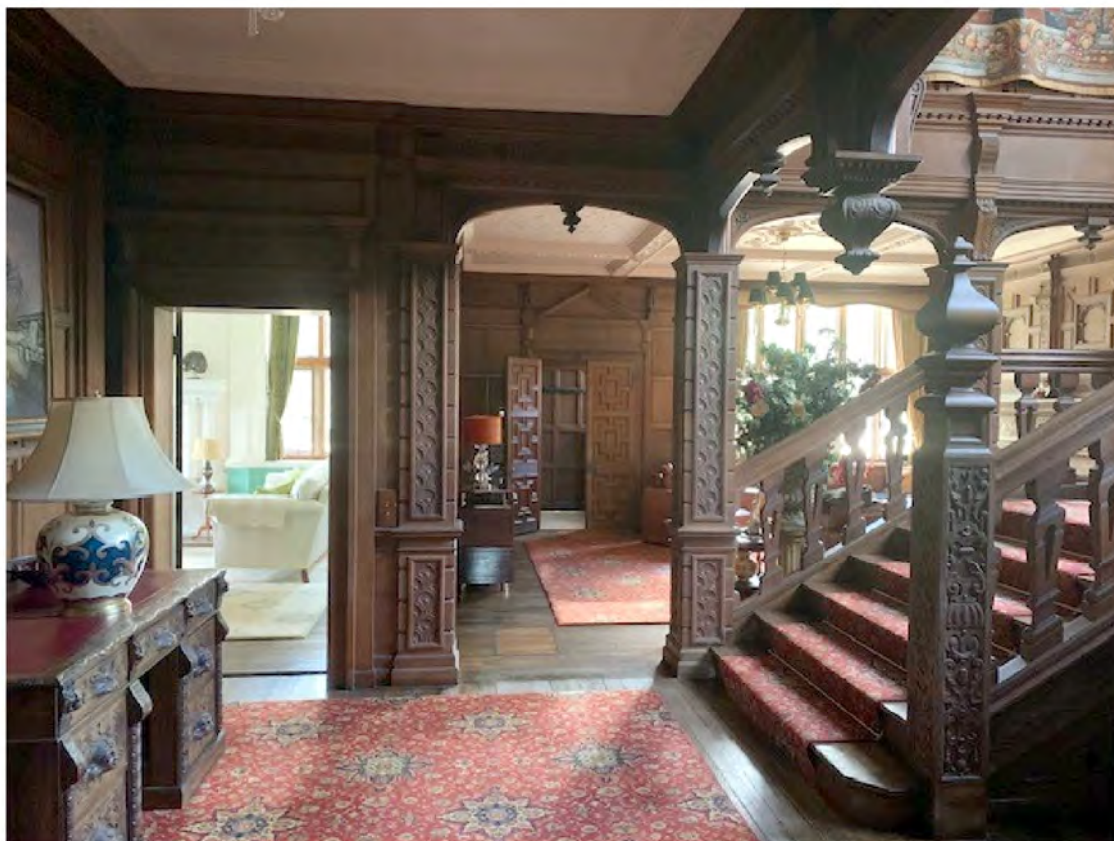
Plate 21: Entrance Hall looking northwest

- 3.15 Many of the rooms have fine ***timber floors*** and skirting which largely co-ordinate with the wall panelling (Plate 21). These have only the expected level of wear and tear. They will be protected when works are carried out and lightly refurbished with gentle cleaning. No areas of instability were observed.

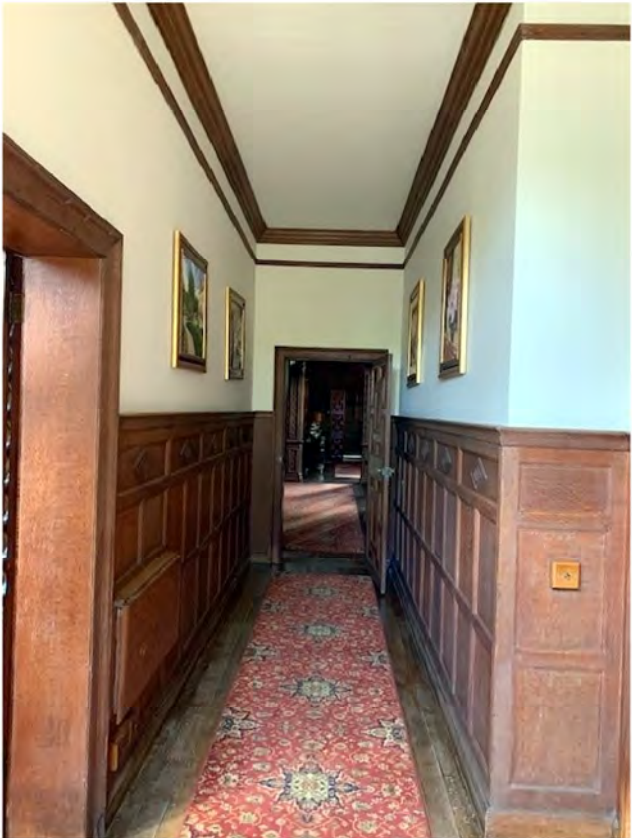
Plate 25: Corridor between Dining Room and Larder

- 3.7** In the corridor, there is panelling to the lower level of the wall (Plate 25). This is in areas which are particularly vulnerable as they are routes for servicing the main rooms. They are in good condition and require only light cleaning. As part of the works, inappropriate light switches and additional fixings will be relocated in less obtrusive areas.

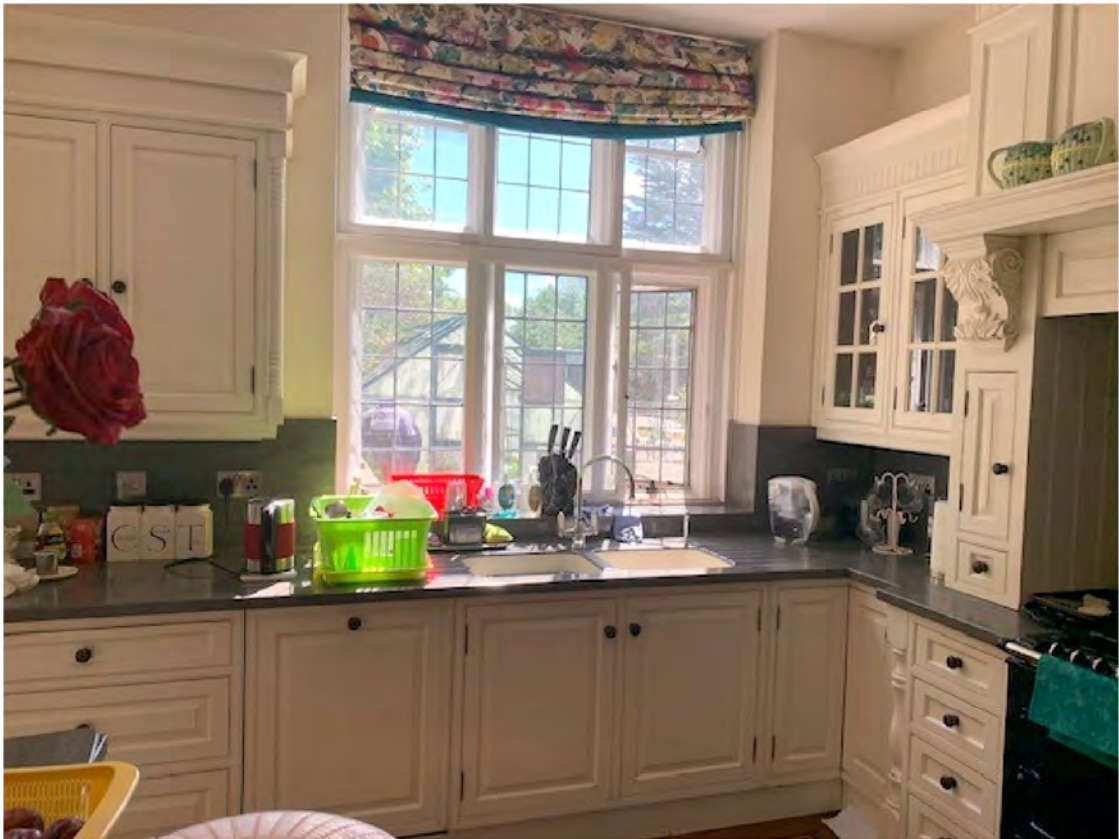
Plate 26: Kitchen southeast wall

- 3.9 Several areas do not have the extent of decorative detail of the main rooms, and these have been relatively recently refurbished including kitchen areas (Plate 26) and Family Rooms (Plate 27). As a result, there is little necessity for repair. These are the areas scheduled for alteration as a minimum of historic fabric, if any, is present.

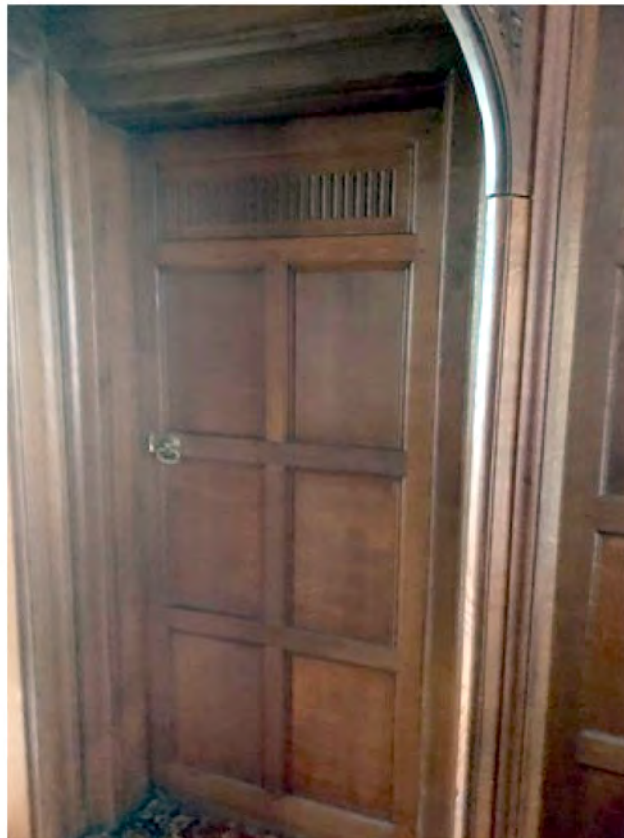
Plate 33: Door, ironmongery and panelling to first floor

- 3.13 Where rooms are panelled, ***doors*** are designed to match (Plate 33). They are in good condition, the only repairs required are replacement of ironmongery, to approved detail, where modern ironmongery has replaced original. Hinges ought to be maintained.

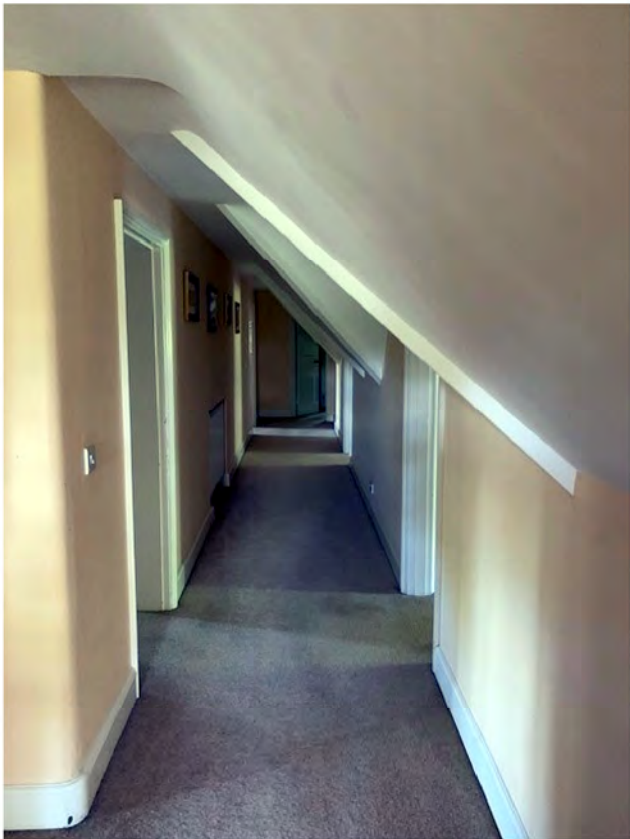
Plate 36: Second floor corridor

- 3.14 In recently refurbished areas, such as the attic spaces (Plate 36), all doors, architraves, and skirtings are of recent date and do not require repair.

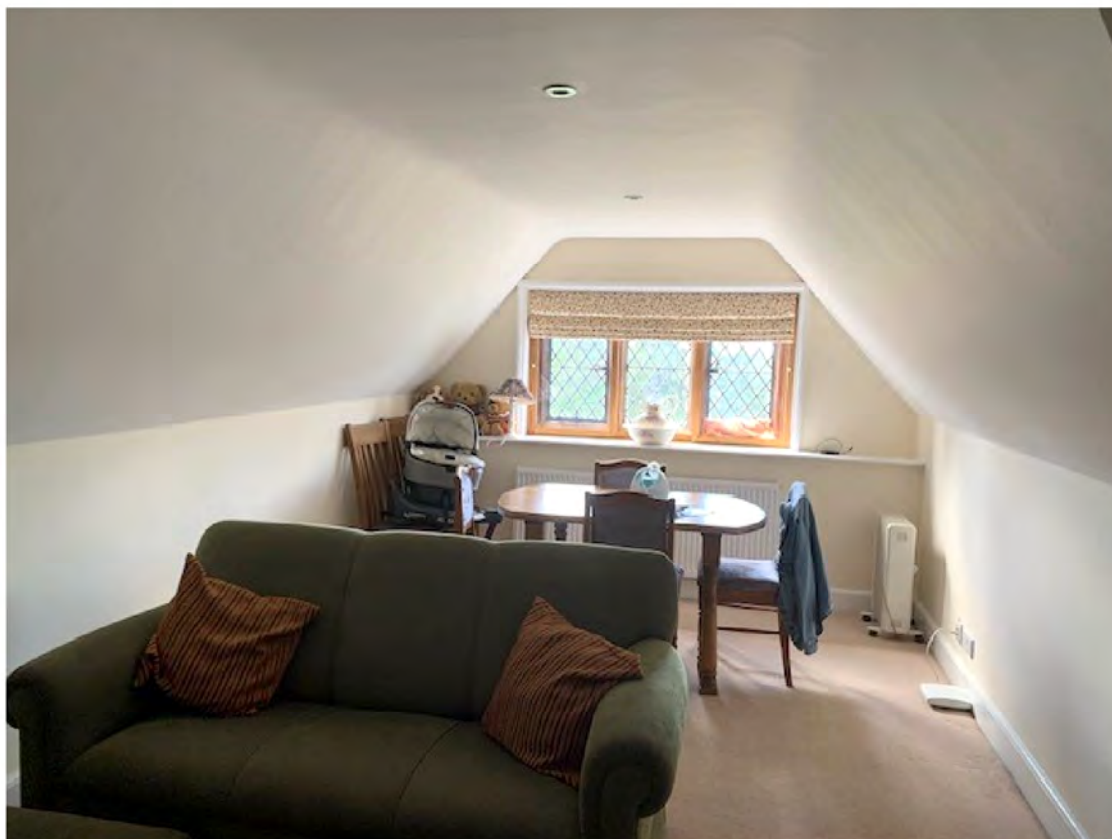
Plate 37: Second floor living room

- 3.3** Upper floors in the former attic space are largely recent with plaster board and skim (Plate 37), thus are in good condition and will require only making goods if affected by alteration.

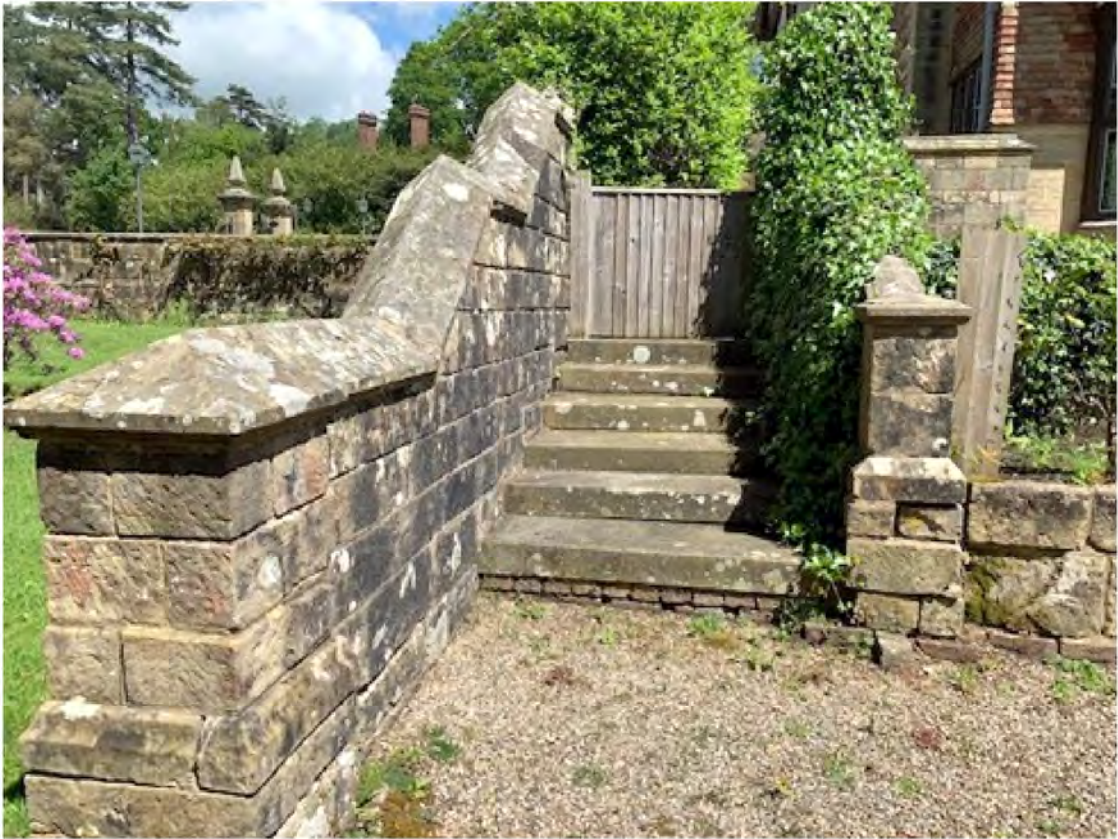
Plate 40: External steps up to southwest terrace

- 2.28** Similarly, the walls and associated steps are in good condition. There are some minor areas of spalling at lower levels (Plate 40), lichen growth and several areas of loose or missing pointing. Where the extent of lost stone is impacting surrounding stones, small areas will be replaced. A sample of the proposed stone and pointing will be provided for approval.

- 2.29** Steps are reasonably even although changes in ground level to the lower steps create an uneven rise and step bases are exposed (base of steps in Plate 40). For example, this has occurred where gravel has replaced either stone or grassed areas. This will be addressed as part of either the hard or soft landscape works, and ground level will be made up to protect the structural base.
