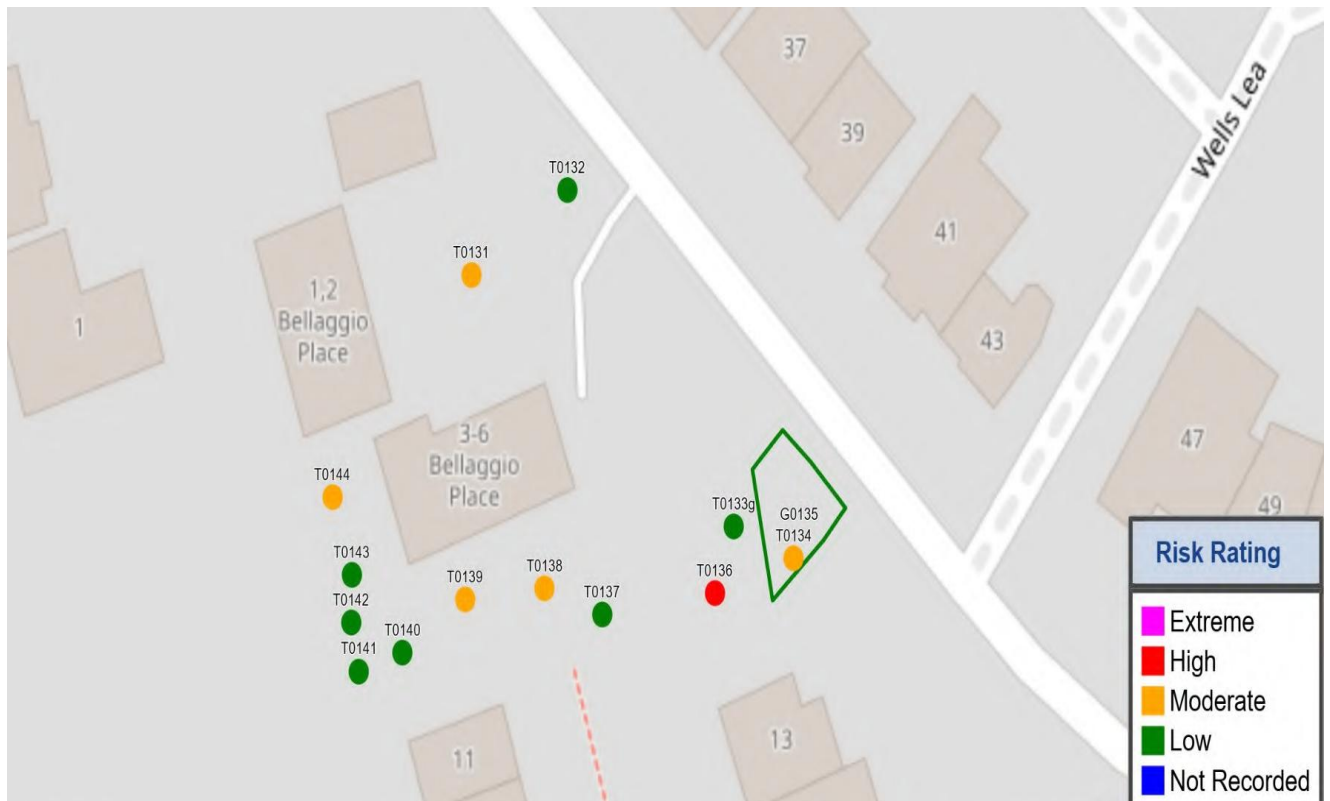
| Measurements | Hazard Target Notes | Physiological Condition | Structural Condition | Risk Assessment | Risk Rating | Tree work | Photo | | What 3 Words |
|---|---|---|---|---|---|---|---|---|---|
| Height (m): 25<br>Life Stage: Mature | Significant deadwood in crown that has been present for several years<br>Showing evidence of natural retrenchment<br>Some bark popping on buttress on SE side | Low | Remediable | Likelihood of Failure: Probable<br>Likelihood of Impact: High<br>Failure x Impact: Likely<br>Consequences: Severe<br>Risk Rating: High | High | Reduce top by no more than 6m to remove dead and declining top and remaining lateral branches forming lower crown by 2m<br><br>This work is imitating natural retrenchment in order to retain the tree | | <b>T0136 Oak</b> | ///burst.saves.terms |
