**Arbor Cultural Ltd. *Providing Expertise on Your Trees*®**

**BS5837 Arboricultural Report and  
 Arboricultural Impact Assessment**

| <b>OUR REFERENCE</b> | <b>AC.2026.1005</b> |
| <b>SITE</b> | <b>Commercial Element for Prince Albert Public House,<br/>Copthorne Bank, Copthorne, Crawley, RH10 3QX</b> |

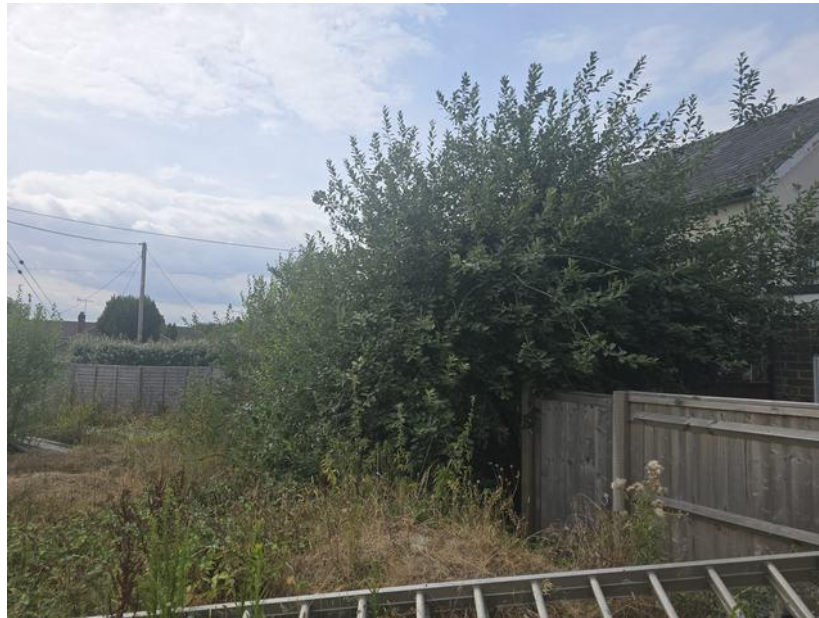
**Image 1 T01 a bushy multi stemmed goat willow.**

**3.2.1** There are seven that are proposed for removal as part of this application. T02 the silver birch tree is due to its declining and unsafe condition. The other six, T01, T04, T05, T06, T07, and T08 are due to conflicts with the proposed design. These are poor quality or small trees with limited amenity value and there is a significant landscaping scheme including replacement trees. Consequently, there will be a minimal effect to the amenity value of the area.

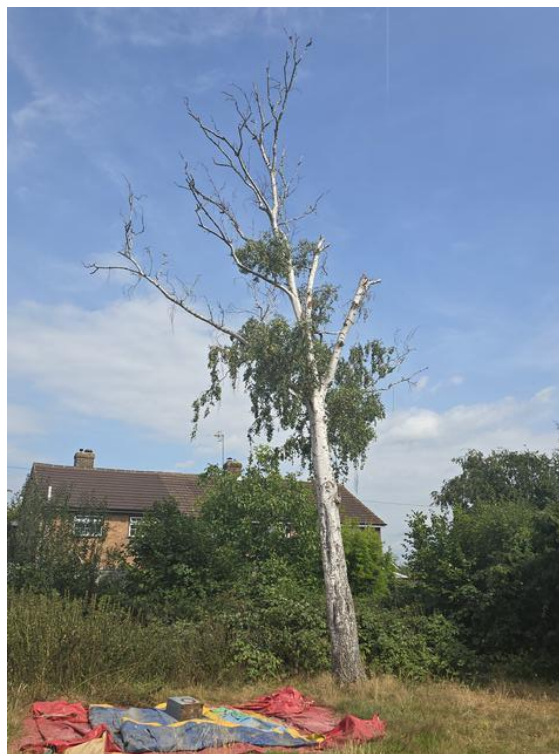
**Image 2 T02 a declining silver birch tree.**

| Ref | Species | Measurements | Spread | General Observations | Retention Category | RPA | Recommendations | Condition | Reinspect |
|---|---|---|---|---|---|---|---|---|---|
| T02 | Silver birch<br>( <i>Betula pendula</i> ) | Height (m): 11<br>Stem Diam(mm): 470<br>Spread (m): 4N, 5E, 2S, 5W<br>Crown Clearance (m): 5<br>Life Stage: Over Mature<br>Rem. Contrib.: <10 years | N:4<br>E:5<br>S:2<br>W:5 | Damaged and decayed buttress roots.<br>Major deadwood and dieback in the crown. | U | Radius: 5.6m.<br>Area: 99 sq. m. | Remove this tree due to reduced safety. | Physiological Cond: Poor<br>Structural Cond: Decaying<br>Bat Habitat: Low | N/A |

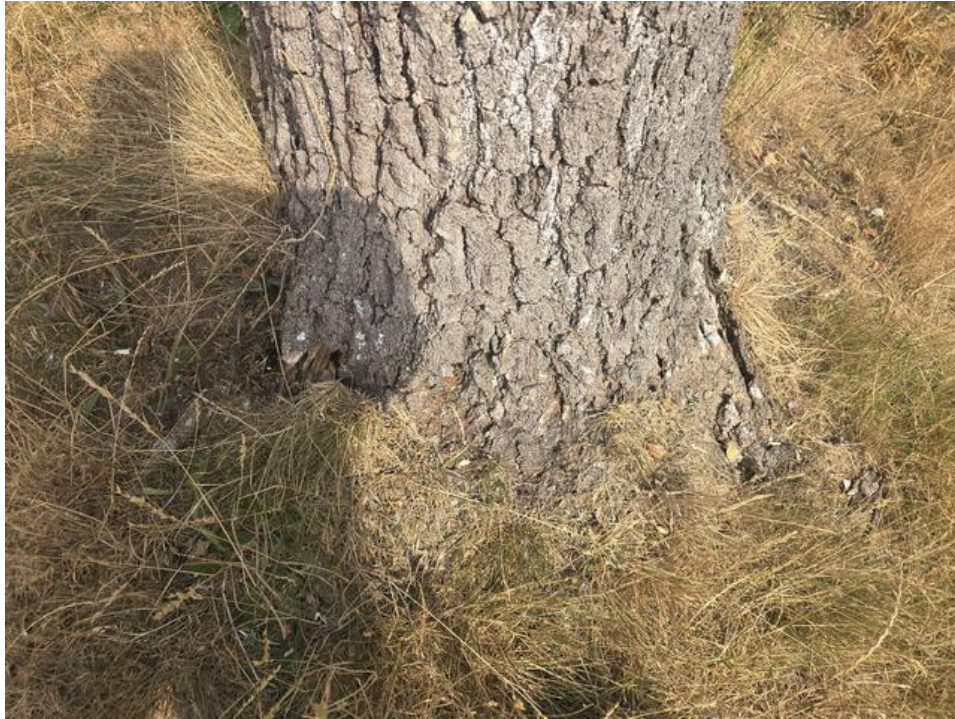
**Image 3**      **Base of silver birch T02 with decay.**

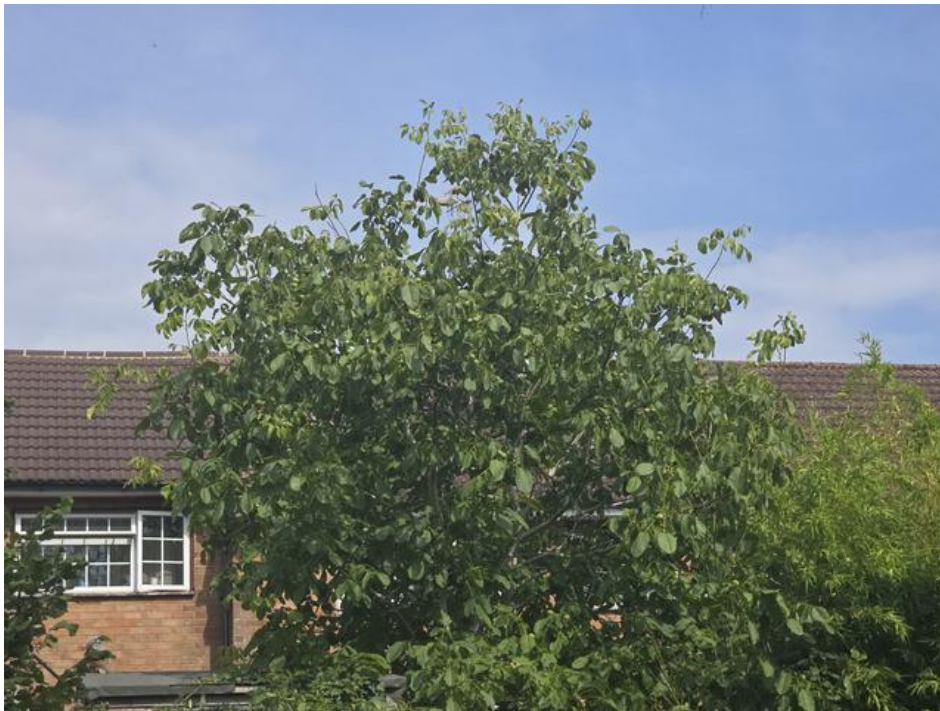
**Image 4**      **The crown of T03 a walnut tree in the adjacent property.**

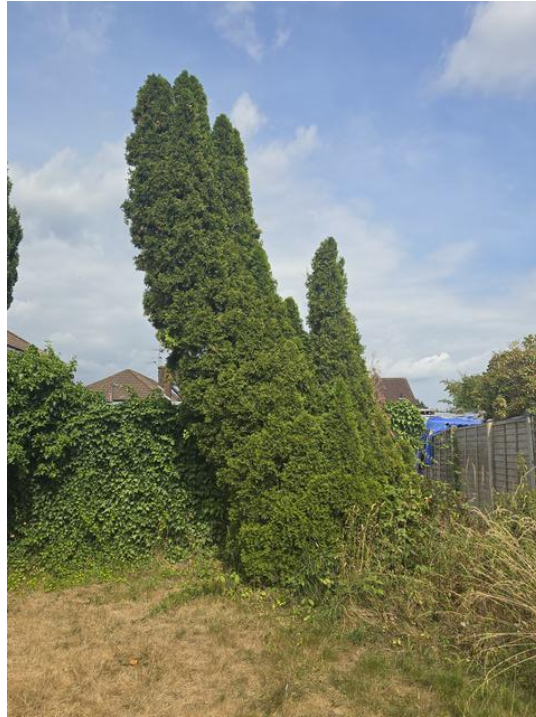
**Image 5** T04 a multi stemmed cypress tree on the site boundary.

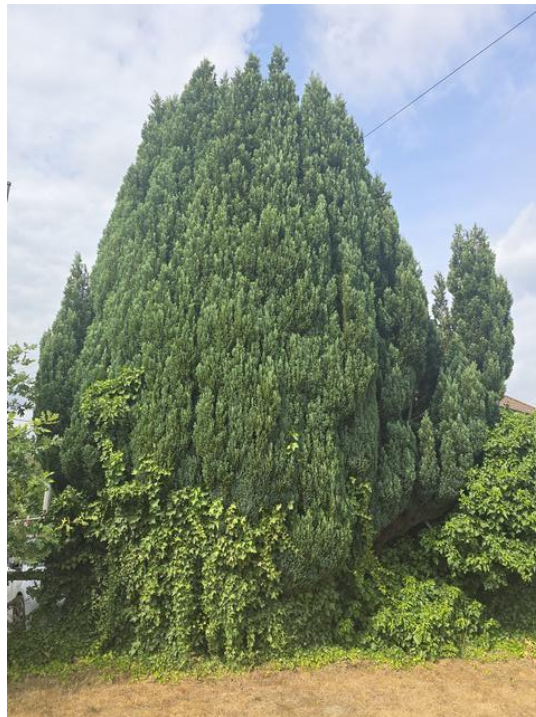
**Image 6** T05 a multi stemmed cypress tree on the site boundary.

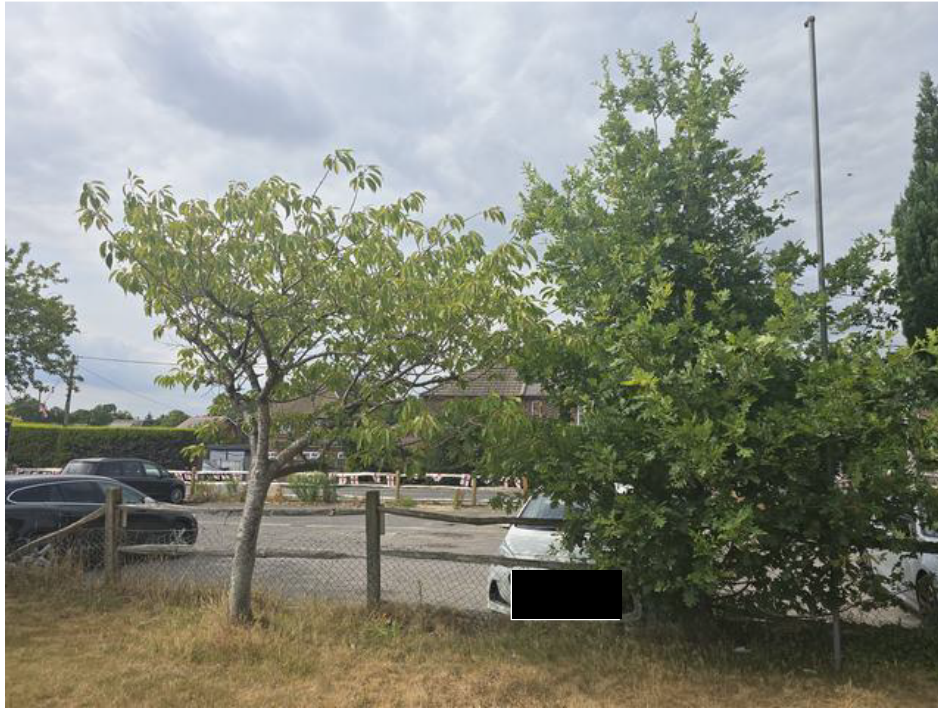
**Image 7** T06 an oak and T07 a cherry on the edge of the car park.

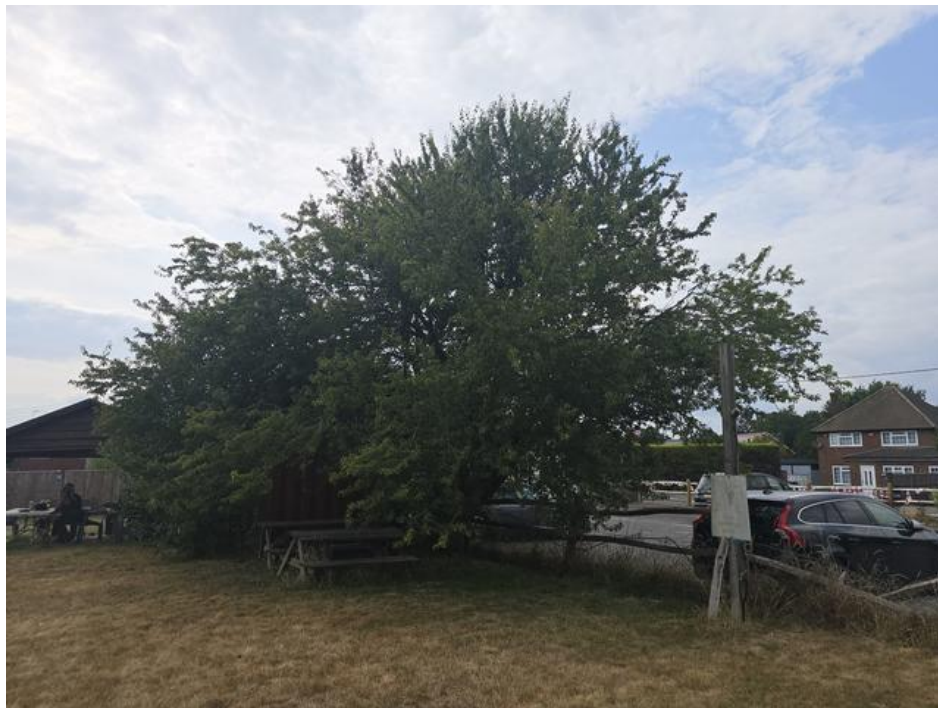
**Image 8** T08 a multi stemmed plum tree on the edge of the car park.

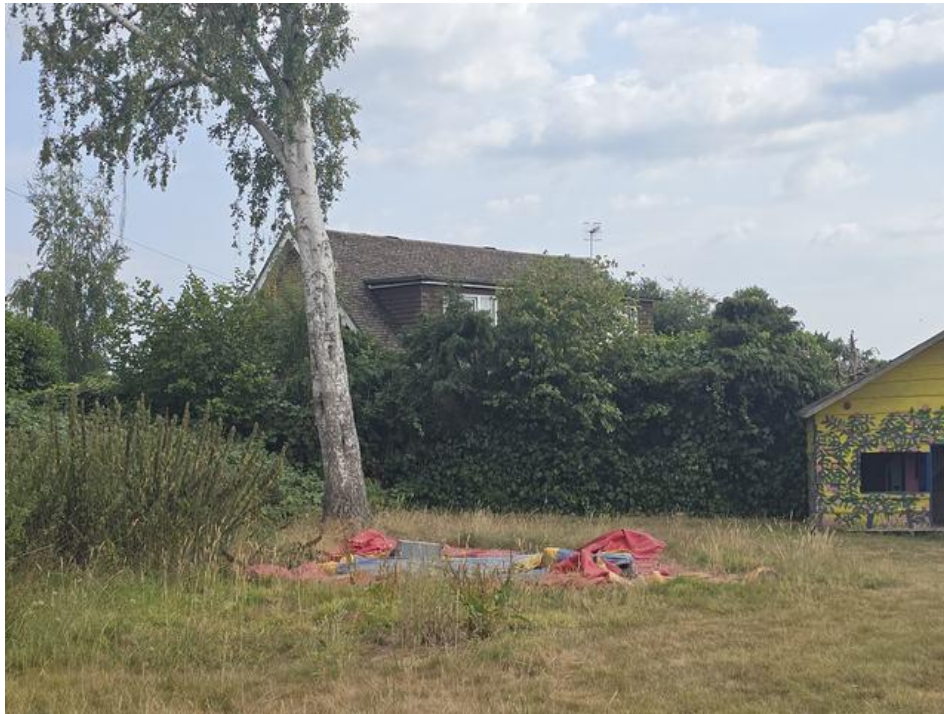
**2.4.1** There will be some shading of the rear of the commercial building from H09. There are no windows on this side of the building, so it is not a constraint.

**Image 9** H09 a mixed species hedge along the southern boundary of the site.

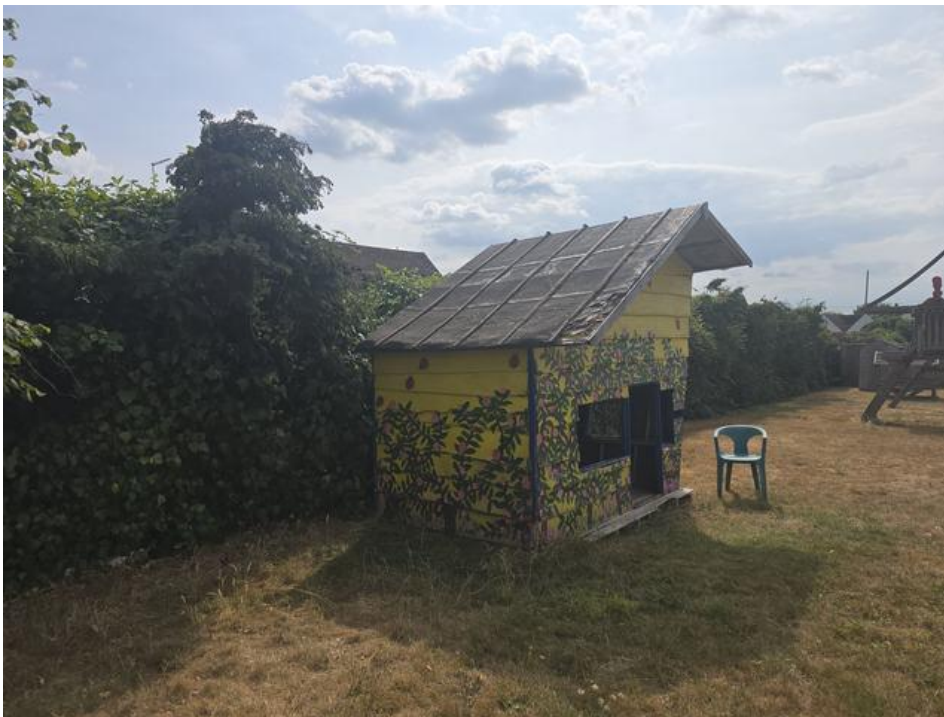
**Image 10** H09 a mixed species hedge along the southern boundary of the site.
