## Foul and Surface Water Drainage Report

**Prince Albert, Copthorne**

**Westcoast Developments Ltd**

Reference **C3261**

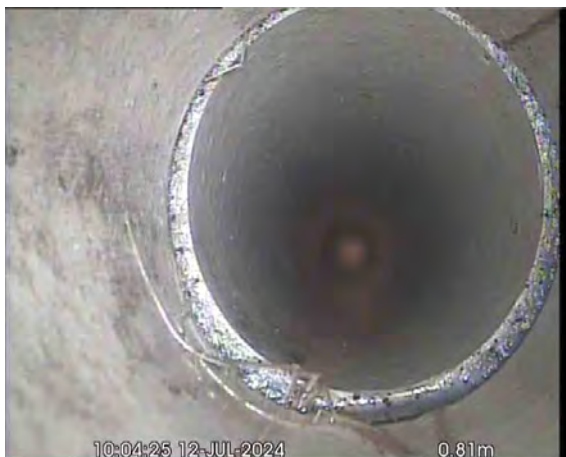
GULLYX\_b10122b8-1f1f-4b61-85ad-1d1dd839dd63\_20240725\_090208\_797.jpg, 00:01:01, 0.81 m  
Crack, circumferential at joint from 6 o'clock to 9 o'clock

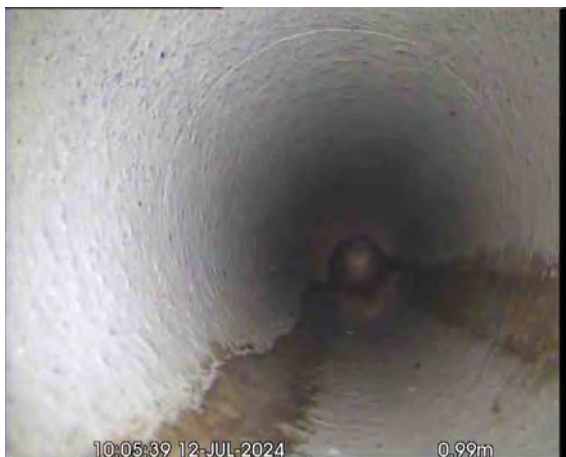
W\_CX\_b0b5a396-c87b-44df-b524-f6ae86763abc\_20240725\_090413\_863.jpg, 00:00:37, 0.99 m  
Crack, circumferential from 9 o'clock to 3 o'clock

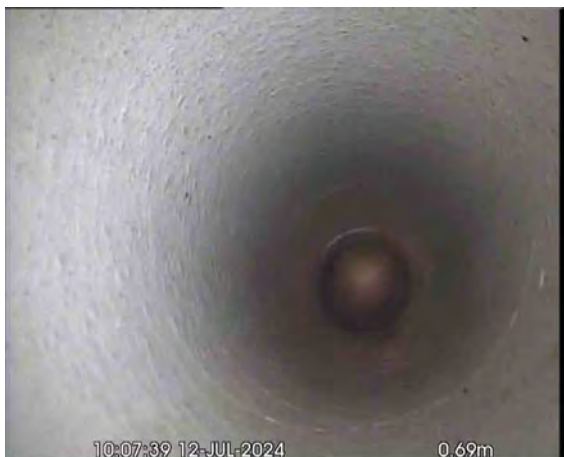
W\_CX\_6de99cdf-b413-404c-b955-bd55d3022d42\_20240725\_090601\_206.jpg, 00:00:31, 0.69 m  
Crack, circumferential from 3 o'clock to 8 o'clock

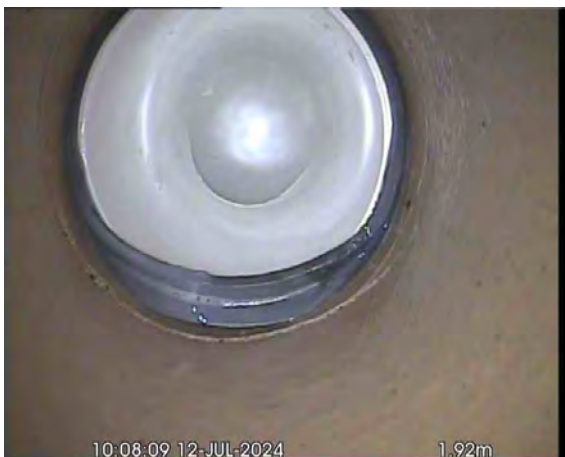
W\_CX\_140950e0-f4b9-4fa9-b1b6-8f3dc2314eb6\_20240725\_090748\_590.jpg, 00:01:01, 1.92 m  
Crack, circumferential at joint from 12 o'clock to 12 o'clock

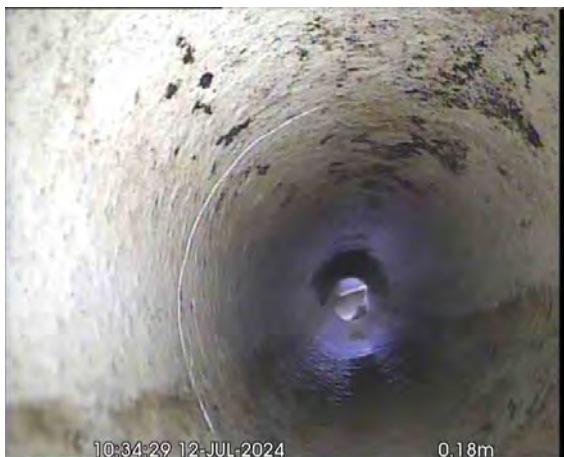
MH1X\_97e7b7b8-20ed-4a65-9726-8e0e94167fbc\_20240725\_090948\_059.jpg, 00:00:28, 0.18 m  
 Crack, circumferential from 6 o'clock to 12 o'clock

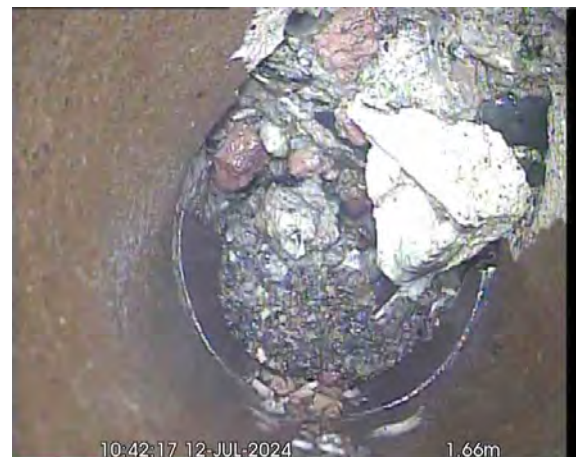
| Section | PLR | Grade | Description |
|---|---|---|---|
| 5 | REDUNDANTX | 4 | Broken pipe from 10 o'clock to 3 o'clock |

REDUNDANTX\_29814b43-2bf2-411c-83a3-7448b2e32080\_2  
 0240725\_091151\_156.jpg, 00:00:47, 1.66 m  
 Broken pipe from 10 o'clock to 3 o'clock

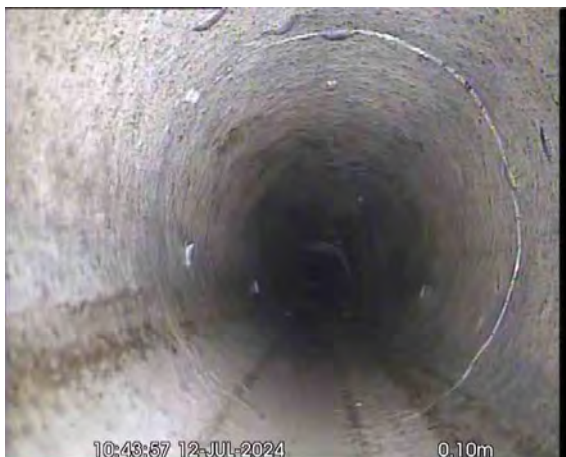
MH6X\_d2fe370d-baf2-4429-b37e-bc117d0a8e8e\_20240725\_091559\_829.jpg, 00:00:23, 0.10 m  
 Fracture, circumferential from 11 o'clock to 5 o'clock

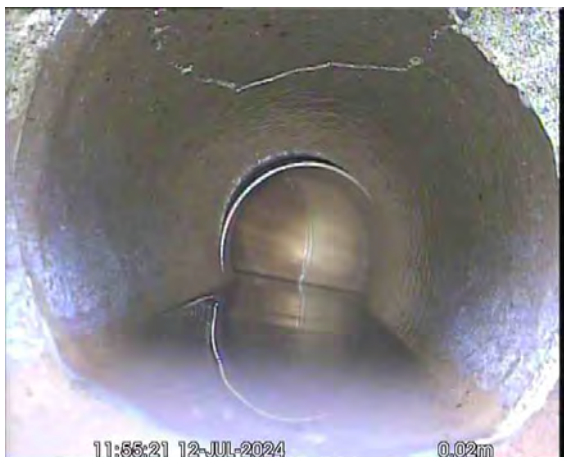
MH2X\_71538d31-1645-4ac7-b3ba-3a632e838191\_20240725\_092525\_584.jpg, 00:00:35, 0.02 m  
 Crack, circumferential from 10 o'clock to 2 o'clock
