# Gibbshaven Barn & Granary, Crawley Down Historic Buildings Report

**Gibbshaven Barn & Granary  
Furnace Farm Road,  
East Grinstead.  
West Sussex  
RH19 2PU  
TQ355 392,**

## **Historic Buildings Report**

**October 2025**

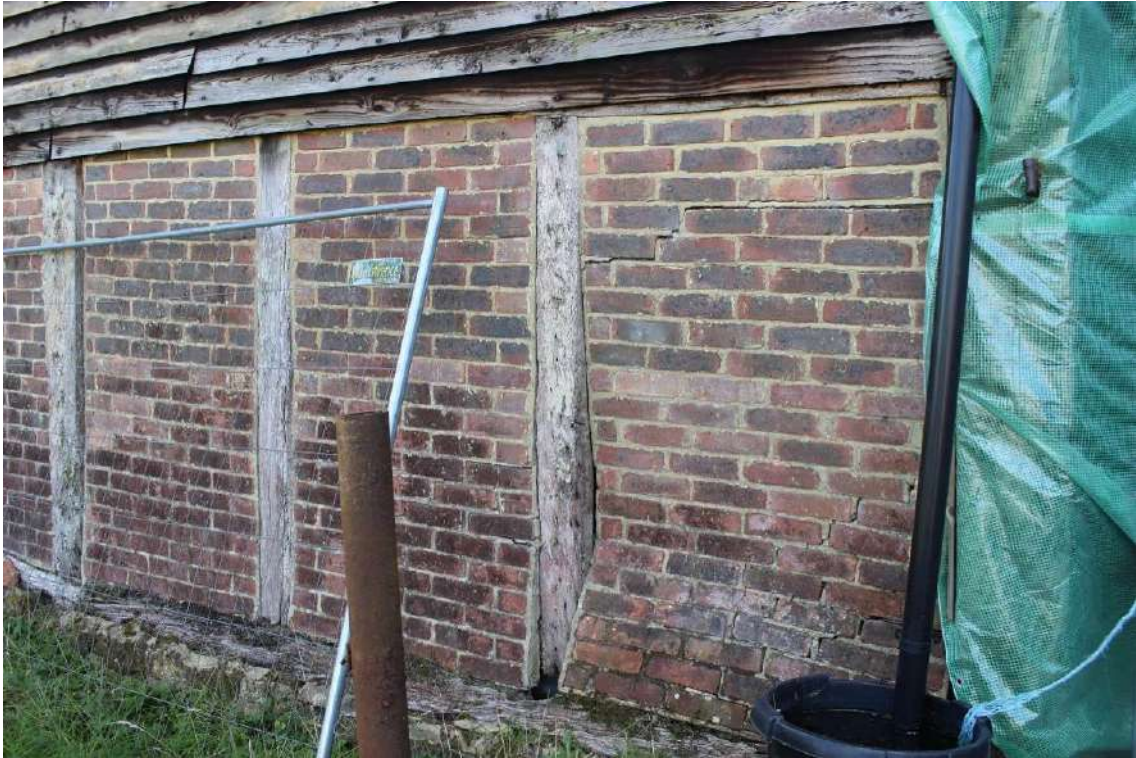
North wall with post C1 at right edge of image showing modern brick infill and stone plinth both with cementitious mortar

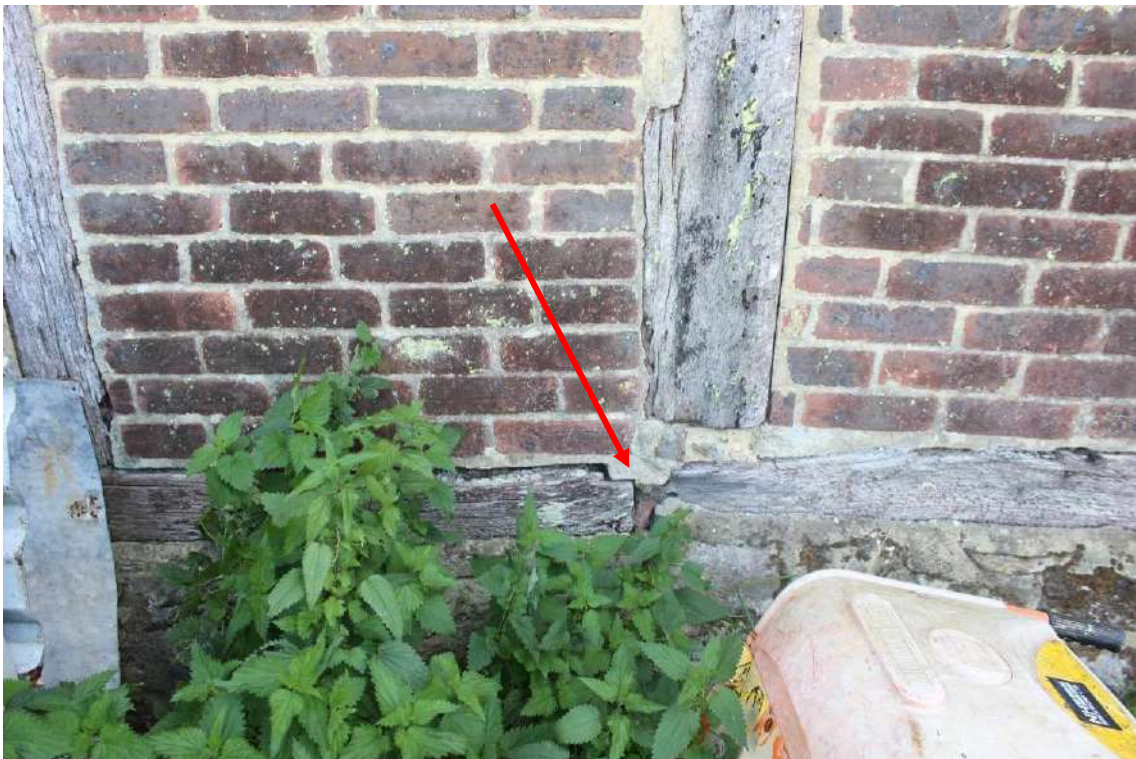
North elevation break in sill beam immediately east of post A1

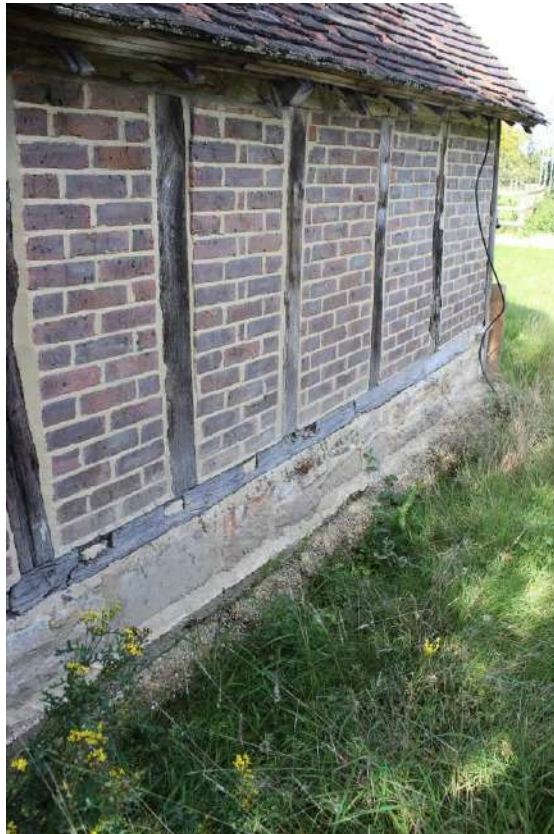
East end showing concrete below the stone plinth and brick infill of panels both with cementitious mortar

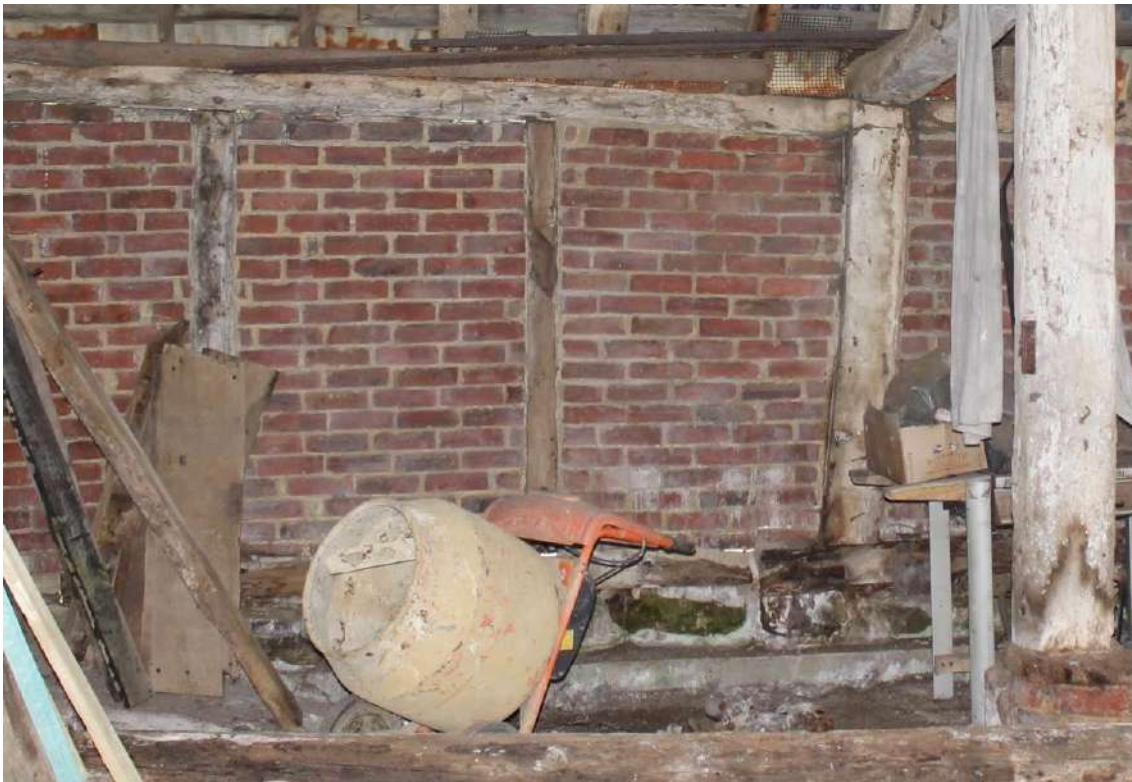
Aisle wall east of frame C showing concrete below stone plinth & brick infill both with cementitious mortar

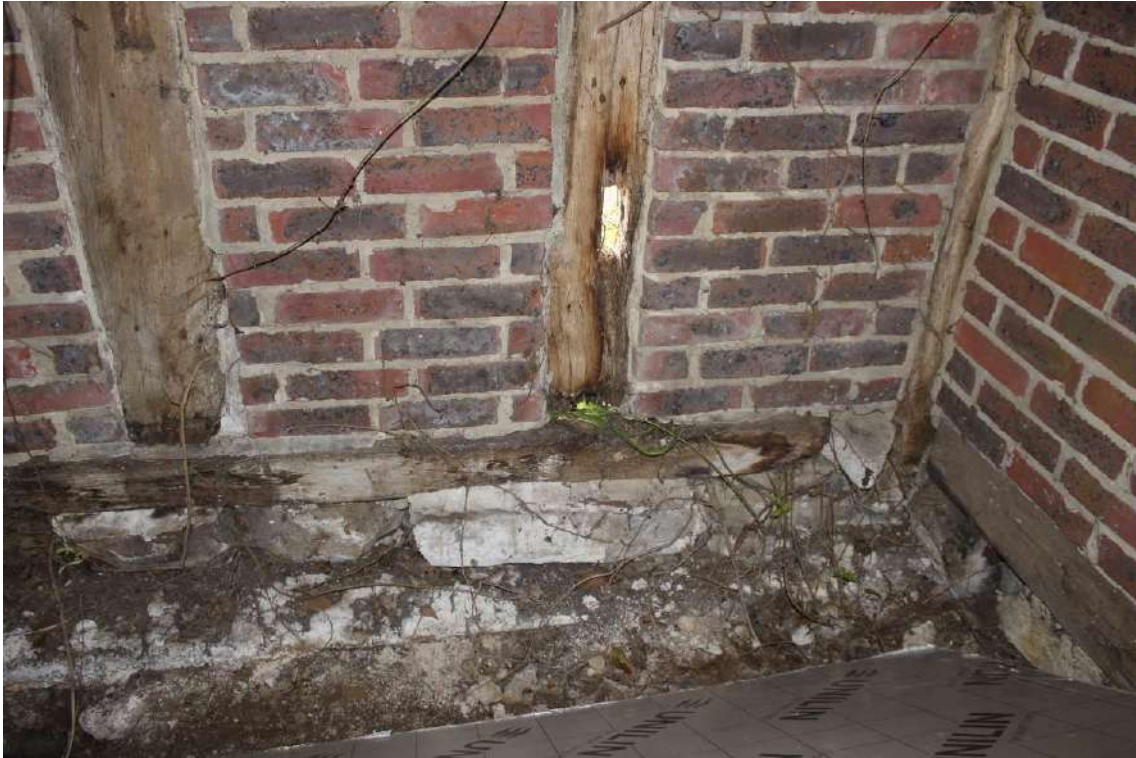
Concrete below stone plinth of west outshot. Looking south at corner L1

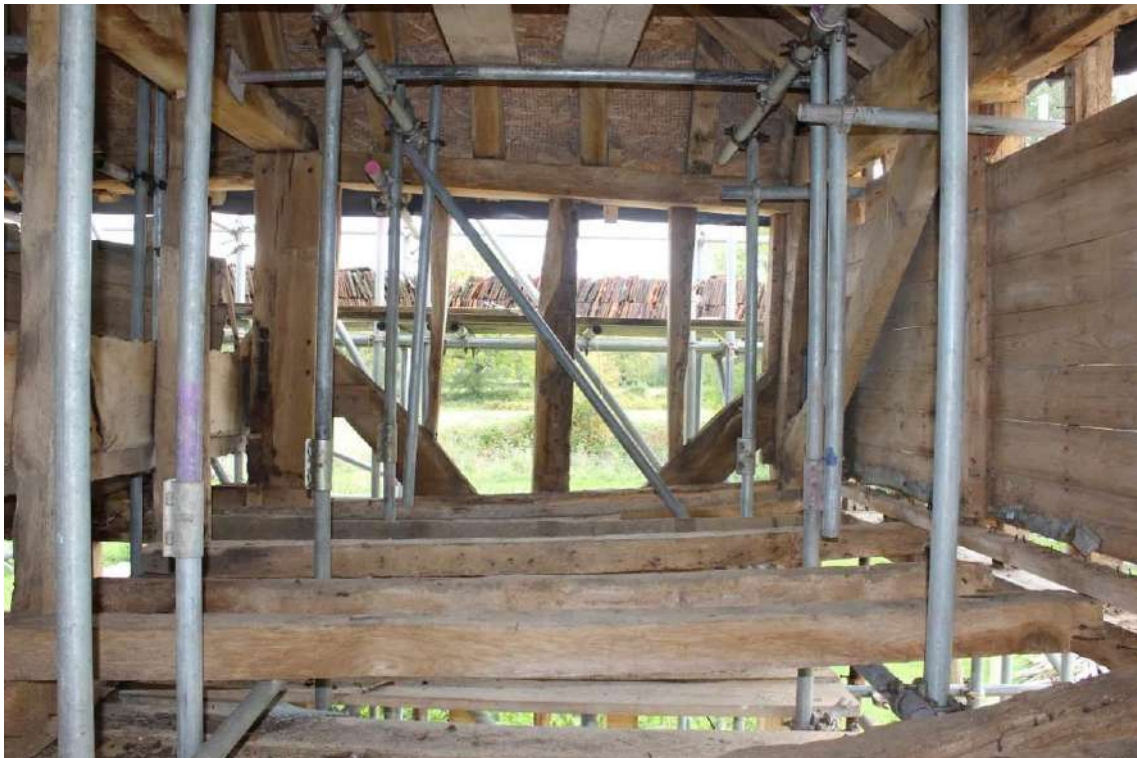
First floor bay B-C looking east with sloping floor joists

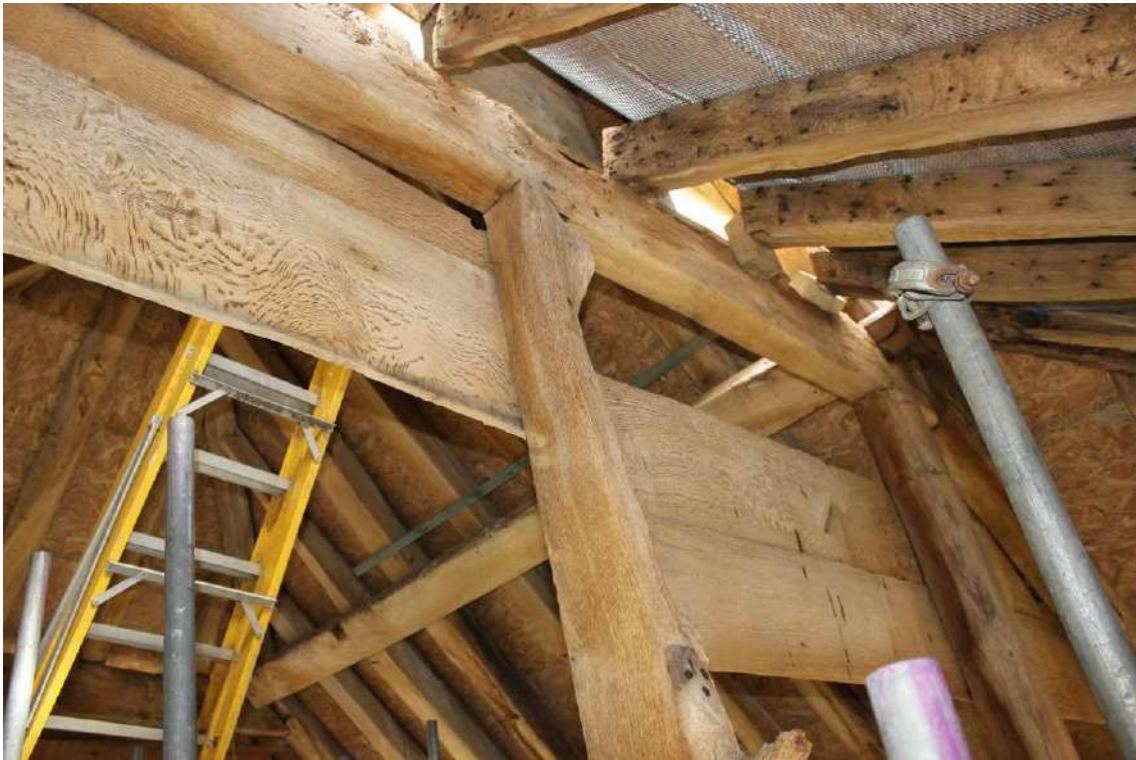
South side of frame B collar supporting reused timbers as rafters for later roof on right

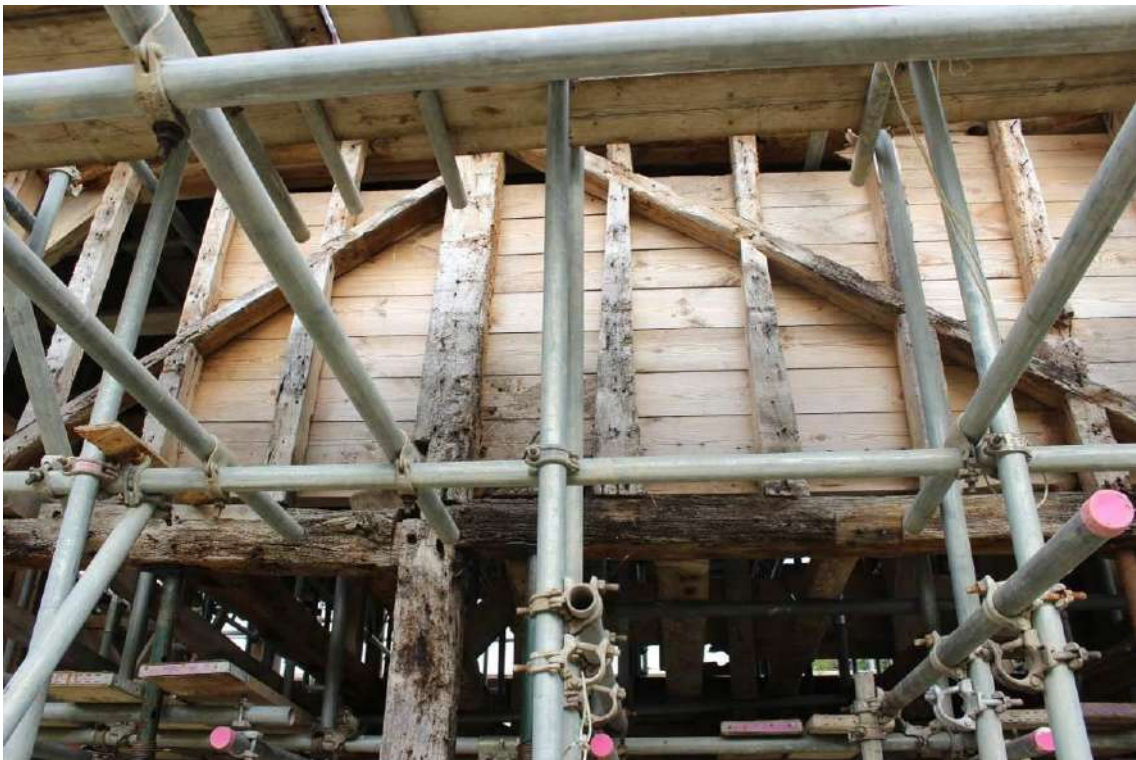
South face of frame C showing phase 3 infill with long diagonal braces
