## Schedule of Works - Addendum

| <b>Project</b> | The Barn and Granary<br>Gibbshaven Farm<br>East Grinstead |
| <b>Stage</b> | Listed Building Consent |

**Further  
Information**     Granary

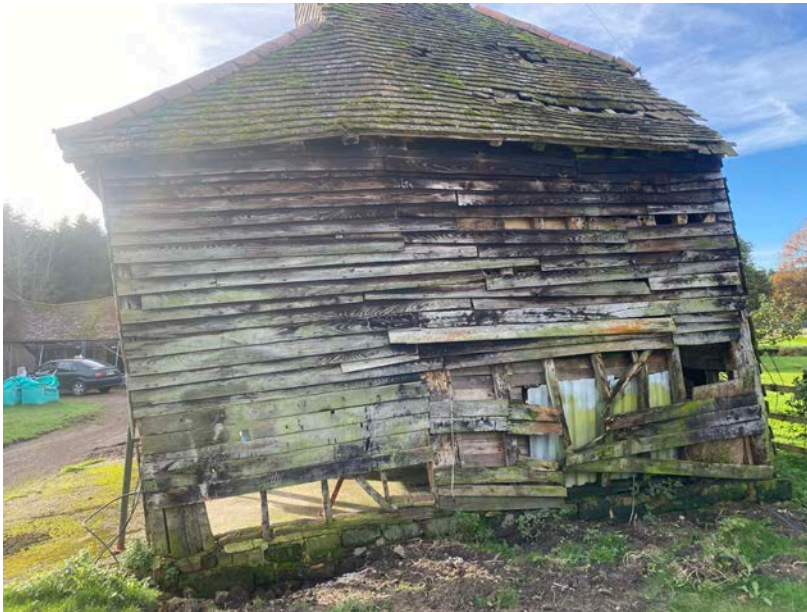
Further evidence showing that the granary was in a poor state and close to collapse is indicated in the attached photographs. These show the lean of the building to the south and that the front of the building is lower than the back. Missing tiles and a long period of neglect has resulted in a considerable amount of wet rot to the timber structure.

East face of granary before removal of tiles and cladding, showing lean to the south and some of the failed timbers.

A bat survey and emergency permission was agreed by Natural England to remove tiles to reduce the weight before any stabilisation work could begin. The building was stabilised and the lean corrected with scaffolding and hydraulics, and covered again to protect from the weather as requested by the council

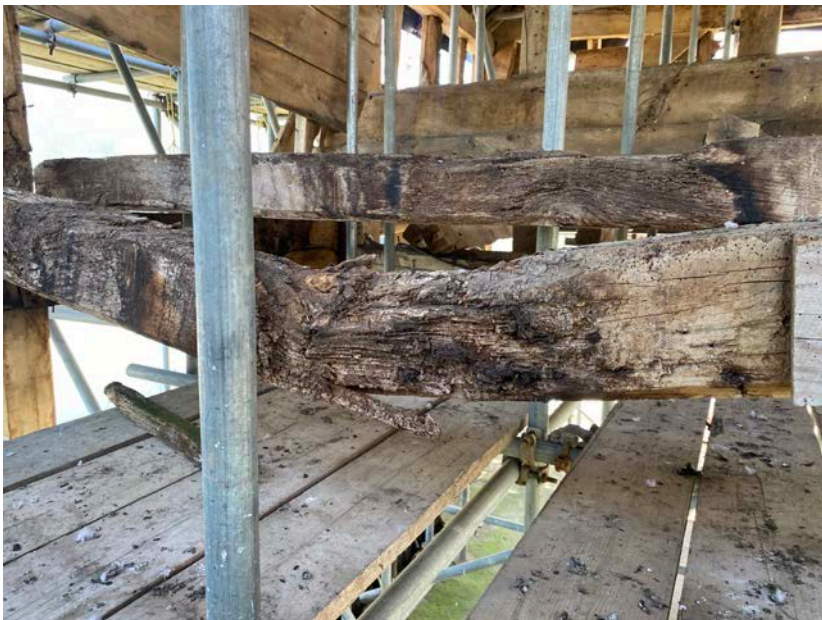
The photograph above shows the wet rot that is directly under the missing tiles that are apparent in the previous photograph. There are nine of these structural first floor beams missing, having been removed before the current ownership. Replacements have been ordered but cannot be installed until approval is gained from the planning authority.

The aforementioned report confirms that certain elements of the structure had 'failed' and replaced with like for like, involving the minimum intervention. These works constituted emergency repair works that were necessary to ensure the stability (and survival) of the building.

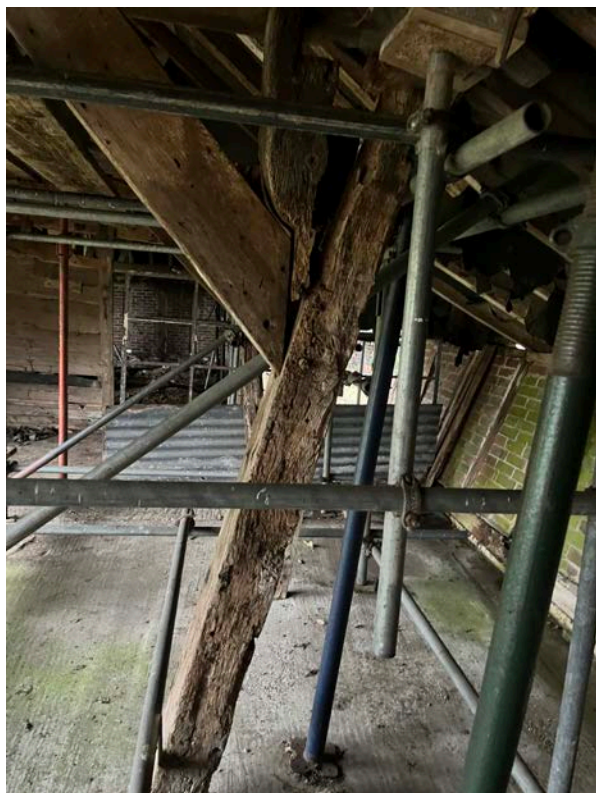
The scaffolding to the west outshot had originally been put in place by the previous owners of the site. However, it was found that further deterioration had taken place to the structure that was beyond its capabilities. Further deterioration of the structure was taking place and therefore emergency repairs had to be instigated.

The barn outshot showing the timber supports and brick panels leaning dangerously prior to stabilisation. This was the situation inherited by the current owners.

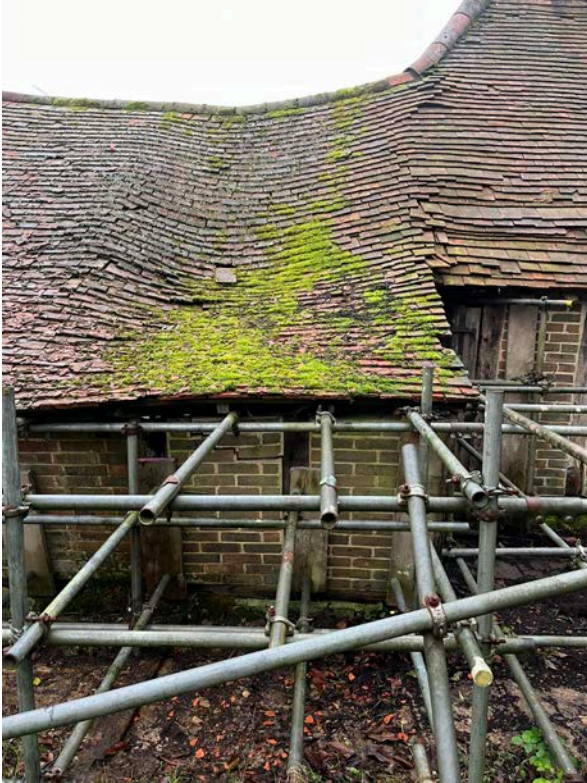
The west elevation of the west outshot as inherited by the current owners. The inner purlin had collapsed due to rot caused by water ingress, allowing the rafters to drop and push over the external wall. This has now been carefully and painstakingly repaired by the current owner.

By relacing the failed timbers, the west outshot has been stabilised. This constitutes emergency repair work. Approval by the local planning authority is awaited before the works can be finalised.
