# THE BARN & GRANARY

GIBBSHAVEN FARM  
EAST GRINSTEAD

## SCHEDULE OF WORKS

| <b>Project</b> | The Barn and Granary<br>Gibbshaven Farm<br>East Grinstead |

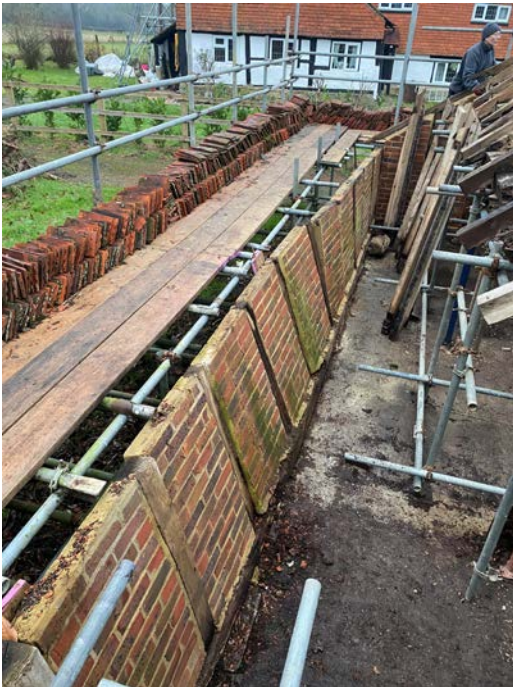
The external infill brick wall panels had partially collapsed and were leaning outwards at approximately 15 degrees. They were being supported by shoring consisting of a scaffold frame which had been installed by previous owners. This partial collapse had been caused by the failure of the main purlin on the west side allowing the roof to spread and push over the western external wall.

collapsed wall with roof removed

- The partially collapsed brick infill panels were carefully removed and the bricks set aside for reuse.
- The existing timber uprights that separated the brick panels were leaning due to the lateral load caused by the collapsed purlin. These were carefully removed and set aside for reuse.

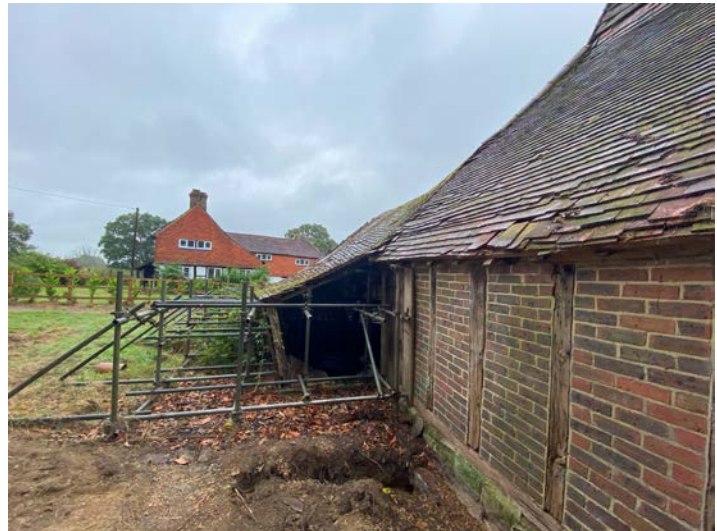
Scaffolding support frame prior to roof removal

- The existing scaffold was augmented by further scaffolding both internally and externally.
- The existing clay peg tiles were carefully removed and stacked on site for re use, Note that many of these tiles are delaminating and may not be suitable for reuse.

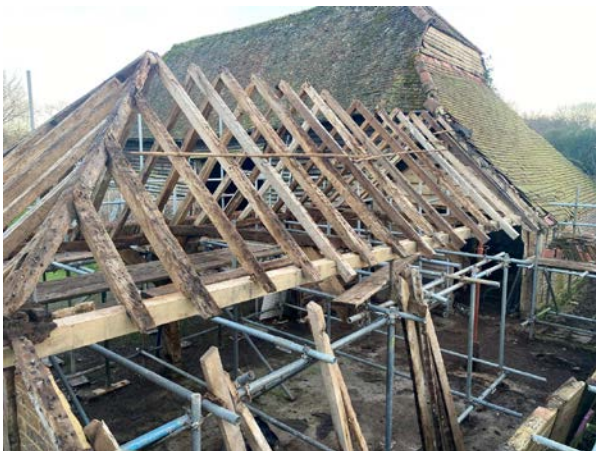
The outshot part of the barn was in a poor state. Parts of the roof structure had collapsed, due to the failure of the main purlin on the west side. This had allowed water ingress, leading to further deterioration of the roof structure generally including the intermediate posts supporting the purlin. It should be noted that the outshot is relatively modern and estimated to have been constructed in the 1960's.

New purlin supporting existing rafters and ready for existing outshot rafters to be installed

- All tile battens were removed due to extensive rot.
- All rafters on the west side were removed and numbered ready for reinstatement.
- The remains of original purlin were removed together with its intermediate supports and a new oak purlin was installed on the existing end bearings. The intermediate supports have been replaced by temporary acrow props pending replacement with new oak posts.

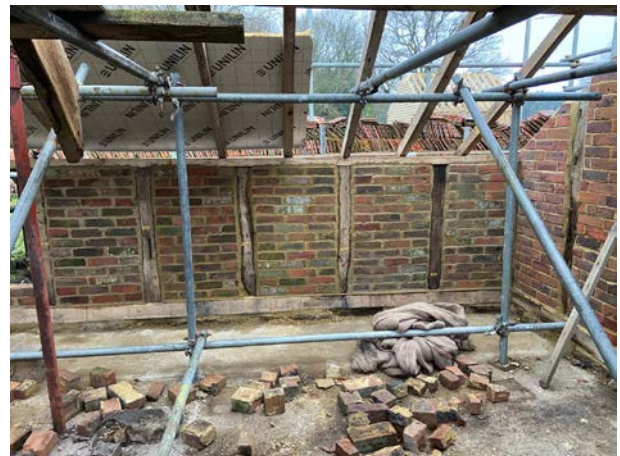
Rebuilt wall, with new sole, wall plates, and existing outshot rafters reinstalled

- The existing rotten sole plate was removed and replaced with new oak sole plate with DPC on the existing brick plinth.
- The new sole plate was morticed to receive the tenons of existing timber uprights and the existing uprights were reinstalled.

- The existing rotten wall plate was removed and replaced with a new oak wall plate morticed to receive the top tenons of the existing uprights.

- The existing rafters were replaced on to the new wall plate in their original positions. One new pair were installed where the existing ones were rotten and beyond reuse.
- Expanded metal lath was fixed to rafters externally to stabilise roof and provide an internal surface for future potential lime mortar render finish.
- Moisture resistant 12 mm thick OSB (oriented strand board) was fixed to rafters, using non ferrous screws, to provide structural bracing and a suitable substrate for battens and tiles.
- Temporary polythene weather proofing was installed on top of the OSB board.
- The brickwork infill panels were rebuilt using the existing bricks with lime mortar bedding joints.
- This building is now in a structurally safe and weatherproof condition.

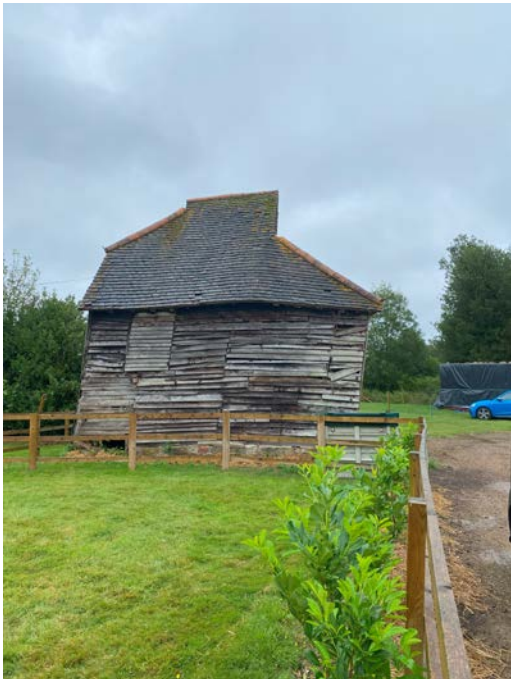
The granary was in a poor state and the structural engineer considered that an imminent collapse was likely. The whole structure had racked and was leaning to such an extent that it was in a state of progressive collapse and near to reaching a point of no return. A complex scaffolding frame work was introduced both internally and externally to the whole structure. This was to both support the structure, and prevent further progression of the collapse, whilst providing 'strong points' for jacking so as to enable a return of the structure to a position nearer to its original condition, thus stabilising it.

Granary west elevation showing racking

The reasons for the racking are the rotting of many of the structural members and lack of diagonal bracing. Therefore these future works are likely to include the replacement of the rotten post at the ground floor front of the building with a more substantial oak post with a proper foundation. Also remedial work to the existing central post and the addition of a proper foundation to its base. A new face will be spliced into the existing upper main vertical support member where the mortice has been damaged.

- The whole structure was now suspended from the scaffolding frame allowing it to be straightened up and returned to a near vertical condition. This was accomplished using a combination of hydraulic jacking, differential chain pulleys and Acrow props. It cannot be overemphasised how complex this operation was, and it is a tribute to the skills and ability of those who accomplished this difficult task.

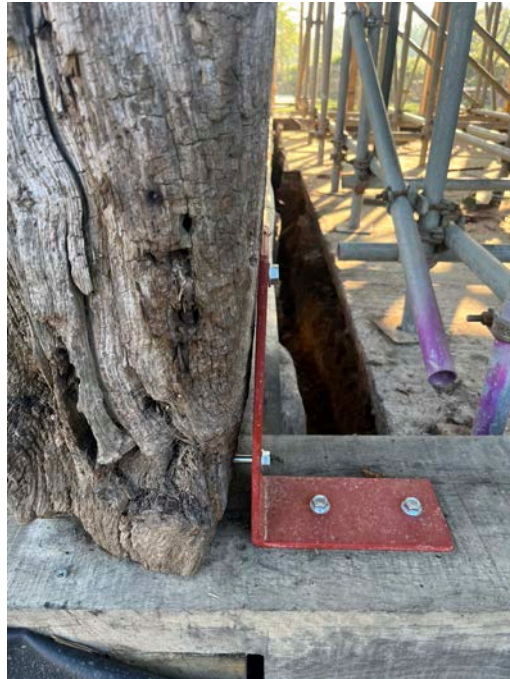
Existing wall member fixed to new sole Plate. (No tenon remaining)

- It was necessary to replace some of the original vertical timber members because they were rotten and not suitable for re use. Other members had lost their tenons due to rot and it was therefore not possible to locate them securely into the mortices within the new sole plate. For this reason it was necessary to add steel angle brackets in order to locate and secure them to the sole plate.

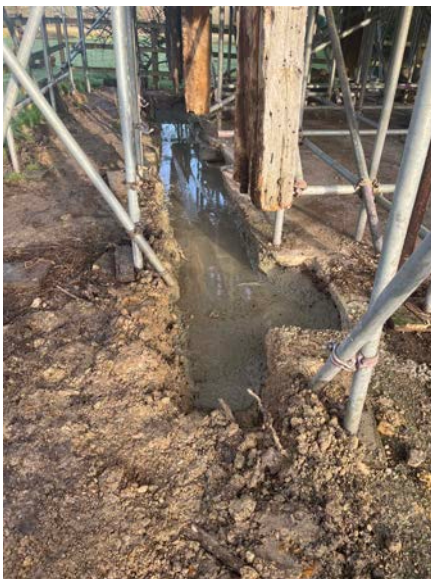
New concrete footings to support existing stone plinth

- Whilst the building was suspended, the existing external wall plinth stones were moved aside to enable the 'earth' foundations to be replaced with concrete strip footings.

- The stone plinth was then reinstated and bedded on to the new concrete footings.
- A new oak sole plate was installed to replace the existing rotten example and this was bedded on to the stone plinth with a new DPC. The sole plate was then morticed to take the tenons of the existing vertical frame members.

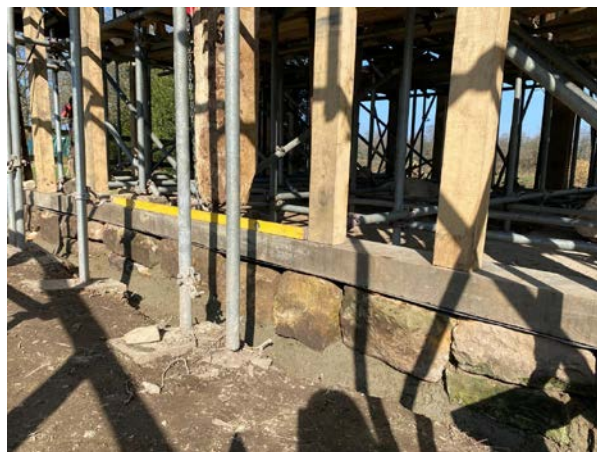
New oak wall members morticed into new sole plate. (Original members too rotten to replace), on reinstated stone plinth.

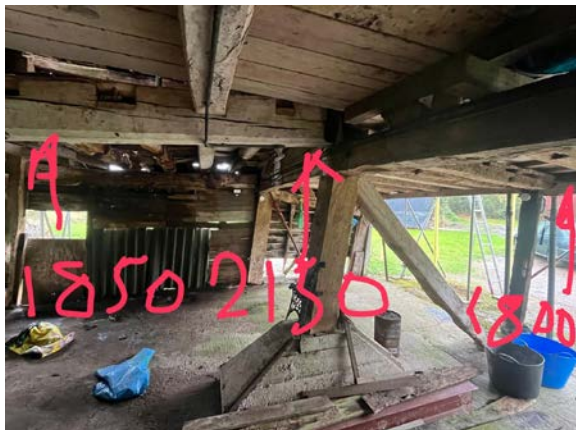
- There is a substantial central post within the building which has had a large concrete flaunching added to its base in the past. This is probably because the base of the post was rotten and the post was starting to lean southwards towards the front of the building. This was an attempt to stop it from doing so, and thus to try to restrict the associated lateral movement of the building. There was also a temporary diagonal brace installed from the head of this central post to the concrete slab at the front (south) face of the building. This was to try to arrest the progressive collapse.

Central post with existing concrete  
flaunching and strut. (Note lean)

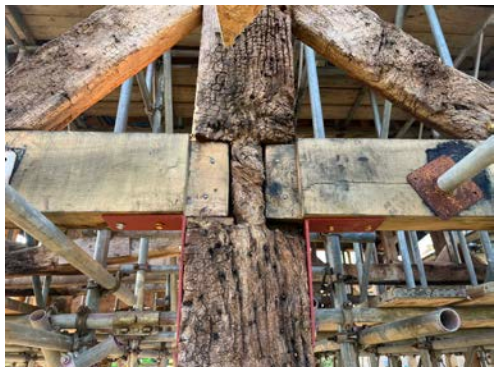
New oak roof truss members housed  
into existing damaged mortice. (New  
face to be spliced in)

- There were two timber roof tie members that were rotten and not fit for reuse. New oak ties were installed and due to the lack of integrity in respect of the post into which they were morticed, had to have steel angle brackets fitted. The mortice which had become exposed and was partly rotten is to have a new oak section spliced onto it.
