| Contract: <b>Furze Field - RMS Verification</b> | | | | Client: | Trial pit: <b>Plot 34</b> |

Gas Membrane Installation  
Validation Report  
Elivia Homes  
The Woodlands  
Reeds Lane  
Sayers Common  
BN6 9JG

## Appendix 1 – Site Survey Sheets

| Housebuilder Name: Elivia Homes - The Woodlands. | | Date: 12/03/2025 | |

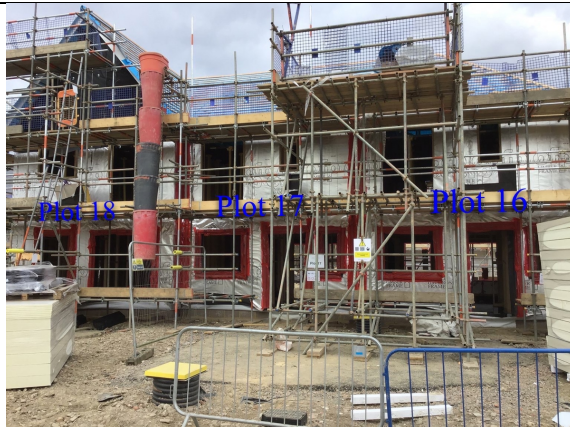
A general overview of plots 16-18.

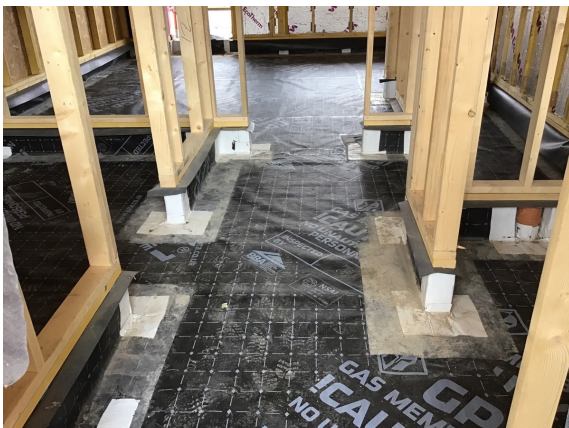
Overview of the Juta GP1 Gas Membrane that has been installed as an infill to plot 16.

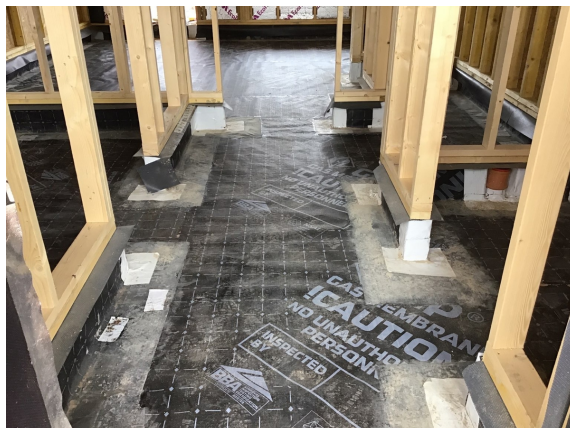
Overview of the Juta GP1 Gas Membrane that has been installed as an infill to plot 17.

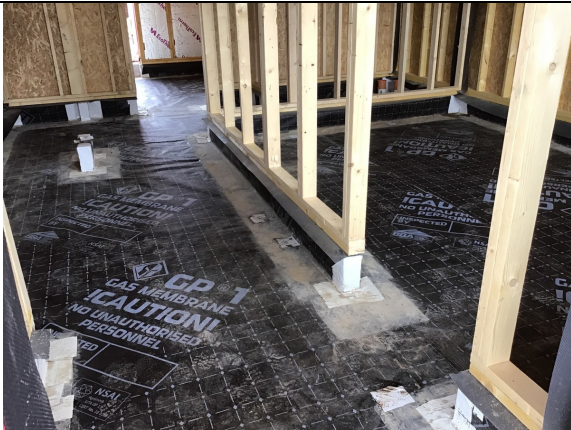
Overview of the Juta GP1 Gas Membrane that has been installed as an infill to plot 18.

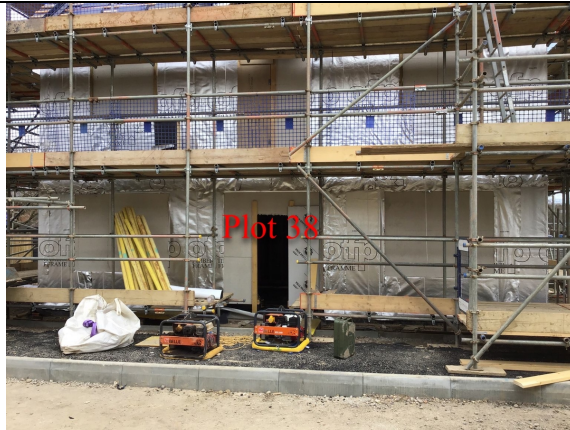
A general overview of plot 38.

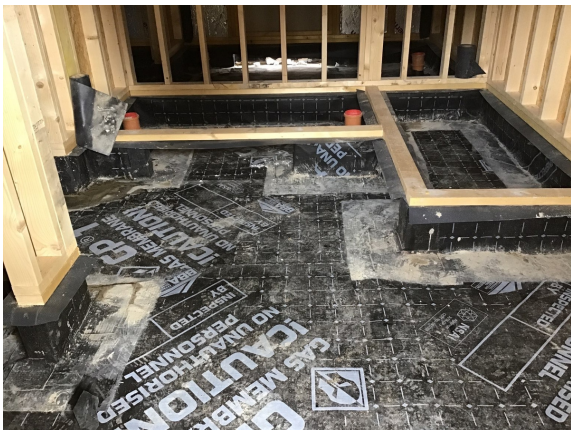
Overview of the Juta GP1 Gas Membrane that has been installed as an infill to detached plot 38.

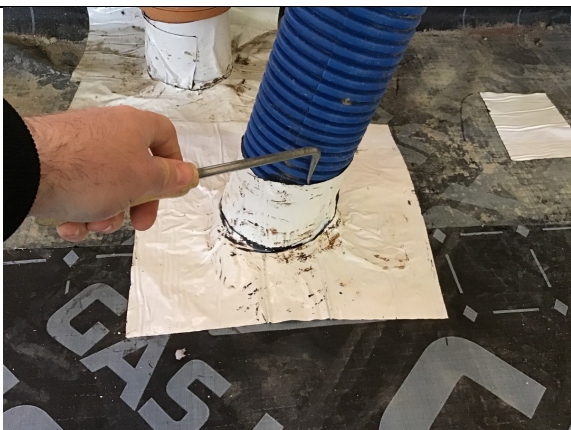
| Housebuilder Name: Elivia Homes - The Woodlands. | | Date: 12/03/2025 | |
|---|---|---|---|
| <b>Service Entry Seal Method:</b> The external of the pipe/ducts have been sealed using strips of self-adhesive gas membrane, this is an approved and recognised method in CIRIA C735 | | | |

Probe testing a typical pipe penetration detail in plot 16.

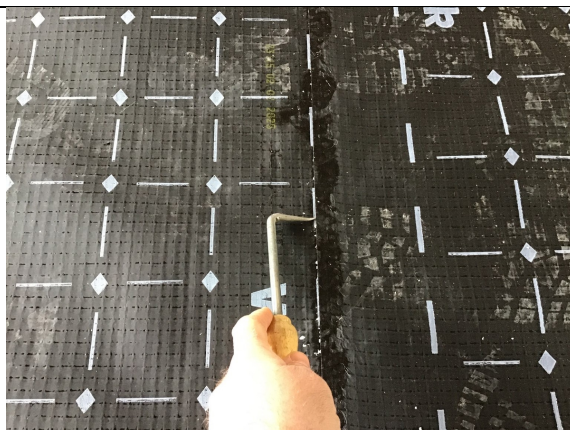
| Housebuilder Name: Elivia Homes - The Woodlands. | | Date: 12/03/2025 | |
|---|---|---|---|
| <b>Material Jointing Method:</b> The membrane has been overlapped sufficiently to achieve a sound joint, the joint is clean and dry and has been joined by means of hand welding with a hot air gun and neoprene roller, the width of the welded joint is a minimum of 30mm. | | | |

Probe testing a typical hand welded membrane lap in plot 16.
