| Housebuilder Name: Elivia Homes - The Woodlands. | | | Date: 21/03/2025 |
| Site Name: Reeds Lane, Sayers Common. | | | Weather: 14 °C Dry |
| Postcode: BN6 9JG. | | Surveyor: Adam McDermott (TGPV) | |

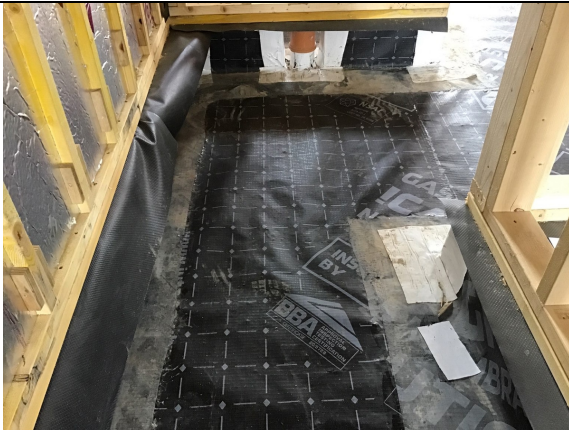
Overview of the infilled membrane in plot 16.

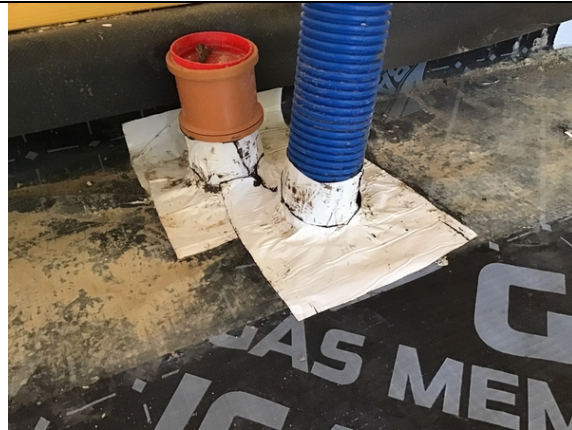
Typical pipe penetration detailing in plot 17.

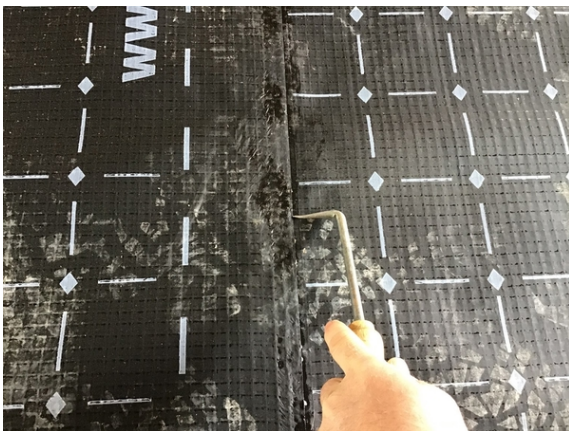
Probe testing all hand welded membrane laps in plot 17.

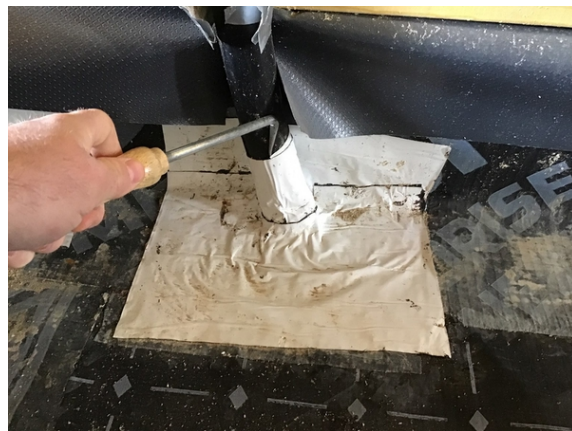
Probe testing all pipe penetration detailing in plot 17.

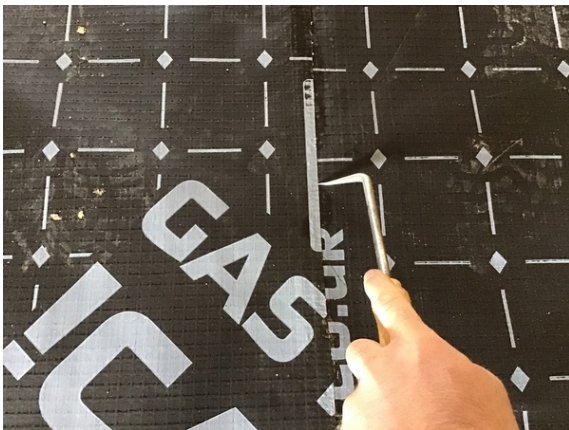
Probe testing all hand welded membrane laps in plot 18.

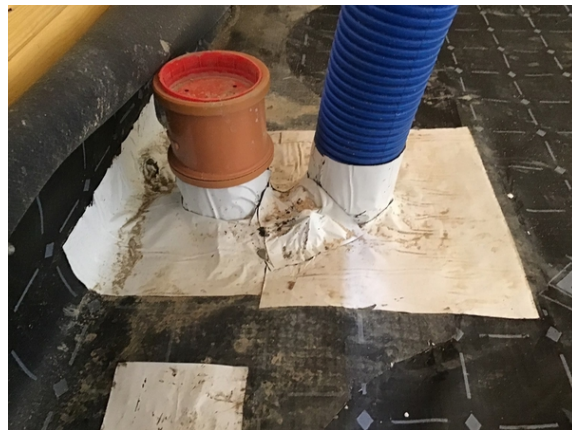
Typical double pipe penetration detailing in plot 18.

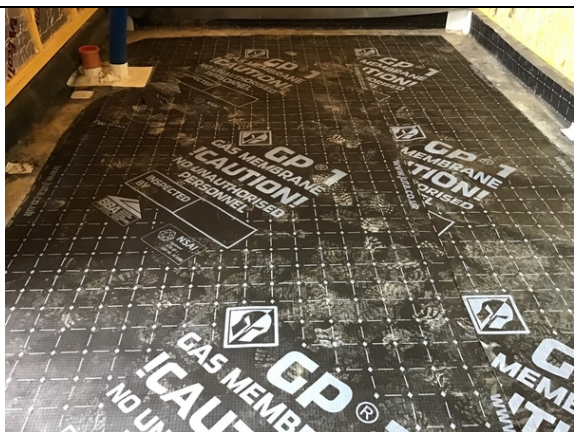
Overview of the infilled membrane to the room at the rear of plot 18.

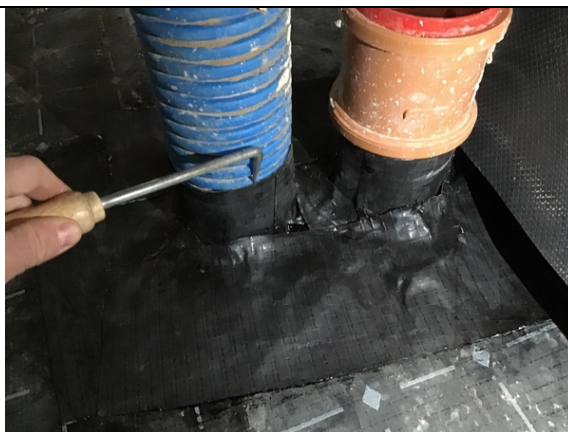
Probe testing all pipe penetration detailing in plot 38.

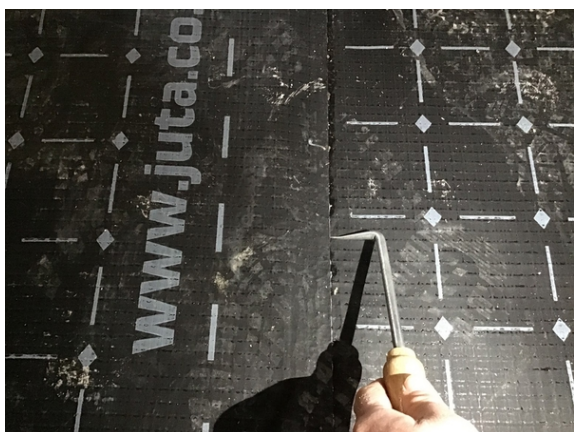
Probe testing all hand welded membrane laps in plot 38.

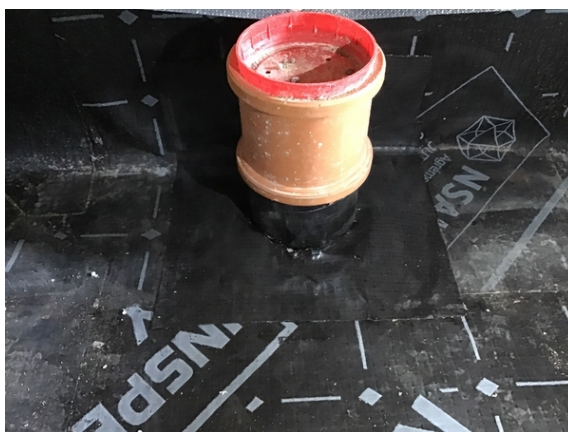
Typical pipe penetration detailing in plot 38.

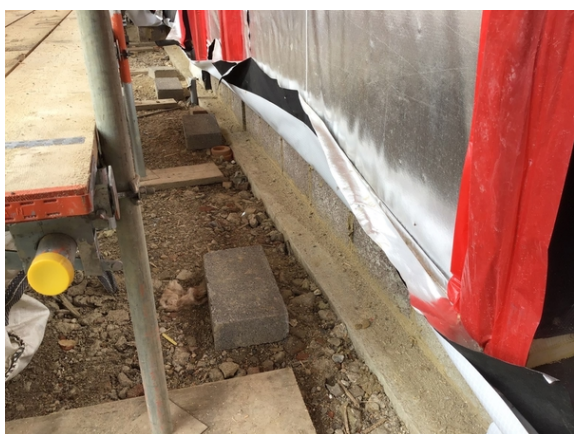
The outer brickwork was not in place to all plots noted above at the time of our inspection.

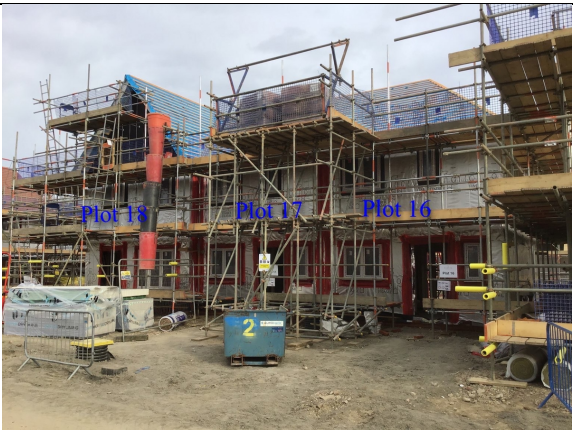
| | <p>membrane didn't span the entire cavity, MB Membranes have now extended the Juta GP1 gas membrane so that it now correctly spans the cavity to terrace plots 16,17,18.</p> <p>Note: the outer brickwork was not in place at the time of our inspection in plots 6 &amp; 7, therefore MEC were unable to obtain evidence of the membrane spanning the cavity.</p> <p>All plots are built on concrete raft foundations therefore the plots do not acquire air bricks.</p> <p>I was unable to obtain any photographic evidence of the Juta GP1 gas membrane &amp; the Juta GP1 SAM during today's inspection.</p> | |

A general overview of terrace plots 16,17 & 18.
