| | All patch repairs were carried out by mb membranes prior to our inspection. | |

Plot Overview Photographs

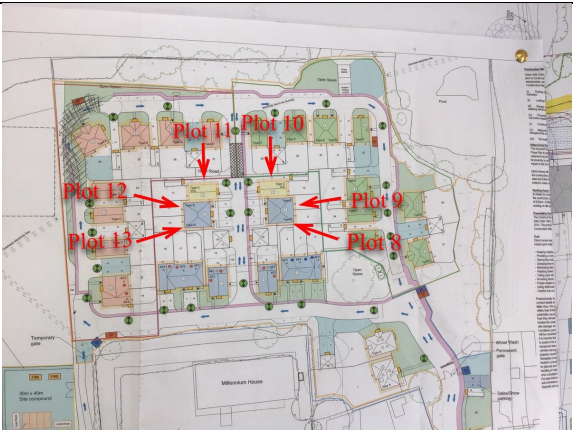
Marked up site plan.

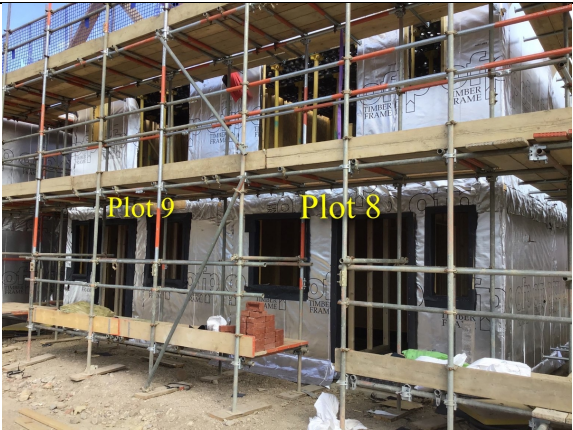
A general overview of semi detached plots 8 & 9.

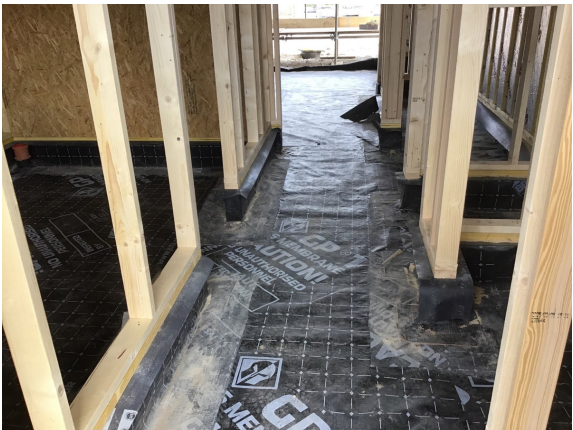
Overview of the Juta GP1 Gas Membrane that has been installed as an infill to plot 8.

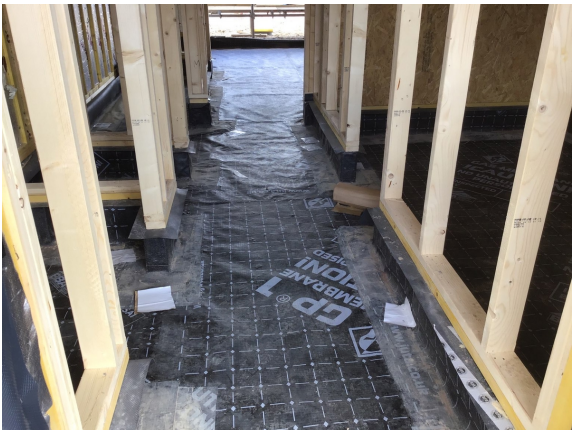
Overview of the Juta GP1 Gas Membrane that has been installed as an infill to plot 9.

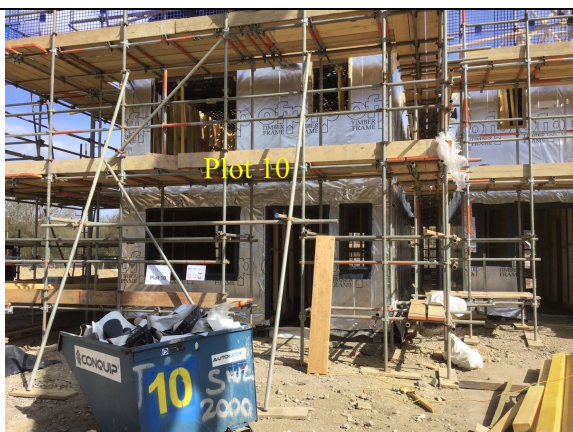
A general overview of plot 10.

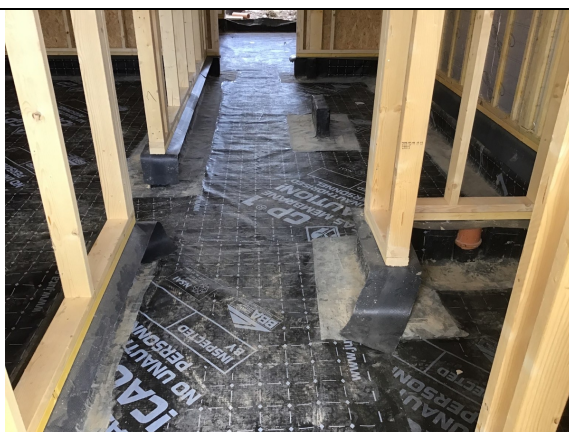
Overview of the Juta GP1 Gas Membrane that has been installed as an infill to plot 10.

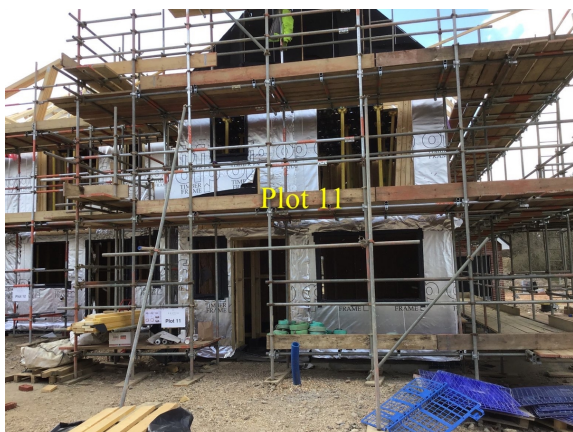
A general overview of detached plot 11.

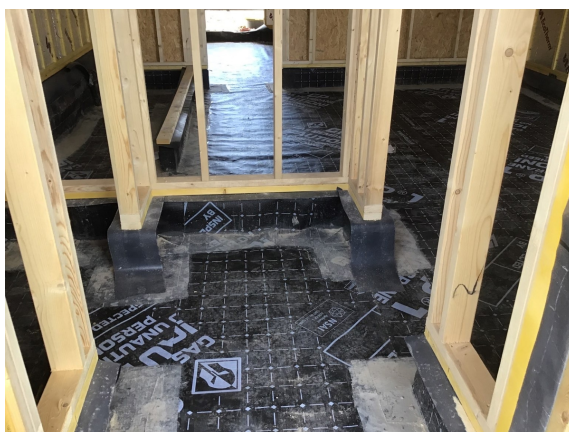
Overview of the Juta GP1 Gas Membrane that has been installed as an infill to plot 11.

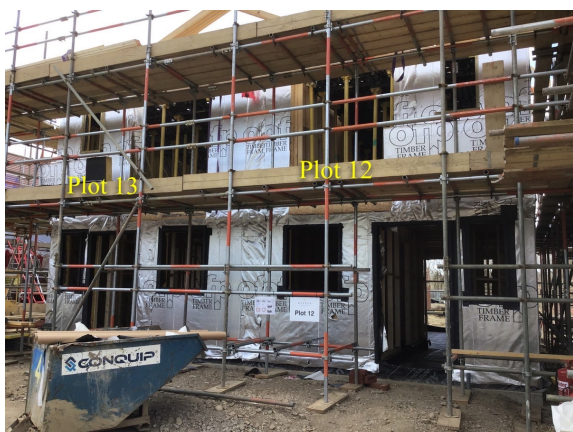
A general overview of semi detached plots 12 & 13.

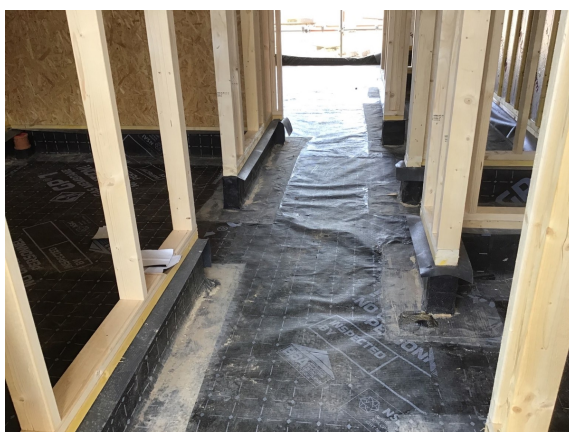
Overview of the Juta GP1 Gas Membrane that has been installed as an infill to plot 12.
