| Housebuilder Name: Elivia Homes - The Woodlands. | | | Date: 14/04/2025 |
| Site Name: Reeds Lane, Sayers Common. | | | Weather: 14 °C Dry |
| Postcode: BN6 9JG. | | Surveyor: Adam McDermott (TGPV) | |

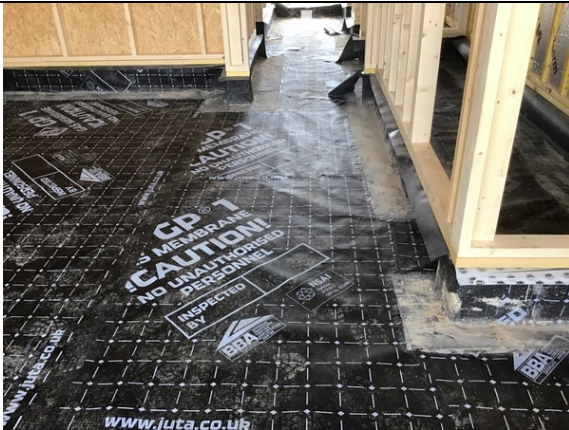
Overview of the Juta GP1 Gas Membrane that has been installed as an infill to plot 13.

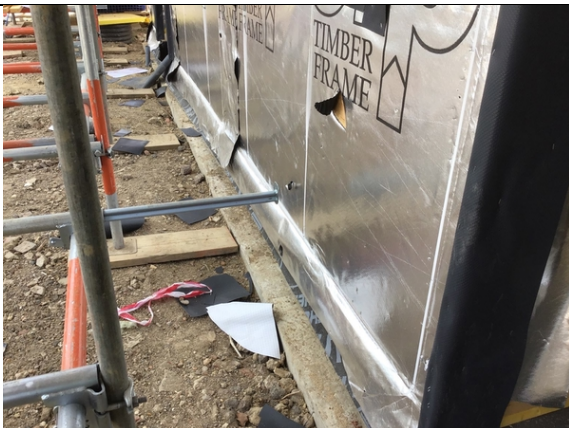
The outer brickwork was not in place to all plots noted above at the time of our inspection therefore MEC Environmental we're unable to inspect the membrane spanning the perimeter cavity walls.

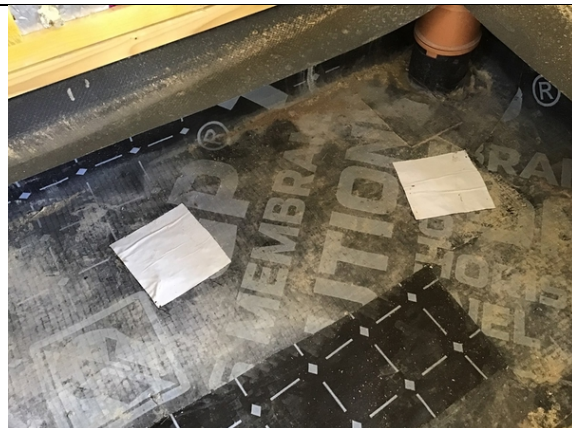
Patch repairs in plot 8 that were completed prior to our inspection by mb membranes.

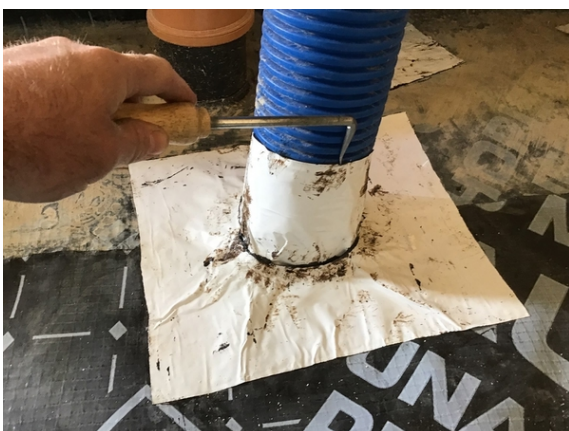
Probe testing a typical pipe penetration detail in plot 8.

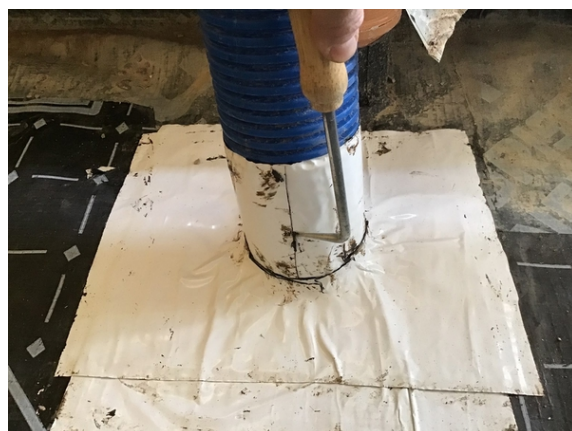
Probe testing a typical pipe penetration detail in plot 9.

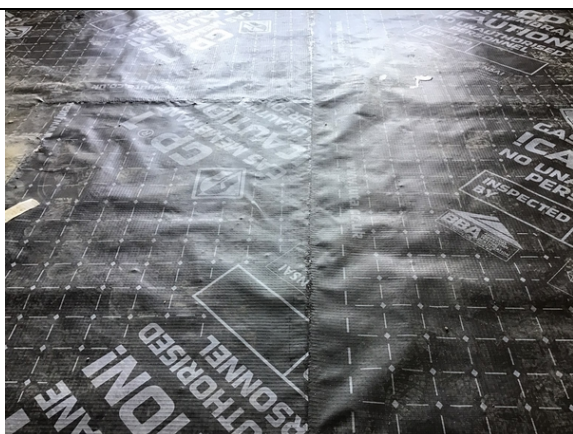
Overview of a typical hand welded membrane lap in plot 9.

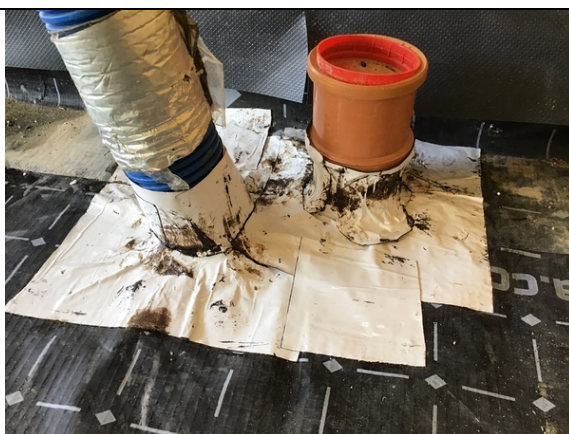
Typical double pipe penetration detailing in plot 10.

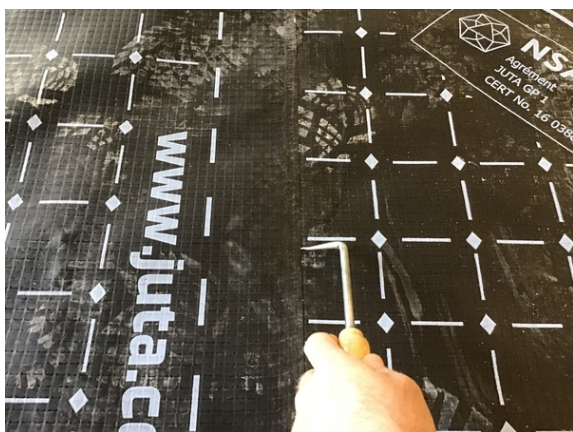
Probe testing a typical hand welded membrane lap in plot 10.

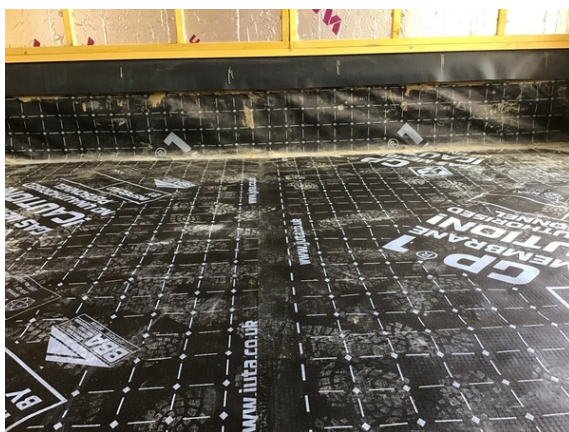
Overview of a typical hand welded membrane lap in plot 11.

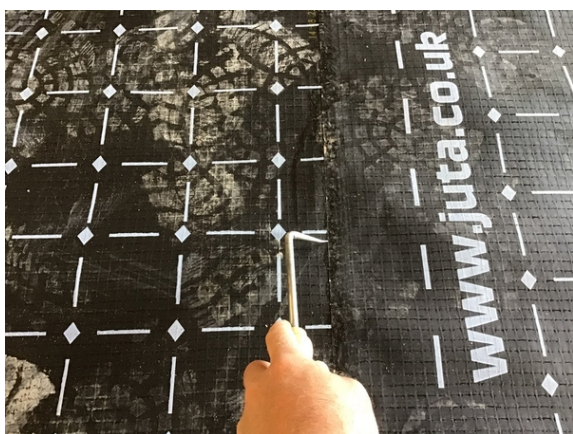
Probe testing all hand welded membrane laps in plot 11.

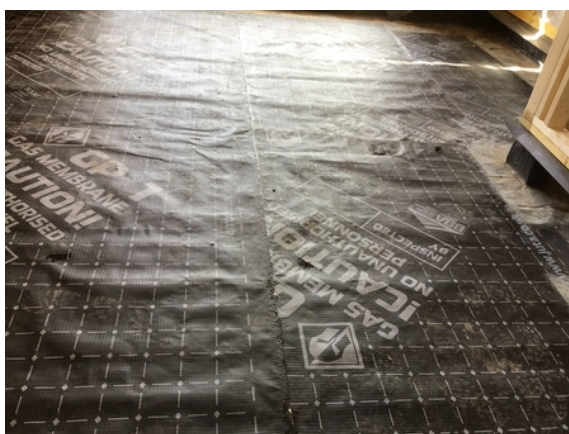
Typical hand welded membrane lap in plot 12.

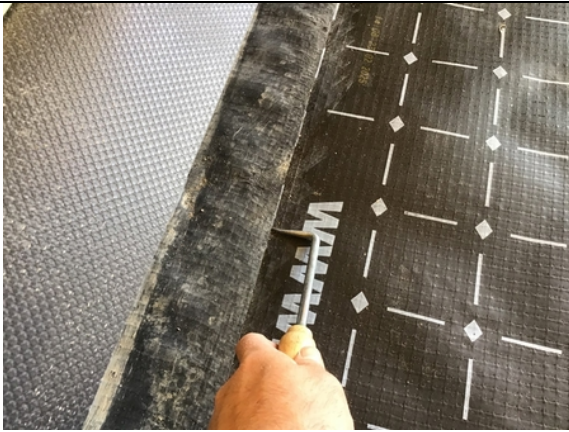
Probe testing all hand welded membrane laps in plot 12.

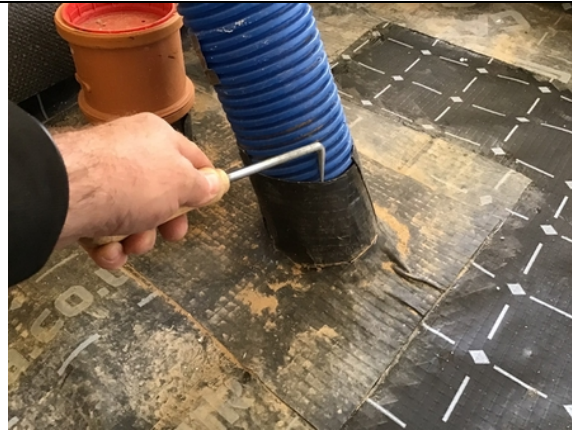
Probe testing a typical pipe penetration detail in plot 13.

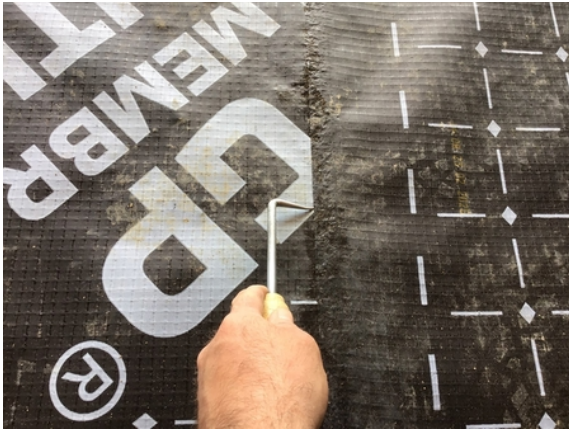
Probe testing all hand welded membrane laps in plot 13.
