### Detailing Sample Photographs

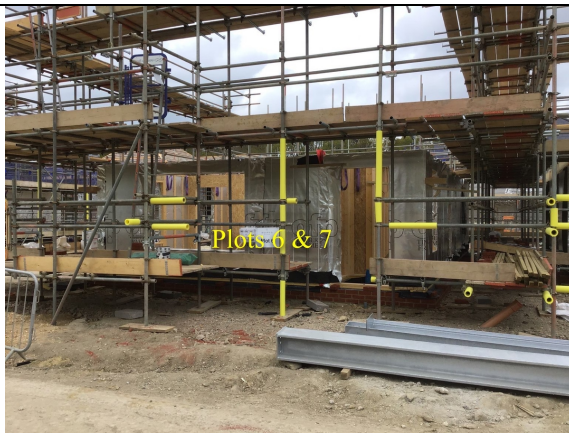
A general overview of maisonette plots 6 & 7.

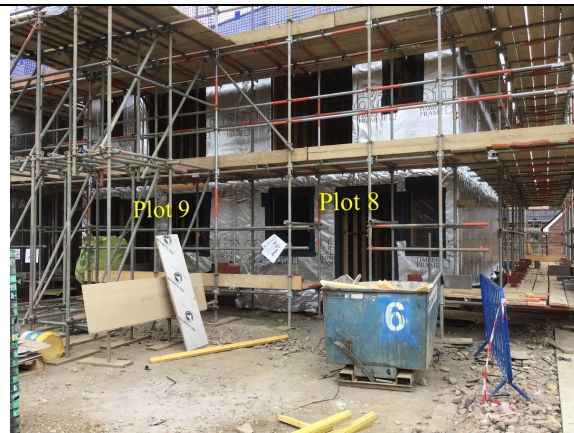
A general overview of semi detached plots 8 & 9.

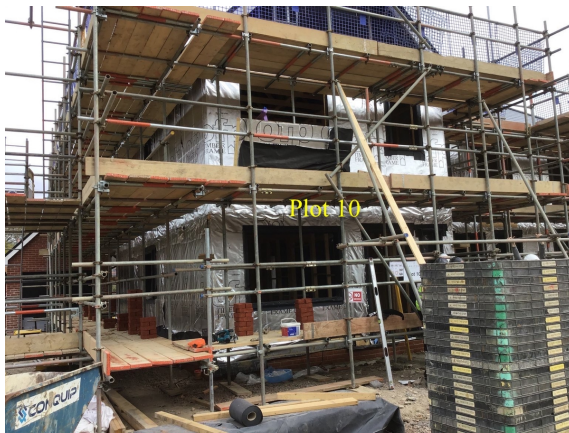
A general overview of detached plot 10.

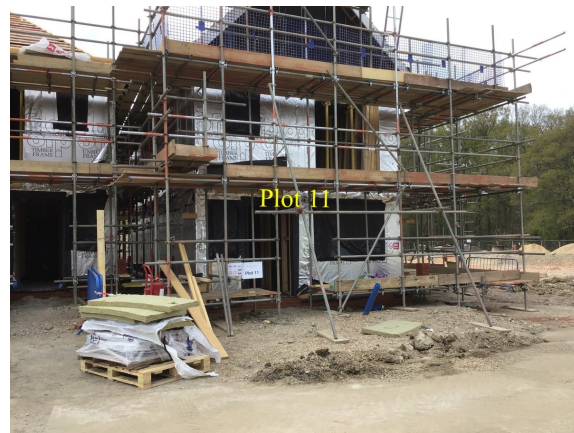
A general overview of detached plot 11.

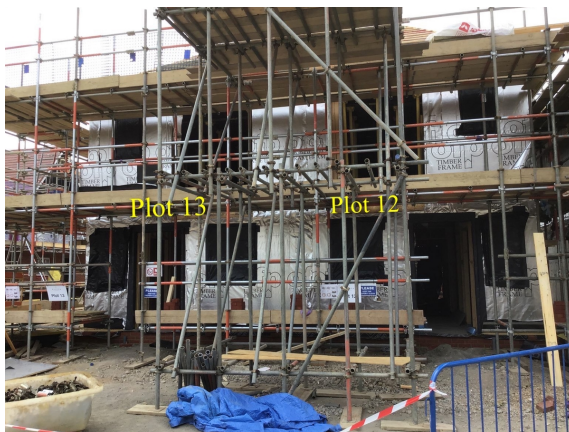
A general overview of semi detached plots 12 & 13.

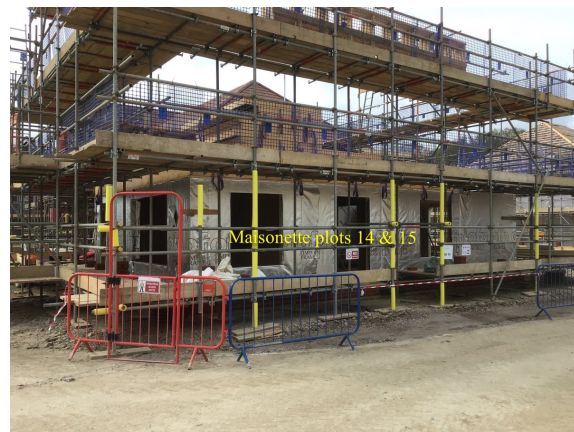
A general overview of maisonette plots 14 & 15.

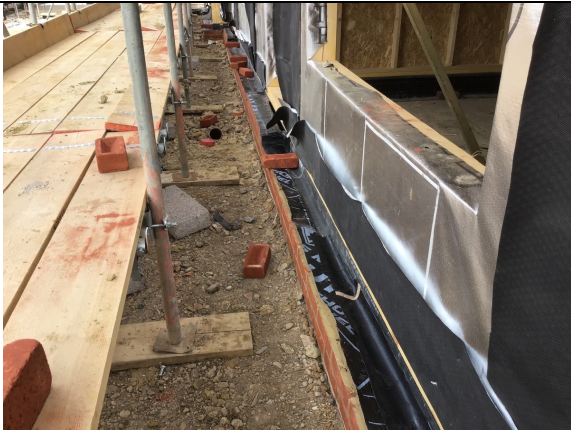
Overview of the extended Juta GP1 gas membrane that has been hand welded to the previously installed gas membrane which now spans the perimeter cavity wall across plots 3-5.

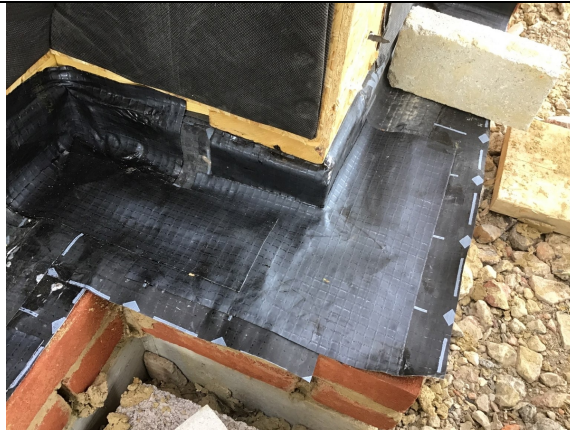
Corner detailing to plot 3.

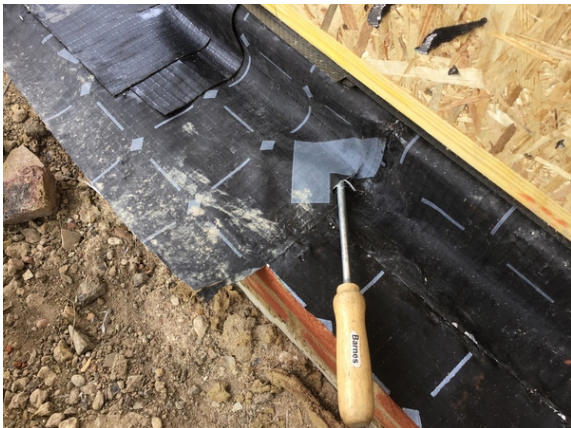
Weld defect found upon our inspection to plot 5.

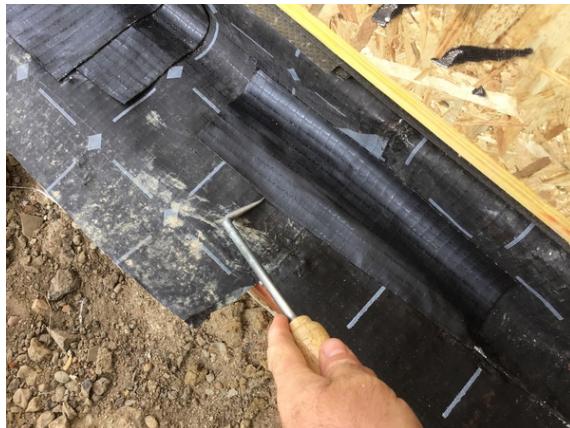
Probe testing the repaired weld defect in plot 5.

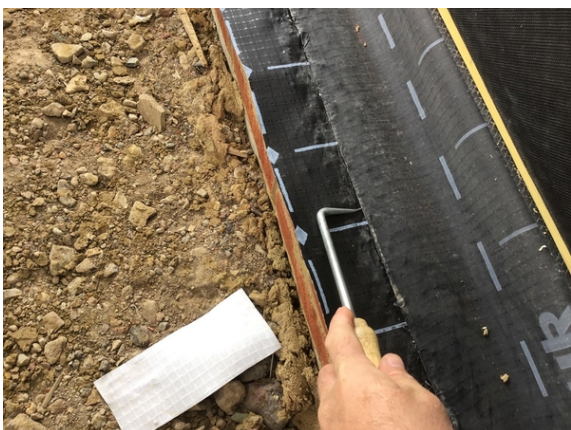
Probe testing the hand welded membrane lap in plot 4.

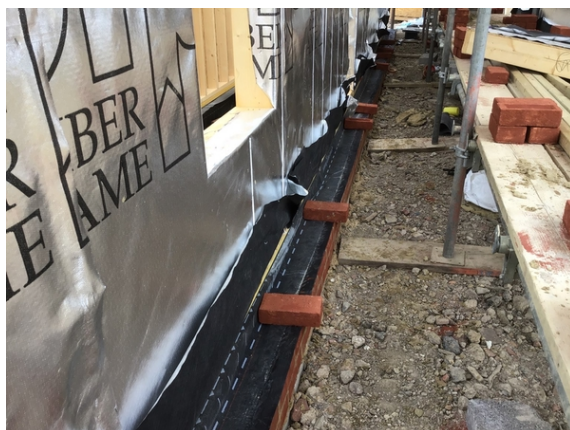
Overview of the extended Juta GP1 gas membrane that has been hand welded to the previously installed gas membrane which now spans the perimeter cavity wall across plots 6 & 7.
